Appendix A
JACOBS CONDITION ASSESSMENT 2019

Wilsonville Wastewater Facility Condition Assessment Report

April 2019

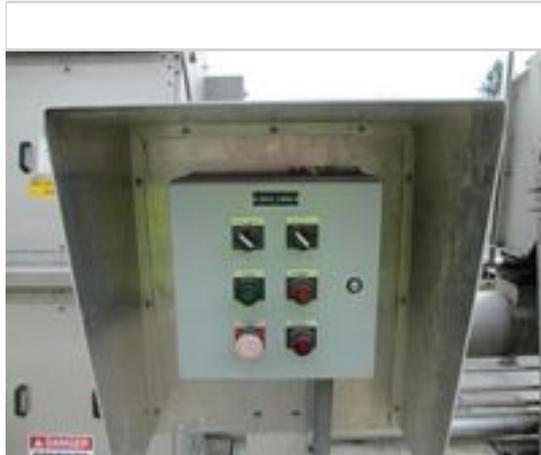
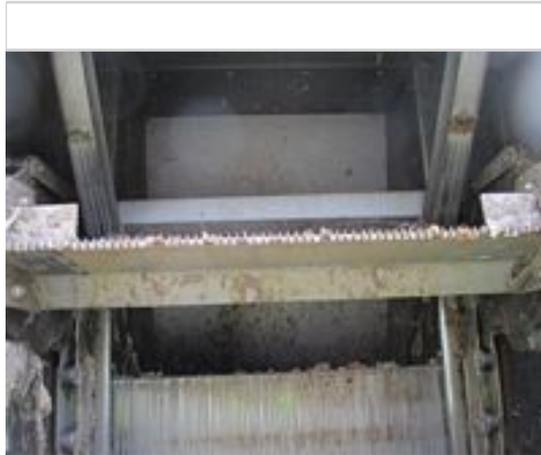
Deterioration of rubber between screen and screening trough

Bar screen rake had several teeth in the rake assembly bent. Would not allow rake to mesh with bar screen.

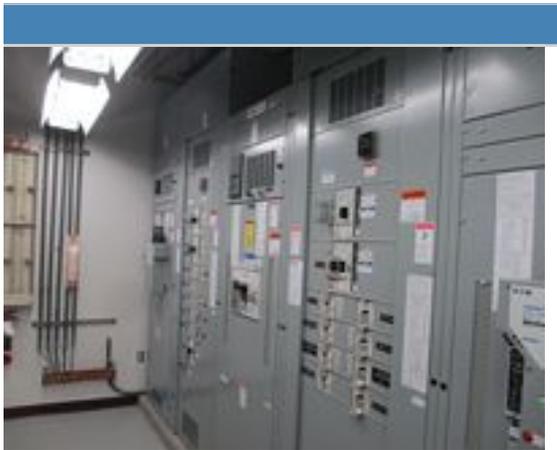
Asset Description	Switchboard SWBD40-02A	System	Secondary Treatment
Asset Type	SWITCHGEAR	Location	Sec Process
Asset ID	SWBD40-02A	Inspection Date	4/2/2019
Comments	Unable to access interior due to bolted panel, arc flash ratings exceeds corporate policy for internal inspection.		Flag

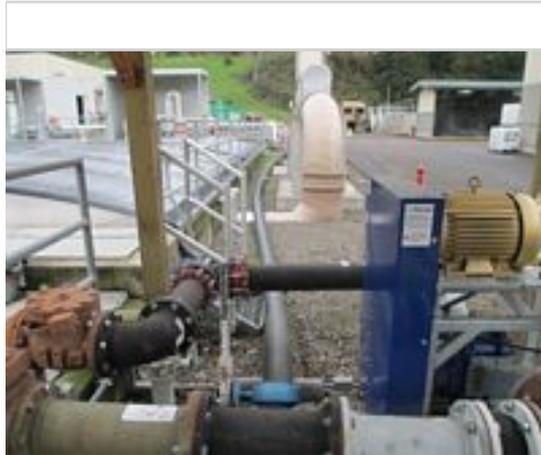
These vertical, submersed progressing cavity pumps were undersized (50 GPM). Are currently unused, replaced with Vogelsang rotary lobe pumps.

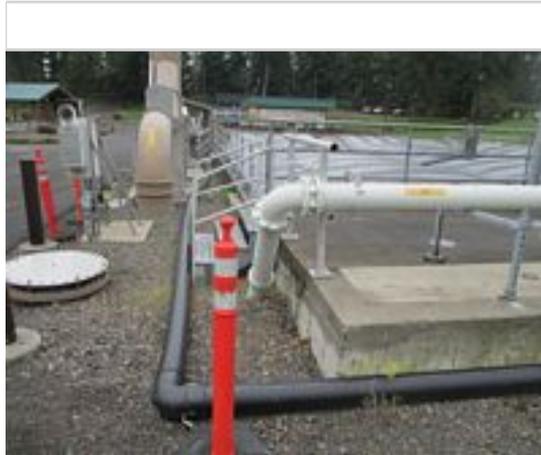
These vertical, submersed progressing cavity pumps were undersized (50 GPM). Are currently unused, replaced with Vogelsang rotary lobe pumps.
