# City of Wilsonville Triennial Inspection Report

Wilsonville WWTP and  
Wastewater Lift Stations:

Project Title: On-Call Civil Engineering and Related Services,  
Triennial Inspection of the Wilsonville WWTP and Nine Lift Stations

Subject: 2019 Triennial Inspection of the Wilsonville WWTP  
and Sewage Lift Stations

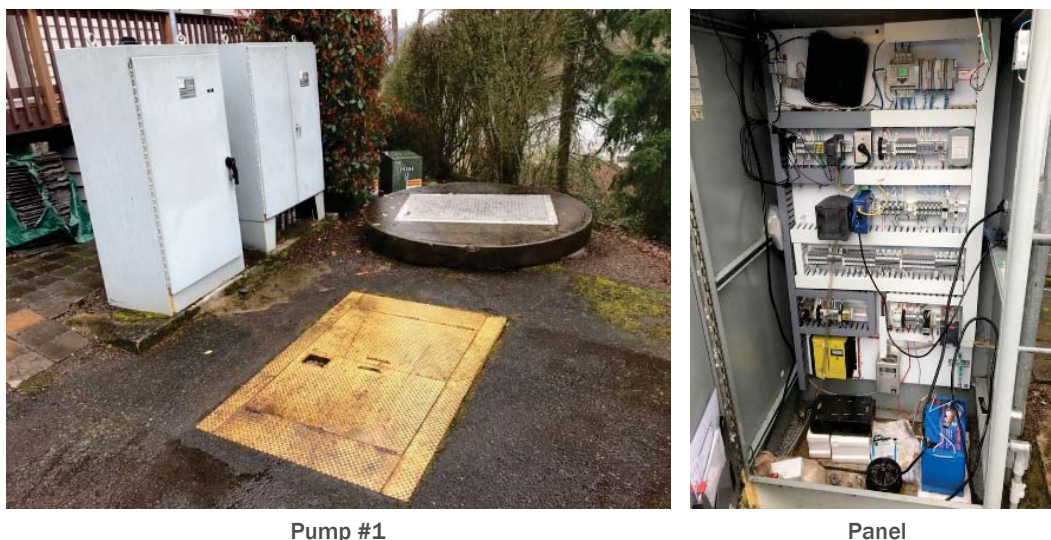
Figure 4-7. Rivergreen Lift Station

Table 4-7. Rivergreen Lift Station				
Asset No.	Asset Name	Condition Score	Performance Score	Comments
RIVG-LS-05	Rivergreen Lift Station	2	1	No confined space entry sign on wet well
RIVG-LS-1	Rivergreen Lift Pump #1	2	1	Could not inspect submersible pump
RIVG-LS-2	Rivergreen Lift Pump #2	2	1	Could not inspect submersible pump

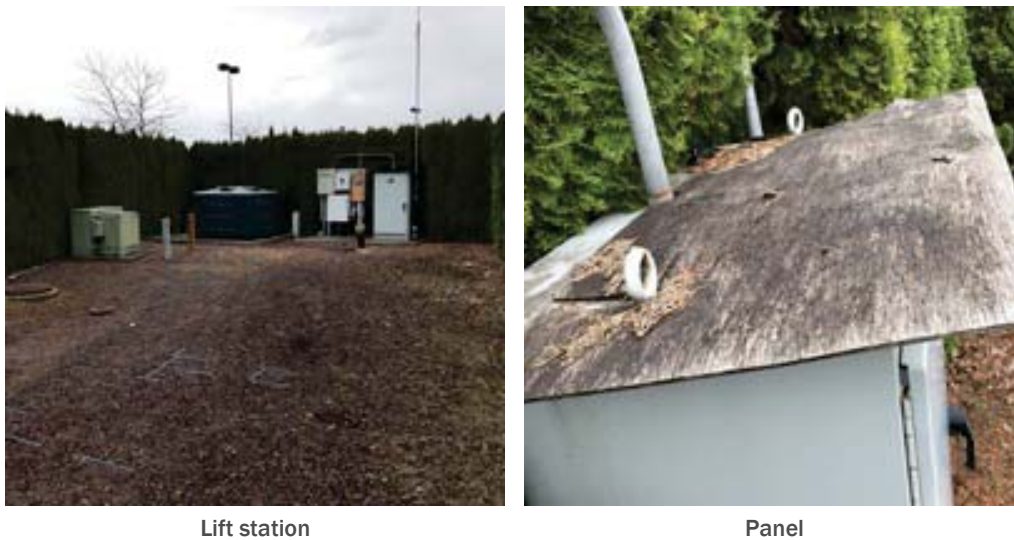
Figure 4-8. Town Center Lift Station

Table 4-9. Towne Center Lift Station				
Asset No.	Asset Name	Condition Score	Performance Score	Comments
TOWNCENTER-LS-02	Town Center Lift Station	2	1	<ul style="list-style-type: none"> <li>Reason for plywood sheeting on top of panel unknown</li> </ul>
TOWNCENTER-LS-02-P-1	Town Center Lift Pump #1	2	1	<ul style="list-style-type: none"> <li>No immediate action required</li> </ul>
TOWNCENTER-LS-02-P-2	Town Center Lift Pump #2	2	1	<ul style="list-style-type: none"> <li>Pump number 2 belt guard and elbow stored on top of pump</li> <li>Install belt guard and remove elbow</li> </ul>

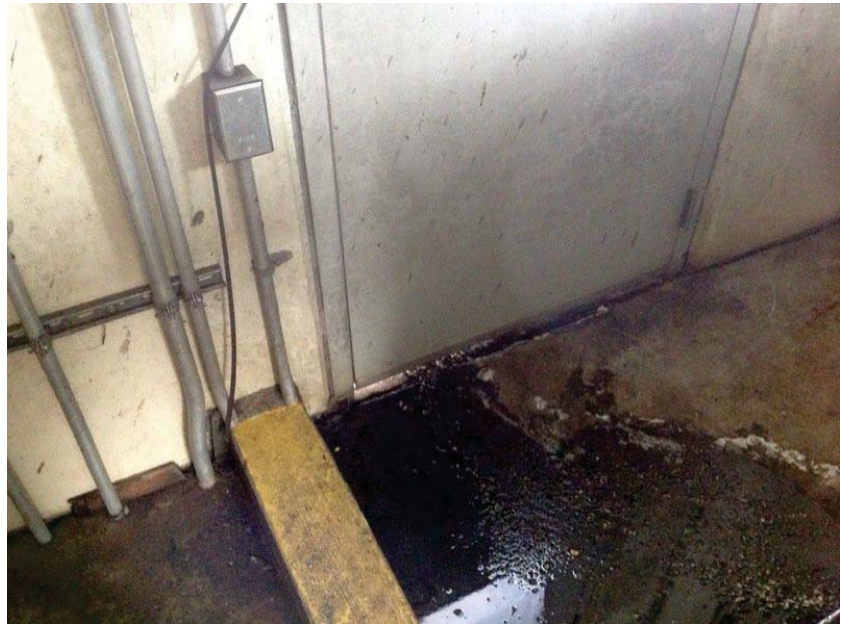
Field Observations	Leaking
Condition Score	2 - Slight Visible Degradation
Performance Score	2 - In Service, but higher than Expected O&M
Recommendation	Schedule corrective action work order near term
Field Observations/Comments	Water leaking in under door by grit bin Joint compound is missing in several areas or the joints have become bigger and the compound no longer covers the joint

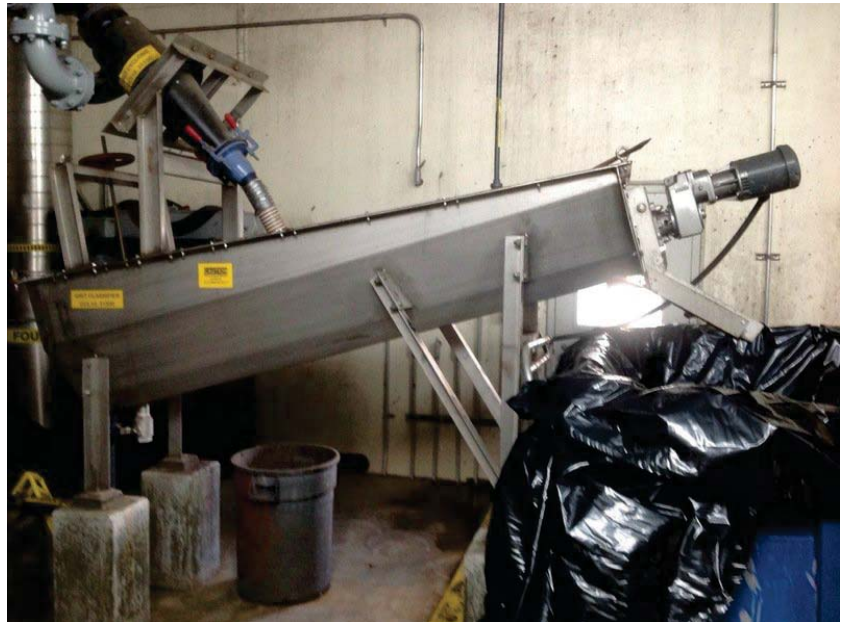
Field Observations	Leaking
Condition Score	2 - Slight Visible Degradation
Performance Score	1 - Component Functioning as Intended
Recommendation	Schedule corrective action work order near term
Field Observations/Comments	Not in operation during site visit Some water leaking out of top inspection cover

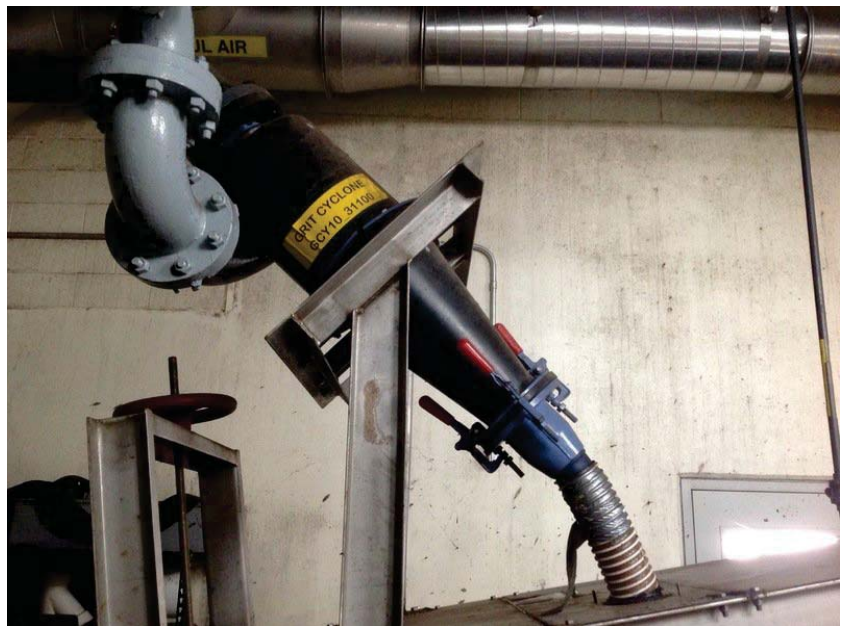
Created	2019-03-27 00:10:52 UTC by Tony Van Haverbeke
Updated	2019-05-28 20:04:51 UTC by Simon Watson
Location	0.0, 0.0
Date	2019-03-28
Time	11:16
Area or Function	Preliminary Treatment
Station ID	GYC10-31100
Asset Description	Grit Cyclone 31100
What type of Asset?	Mechanical
Condition Score	2 - Slight Visible Degradation
Performance Score	1 - Component Functioning as Intended
Recommendation	No immediate action required
Field Observations/Comments	Not in operation during site visit Duct tape on effluent hose

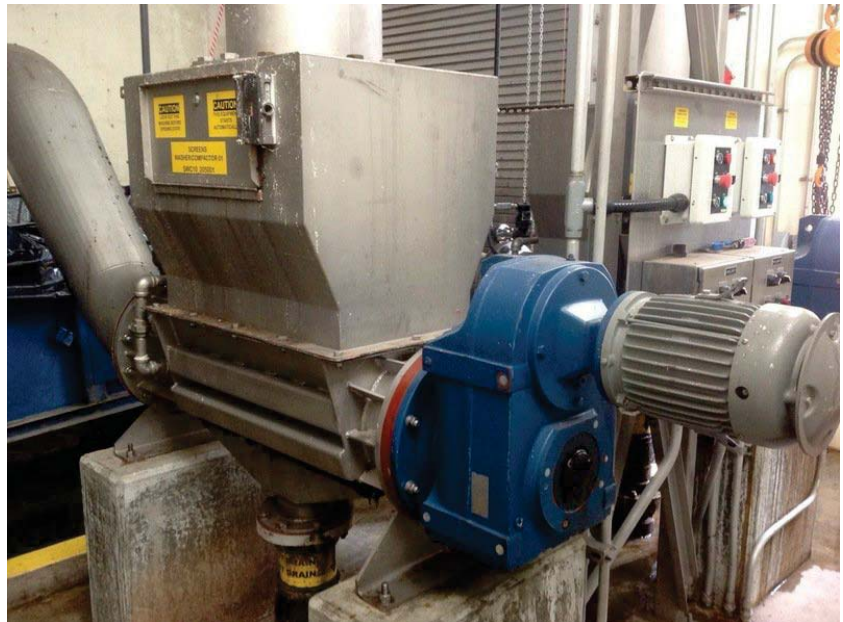
Field Observations	Leaking
Condition Score	2 - Slight Visible Degradation
Performance Score	1 - Component Functioning as Intended
Recommendation	Schedule corrective action work order near term
Field Observations/Comments	Not in operation while onsite Leaking oil between gearbox and auger Appears to be leaking oil from fill plug

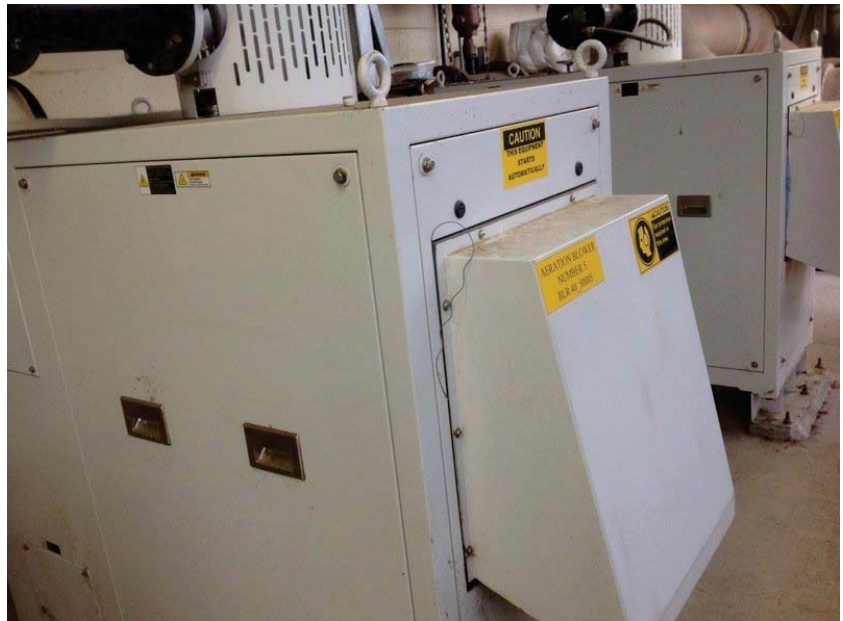
Created	2019-03-27 00:10:47 UTC by Tony Van Haverbeke
Updated	2019-05-28 19:43:30 UTC by Simon Watson
Location	0.0, 0.0
Date	2019-03-29
Time	07:44
Area or Function	Secondary Treatment
Station ID	BLW40-50005
Asset Description	Aeration Blower #5
What type of Asset?	Mechanical
Condition Score	2 - Slight Visible Degradation
Performance Score	1 - Component Functioning as Intended
Recommendation	Initiate more detailed inspection
Field Observations/Comments	Not in operation Unable to inspect inside Rear filter louvers and media are dirty

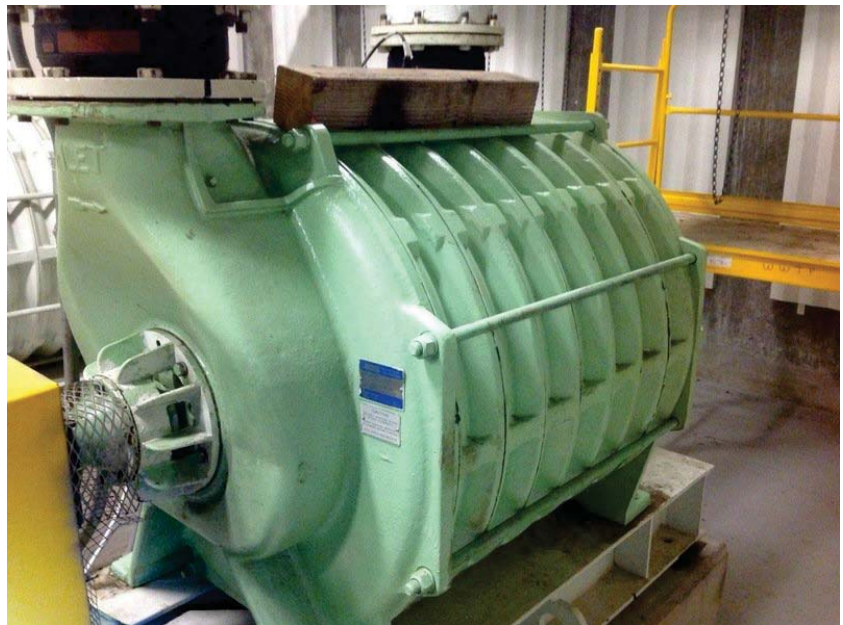
Table 3-3. Area 40 Process Gallery Equipment and Facilities				
Asset No.	Asset Name	Condition Score	Performance Score	Comments
PGB-M-40-5-1	Aeration Basin Blower #1	2	1	Excessive grease on outboard bearing or seal is leaking
PGB-M-40-5-1-M	Aeration Basin Blower Motor #1	2	1	No immediate action required
PGB-M-40-5-2	Aeration Basin Blower #2	2	1	Both bearings have excessive grease or seals are leaking
PGB-M-40-5-2-M	Aeration Basin Blower Motor #2	2	1	No immediate action required
PGB-M-40-5-3	Aeration Basin Blower #3	2	1	Outboard bearing seal appears to be starting to fail, grease leaking from discharge valve stem
PGB-M-40-5-3-M	Aeration Basin Blower Motor #3	2	1	Part of base has no coating

Secondary Treatment	Aeration Basin Blower #1, PGB-M-40-5-1
Station ID	PGB-M-40-5-1
Asset Description	Aeration Basin Blower #1
What type of Asset?	Mechanical
Condition Score	2 - Slight Visible Degradation
Performance Score	1 - Component Functioning as Intended
Recommendation	No immediate action required
Field Observations/Comments	Excessive grease on outboard bearing or seal is leaking Not in operation

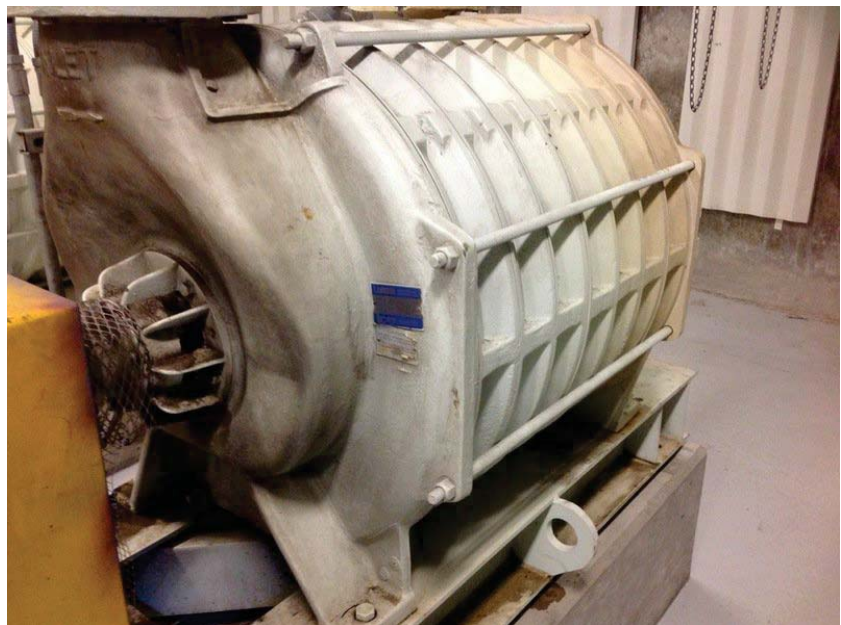
Field observations	Leaking
Condition Score	2 - Slight Visible Deterioration
Performance Score	1 - Component Functioning as Intended
Recommendation	Schedule corrective action work order near term
Field observations & Comments	Out of operation Both bearings have excessive grease or seals are leaking Not sure why open drain line is on the outboard bearing Grease leaking from discharge valve stem

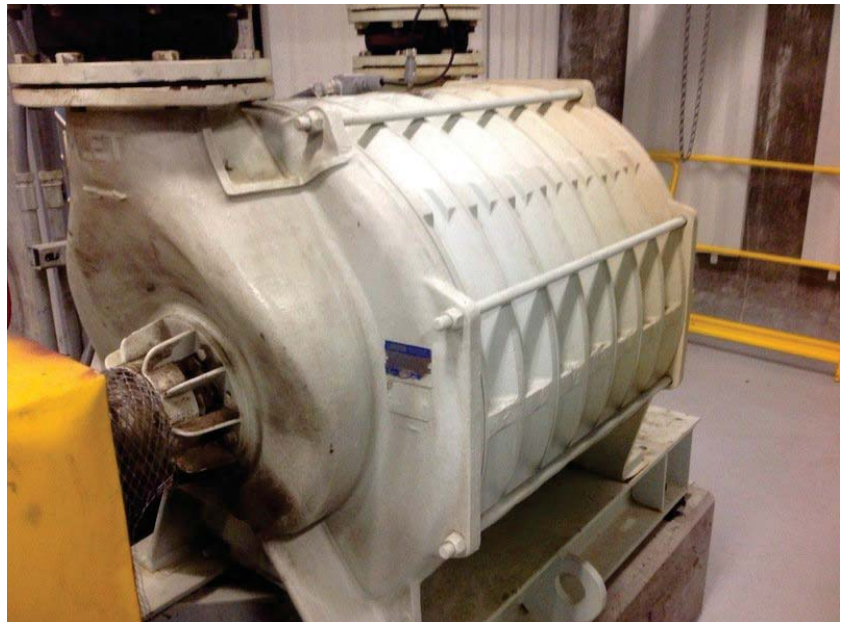
Field Observations	Leaking
Condition Score	2 - Slight Visible Degradation
Performance Score	1 - Component Functioning as Intended
Recommendation	No immediate action required
Field Observations/Comments	Outboard bearing seal appears to be starting to fail Grease leaking from discharge valve stem Not in operation

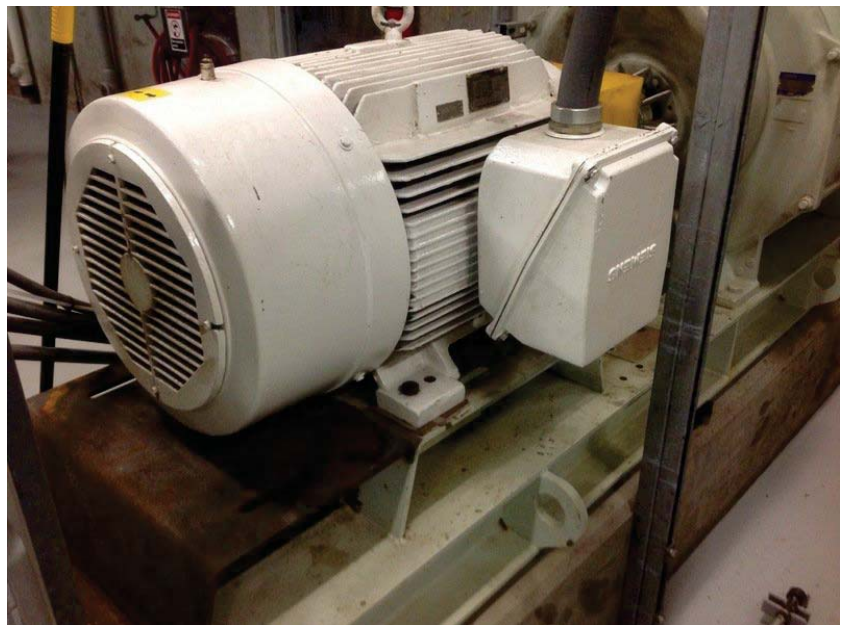
Description	Aeration Basin Blower Motor #3
Field observations	Corrosion
Condition Score	2 - Slight Visible Degradation
Performance Score	1 - Component Functioning as Intended
Recommendation	Schedule corrective action work order near term
Field observations/Comments	Part of base has no coating Out in operation

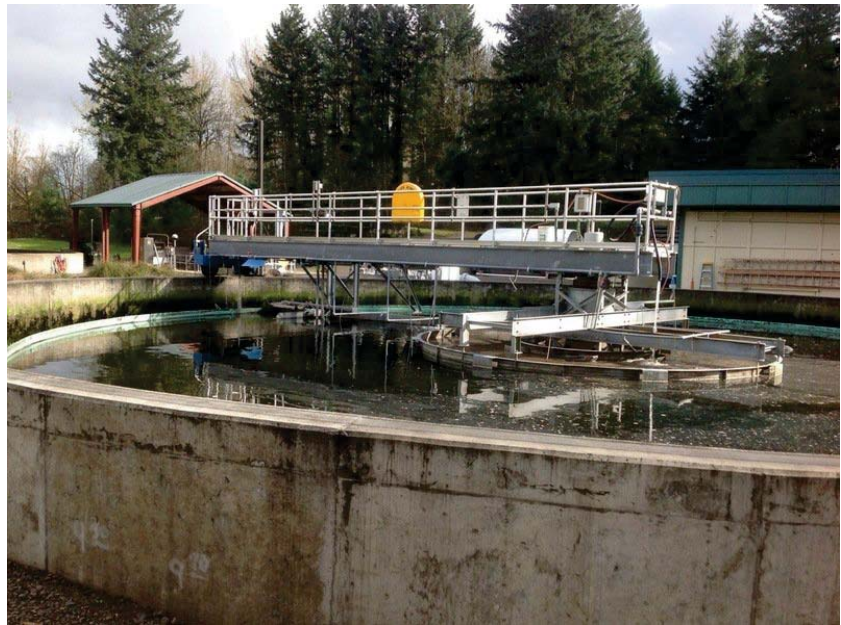
Table 3-4. Area 50 Secondary Clarifiers Equipment and Facilities				
Asset No.	Asset Name	Condition Score	Performance Score	Comments
CLR50-00103	Secondary Clarifier #3	2	1	Slight oil leak between motor and gearbox
LCP50-10103	Sec Clarifier #3 Control Panel	2	1	See report for CLR50-10103
PMP50-03001	RAS Pump #1	2	1	No immediate action required
PMP50-03002	RAS Pump #2	2	1	No immediate action required
PMP50-03003	RAS Pump #3	2	1	Slight oil leak on check valve packing
PMP50-03004	RAS Pump #4	2	1	No immediate action required
PMP50-20100	Scum Pump	2	1	No immediate action required
SC-50-1-1	Secondary Clarifier #1	2	2	See weir washer and mechanism below
SC-50-1-2	Secondary Clarifier #2	3	1	Spalling on upper wall by UV facilities
SC-50-1-3	Sec Clarifier #1 Weir Washer	3	4	Weir washers not working
SC-50-1-4	Sec Clarifier #2 Weir Washer	3	3	One of the weir washers is not working
SC-M-50-1-1	Secondary Clarifier, #1 Mechanism	3	1	Motor/upper gearbox noise, slight oil leak from torque meter, torque meter at 5

Secondary Treatment	Secondary Clarifier #3, CLR50-00103
Station ID	CLR50-00103
Asset Description	Secondary Clarifier #3
What type of Asset?	Mechanical
Condition Score	2 - Slight Visible Degradation
Performance Score	1 - Component Functioning as Intended
Recommendation	No immediate action required
Field Observations/Comments	Slight oil leak between motor and gearbox

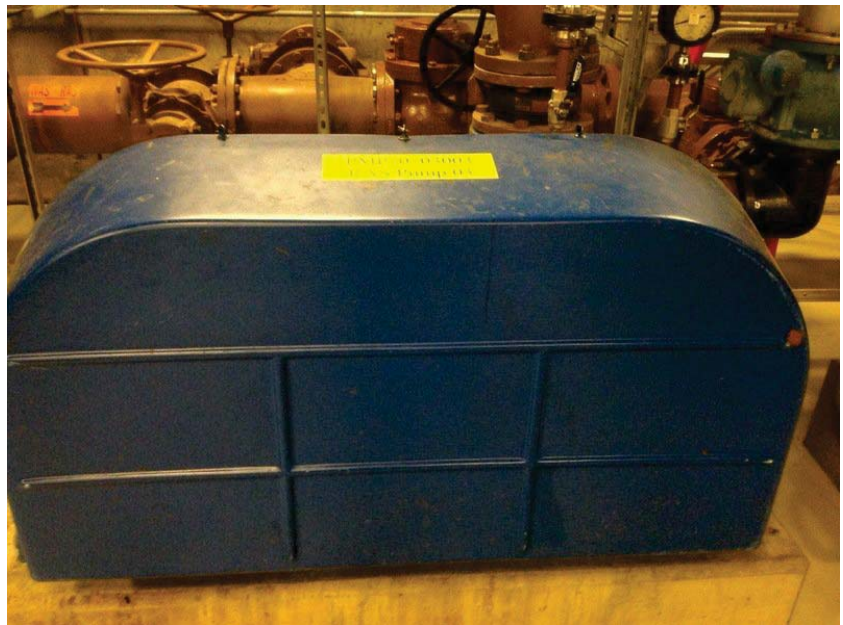
Secondary Treatment	RAS Pump #3, PMP50-03003
Station ID	PMP50-03003
What type of Asset?	Pumps and Motors
Condition Score	2 - Slight Visible Degradation
Performance Score	1 - Component Functioning as Intended
Recommendation	No immediate action required
Field Observations/Comments	Slight leak on check valve packing

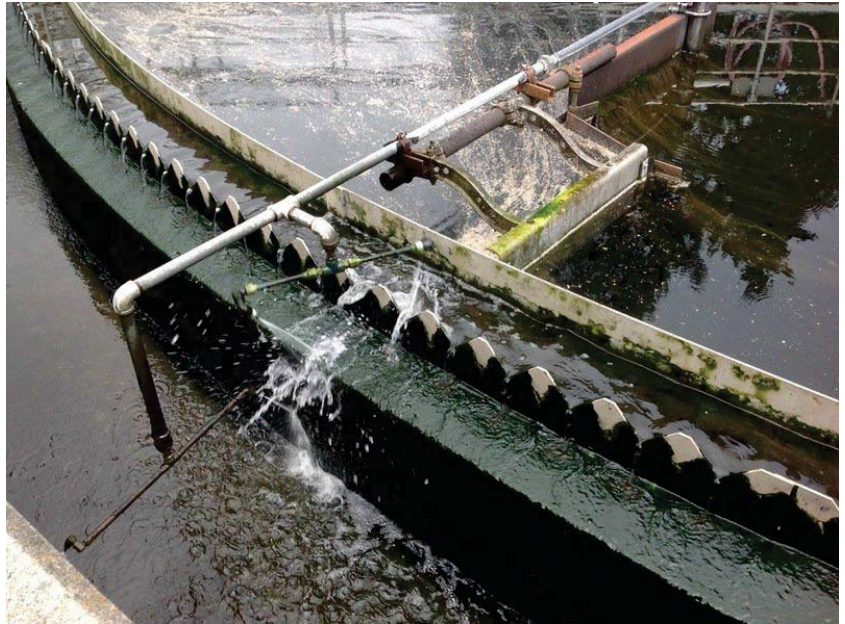
Concret damage

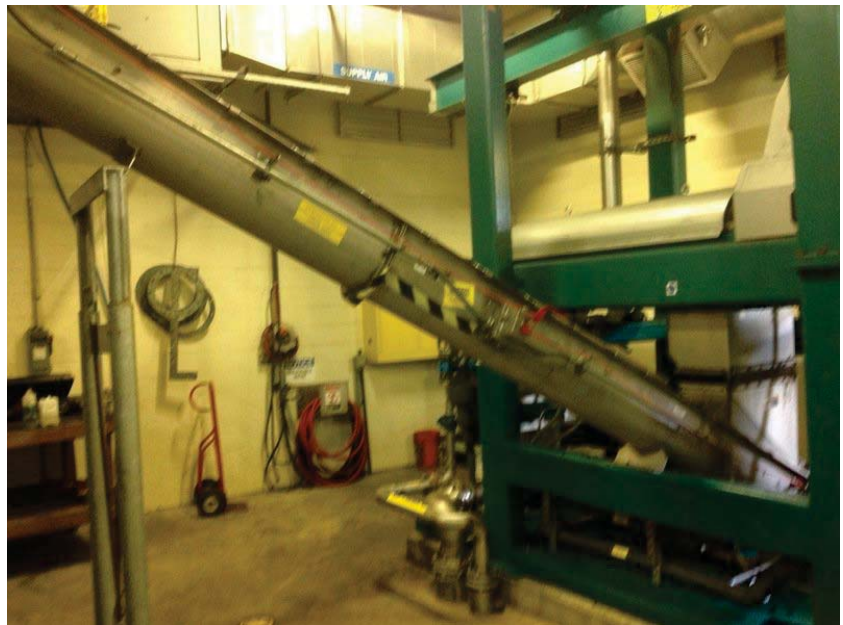
Field Observations	Leaking
Condition Score	2 - Slight Visible Degradation
Performance Score	1 - Component Functioning as Intended
Recommendation	No immediate action required
Field Observations/Comments	Not in operation Liner looks to be in good shape

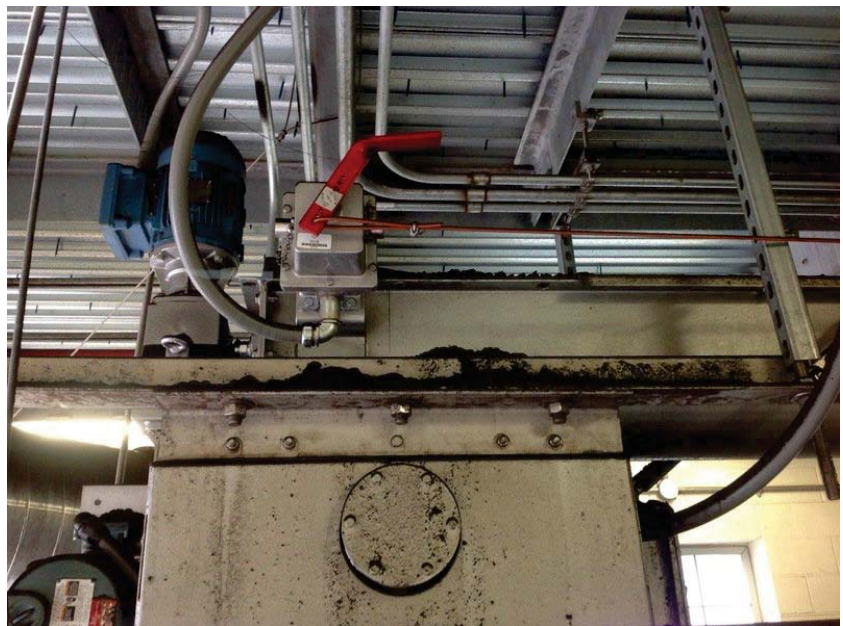
Created	2019-03-27 00:10:49 UTC by Tony Van Haverbeke
Updated	2019-05-28 21:33:44 UTC by Simon Watson
Location	0.0, 0.0
Date	2019-03-28
Time	14:15
Area or Function	Solids Drying
Station ID	CNV78-10100
Asset Description	Load Out Distribution Conveyor
What type of Asset?	Mechanical
Condition Score	2 - Slight Visible Degradation
Performance Score	1 - Component Functioning as Intended
Recommendation	No immediate action required
Field Observations/Comments	Visually appears to be in good order A lot of dry product in the room

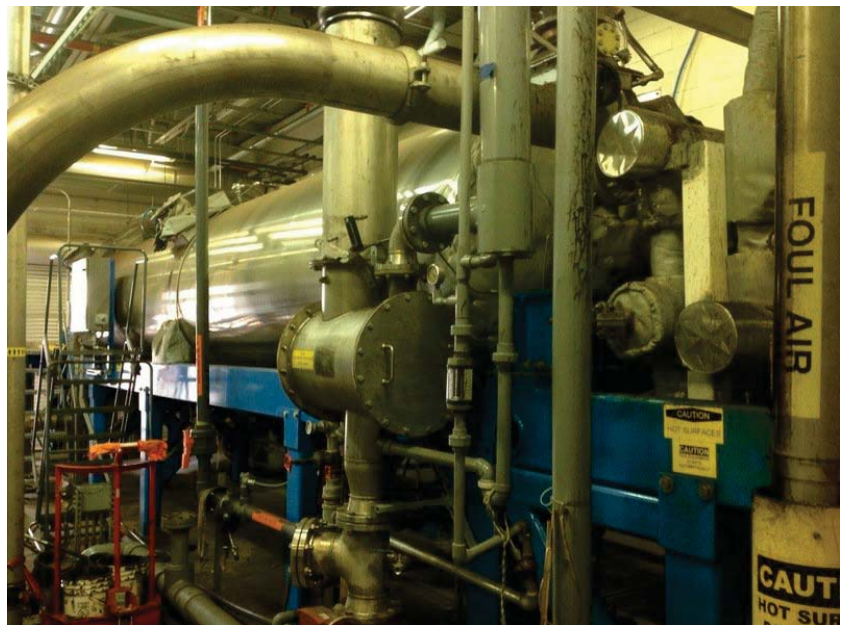
Field Observations	Leaking
Condition Score	2 - Slight Visible Degradation
Performance Score	1 - Component Functioning as Intended
Recommendation	No immediate action required
Field Observations/Comments	Some excessive grease around the drive shafts Side valve leaking

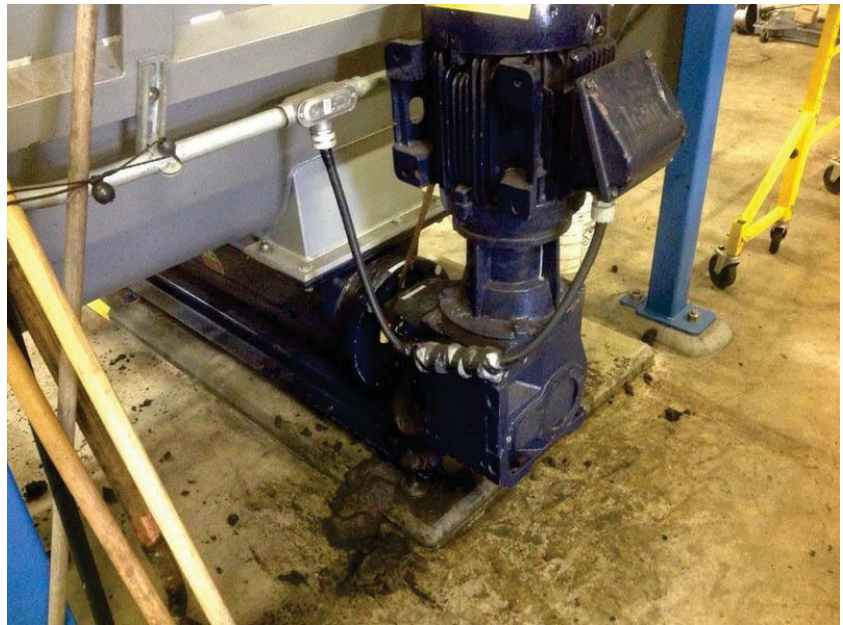
Field Observations	Leaking
Condition Score	2 - Slight Visible Degradation
Performance Score	1 - Component Functioning as Intended
Recommendation	Schedule corrective action work order near term
Field Observations/Comments	Sludge leaking from packing

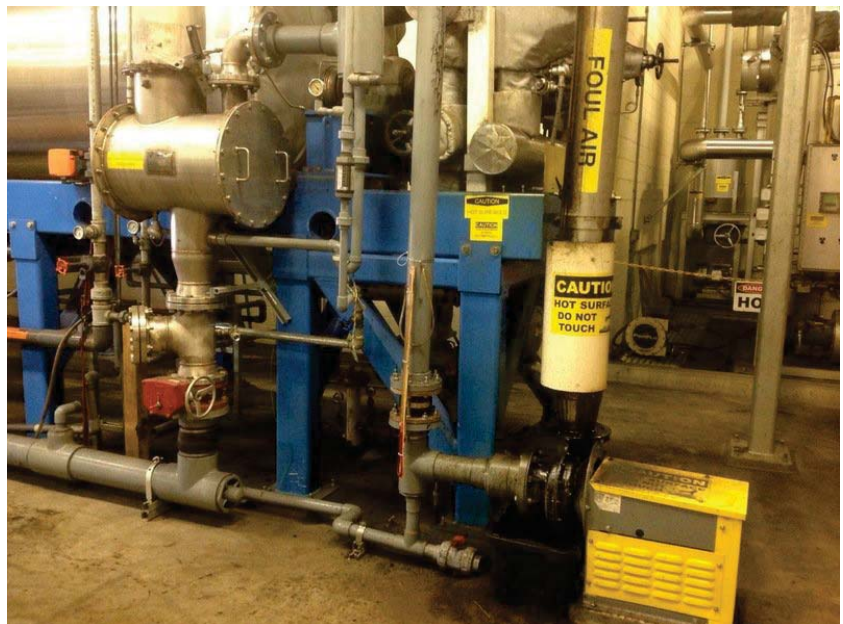
Field Observations	Leaking
Condition Score	3 - Visible Degradation
Performance Score	2 - In Service, but higher than Expected O&M
Recommendation	Schedule corrective action work order near term
Field Observations/Comments	Scrubber fan has excessive oil leaking out

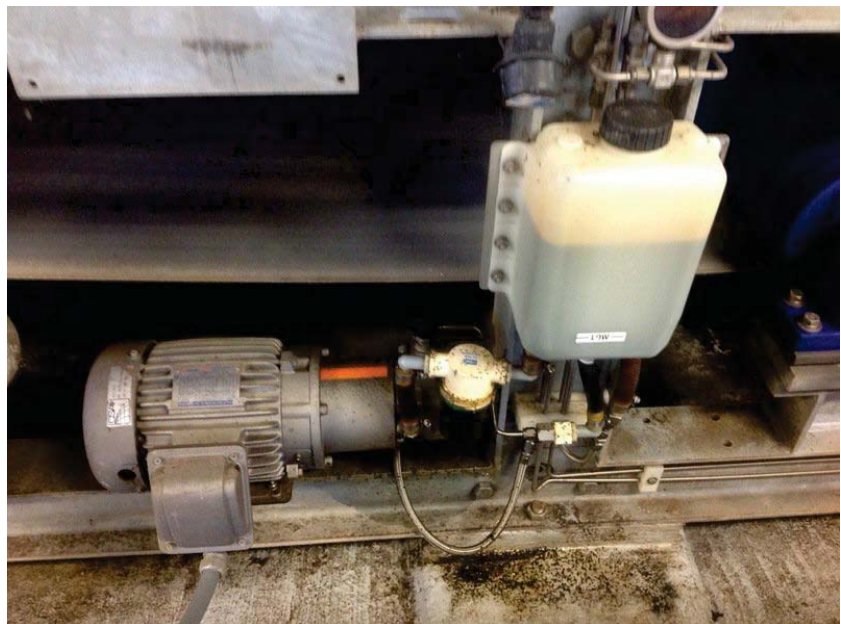
Field Observations	Leaking
Condition Score	2 - Slight Visible Degradation
Performance Score	1 - Component Functioning as Intended
Recommendation	Schedule corrective action work order near term
Field Observations/Comments	Pump leaking

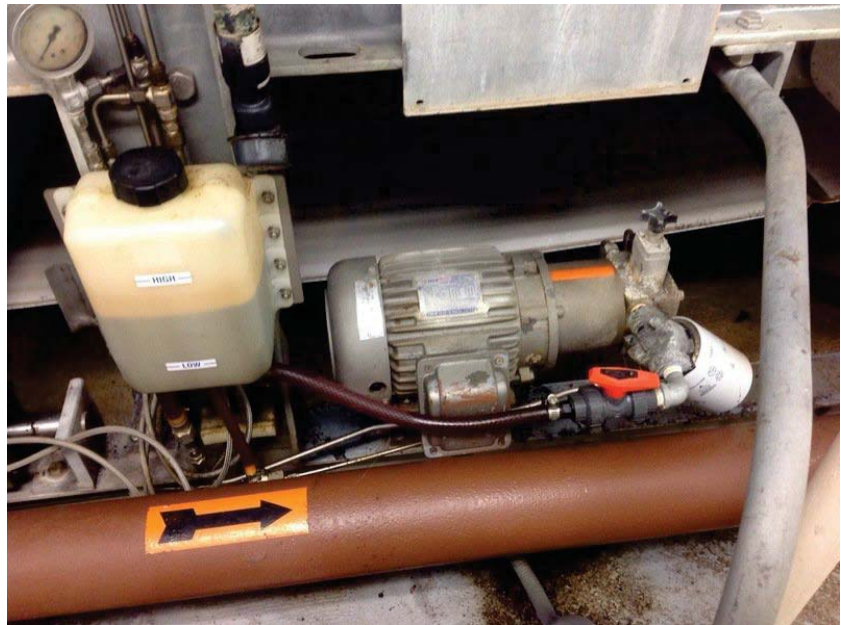
Field Observations	Corrosion
Condition Score	2 - Slight Visible Degradation
Performance Score	1 - Component Functioning as Intended
Recommendation	No immediate action required
Field Observations/Comments	Not operating

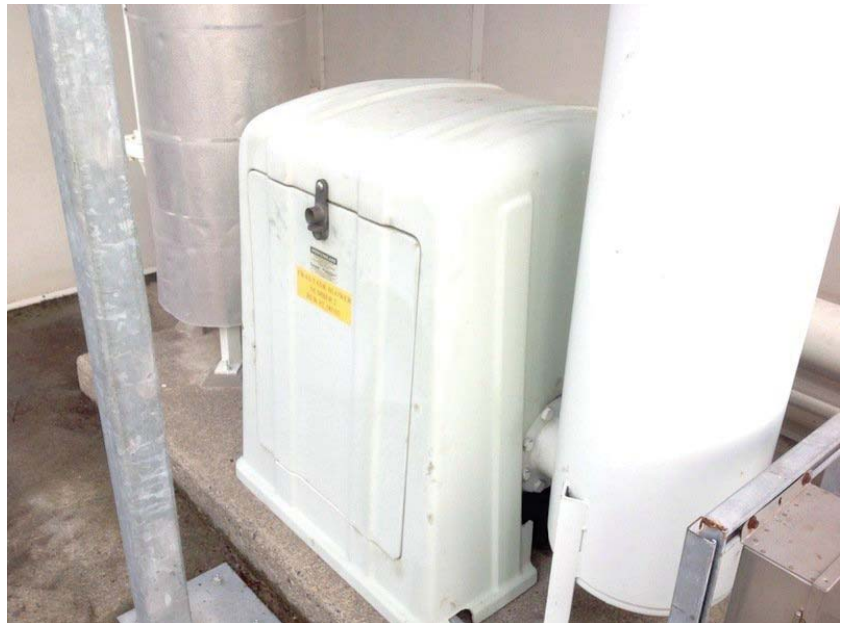
Created	2019-03-27 00:10:48 UTC by Tony Van Haverbeke
Updated	2019-05-28 22:05:53 UTC by Simon Watson
Location	0.0, 0.0
Date	2019-03-29
Time	07:56
Area or Function	Solids Handling
Station ID	BS-M-82-1-2
Asset Description	Biosolids Storage Blower #2
What type of Asset?	Mechanical
Condition Score	2 - Slight Visible Degradation
Performance Score	1 - Component Functioning as Intended
Recommendation	No immediate action required
Field Observations/Comments	Slight oil leak

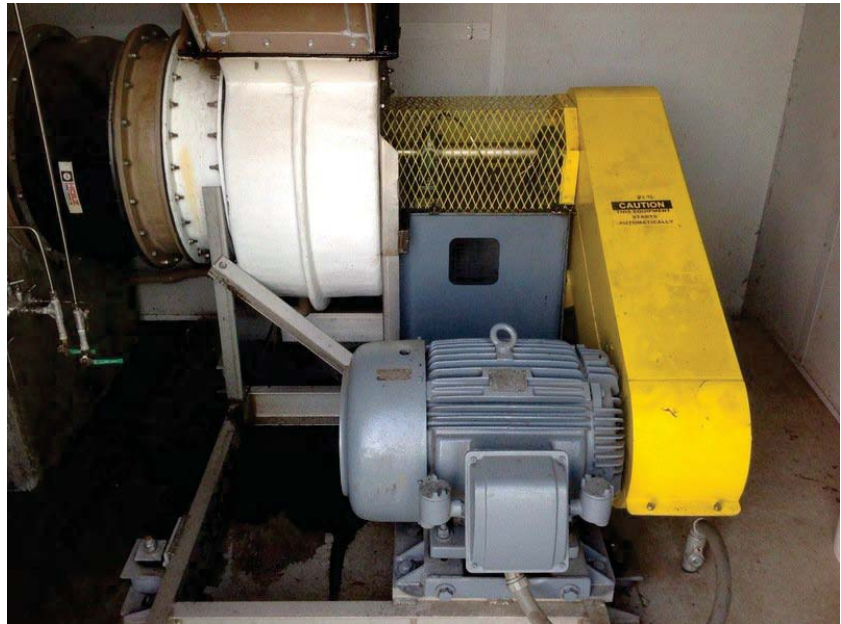
Field Observations	Leaking
Condition Score	2 - Slight Visible Degradation
Performance Score	1 - Component Functioning as Intended
Recommendation	Initiate more detailed inspection
Field Observations/Comments	Unit running smoothly Dripping black tar substance from fan. This comes from the solids dryer.

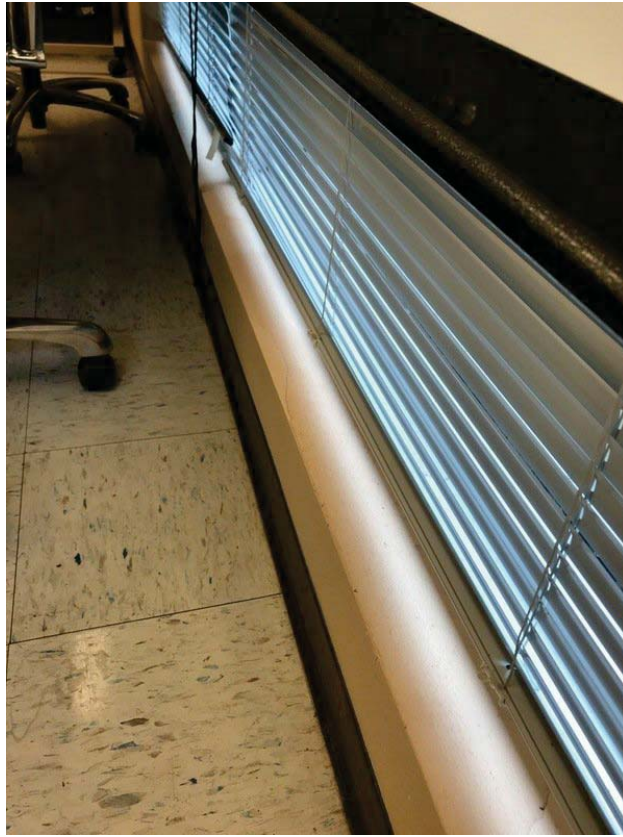
Back window in break room leaking
