OVIVO FIELD SERVICE REPORT

*FIELD SERVICE ENGINEER: JACOB PARTRIDGE		*DATE(S) ONSITE: 4.19.22-4.21.22		*CHARGE # FSW604-01	
*Plant: Wilsonville WWTP *Customer Name: Cindy Kehoe 971-832-4001 *Phone Number: *Email Address: *Office Phone: *Cell Phone:

The purpose of this visit was to inspect both of the customers clarifier units. These are existing units manufactured 2-97.

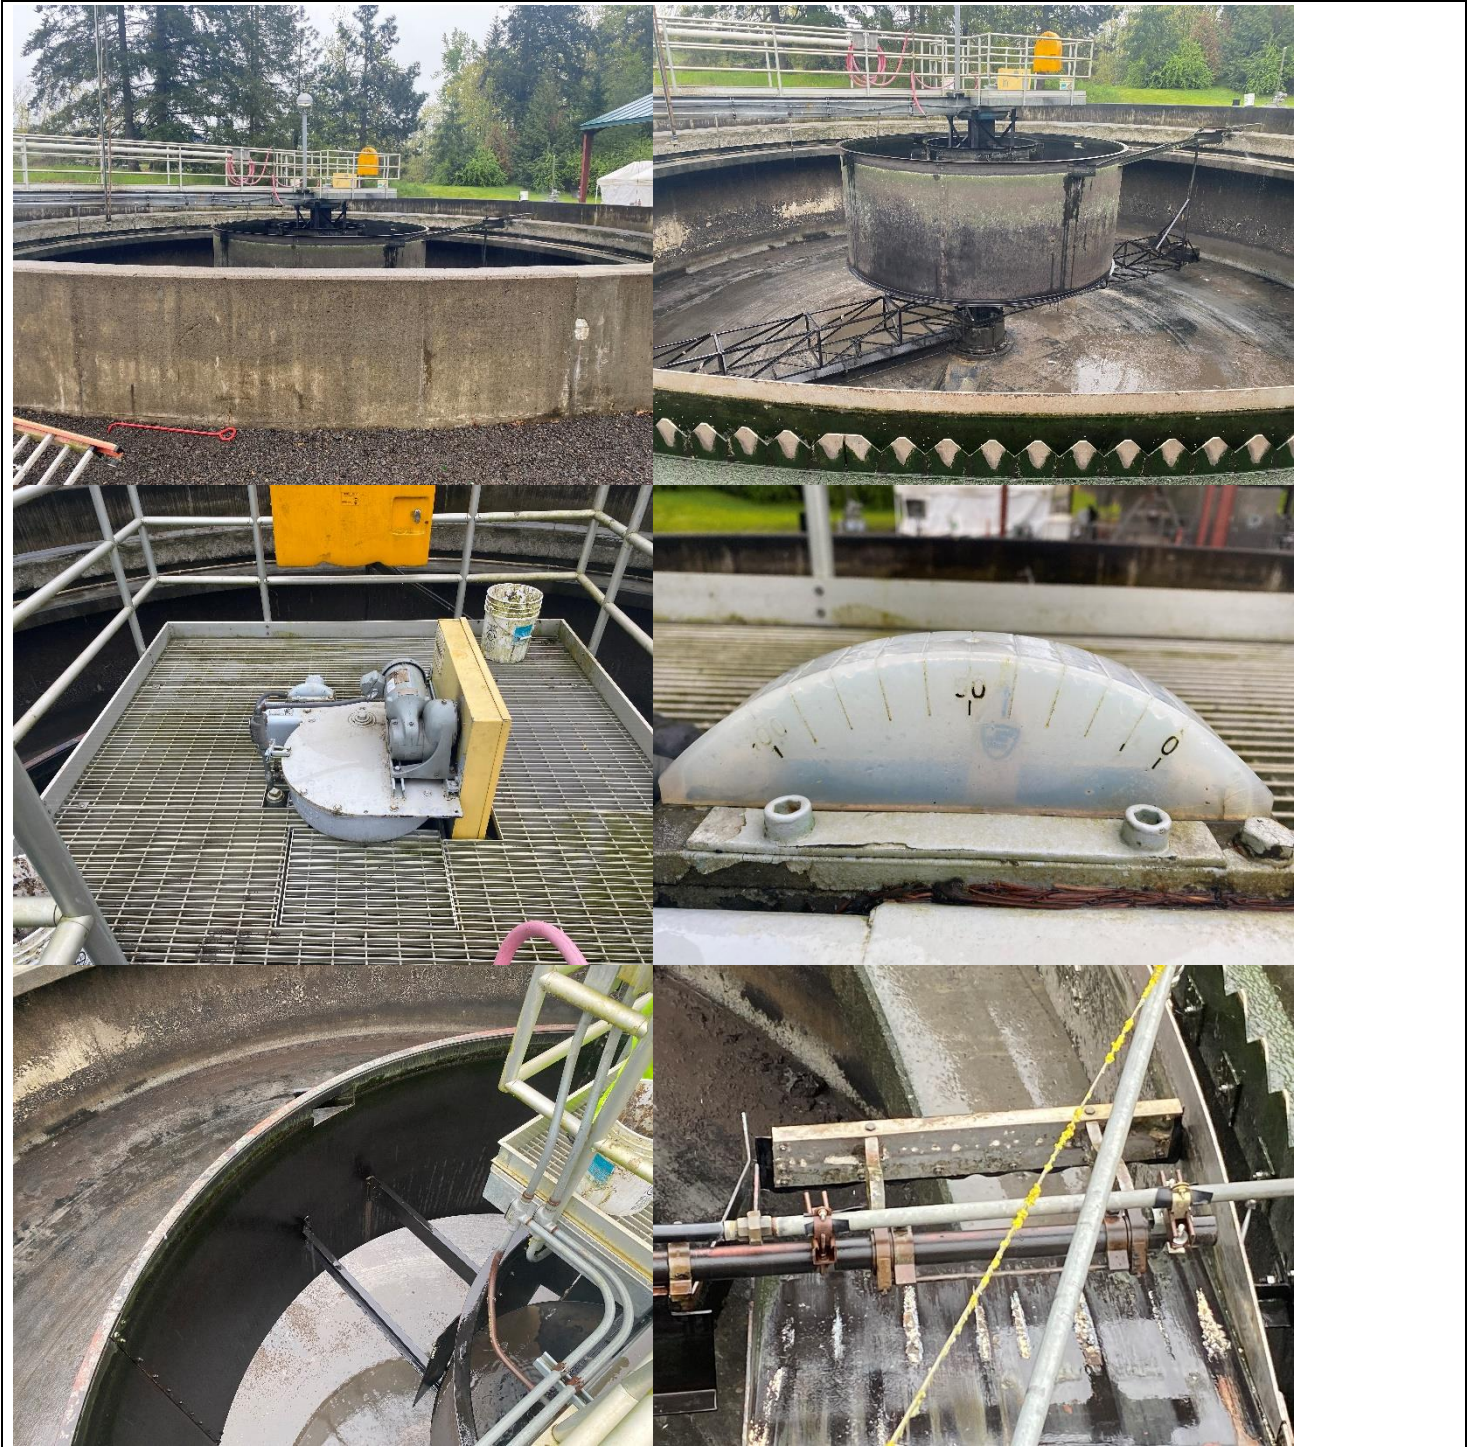
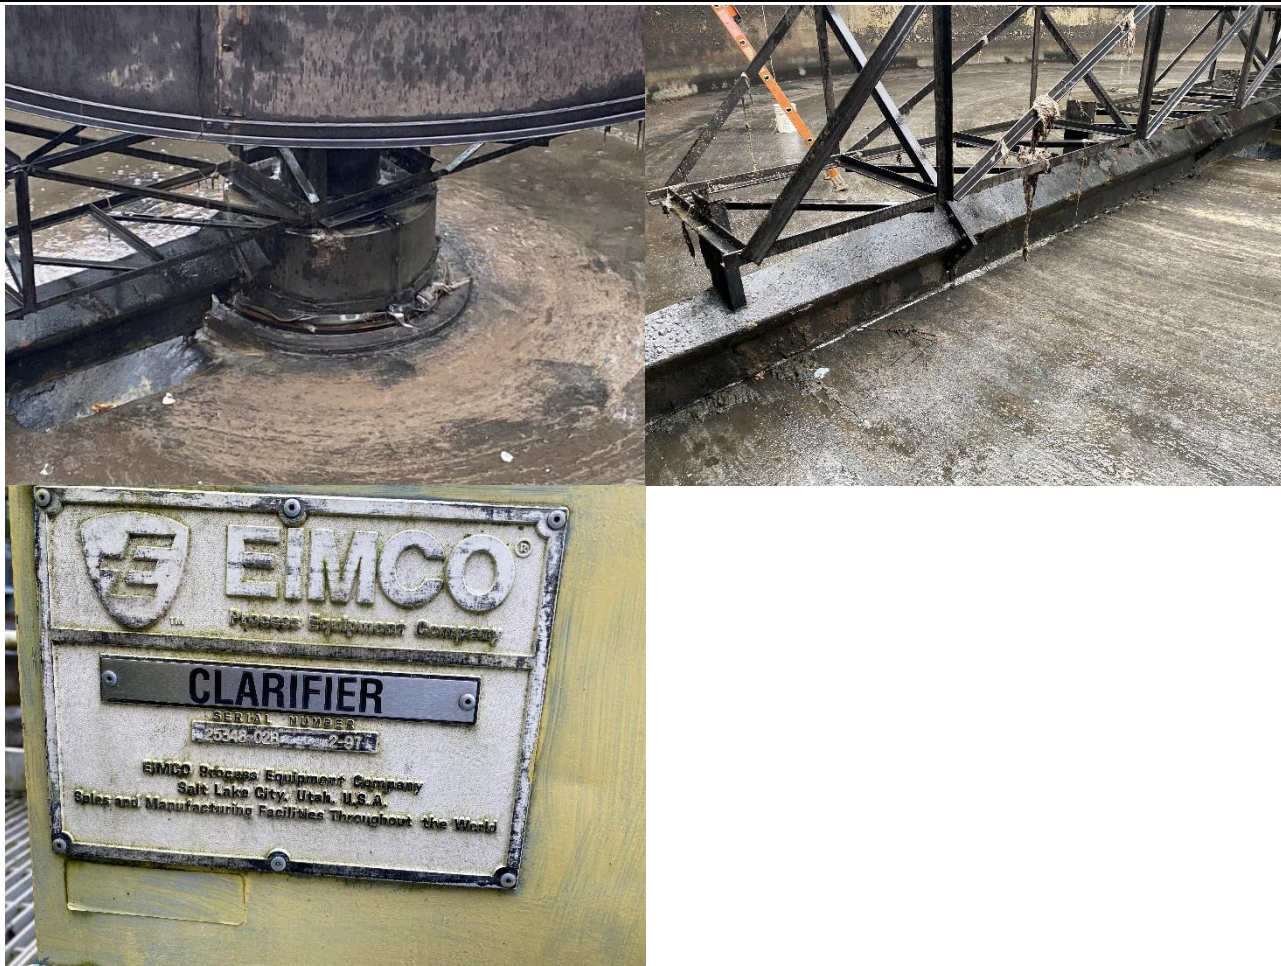
Began inspection on clarifier unit

- 1) Began inspecting top portion of drive unit. inspected drive oil levels, inspected overall condition of the drive unit. unit is in appearance good condition. Paint is still holding strong on this unit. inspected for operational noises. No abnormal noises coming from drive unit. unit is running smooth and without vibrations. Inspected chain and sprocket assembly, these are still in ok shape and well lubricated. Unit appears to be in good maintenance order and operational. This unit is 25 years old and well within the recommended overhaul time frame for seals and bearings. Customer would like pricing on new and rebuild of drive unit.

- 2) Inspected operation of drive control unit. this unit is completely seized up and not turning at all. The unit has no torque protection as of right now and recommend new drive control.

- 3) Motor and reducer on this unit are running smoothly and without abnormal noises or vibrations.
- 4) Inspected EDI on unit. unit is in good condition. Some of the chains for the EDI adjustment doors are broken or missing and recommend replacement of chains for unit to properly adjust flow out of EDI.

- 5) Inspected skimmer unit. unit is in poor condition and recommend replacement of skimmer assembly.
- 6) Inspected center column assembly. Grouting against floor appears to be in good shape with no Spaulding or chunks missing. Bolts appear to be holding and secured tightly. Measured center column for plumb with laser over 8'. Unit measured 1 3/8" and 1 3/8". Unit column is plumb. Outlet ports at top portion of column are in good condition with little wear showing over the years.

- 7) Paint on overall is in good condition with little flaking here and there but holding up very well over the 25 years in service. Unit could do with a new coating to further protect for years to come but steel is in good condition. Welds still holding strong and no breaks or bends found. Bolted connections on overall machine are all present and appear to be securely fastened.

- 8) Rake arm with scum suction manifold in good condition. The squeegee along the bottom has torn and ripped apart in multiple spots and recommend replacement. Also the seal along the center manifold is torn and worn out overall on top and bottom of unit and recommend replacement.

- 9) Operational of unit, ran unit around for about 1 hour listening and watching for scraping along floor. There is an intermittent squeal noise coming from drive unit. however it was determined that this was not coming from the mechanism itself but coming from the spray piping/valving. I shut the unit off while the squeal was occurring and the unit completely stopped but the squeal noise did not. Watched the unit rotate around, at no point did the rake arm come in contact with the floor. Unit appears to be holding strong and not dragging at any point.

- 10) Inspected weirs, baffles and scum beach along outer perimeter of tank. All units still bolted firmly to tank wall and present.

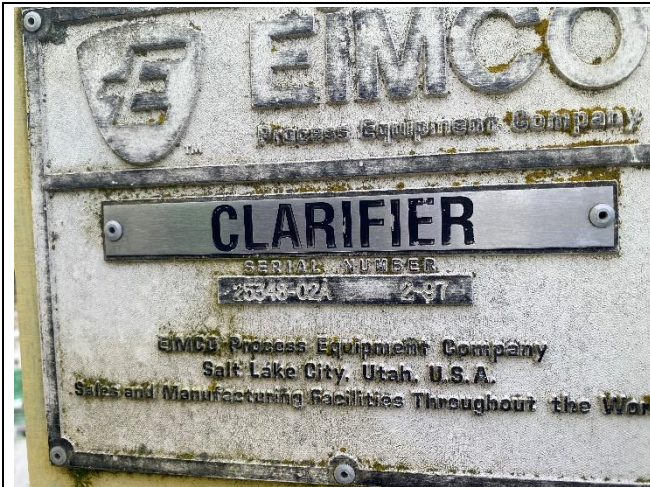
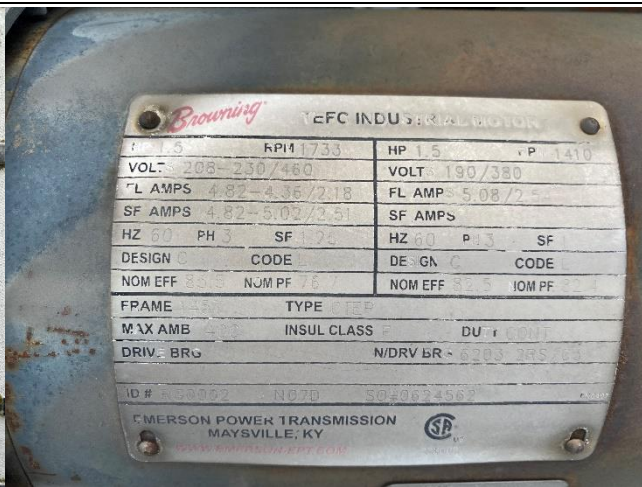
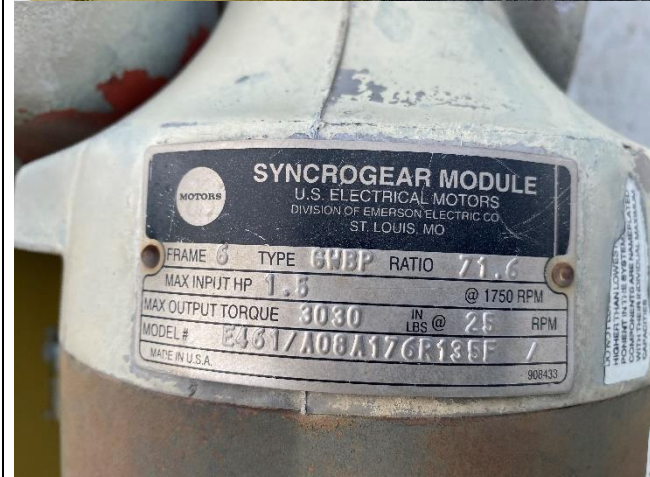
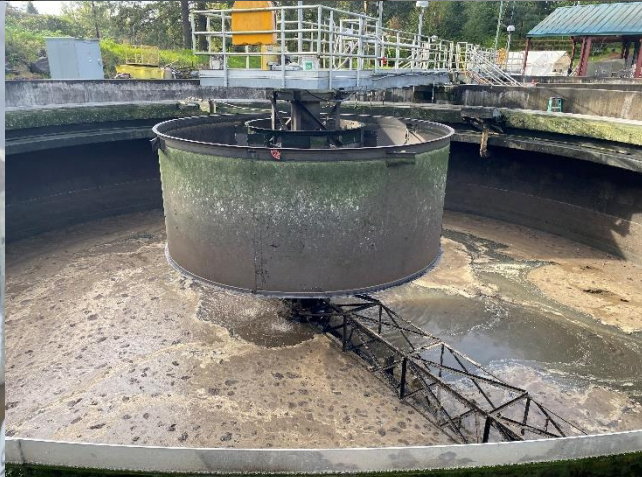
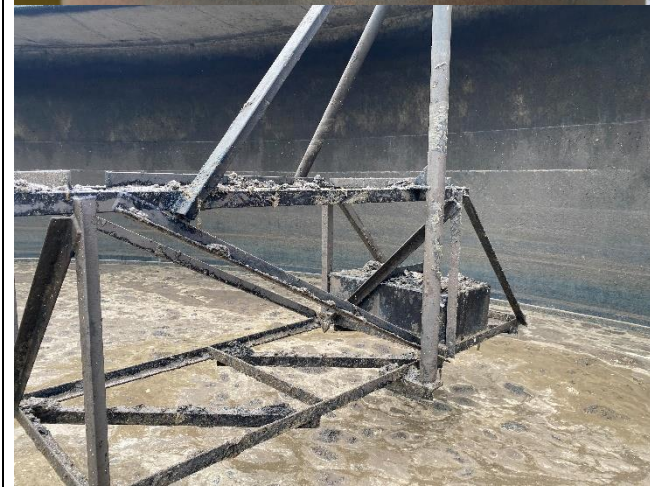
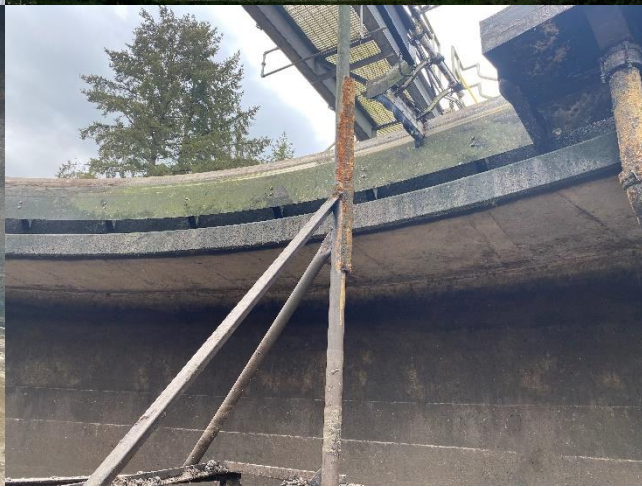
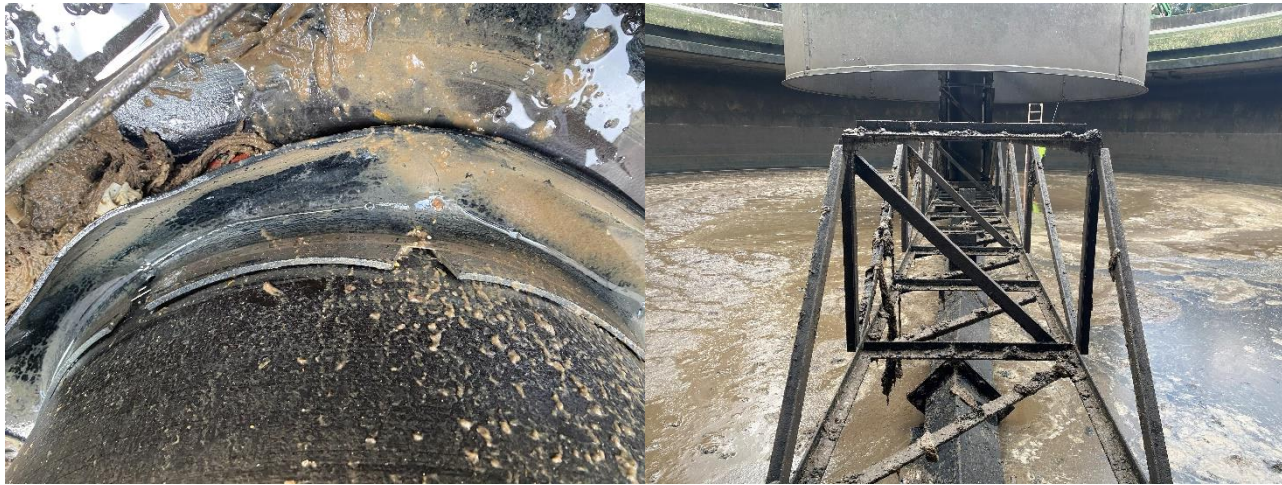
Began inspection of unit 25348-02A

- 1) This unit was having issues with the gates and pumping out fully from the sediment in the bottom. The tank was unable to be fully drained but I was able to get down into it with boots on and get overall view inspection of clarifier unit steel. I was unable to see the condition of the manifold seals and squeegees but based on age and condition of first tank I would assume that they are in a similar condition and would need replacement .

- 2) Began inspection of drive unit. inspected oil levels and overall paint of drive unit. unit is still in good appearance and paint is holding up. maintenance appears to be well performed on this unit and drive is moving smoothly and with no abnormal vibration

- 3) The drive control is in the same condition and not working properly. Recommend new drive torque control.
- 4) The motor and reducer on this unit is knocking during operation internally and I would recommend replacement or have spare unit on standby for when they finally give out. the chain and sprockets are still in good condition and well lubricated. The drive unit is 25 years old and in the recommended time for rebuild of bearings and seals internally.

- 5) Inspected EDI on unit. unit is in good condition. Some of the chains for the EDI adjustment doors are broken or missing and recommend replacement of chains for unit to properly adjust flow out of EDI.

- 6) this unit had an incident in the past where the skimmer bound up and was damaged over the scum beach. The support arm was bent and they have currently welded a temporary part to try and hold the unit into place. The skimmer itself is well worn out and in need of replacement. Customer would like pricing on new skimmer arm and skimmer assembly for this unit.

- 7) inspected center column assembly for excessive wear or out of plumb. The column appears to be still in good condition. I was unable to see the base of this unit due to water. I was able to measure plumb over 8' with laser 1 ¼" and 1 ¼". Unit center column is still plumb.

- 8) Overall paint is in similar condition to the first tank with spots of paint coming off but overall in decent condition considering time in service. All welds are still in good condition with no breaks or bends found in any of the support arms. Feed well still looks great with a couple spots here and there of paint flaking but overall condition is good. All hardware and bolted fasteners appear to be secured.

- 9) Inspected weirs, baffles and scum beach along outer perimeter of tank. All units still bolted firmly to tank wall and present
