Hydromodification Assessment

Prepared for
City of Wilsonville
June 2015

**NATIONAL POLLUTANT DISCHARGE ELIMINATION SYSTEM (NPDES)
HYDROMODIFICATION ASSESSMENT
JULY 1, 2015**

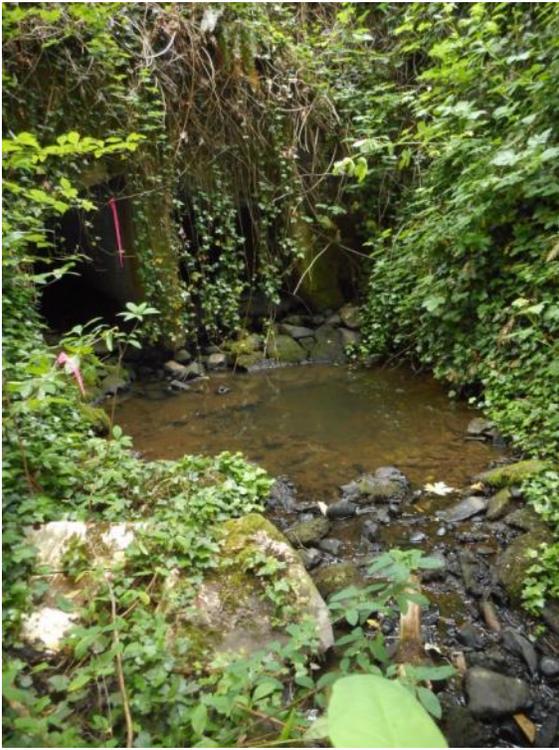
<p>Site location: 001 Photo number: 005 Description: Scour hole at outlet of 48" culvert along Arrowhead Creek (CIP CLC-9 location)</p>

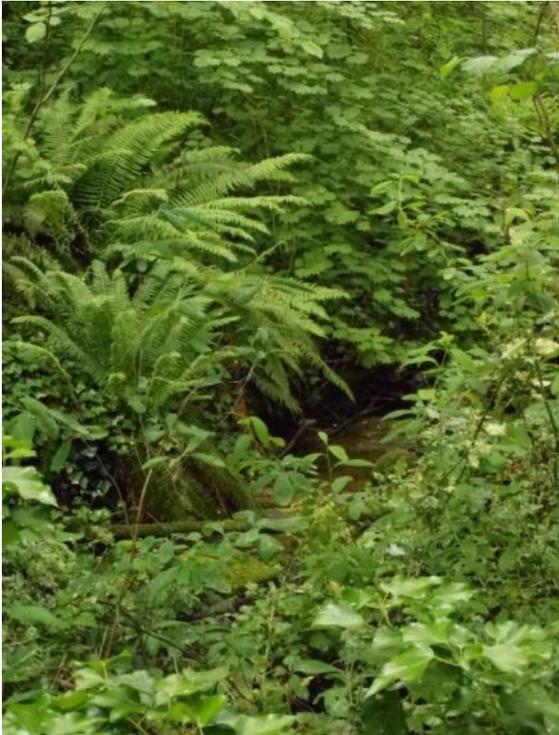
<p>Site location: 001 Photo number: 0006 Description: Looking downstream from 48" culvert. Observed invasives.</p>

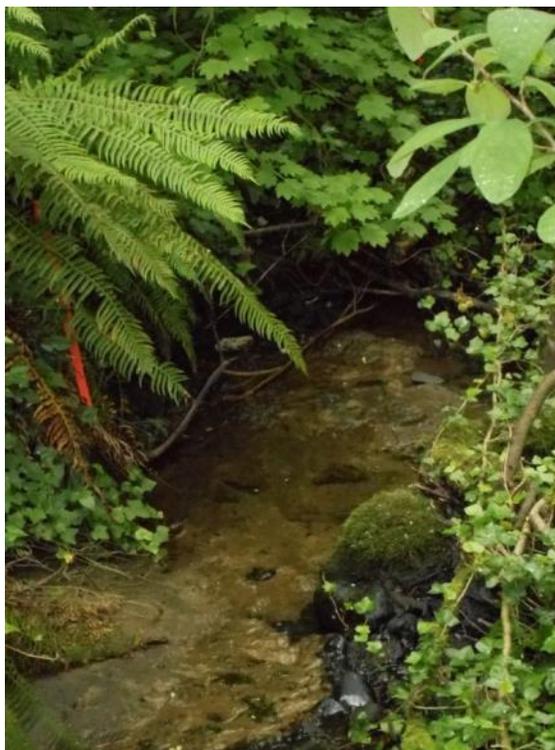
Site location: 001
Photo number: 009
Description: Hardpan bed material with small cobbles and gravel.

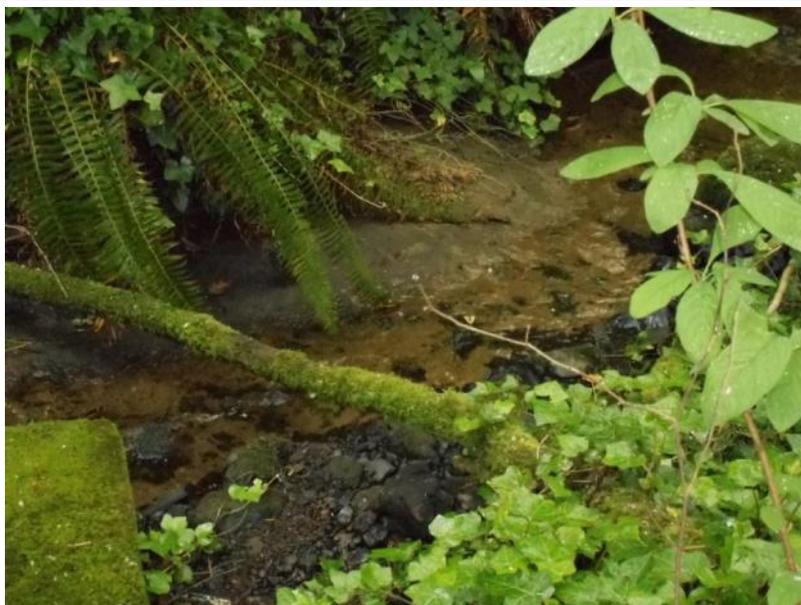
Site location: 001
Photo number: 008
Description: Limited flow observed during field assessment. Hardpan bed material. No observed incision or widening in channel.

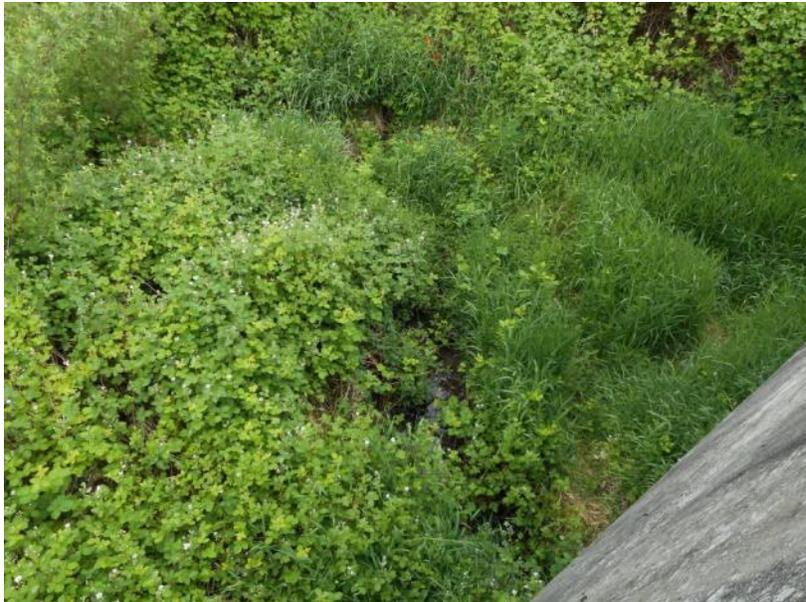
<p>Site location: 002 Photo number: 011 Description: Arrowhead Creek downstream of bridge on Arrowhead Creek Lane. Wide floodplain and dense vegetation.</p>

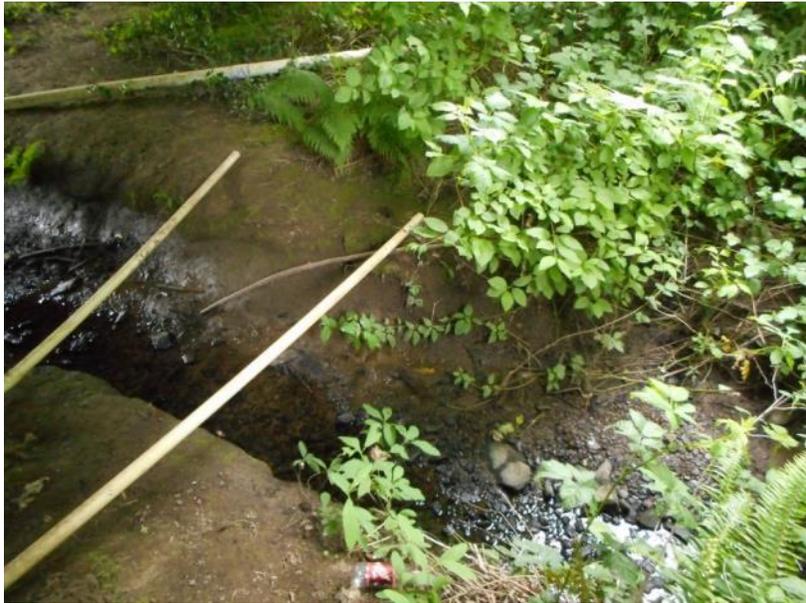
<p>Site location: 002 Photo number: 012 Description: Under bridge at Arrowhead Creek Lane. Observed hardpan and gravel/ cobbles. Limited observed channel incision and widening</p>

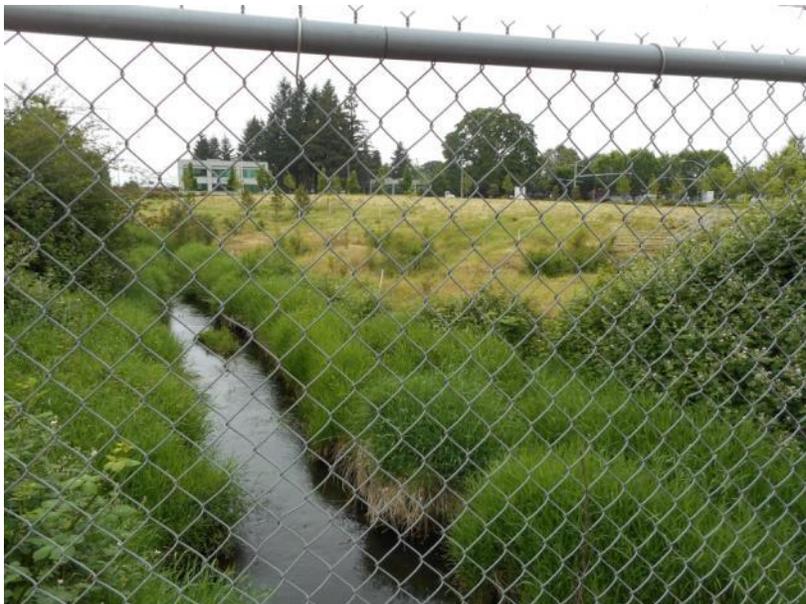
Site location: 003
Photo number: 020
Description: Looking upstream from Ore Pac Ave. Wide floodplain with proposed development area to the east. Straightened, incised channel with established vegetation.

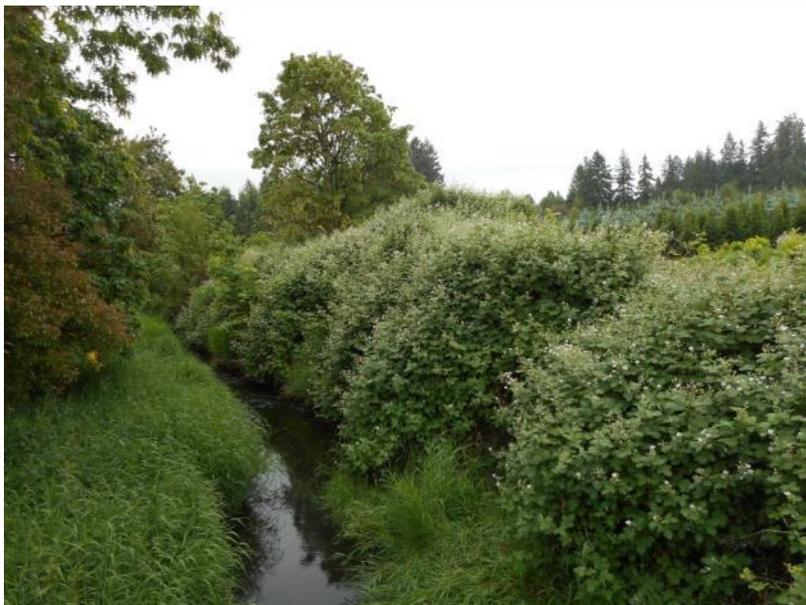
Site location: 003
Photo number: 022
Description: Looking downstream from Ore Pac Ave. Wide floodplain. Nursery to the west. Straightened, incised channel with established vegetation.

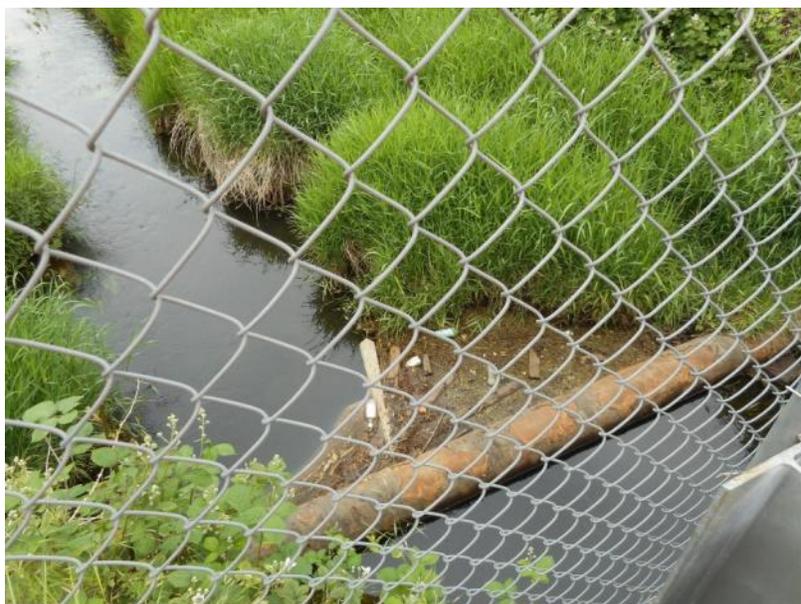
Site location: 003
Photo number: 019
Description: Pipe serving as a debris dam along Coffee Lake Creek.

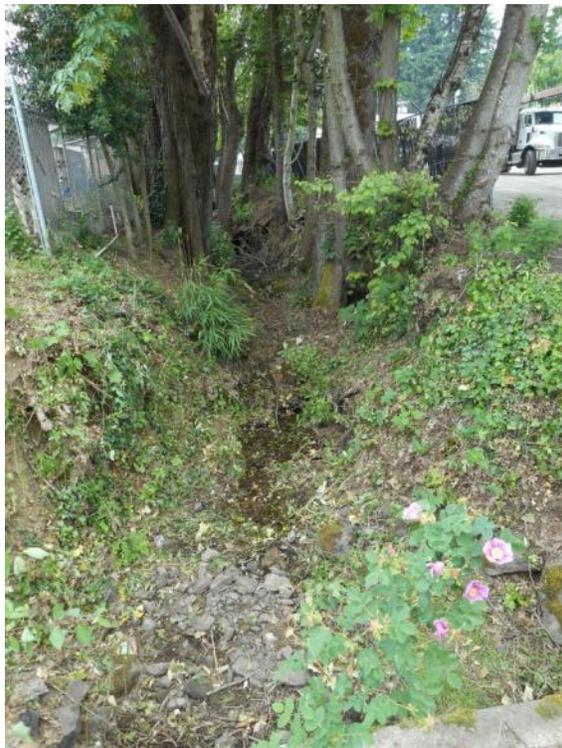
Site location: 004
Photo number: 025
Description: Looking upstream from Boberg Road toward 42" culvert. No observed flow.

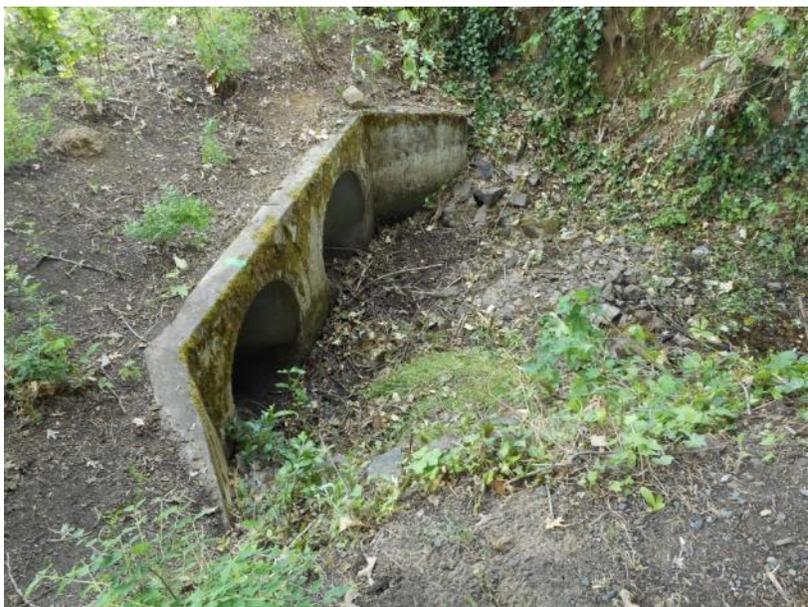
Site location: 004
Photo number: 026
Description: Channel crossing under Boberg Rd.

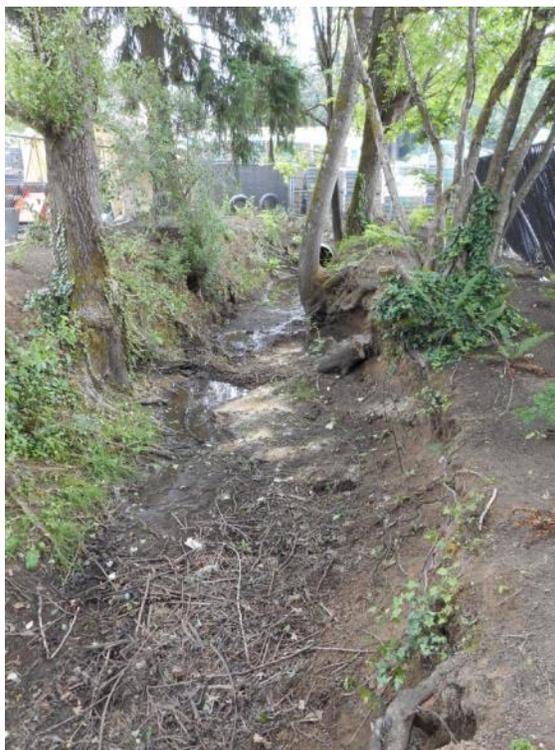
Site location: 004
Photo number: 028
Description: Looking downstream toward Boberg Rd. Incised channel appears stabilized based on observed vegetation. Significant private property encroachment.

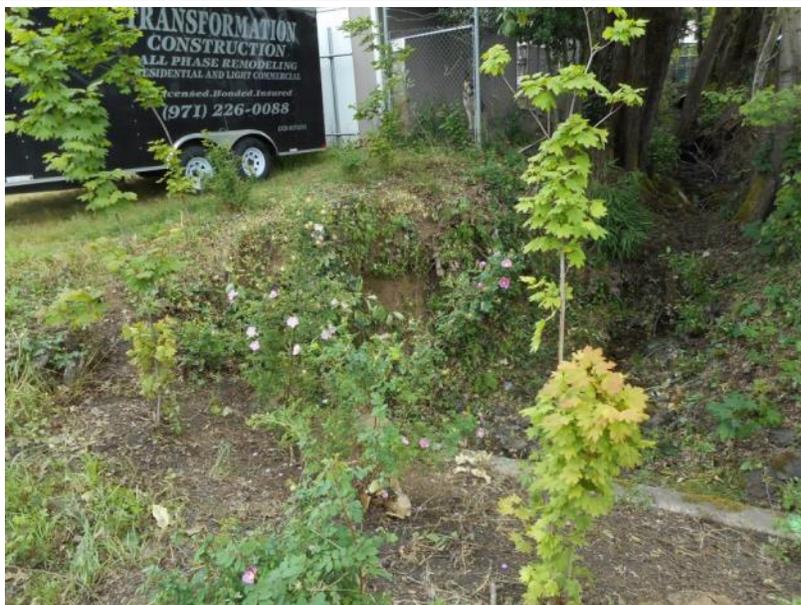
Site location: 004
Photo number: 029
Description: Sloughing north bank of channel.

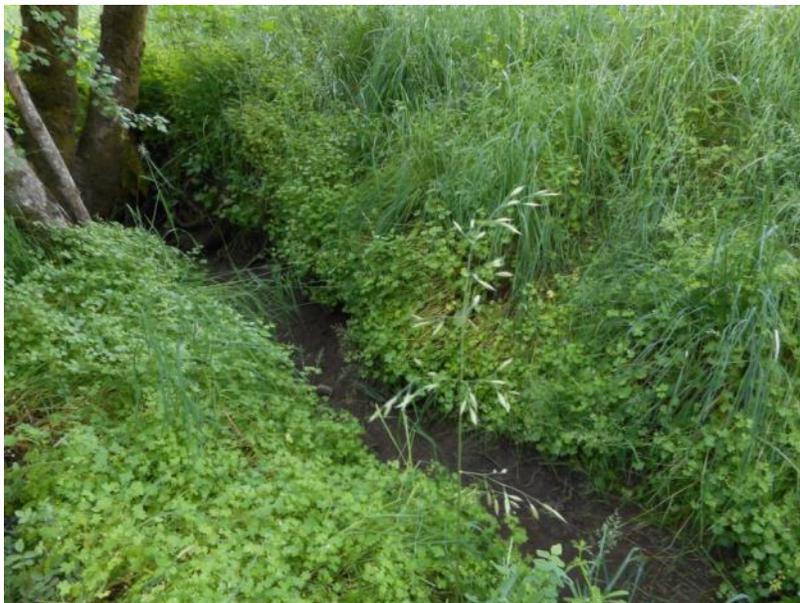
Site location: 004
Photo number: 032
Description: Approximately 300' downstream from photos 025-029. Dense vegetation and invasives. No flow observed in channel.

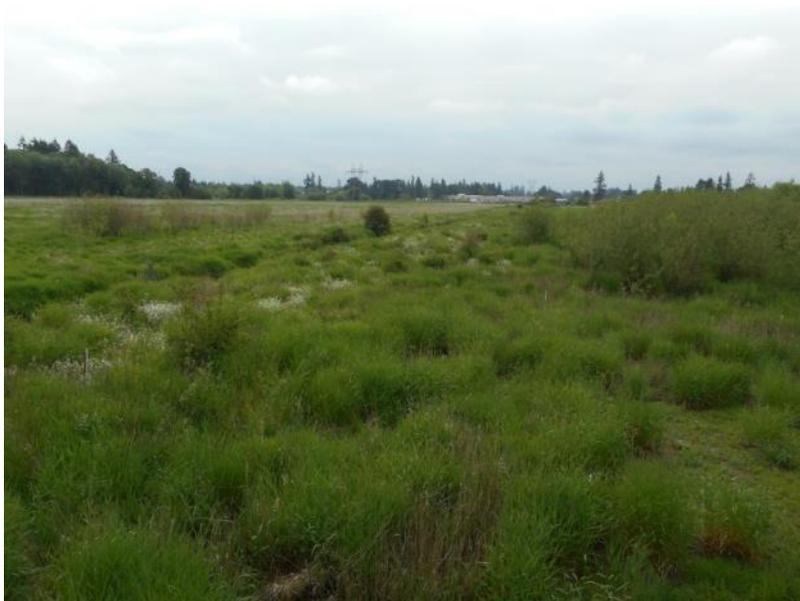
Site location: 005
Photo number: 035
Description: Coffee Lake wetlands complex, looking downstream.

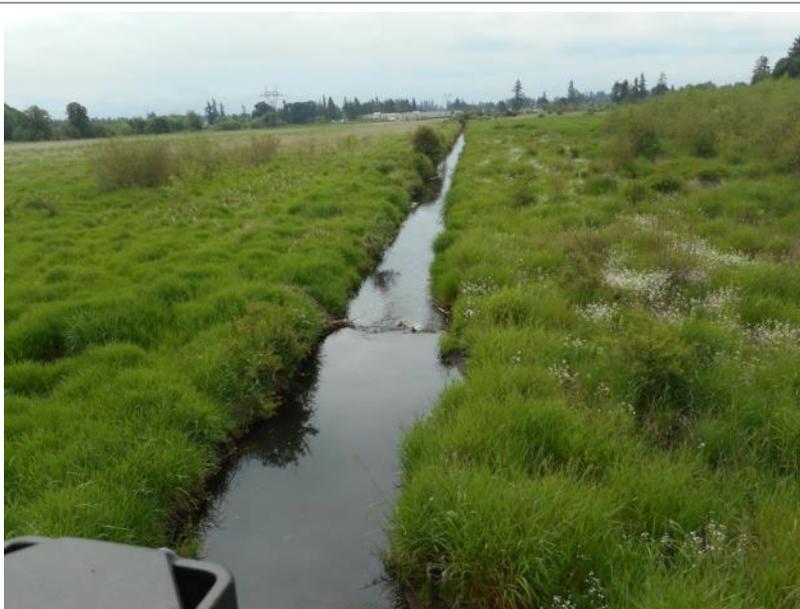
Site location: 005
Photo number: 037
Description: Looking downstream along Seely Ditch, which flows through the Coffee Lake wetlands. Observed beaver dam. Straightened channel with wide floodplain and dense vegetation.

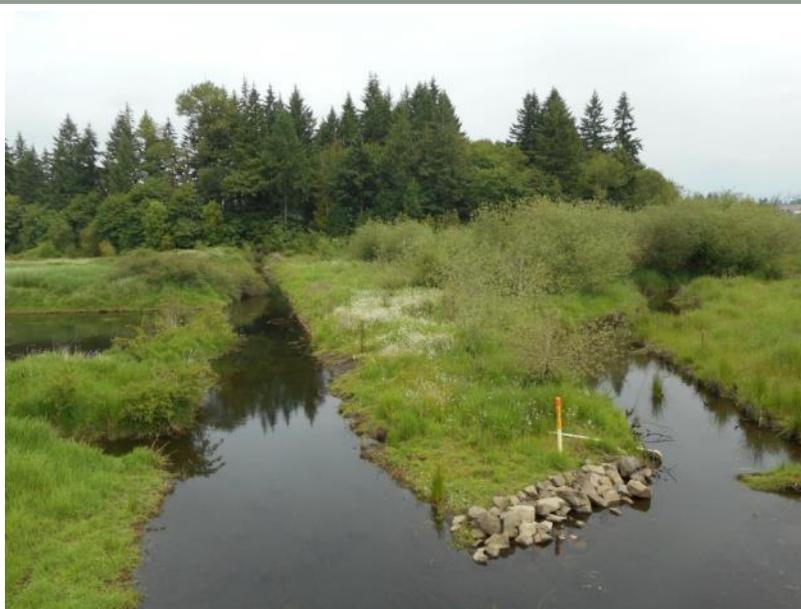
Site location: 005
Photo number: 039
Description: Looking upstream along Seely Ditch at channel diversion around basalt hummock island.

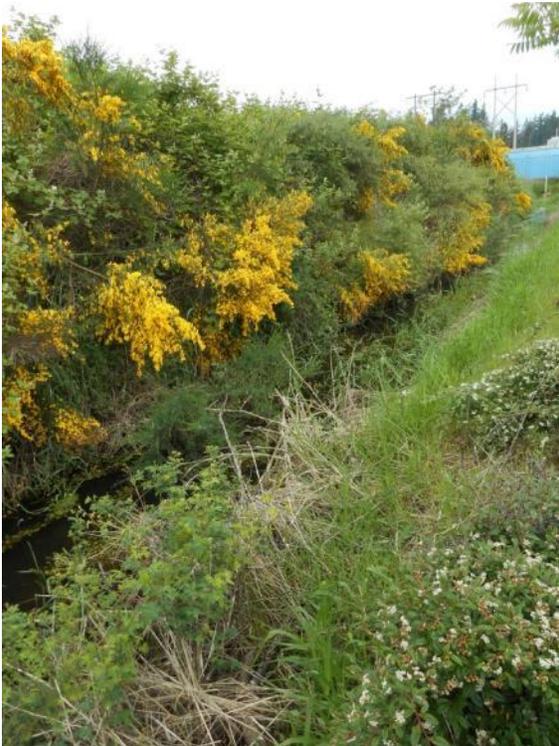
<div style="margin-left: 20px;"> <p>Site location: 006 Photo number: 042 Description: Looking upstream along channel. Industrial property owners report flooding in adjacent parking.</p> </div> </div>
	<div style="display: flex; align-items: flex-start;">

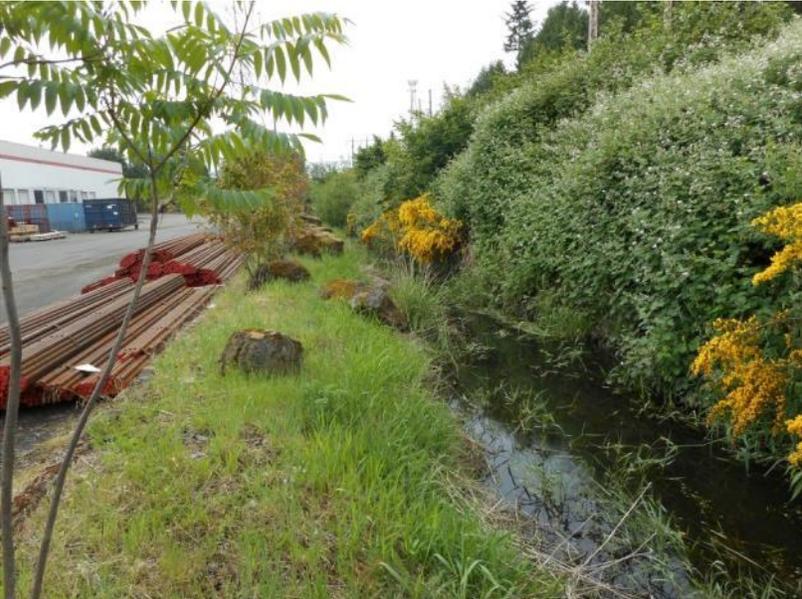
<div style="margin-left: 20px;"> <p>Site location: 006 Photo number: 043 Description: Looking downstream along channel. Channel straightened but significant vegetation including invasives within flow path.</p> </div> </div>

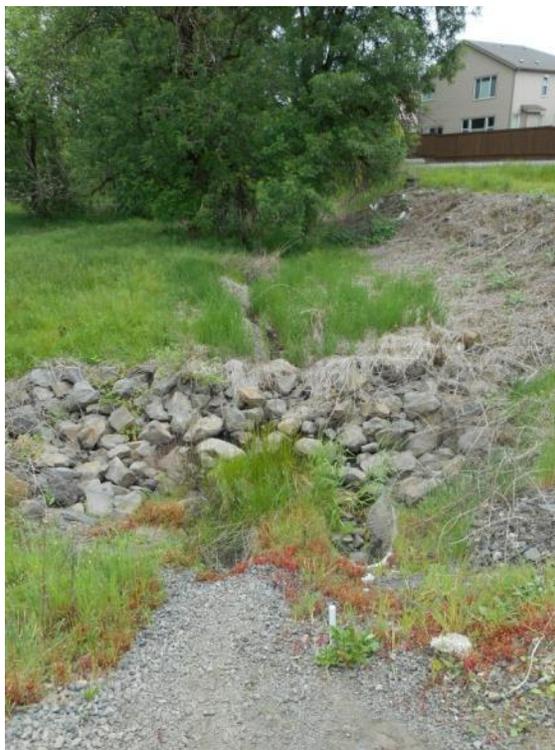
Site location: 007
Photo number: 045
Description: New development with channel restoration. Wide floodplain and boulder energy dissipation.

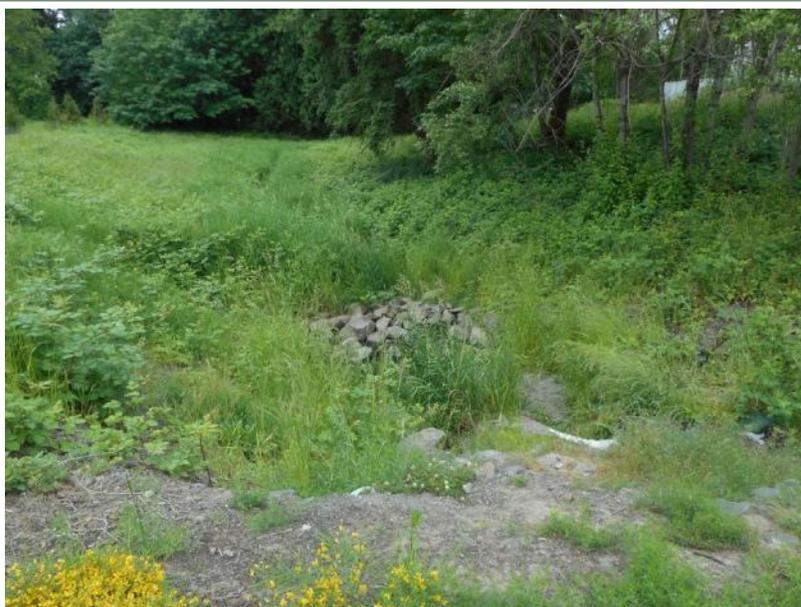
Site location: 007
Photo number: 047
Description: Looking downstream from photo 045.

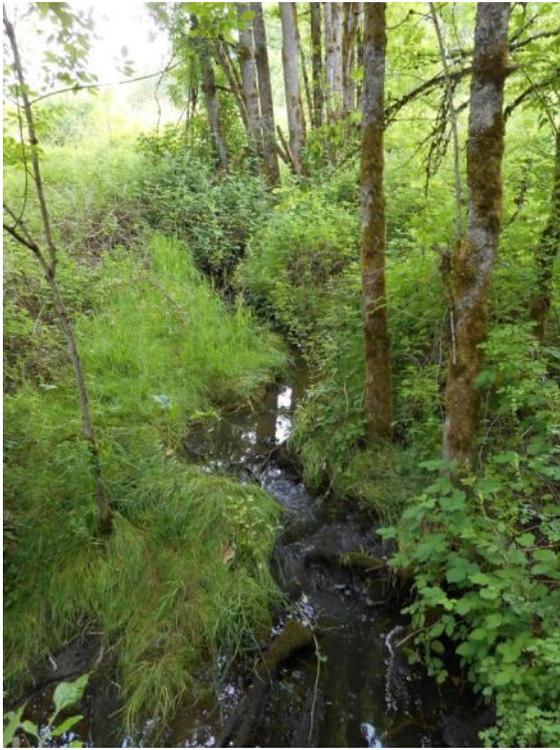
<div style="margin-left: 20px;"> <p>Site location: 008 Photo number: 049 Description: Looking downstream from footbridge. Wide floodplain and vegetation (including invasives).</p> </div> </div>
	<div style="display: flex; align-items: center;">

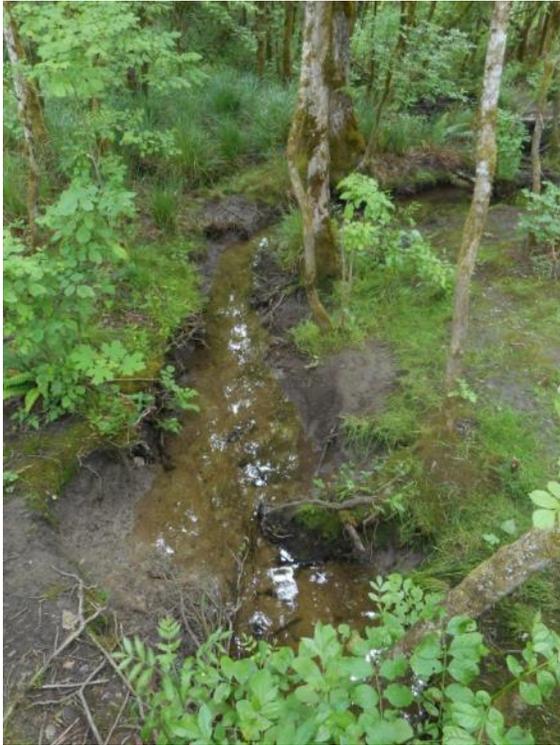
<div style="margin-left: 20px;"> <p>Site location: 008 Photo number: 050 Description: Observed channel downcutting and widening.</p> </div> </div>

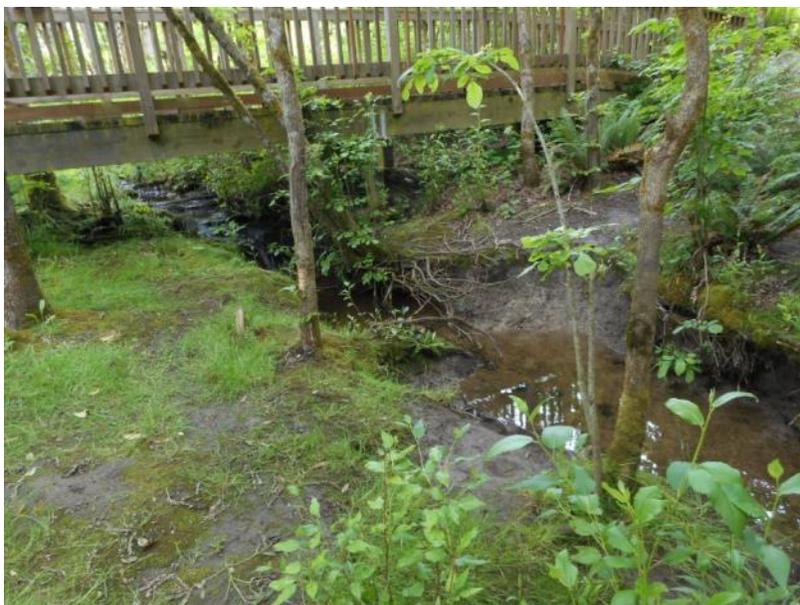
Site location: 008
Photo number: 051
Description: Observed nick points and scour holes and the footbridge (channel crossing).

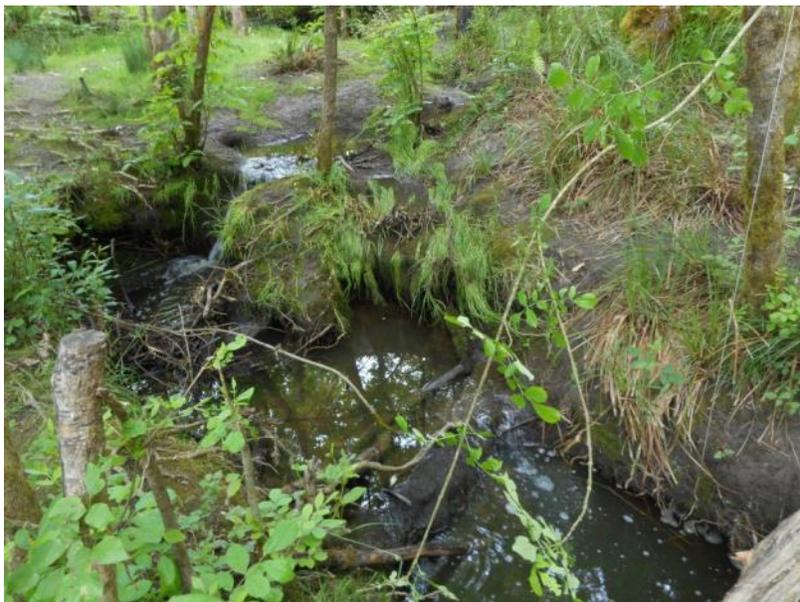
Site location: 008
Photo number: 053
Description: Observed some exposed roots and evidence of channel widening. No observed aggradation.

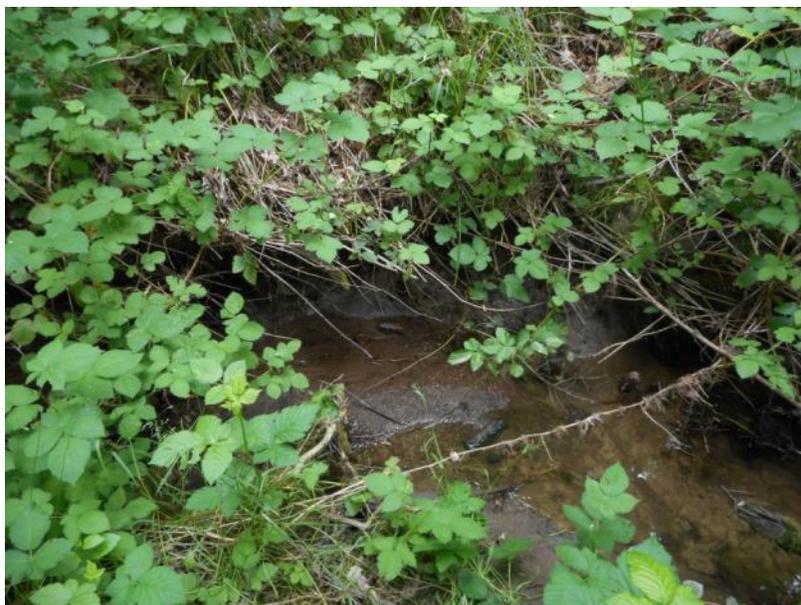
Site location: 008
Photo number: 056
Description: Silty loam bed material with little/ no cobbles and gravel.

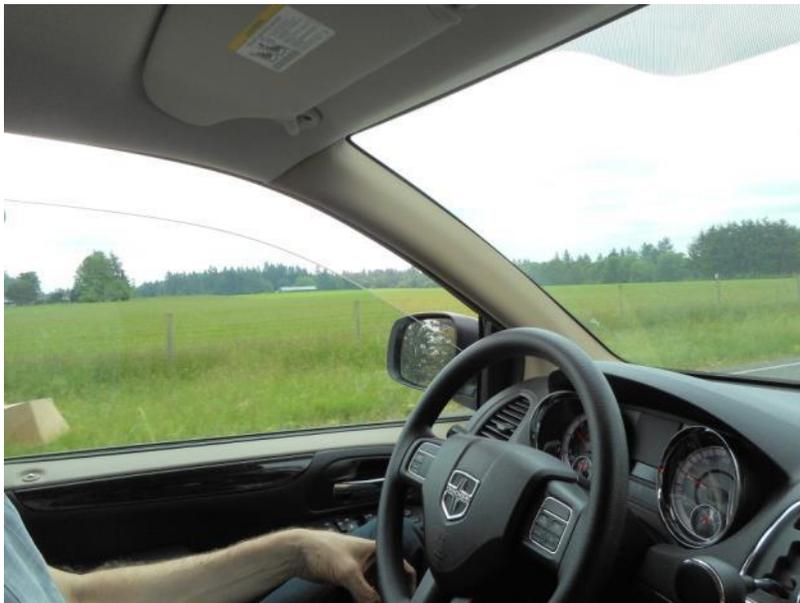
Site location: 009
Photo number: 059
Description: Proposed location of future school and City park.

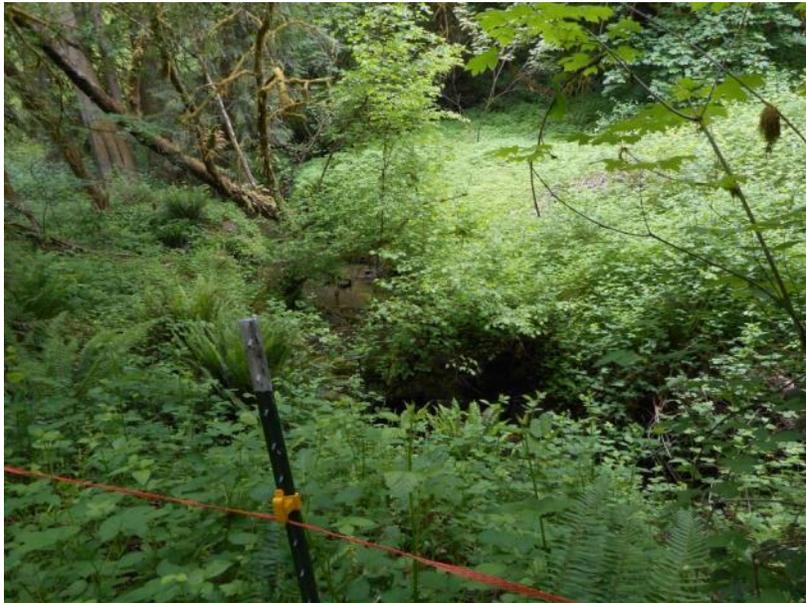
Site location:	010
Photo number:	061
Description:	Boeckman Creek from beginning of trail at public access (off Boeckman Rd.). Wide canyon with heavy vegetation and canopy.

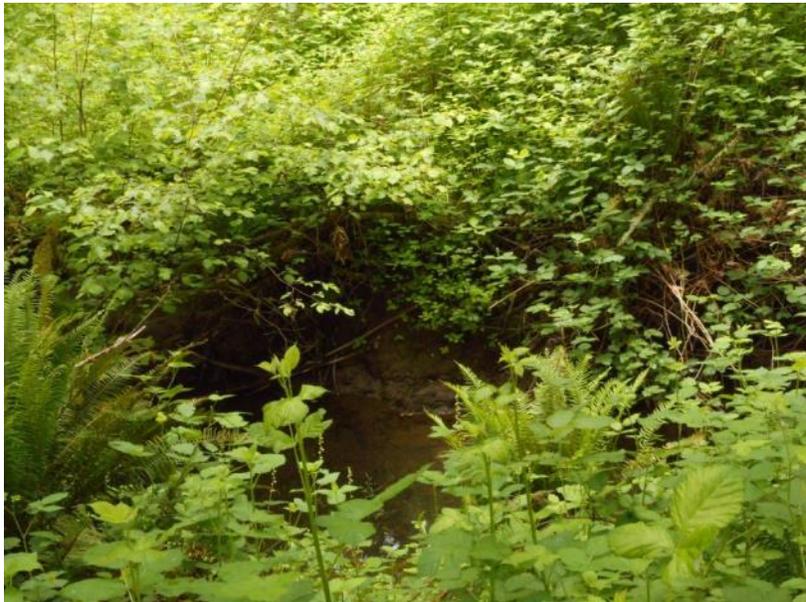
Site location:	010
Photo number:	063
Description:	Slight observed downcutting and incision along channel.

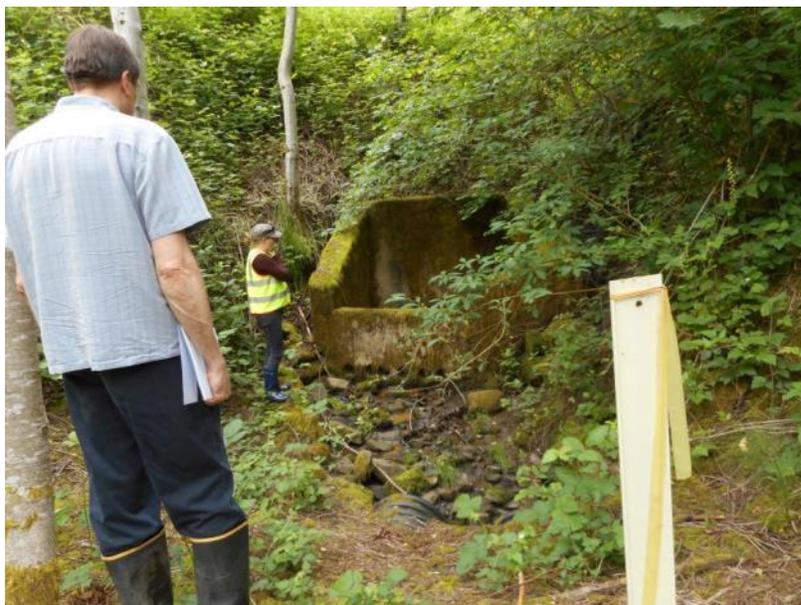
Site location: 010
Photo number: 066
Description: Existing outfall from Arbor Crossing Development area. Outfall structure appears to provide energy dissipation prior to discharge down canyon slope.

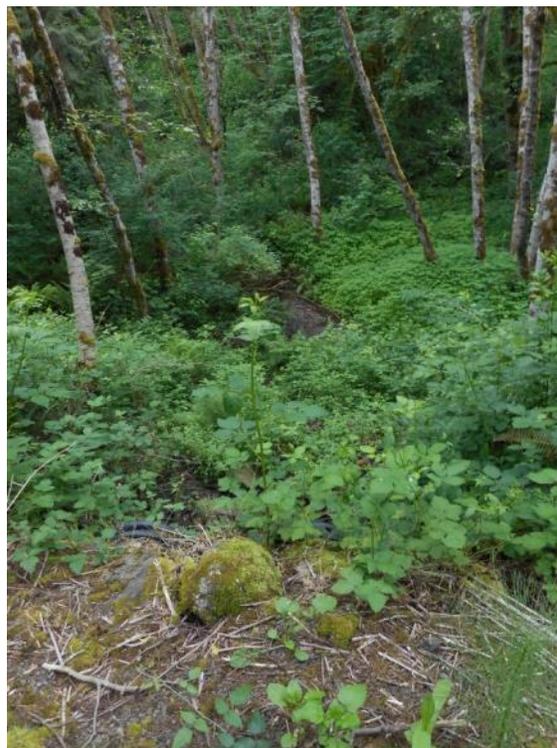
Site location: 010
Photo number: 065
Description: Outfall across trail to Boeckman Creek (from photo 066)

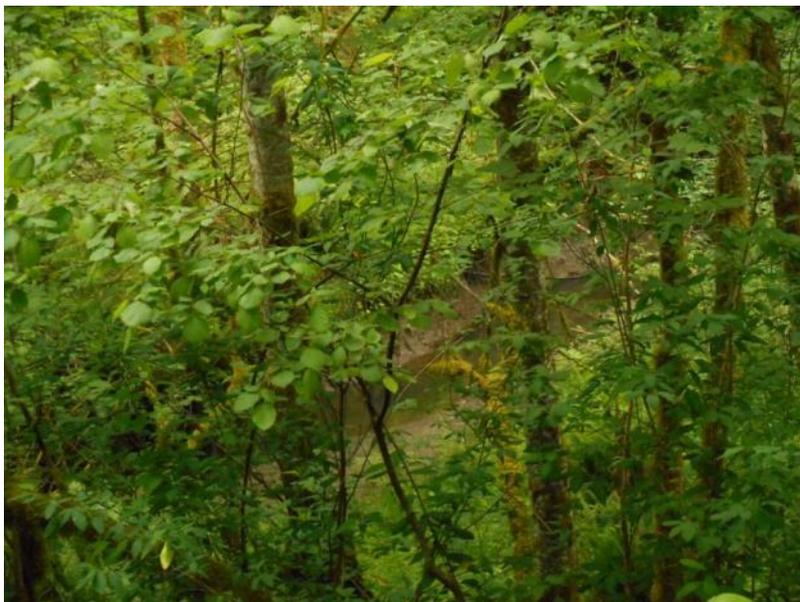
Site location: 010
Photo number: 068
Description: Evidence of eroding stream banks.

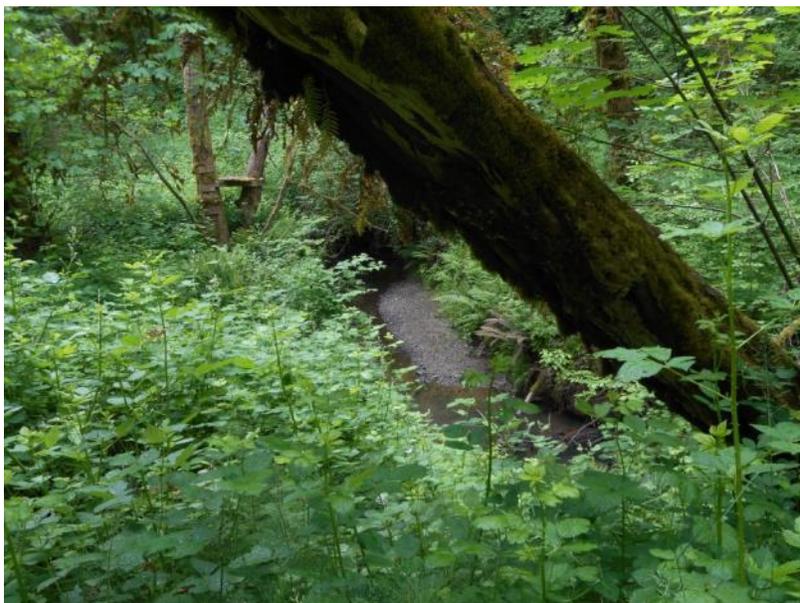
Site location: 010
Photo number: 070
Description: Point bar along Boeckman Creek.

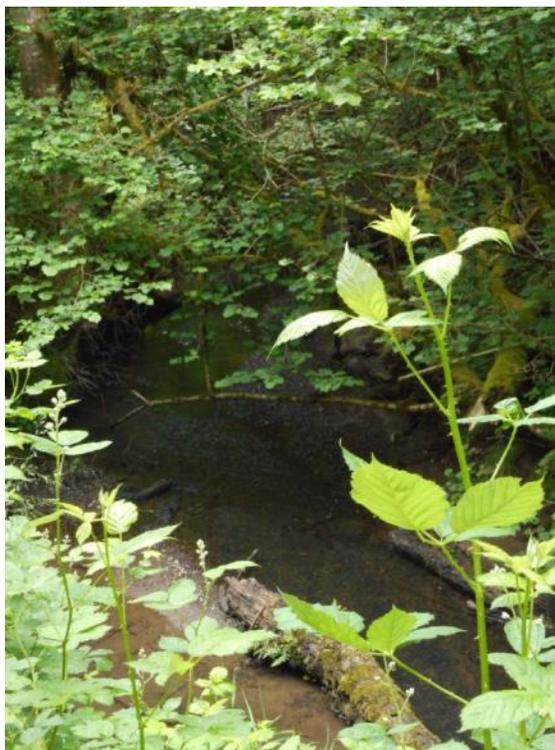
Site location: 010
Photo number: 082
Description: Bed material appears poorly sorted with evidence of aggradation.

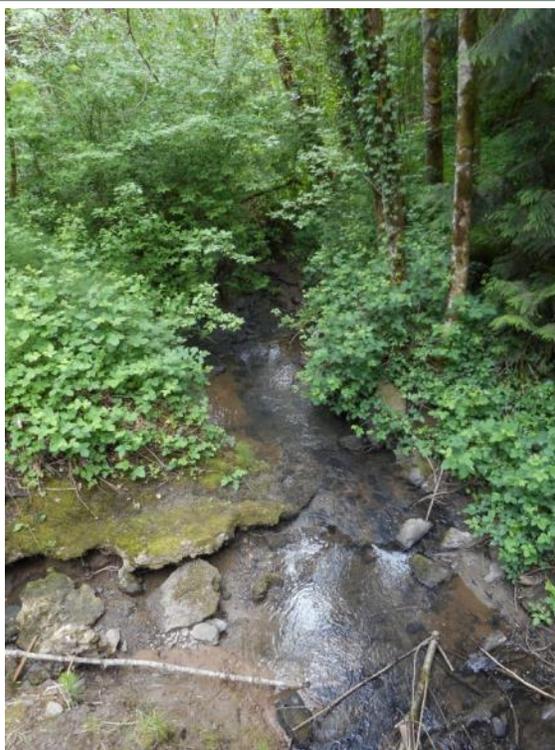
Site location: 010
Photo number: 084
Description: Outfall to Boeckman Creek with observed erosion (one of the CIP BC-2 locations) .

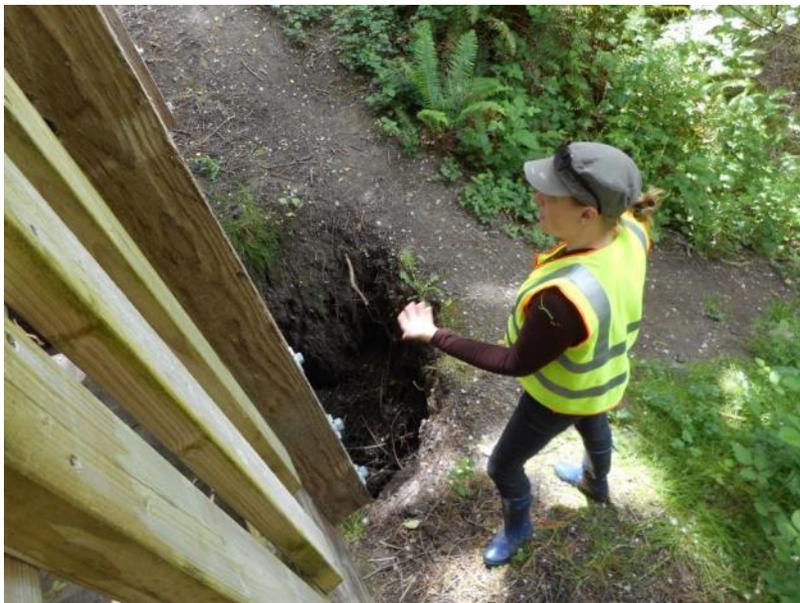
Site location: 010
Photo number: 086
Description: Observed sinkhole associated with photo 084.

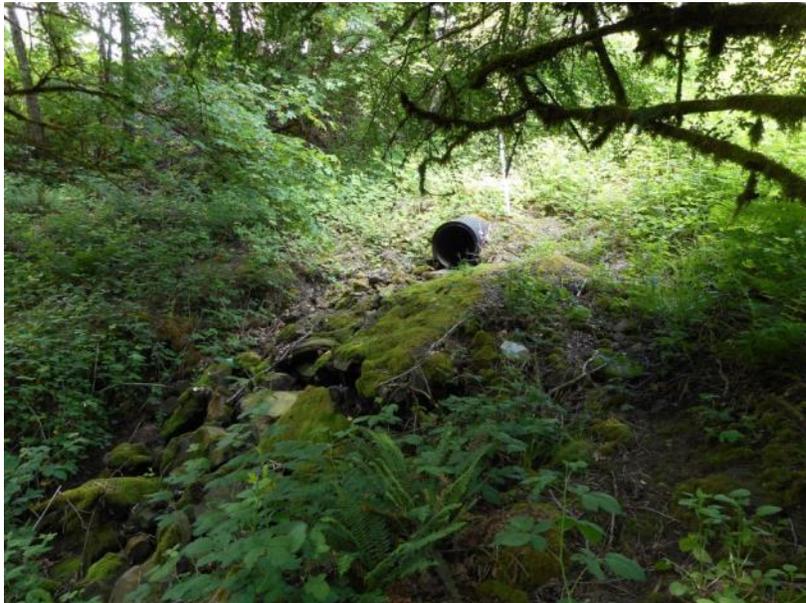
Site location:	011
Photo number:	089
Description:	Outlet from Gessellschaft Water Well (CIP BC-4).

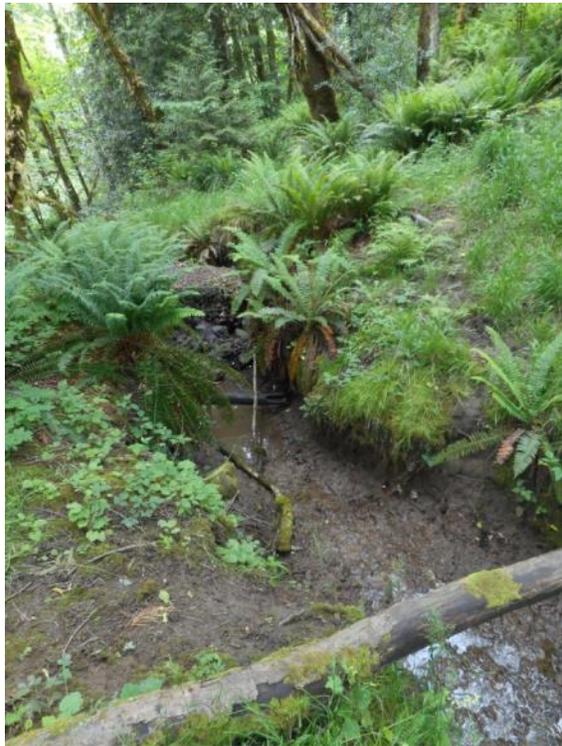
Site location:	011
Photo number:	091
Description:	Observed channel incision and nick points along channel alignment.

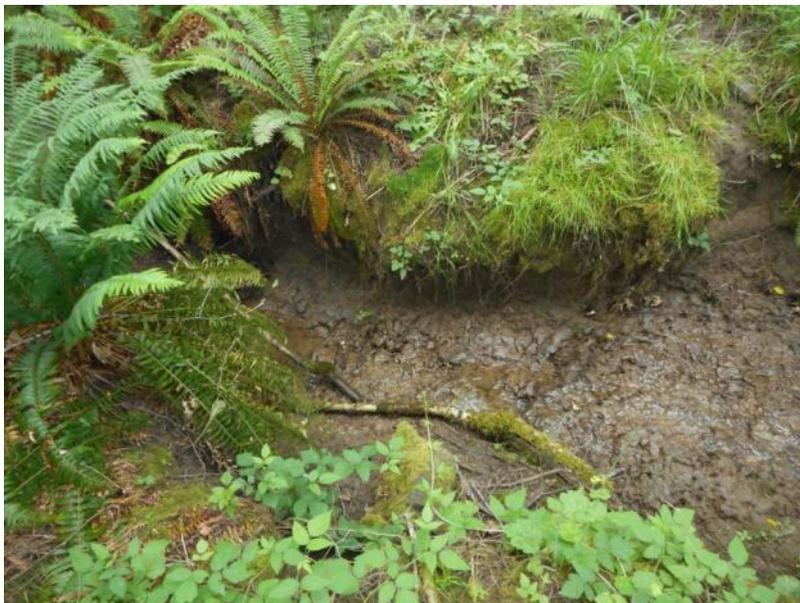
Site location: 011
Photo number: 093
Description: Observed silty loam bed material with limited gravel or cobbles toward middle/ downstream end of channel.

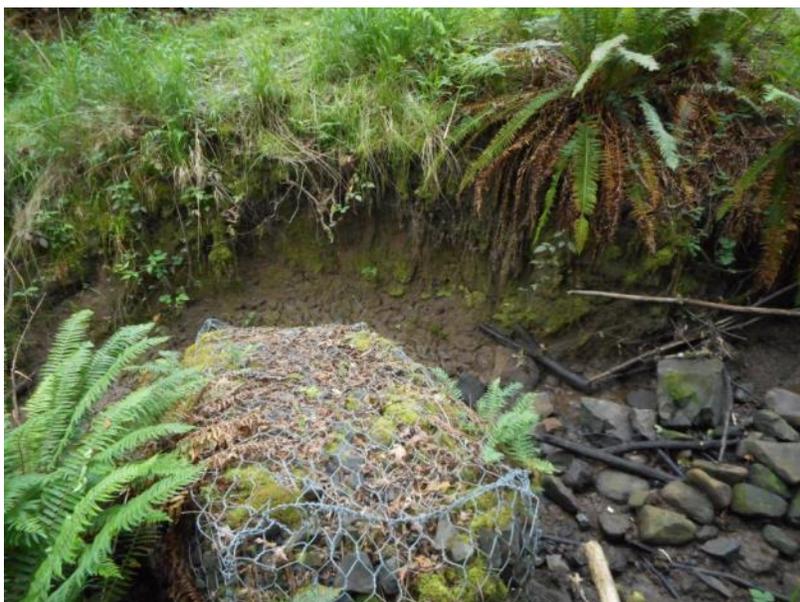
Site location: 011
Photo number: 094
Description: Upstream end of channel, observed active bank erosion along right bank.

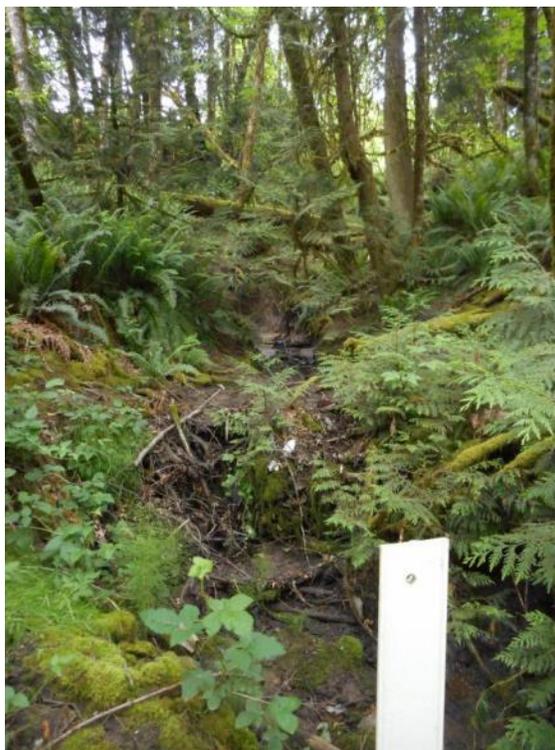
Site location: 011
Photo number: 074
Description: Looking upstream along Gessellscheft Water Well discharge channel from trail along Boeckman Creek.

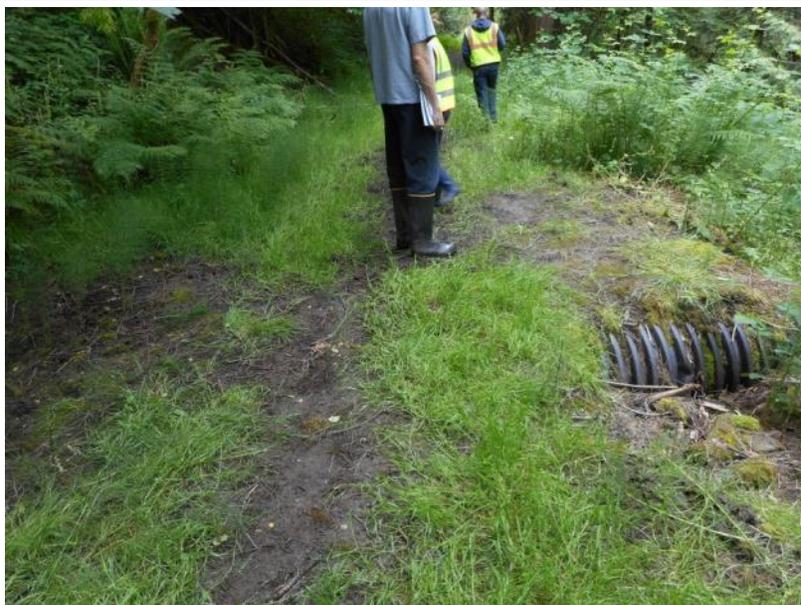
Site location: 011
Photo number: 080
Description: Observed trail settling and erosion at outfall from Gessellscheft Water Well channel.

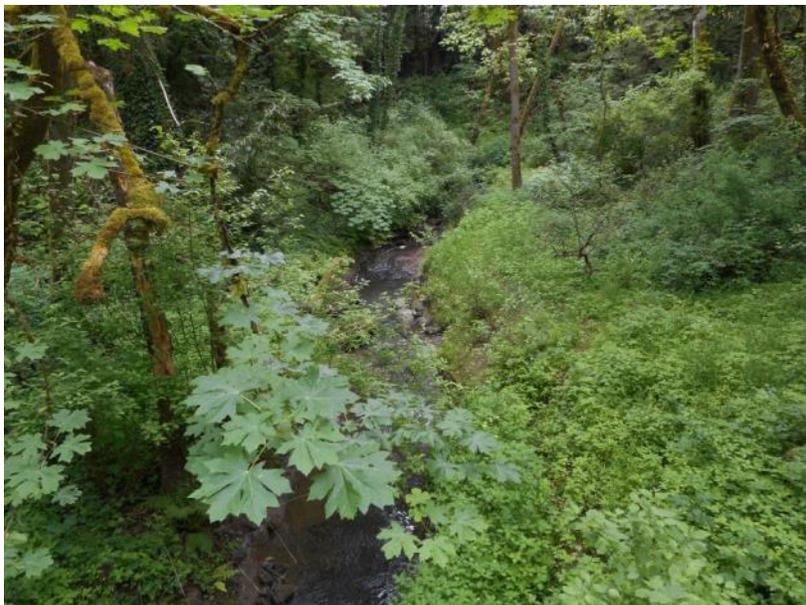
<p>Site location: 012 Photo number: 099 Description: Looking upstream along channel from footbridge. Channel alignment in canyon with dense vegetation and tree cover. Observed invasives.</p>

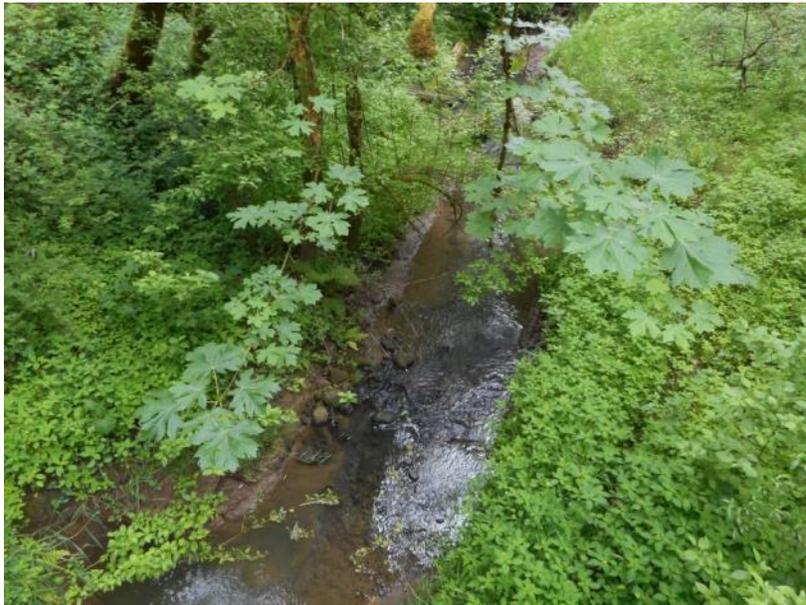
<p>Site location: 012 Photo number: 098 Description: Observed gravel and cobbles along channel bank.</p>

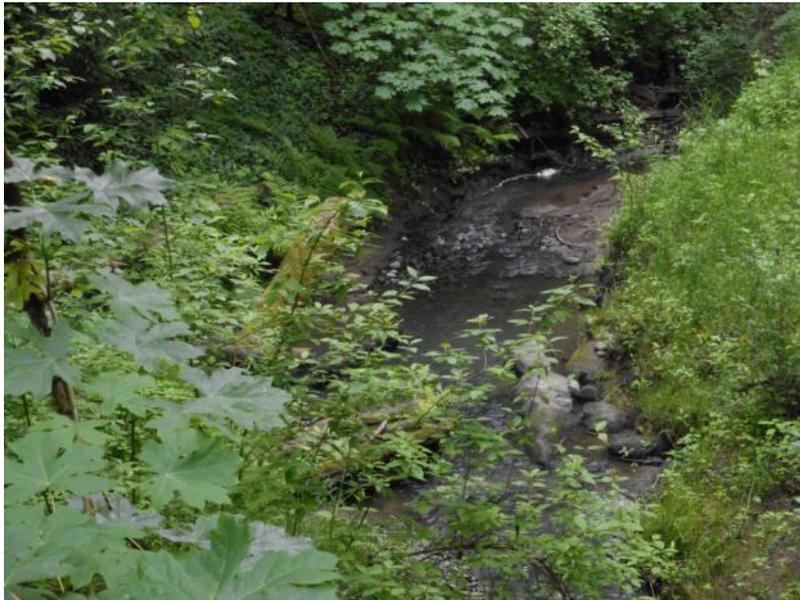
Site location: 012
Photo number: 100
Description: Established vegetation along channel banks and observed point bar.

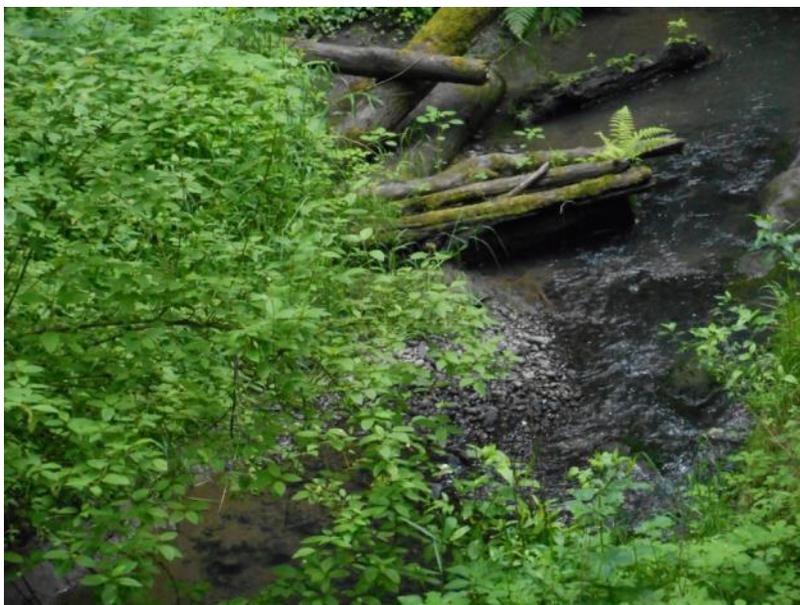
Site location: 012
Photo number: 102
Description: Point bar along channel alignment.
