2021 Street Tree Inventory

2021 Street Tree Inventory, continued

Utilities

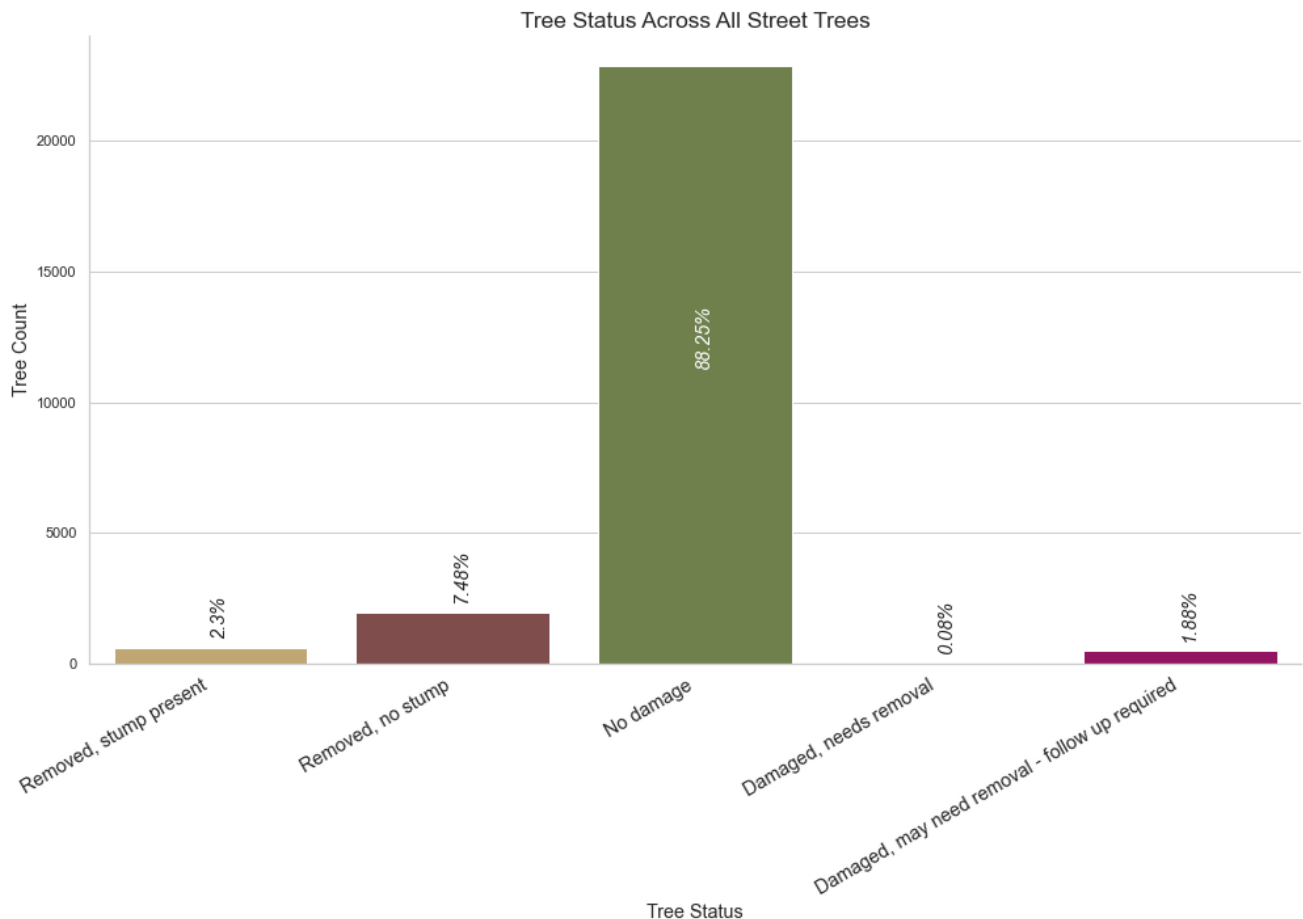
After updating and inventorying every street tree in Wilsonville, there were 25,998 data points. Of the total, 23,398 of those points represented trees that were in place while 2,531 represented trees that were removed. *See tree status chart on next page.*

For this analysis, the trees marked with the condition as "Damaged, May Need Removal", "Damaged, Needs Removal" and "Removed, Stump Present" were associated with ice storm damage. While it was assumed trees marked as "Removed, No Stump" were removed prior to the storm due to the time and effort of removing a tree stump. Those identified as "No damage" were found to be in the same condition as the previous survey.

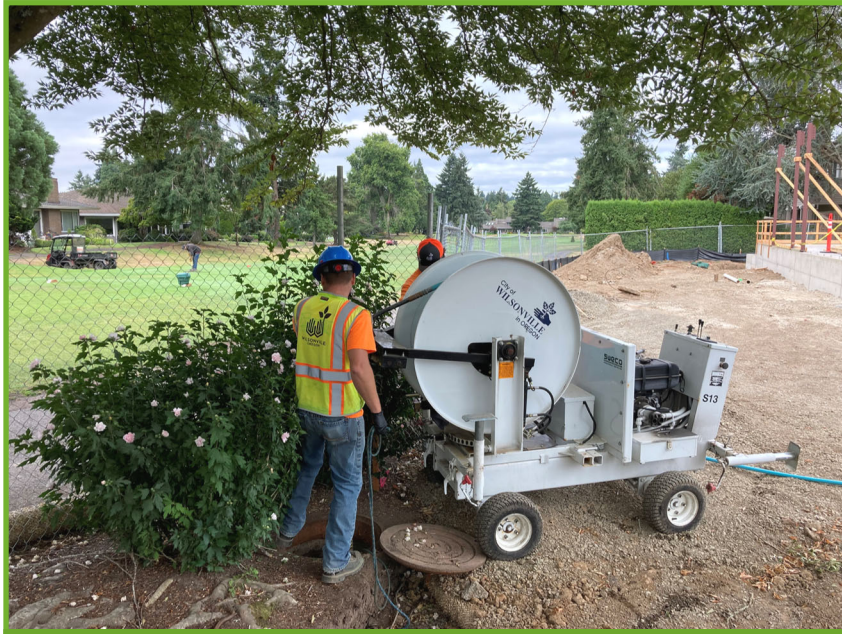
Cleaning sewer mains at the Charbonneau Golf course

The Wastewater crew performed routine cleaning in the sewer mains located at the Charbonneau golf course to keep the wastewater flowing efficiently. Staff accessed manholes at the course using an easement machine, a maneuverable unit with a sewer cleaning hose reel. It attaches to the combination cleaning truck that provides the water pressure for the cleaning hose. The truck is parked on an adjacent street and the small walk-behind machine is driven to the manhole that needs to be accessed.

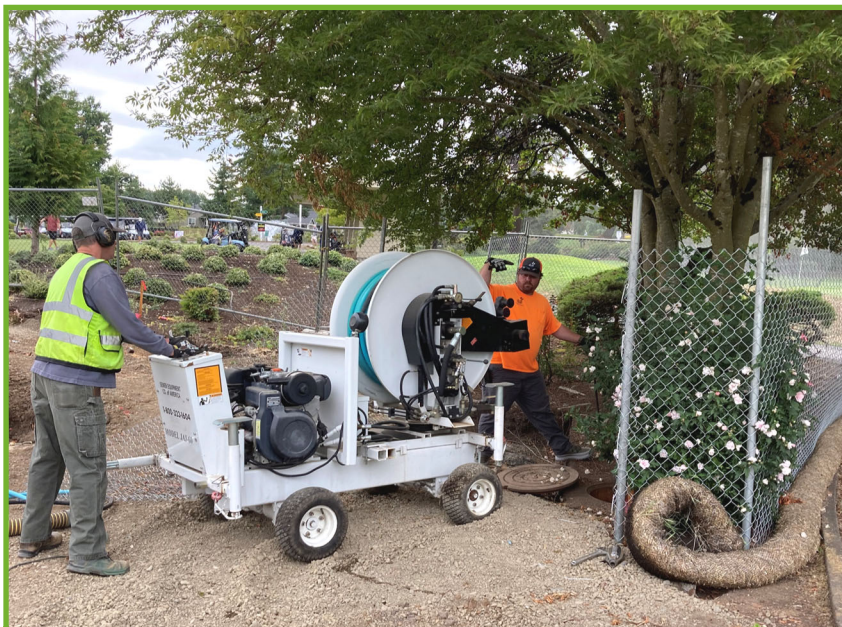
Positioning the easement machine

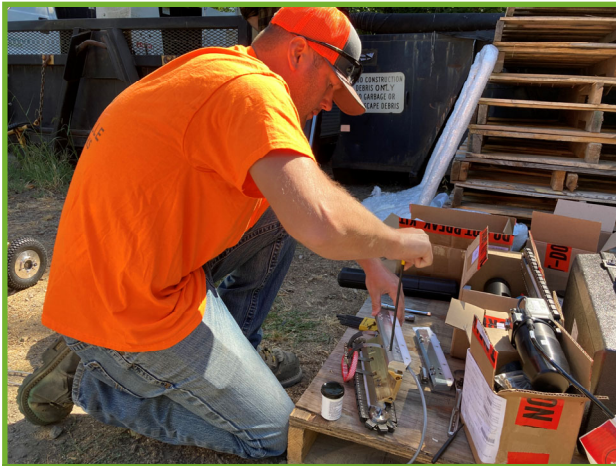
Randy assembling the remote camera

The crew received a two day training from the vendor the truck was purchased from. The crew learned about how to set up the camera, make adjustments to the transporters, and how to operate the inspection software. The training was conducted in the field to give the operators hands on experience using the new equipment.

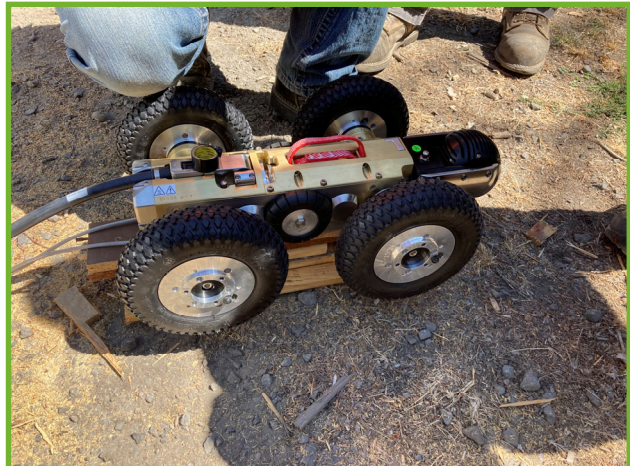
Finished remote camera

The Wastewater and Stormwater divisions are excited about our new CCTV inspection van. The equipment will be used to inspect sewer and storm pipes for structural or functional issues. It will also allow the crews to assess the effectiveness of the pipeline cleaning efforts and provide valuable information to the Engineering department in order to plan capital improvement projects.

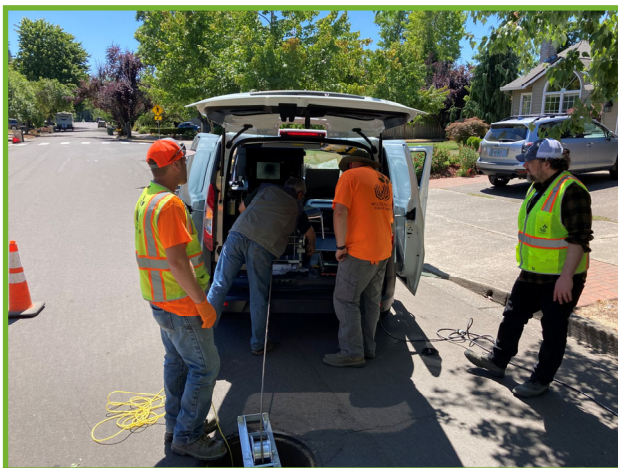
The new CCTV van

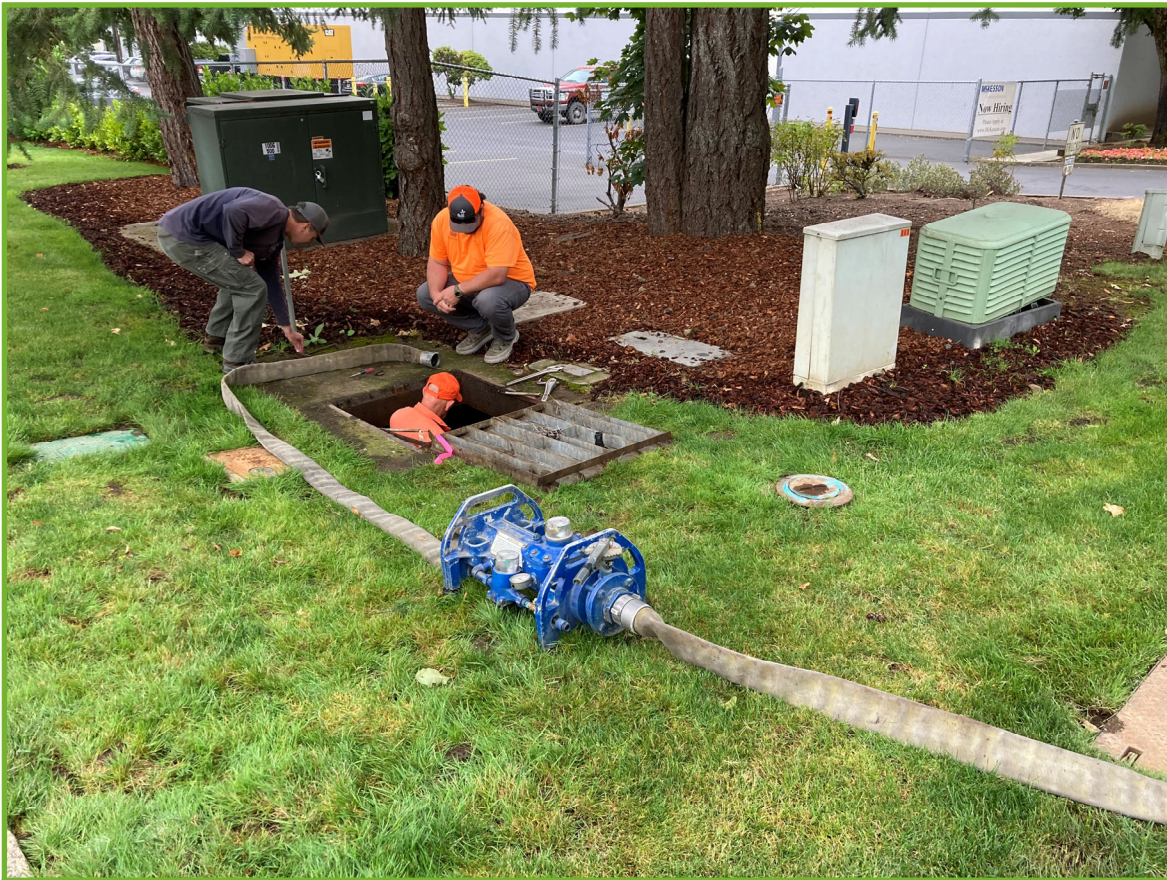
Testing a large meter on commercial property

When testing a large meter, the contract provides a calibrated, bench-tested meter, which is connected to the meter being tested. Water is run through both meters and compared for accuracy. The contractor performs any necessary repairs or adjustments on site. If the meter is beyond repair, it is scheduled to be replaced.
