Appendix A
JACOBS CONDITION ASSESSMENT 2019

Wilsonville Wastewater Facility Condition Assessment Report

April 2019

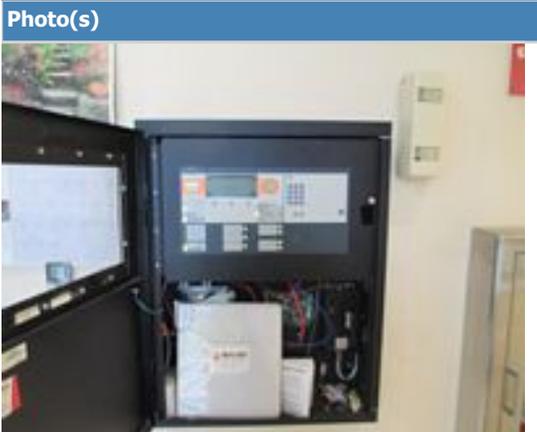
Asset Description	Fire Alarms in Laboratory Hall	System	Building
Asset Type	ALARM	Location	Control Building
Asset ID	CONTROL-Fire Alarms	Inspection Date	4/4/2019
Comments		Flag

Question	Overriding?	Answer	NA	Flag	Answer Comment
All Components		1 yes			
All Safety Features Present		1 yes			
Connections Ok		1 yes			
Corrosion - Metal		1 Like New			
Display Ok		1 yes			
Installation/Accessibility		1 Installed properly, easy to access			
Mounting		1 Excellent			
Obsolescence		1 Current, Supported

Condition Category Very good. Condition Grade 1. New or nearly new. Only normal maintenance required.

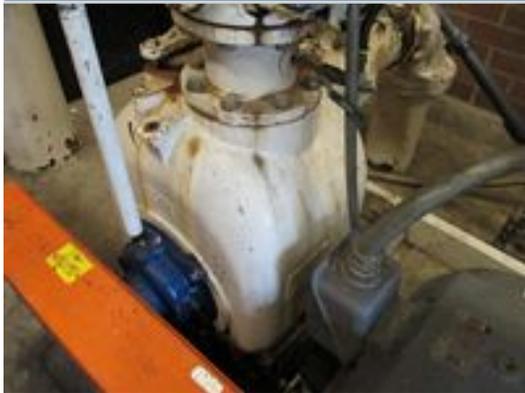
Asset Description	Charbonneau Lift Pump #1	System	Charbonneau LS
Asset Type	PUMP CENT	Location	Charbonneau Liftstation
Asset ID	CHAR-LS-01-P-1	Inspection Date	4/3/2019
Comments		Flag

Question	Overriding?	Answer	NA	Flag	Answer Comment
Absence of Leaks		1 yes			
Absence of Pump Cavitations		1 yes			
Acceptable Noise		1 yes			
All Safety Guards Present		1 yes			
Corrosion - Structural Metal Condition?		2 Minor corrosion			
Mounting		1 Excellent			
Vibration Analysis		3 -Fair .15 - .31 inches/sec			0.19" / second

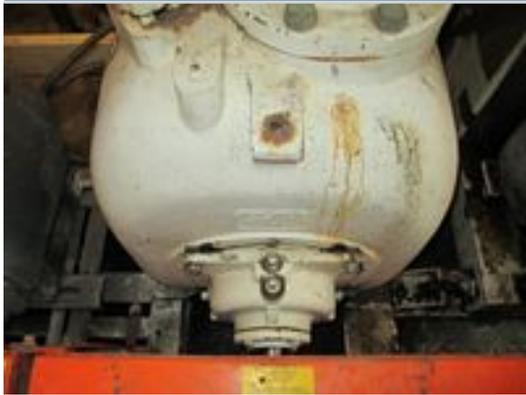
Asset Description	Charbonneau Lift Pump #2	System	Charbonneau LS
Asset Type	PUMP CENT	Location	Charbonneau Liftstation
Asset ID	CHAR-LS-01-P-2	Inspection Date	4/3/2019
Comments		Flag

Question	Overriding?	Answer	NA	Flag	Answer Comment
Absence of Leaks		1 yes			
Absence of Pump Cavitations		1 yes			
Acceptable Noise		1 yes			
All Safety Guards Present		1 yes			
Corrosion - Structural Metal Condition?		2 Minor corrosion			
Mounting		1 Excellent			
Vibration Analysis		3 -Fair .15 - .31 inches/sec			0.23" / second

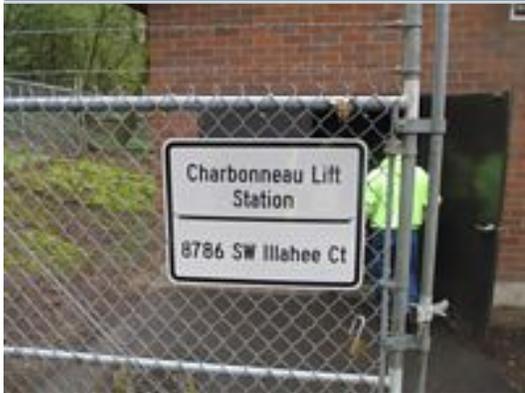
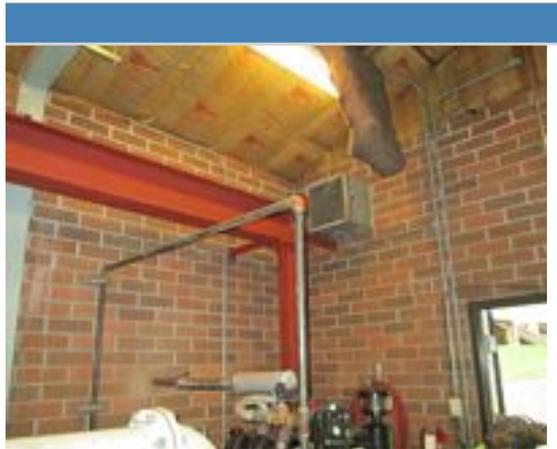
Asset Description	Charbonneau Lift Station	System	Charbonneau LS
Asset Type	SITE	Location	Charbonneau Liftstation
Asset ID	CHAR-LS-01	Inspection Date	4/3/2019
Comments		Flag

Question	Overriding?	Answer	NA	Flag	Answer Comment
Civil - Drainage		2 5% needs maintenance			
Civil- Fences and Security		1 Normal maintenance			
Civil- Flood Protection		1 Normal maintenance			
Civil- Roads		1 Normal maintenance			
Civil- Vegetation and Landscaping		2 5% needs maintenance			
Site Access		1 Very Good			
Site Lighting Adequate		5 No

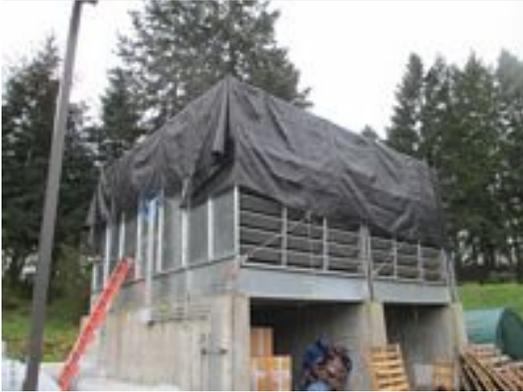
Asset Description	Cooling Tower Fan #2	System	Cooling
Asset Type	FAN	Location	Cooling
Asset ID	CTW55-11002	Inspection Date	4/4/2019
Comments	The cooling tower and associated equipment was not in operation (not necessary this time of year), and covered to prevent fouling from pine needles from adjacent trees.	Flag	Not Evaluated

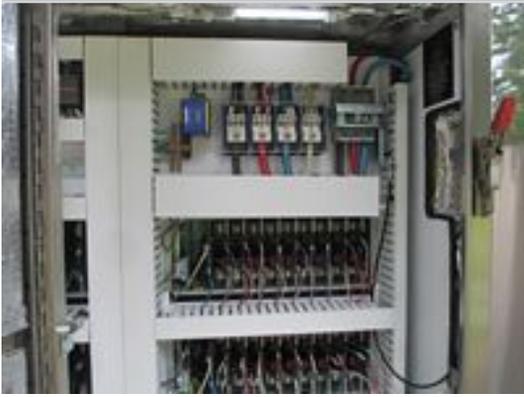
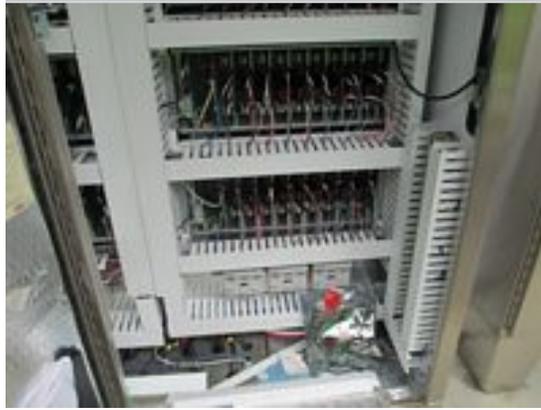
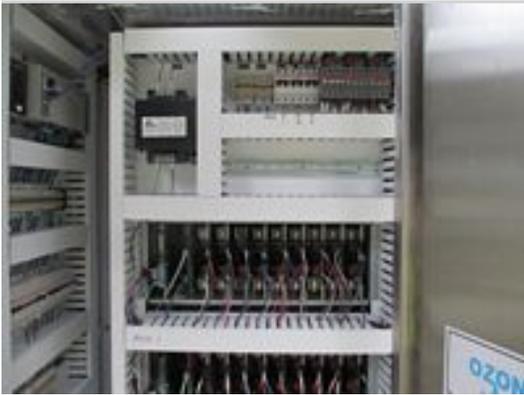
Question	Overriding?	Answer	NA	Flag	Answer Comment
Absence of Burn Marks		1 yes			
Acceptable Smell or Heat		1 yes			
All Safety Features Present		1 yes			
Control Switches		2 Good			
Good House Keeping		1 yes			
Good Wire Labeling		1 yes			
Infrared		2 Normal			
Installation		1 Excellent			
Obsolescence		1 Current and supported			
Operating at Inspection		1 yes			
Panel Labeling		1 yes			
Structural (Panel)		1 Excellent

Condition Category Very good. Condition Grade 1. New or nearly new. Only normal maintenance required.

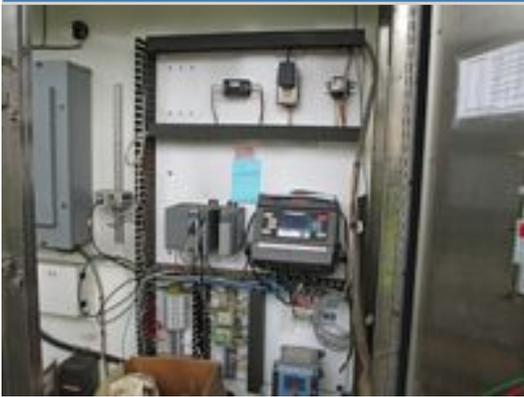
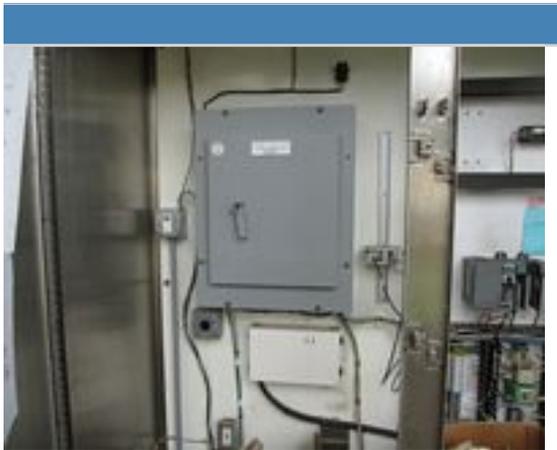
Asset Description	UV Control Panel	System	Effluent
Asset Type	CONTROL PANEL	Location	Effluent Channel
Asset ID	UV-LCP-70-1	Inspection Date	4/3/2019
Comments		Flag

Question	Overriding?	Answer	NA	Flag	Answer Comment
Absence of Burn Marks		1 yes			
Acceptable Smell or Heat		1 yes			
All Safety Features Present		1 yes			
Control Switches		2 Good			
Good House Keeping		1 yes			
Good Wire Labeling		1 yes			
Infrared		2 Normal			
Installation		2 Normal			
Obsolescence		3 Limited Parts Available			
Operating at Inspection		1 yes			
Panel Labeling		1 yes			
Structural (Panel)		1 Excellent

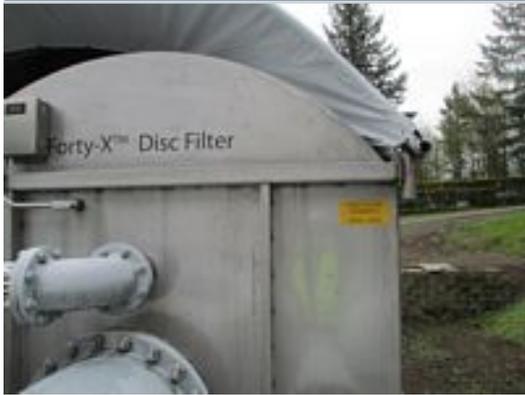
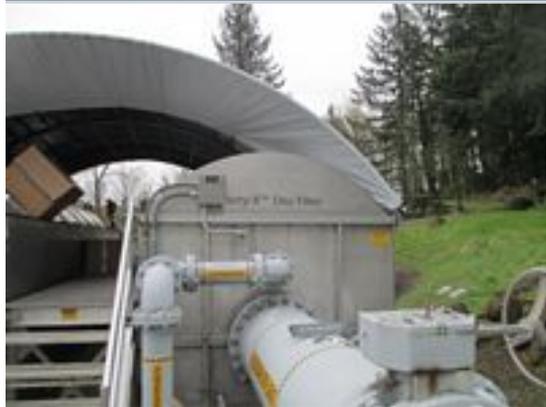
Asset Description	Disk Filter #2	System	Filtration
Asset Type	FILTER	Location	Filter
Asset ID	DF60-10002	Inspection Date	4/4/2019
Comments		Flag

Question	Overriding?	Answer	NA	Flag	Answer Comment
All Components		1 yes			
All Safety Features Present		1 yes			
Corrosion - Structural Concrete		1 Like new condition			
Handrails		1 Very Good			
Media Condition (Media study)		2 Good			
Operating at Inspection		1 yes			
Surface washer		1 Good

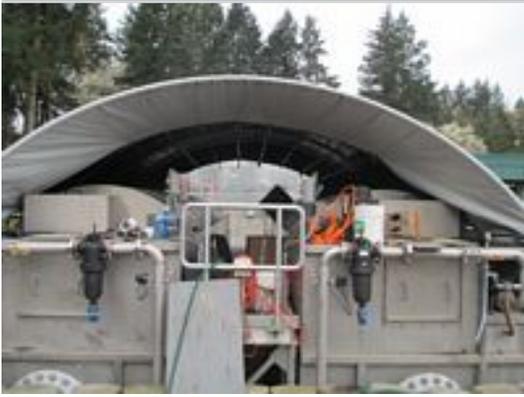
Asset Description	Disk Filter Drive Motor #2	System	Filtration
Asset Type	MOTOR	Location	Filter
Asset ID	FLT60-10002	Inspection Date	4/4/2019
Comments		Flag

Question	Overriding?	Answer	NA	Flag	Answer Comment
Acceptable Noise		1 yes			
Acceptable Smell or Heat		1 yes			
All Components		1 yes			
All Safety Guards Present		1 yes			
Bearings		2 Minor Wear			
Corrosion - Structural Metal Condition?		2 Minor corrosion			
Drive Shaft Alignment		1 Excellent			
Insulation Resistance	Yes	1 Greater than 10 Meg Ohm			420 Meg ohms
Oil Level within Range			X	Non Existent	Greased bearings
Operating at Inspection		1 yes			
Structural Integrity		1 Excellent			
Vibration Analysis	Yes	2 2 -Good .039 - .15 inches/sec			0.05" / second

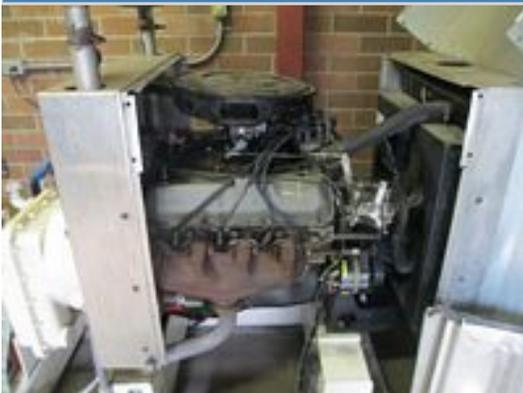
Asset Description	Memorial Park Auxillary Engine	System	Memorial Park LS
Asset Type	GENERATOR	Location	Memorial Park Liftstation
Asset ID	MEMP-LS-03-AUX	Inspection Date	4/3/2019
Comments		Flag

Question	Overriding?	Answer	NA	Flag	Answer Comment
Acceptable Noise		1 yes			
Acceptable Oil/Grease		1 yes			
Acceptable Smell or Heat		1 yes			
Acceptable Vibration		1 yes			
Air Filter		1 Excellent			
All Components		1 yes			
All Safety Guards Present		1 yes			
Automatic Transfer Switch			X	Non Existent	Auxillary engine
Battery/ Charging System		2 Minor			
Control Gauges (Hour Meters Volts & Amps)		2 Good			
Control Switches		2 Good			
Cooling System		1 Proper Coolant Additives No Corrosion			
Corrosion - Structural Metal Condition?		2 Minor corrosion			
Exhaust System		1 Excellent			
Heater Jacket		1 Excellent			
Hoses and Belts		3 Moderate			
Monitoring Panel		1 Excellent			
Oil OK at Inspection		1 yes			
Oil Pressure		1 Good			
Running at Inspection		1 yes			
Starting System		1 Proper Operation

Condition Category Very good. Condition Grade 1. New or nearly new. Only normal maintenance required.

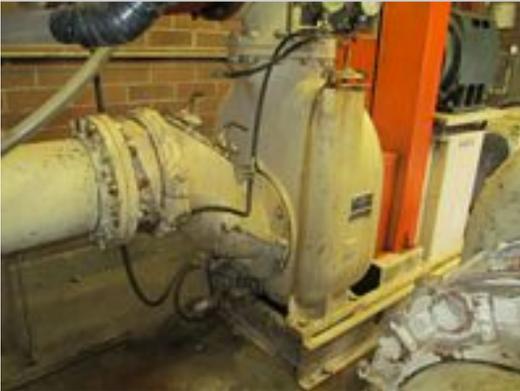
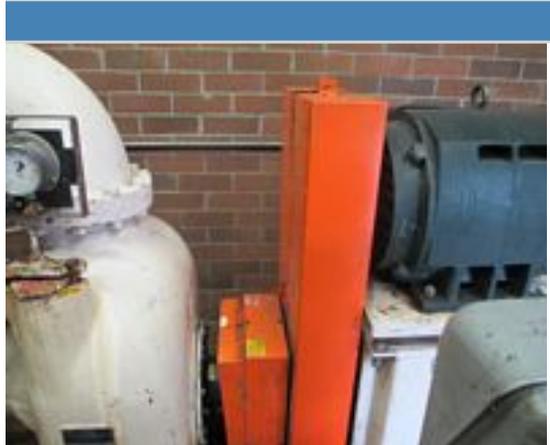
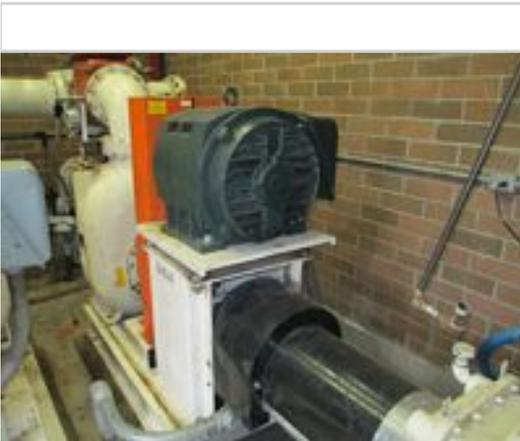
Asset Description **Memorial Park Lift Pump #1**

Question	Overriding?	Answer	NA	Flag	Answer Comment
Absence of Leaks		1 yes			
Absence of Pump Cavitations		1 yes			
Acceptable Noise		1 yes			
All Safety Guards Present		1 yes			
Corrosion - Structural Metal Condition?		2 Minor corrosion			
Mounting		1 Excellent			
Vibration Analysis		3 3 -Fair .15 - .31 inches/sec			0.17" / second

Condition Category Very good. Condition Grade 1. New or nearly new. Only normal maintenance required.

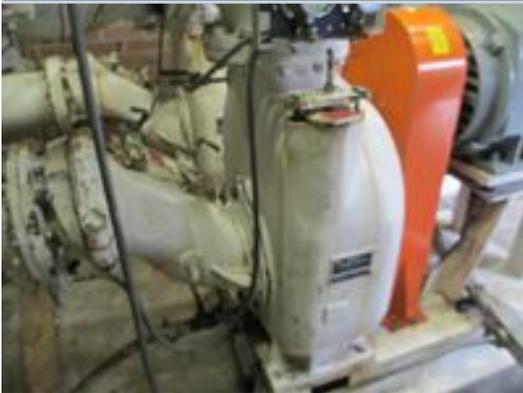
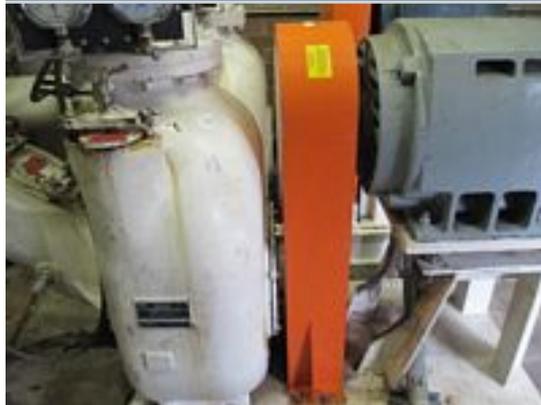
Asset Description **Memorial Park Lift Pump #2**

Question	Overriding?	Answer	NA	Flag	Answer Comment
Absence of Leaks		1 yes			
Absence of Pump Cavitations		1 yes			
Acceptable Noise		1 yes			
All Safety Guards Present		1 yes			
Corrosion - Structural Metal Condition?		2 Minor corrosion			
Mounting		1 Excellent			
Vibration Analysis		5 5 -Very Rough >.59 inches/sec			0.77" / second

Condition Category Good. Condition Grade 2. Minor wear.

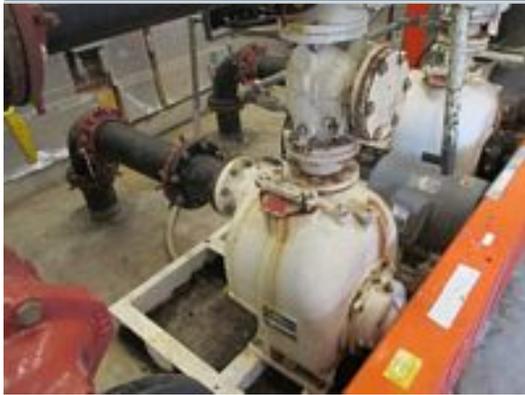
Asset Description	Morey's Landing Lift Pump #1	System	Moreys LS
Asset Type	PUMP CENT	Location	Moreys Landing Liftstation
Asset ID	MORL-LS-08-P1	Inspection Date	4/3/2019
Comments		Flag

Question	Overriding?	Answer	NA	Flag	Answer Comment
Absence of Leaks		1 yes			
Absence of Pump Cavitations		1 yes			
Acceptable Noise		1 yes			
All Safety Guards Present		1 yes			
Corrosion - Structural Metal Condition?		2 Minor corrosion			
Mounting		1 Excellent			
Vibration Analysis		3 -Fair .15 - .31 inches/sec			0.17" / second

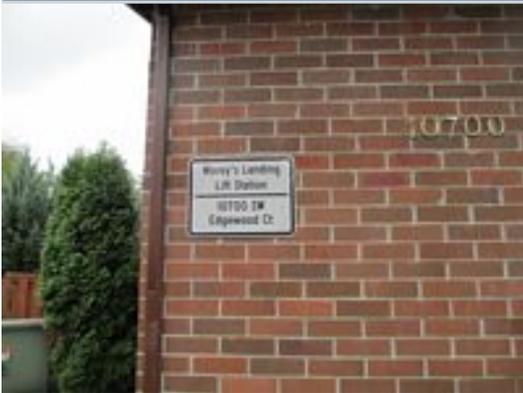
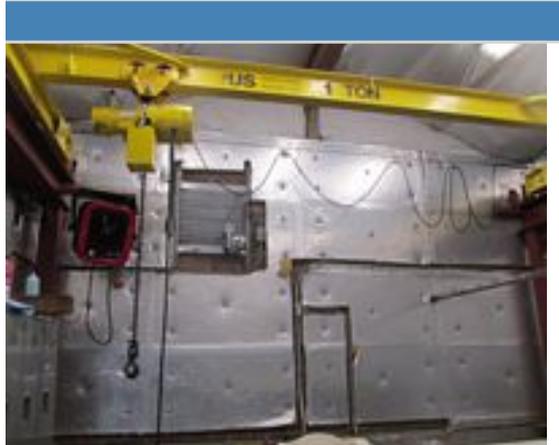
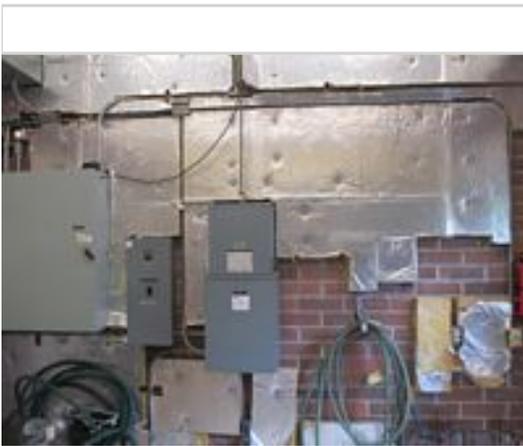
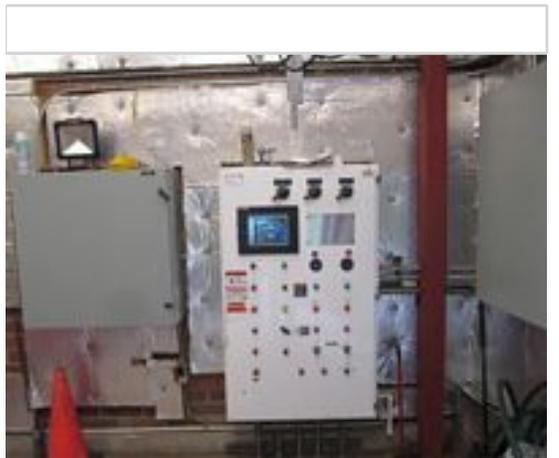
Asset Description **Morey's Landing Lift Station**

Condition Category Good. Condition Grade 2. Minor wear.

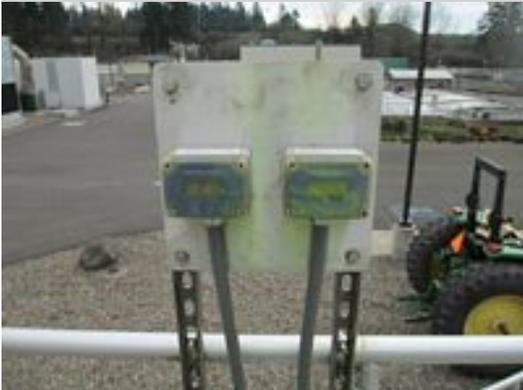
Asset Description	Level Element 10-12100	System	Preliminary
Asset Type	INSTRUMENT	Location	Headworks
Asset ID	LET10-12100	Inspection Date	4/1/2019
Comments	No level indication on display	Flag

Question	Overriding?	Answer	NA	Flag	Answer Comment
Absence of Leaks		1 yes			
Acceptable Smell or Heat		1 yes			
Acceptable Wire Labeling		1 yes			
All Components		1 yes			
Calibration		1 Excellent			
Connections Ok		1 yes			
Display Ok		5 no			No level indication on display
Indicator		5 Failure			No level indication on display
Installation/ Accessibility		1 Excellent			
Operating at Inspection		1 yes			
Tubing / Connections		2 Normal

No level indication on display (right)

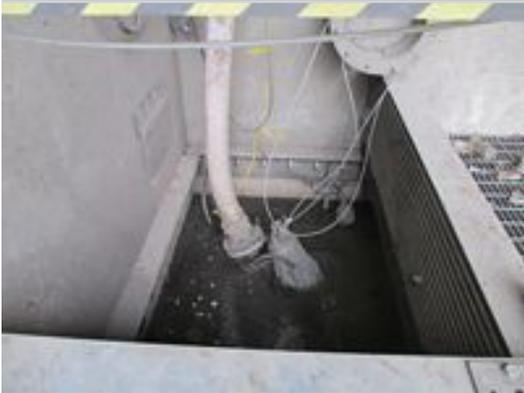
Asset Description	Composite Sampler #1	System	Preliminary
Asset Type	SAMPLER	Location	Headworks
Asset ID	SAM10-11000	Inspection Date	4/1/2019
Comments		Flag

Question	Overriding?	Answer	NA	Flag	Answer Comment
Absence of Leaks		1 yes			
Acceptable Smell or Heat		1 yes			
All Components		1 yes			
Display/Indicator Ok		1 yes			
Installation/ Accessibility		1 Excellent			
Operating at Inspection		1 yes			
Tubing / Connections		2 Normal

Condition Category Very good. Condition Grade 1. New or nearly new. Only normal maintenance required.

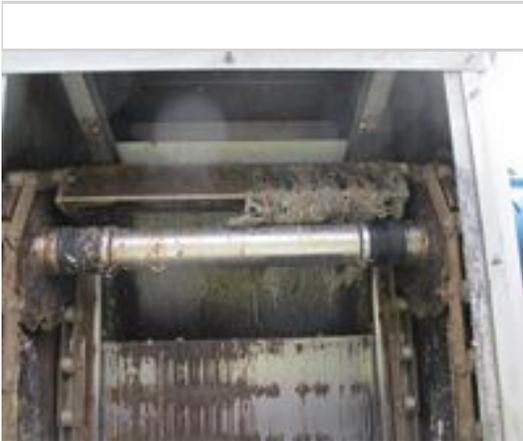
Bar screen rake had several teeth in the rake assembly bent. Would not allow rake to mesh with bar screen.

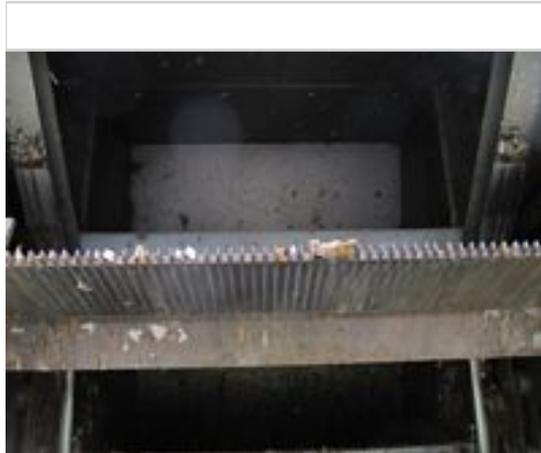
Bar screen rake had several teeth in the rake assembly bent. Would not allow rake to mesh with bar screen.

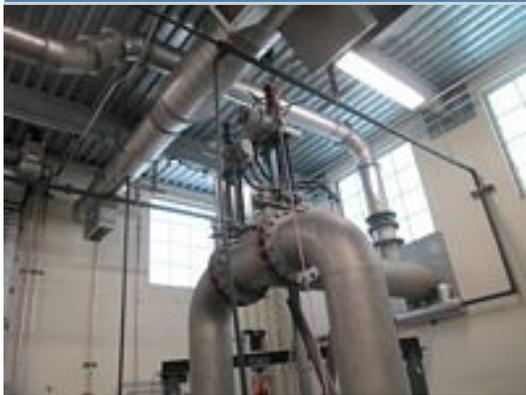
Question	Overriding?	Answer	NA	Flag	Answer Comment
Absence of Leaks		1 yes			
All Components		1 yes			
Functional		1 Fully Opens/Closes, Stops on Limits, and Holds Without Assistance			
Support		1 Excellent			
Valve Isolates (Holds)		1 yes

Condition Category Very good. Condition Grade 1. New or nearly new. Only normal maintenance required.

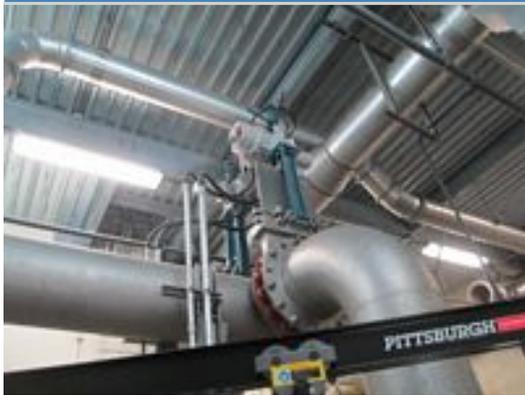
Asset Description	Flow Valve 10-20102	System	Preliminary
Asset Type	VALVE-BUTTERFLY	Location	Headworks
Asset ID	FV10-20102	Inspection Date	4/2/2019
Comments		Flag

Question	Overriding?	Answer	NA	Flag	Answer Comment
Absence of Leaks		1 yes			
All Components		1 yes			
Functional		1 Fully Opens/Closes, Stops on Limits, and Holds Without Assistance			
Support		1 Excellent			
Valve Isolates (Holds)		1 yes

Condition Category Very good. Condition Grade 1. New or nearly new. Only normal maintenance required.

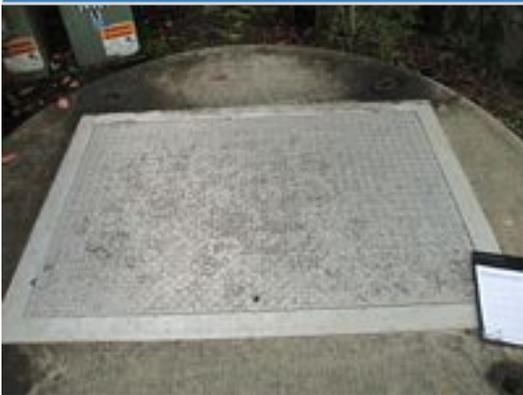
Condition Category Poor. Condition Grade 4. Unable to meet level of service life. Failure imminent.

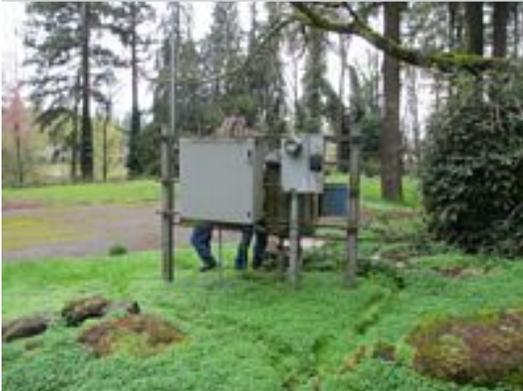
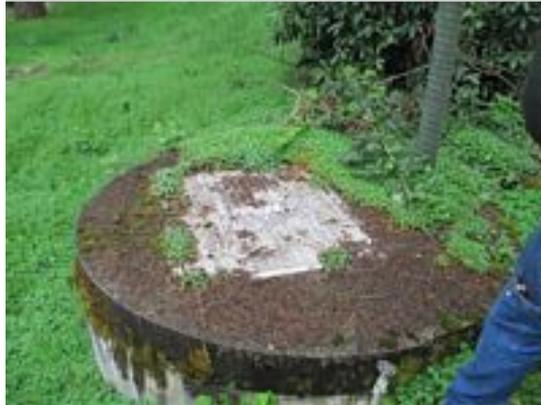
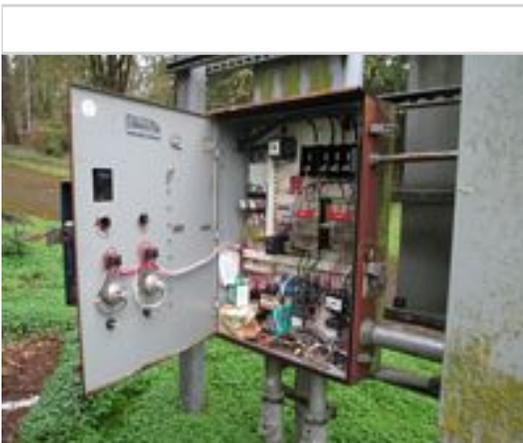
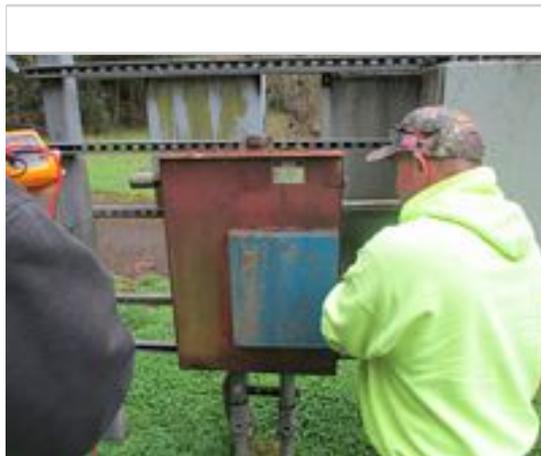
Condition Category Poor. Condition Grade 4. Unable to meet level of service life. Failure imminent.

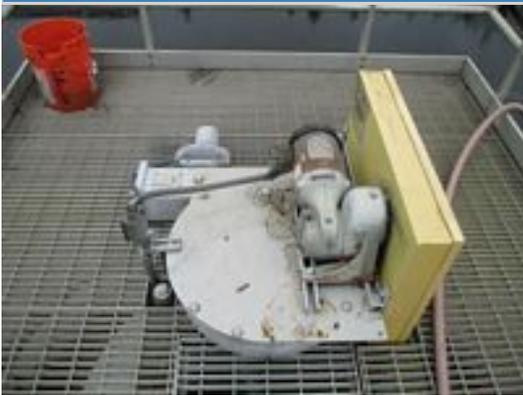
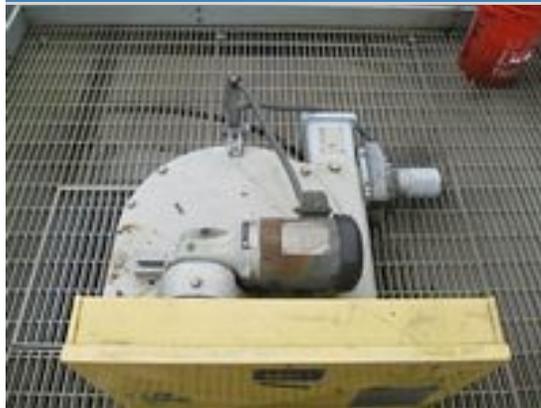
Question	Overriding?	Answer	NA	Flag	Answer Comment
Acceptable Noise		5 no			Drive motor noisy
Acceptable Oil/Grease		1 yes			
Acceptable Smell or Heat		1 yes			
Acceptable Vibration		1 yes			
All Components		1 yes			
All Safety Guards Present		1 yes			
Corrosion - Structural Concrete		2 Staining			
Corrosion - Structural Metal Condition?		2 Minor corrosion			
Oil Seal		3 Moderate Wear			
Running at Inspection		1 yes			
Structural Integrity		2 Minor wear

Condition Category Good. Condition Grade 2. Minor wear.

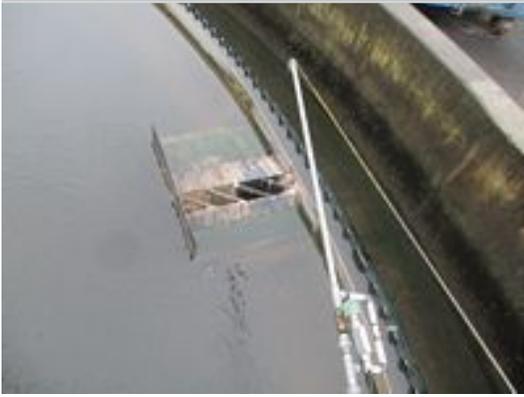
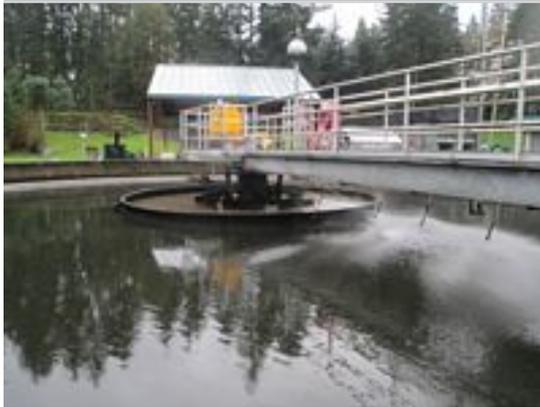
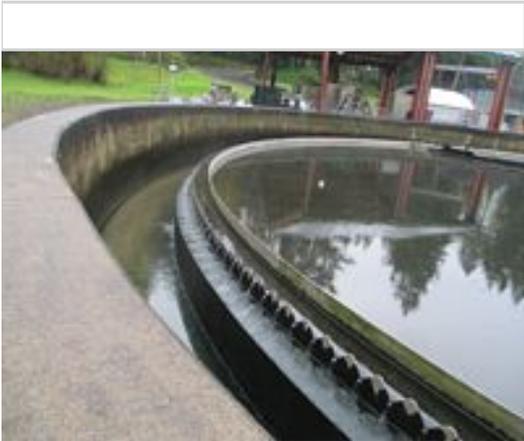
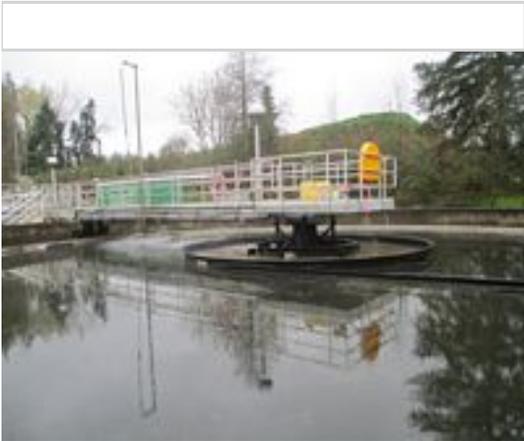
Asset Description	Secondary Clarifier #2	System	Secondary Clarification
Asset Type	CLARIFIER	Location	Secondary Clarifier #2
Asset ID	SC-50-1-2	Inspection Date	4/2/2019
Comments		Flag

Question	Overriding?	Answer	NA	Flag	Answer Comment
Acceptable Noise		1 yes			
Acceptable Oil/Grease		1 yes			
Acceptable Smell or Heat		1 yes			
Acceptable Vibration		1 yes			
All Components		1 yes			
All Safety Guards Present		1 yes			
Corrosion - Structural Concrete		2 Staining			
Corrosion - Structural Metal Condition?		2 Minor corrosion			
Oil Seal		3 Moderate Wear			
Running at Inspection		1 yes			
Structural Integrity		2 Minor wear

Condition Category Good. Condition Grade 2. Minor wear.

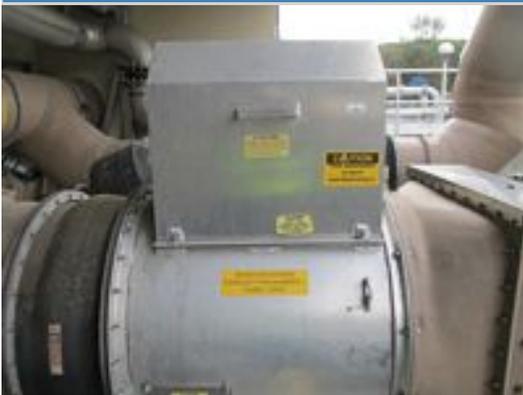
Asset Description	Aeration Basin Ex Fan 30501	System	Secondary Treatment
Asset Type	FAN	Location	Aeration Basin
Asset ID	FAN91-30501	Inspection Date	4/3/2019
Comments		Flag

Question	Overriding?	Answer	NA	Flag	Answer Comment
Acceptable Noise		1 yes			
Acceptable Oil/Grease		1 yes			
Acceptable Smell or Heat		1 yes			
Acceptable Vibration		5 no			Measured 0.77" / second
All Components		1 yes			
All Safety Guards Present		1 yes			
Belt		2 Minor Wear			
Controls		1 Excellent			
Corrosion - Structural Metal Condition?		1 Like new			
Duct Work		1 Excellent			
Fan and Fan Motor		3 Maintenance Required			
Installation/ Accessibility		1 Excellent			
Structural Integrity		1 Excellent			
Support		1 Excellent

Condition Category Good. Condition Grade 2. Minor wear.

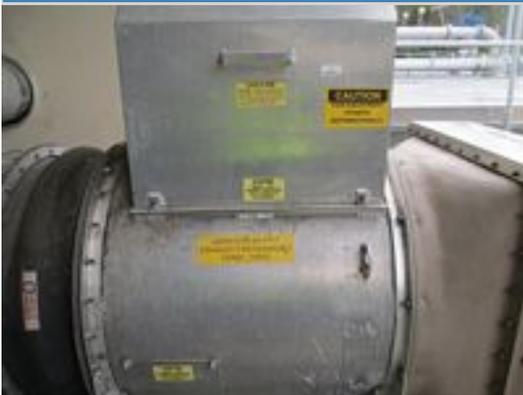
Asset Description	Aeration Basin Em Bypass Fan	System	Secondary Treatment
Asset Type	FAN	Location	Aeration Basin
Asset ID	FAN91-30502	Inspection Date	4/3/2019
Comments		Flag

Question	Overriding?	Answer	NA	Flag	Answer Comment
Acceptable Noise		1 yes			
Acceptable Oil/Grease		1 yes			
Acceptable Smell or Heat		1 yes			
Acceptable Vibration		1 yes			Measured 0.07" / second
All Components		1 yes			
All Safety Guards Present		1 yes			
Belt		2 Minor Wear			
Controls		1 Excellent			
Corrosion - Structural Metal Condition?		1 Like new			
Duct Work		1 Excellent			
Fan and Fan Motor		1 Excellent			
Installation/ Accessibility		1 Excellent			
Structural Integrity		1 Excellent			
Support		1 Excellent

Condition Category Very good. Condition Grade 1. New or nearly new. Only normal maintenance required.

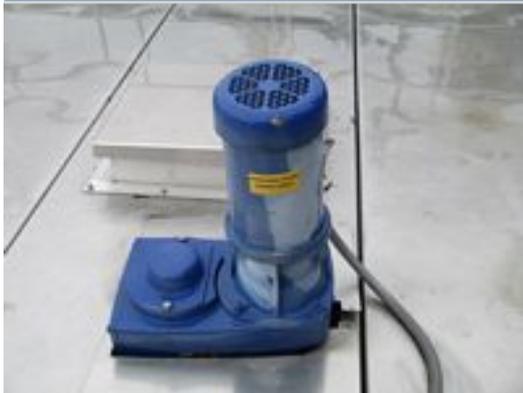
Asset Description	Anaerobic Mixer #1	System	Secondary Treatment
Asset Type	MIXER	Location	Aeration Basin
Asset ID	MXR40-20001	Inspection Date	4/2/2019
Comments	Mixer 1 has failed, and will be replaced with different technology with the next plant upgrade	Flag

Question	Overriding?	Answer		NA	Flag	Answer Comment
Acceptable Smell or Heat		5	no			
Acceptable Vibration				X		
All Components				X		
All Safety Guards Present				X		
Corrosion - Structural Metals				X		
Installation/ Accessibility				X		
Obsolescence				X		
Operating at Inspection				X		
Support				X

Condition Category Very poor. Grade 5. Requires complete rehabilitation or replacement. Failed.

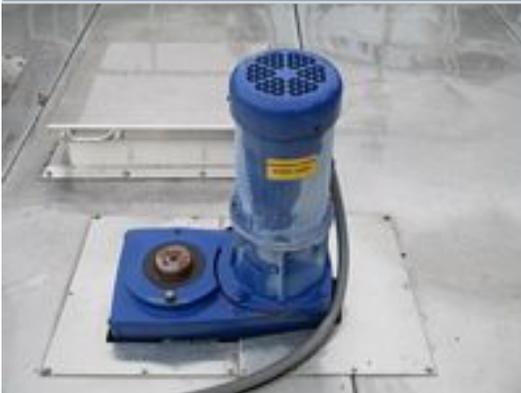
Asset Description	Anaerobic Mixer #2	System	Secondary Treatment
Asset Type	MIXER	Location	Aeration Basin
Asset ID	MXR40-20002	Inspection Date	4/2/2019
Comments	Mixer 2 has failed, and will be replaced with different technology with the next plant upgrade		Flag

Question	Overriding?	Answer		NA	Flag	Answer Comment
Acceptable Smell or Heat		5	no			
Acceptable Vibration				X		
All Components				X		
All Safety Guards Present				X		
Corrosion - Structural Metals				X		
Installation/ Accessibility				X		
Obsolescence				X		
Operating at Inspection				X		
Support				X

Condition Category Very poor. Grade 5. Requires complete rehabilitation or replacement. Failed.

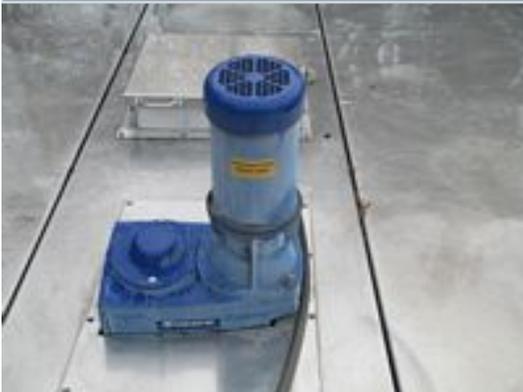
Asset Description	Anaerobic Mixer #3	System	Secondary Treatment
Asset Type	MIXER	Location	Aeration Basin
Asset ID	MXR40-20003	Inspection Date	4/2/2019
Comments		Flag

Question	Overriding?	Answer	NA	Flag	Answer Comment
Acceptable Smell or Heat		1 yes			
Acceptable Vibration		1 yes			
All Components		1 yes			
All Safety Guards Present		1 yes			
Corrosion - Structural Metals		2 Slight staining/small chips			
Installation/ Accessibility		1 Excellent			
Obsolescence		1 Current and supported			
Operating at Inspection		1 yes			
Support		2 Minor

Condition Category Very good. Condition Grade 1. New or nearly new. Only normal maintenance required.

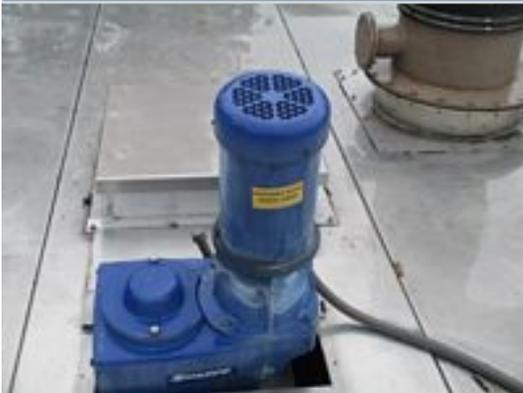
Asset Description	Anaerobic Mixer #4	System	Secondary Treatment
Asset Type	MIXER	Location	Aeration Basin
Asset ID	MXR40-20004	Inspection Date	4/2/2019
Comments	Mixer 4 has failed, and will be replaced with different technology with the next plant upgrade		Flag

Question	Overriding?	Answer		NA	Flag	Answer Comment
Acceptable Smell or Heat		5	no			
Acceptable Vibration				X		
All Components				X		
All Safety Guards Present				X		
Corrosion - Structural Metals				X		
Installation/ Accessibility				X		
Obsolescence				X		
Operating at Inspection				X		
Support				X

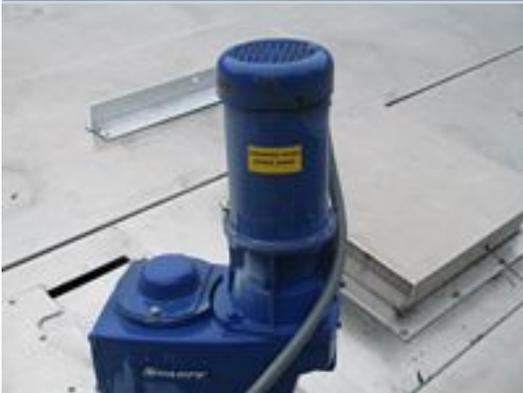
Asset Description	Anaerobic Mixer #5	System	Secondary Treatment
Asset Type	MIXER	Location	Aeration Basin
Asset ID	MXR40-20005	Inspection Date	4/2/2019
Comments	Mixer 5 has failed, and will be replaced with different technology with the next plant upgrade		Flag

Question	Overriding?	Answer		NA	Flag	Answer Comment
Acceptable Smell or Heat		5	no			
Acceptable Vibration				X		
All Components				X		
All Safety Guards Present				X		
Corrosion - Structural Metals				X		
Installation/ Accessibility				X		
Obsolescence				X		
Operating at Inspection				X		
Support				X

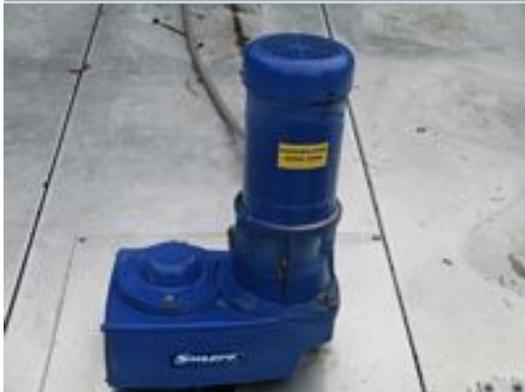
Asset Description	Anaerobic Mixer #6	System	Secondary Treatment
Asset Type	MIXER	Location	Aeration Basin
Asset ID	MXR40-20006	Inspection Date	4/2/2019
Comments		Flag

Question	Overriding?	Answer	NA	Flag	Answer Comment
Acceptable Smell or Heat		1 yes			
Acceptable Vibration		1 yes			
All Components		1 yes			
All Safety Guards Present		1 yes			
Corrosion - Structural Metals		2 Slight staining/small chips			
Installation/ Accessibility		1 Excellent			
Obsolescence		1 Current and supported			
Operating at Inspection		1 yes			
Support		2 Minor

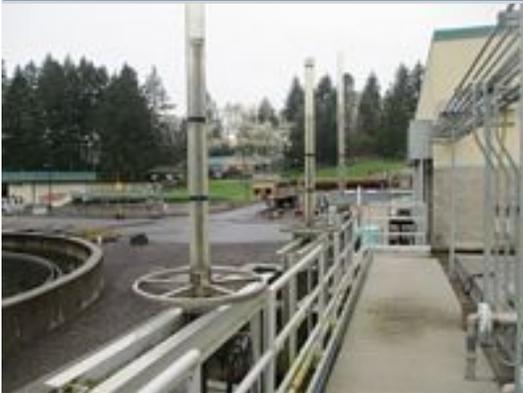
Asset Description	Slide Gate AB-G-40-1	System	Secondary Treatment
Asset Type	VALVE SLIDE	Location	Aeration Basin Effluent Channe
Asset ID	AB-G-40-1	Inspection Date	4/2/2019
Comments		Flag

Question	Overriding?	Answer	NA	Flag	Answer Comment
Absence of Leaks		1 yes			
Actuator			X	Non Existent	
Corrosion - Structural Concrete		2 Staining			
Corrosion - Structural Metal Condition?		2 Minor corrosion			
Lubrication OK at Inspection		1 yes			
Mounting		1 Excellent			
Valve Isolates (Holds)		1 yes

Condition Category Very good. Condition Grade 1. New or nearly new. Only normal maintenance required.

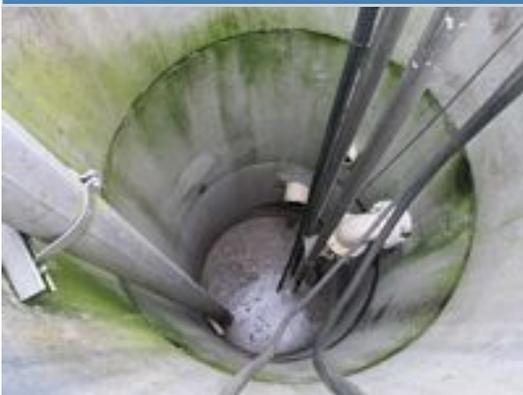
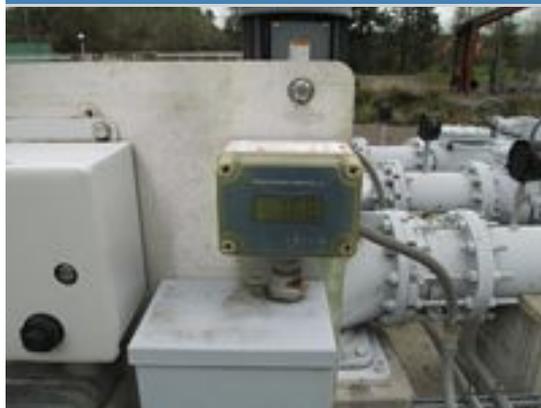
Question	Overriding?	Answer	NA	Flag	Answer Comment
Absence of Leaks		1 yes			
Acceptable Smell or Heat		1 yes			
Acceptable Wire Labeling		1 yes			
All Components		1 yes			
Calibration		1 Excellent			
Connections Ok		1 yes			
Display Ok		1 yes			
Indicator		2 Good			
Installation/ Accessibility		1 Excellent			
Operating at Inspection		1 yes			
Tubing / Connections		2 Normal

Condition Category Very good. Condition Grade 1. New or nearly new. Only normal maintenance required.

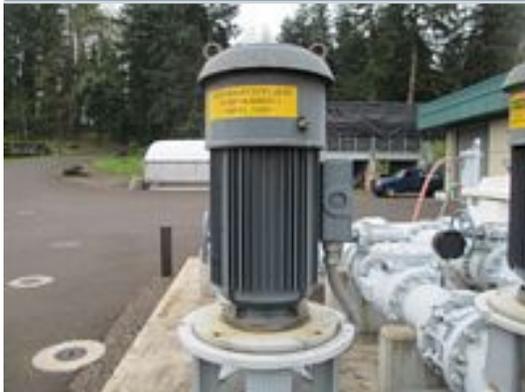
Question	Overriding?	Answer	NA	Flag	Answer Comment
Absence of Cavitation		1 yes			
Absence of Leaks		1 yes			
All Safety Features Present		1 yes			
Coating Condition		2 Minor Defects			
Corrosion - Metal		2 Minor Corrosion			
Gallons per kW		1 At BEP			
Motor Coupling		1 Excellent			
Packing Gland		2 Normal			
Vibration Analysis (0.10 in/sec)		1 Smooth, < 0.10 in/sec			0.05" / second

Condition Category Very good. Condition Grade 1. New or nearly new. Only normal maintenance required.

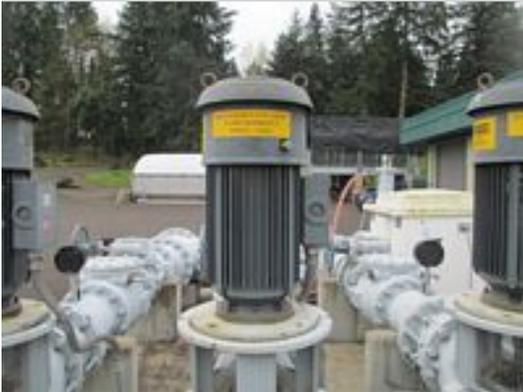
Asset Description	Secondary Effluent Pump #2	System	Secondary Treatment
Asset Type	PUMP-VERT TURBINE	Location	Flow Control
Asset ID	PMP53-10002	Inspection Date	4/4/2019
Comments		Flag

Question	Overriding?	Answer	NA	Flag	Answer Comment
Absence of Cavitation		1 yes			
Absence of Leaks		1 yes			
All Safety Features Present		1 yes			
Coating Condition		2 Minor Defects			
Corrosion - Metal		2 Minor Corrosion			
Gallons per kW		1 At BEP			
Motor Coupling		1 Excellent			
Packing Gland		2 Normal			
Vibration Analysis (0.10 in/sec)		1 Smooth, < 0.10 in/sec			0.05" / second

Condition Category Very good. Condition Grade 1. New or nearly new. Only normal maintenance required.

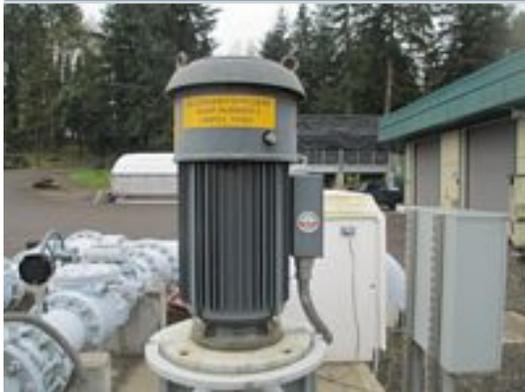
Asset Description	Secondary Effluent Pump #3	System	Secondary Treatment
Asset Type	PUMP-VERT TURBINE	Location	Flow Control
Asset ID	PMP53-10003	Inspection Date	4/4/2019
Comments		Flag

Question	Overriding?	Answer	NA	Flag	Answer Comment
Absence of Cavitation		1 yes			
Absence of Leaks		1 yes			
All Safety Features Present		1 yes			
Coating Condition		2 Minor Defects			
Corrosion - Metal		2 Minor Corrosion			
Gallons per kW		1 At BEP			
Motor Coupling		1 Excellent			
Packing Gland		2 Normal			
Vibration Analysis (0.10 in/sec)		1 Smooth, < 0.10 in/sec			0.06" / second

Condition Category Very good. Condition Grade 1. New or nearly new. Only normal maintenance required.

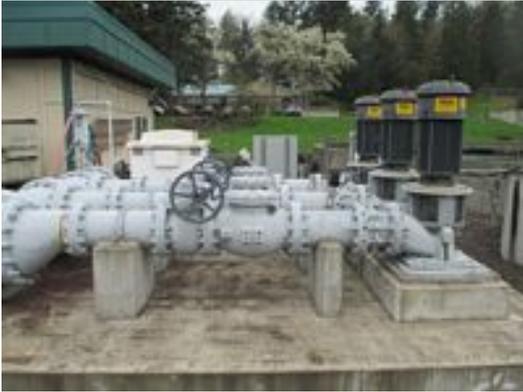
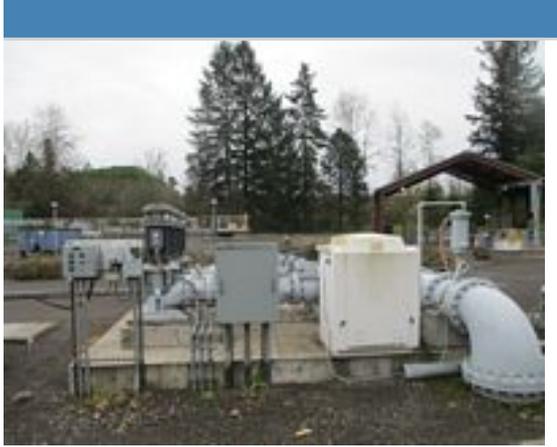
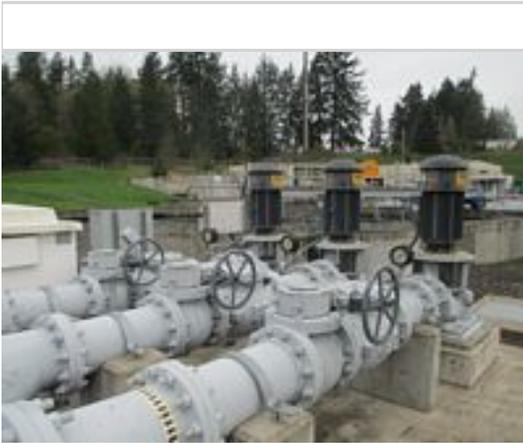
Question	Overriding?	Answer	NA	Flag	Answer Comment
Absence of Leaks		1 yes			
Access Doors			X	Non Existent	
Architectural - Ceilings			X	Non Existent	
Architectural - Floors		2 Good			
Architectural - Roof			X	Non Existent	
Architectural - Windows - Physical Integrity/Appearance			X	Non Existent	
Corrosion - Cathodic Protection			X	Non Existent	
Corrosion - Concrete		2 Staining			
Corrosion - Mechanical/Piping Metal Condition		2 Minor Corrosion			
Corrosion - Metal		2 Minor Corrosion			
Corrosion - Pipes		2 Staining/chipping			
Corrosion - Soil Resistivity			X	Not Evaluated	
Corrosion - Visible Coating Condition		2 Minor damage			
Corrosion - Visible Concrete Condition		1 Like new			
Duct Work			X	Non Existent	
External Wall			X	Non Existent	
Fire Extinguisher Present/Certification Current		1 yes			
Handrails			X	Non Existent	
Installation		1 Excellent			
Internal Wall			X	Non Existent	
Lighting			X	Non Existent

Pipe System		1 Excellent			
Safety (General Review)		1 Very Good			
Stairs			X	Non Existent	
Structural - Above Grade - Structure Irregularities/Code		1 No Irregularities			
Structural - Aboveground Pipe		1 Constructed Of Ductile Materials And Flexible Restrained Joints			
Structural - Building and System Piping		2 Flexibility and bracing provided			
Structural - Columns			X	Non Existent	
Structural - Condition of Foundations		1 No movement			
Structural - Connections in Lateral Force Resisting Systems		1 Direct Positive Connection Between Horizontal Transfer Elements (Diaphragm Or Bracing) And V			
Structural - Equipment Anchorage - Epoxy-Cast-In-Place or Wedge Anchors		1 Anchors/Bolts All Present And Fully Embedded And/Or Threaded			
Structural - Load Path/Redundancy		1 Complete Load Path To Foundation - 3 Or More Vertical Resisting Elements In Each Direction			
Structural - Piping Connections to Above Ground Facilities		2 Connections present, full flexibility

Condition Category Very good. Condition Grade 1. New or nearly new. Only normal maintenance required.

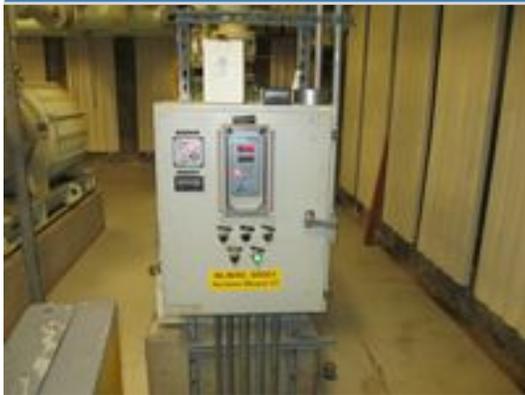
Asset Description	Aeration Blower #1 Controls	System	Secondary Treatment
Asset Type	CONTROL PANEL	Location	Process Gallery
Asset ID	PG-LCP-40-5-1	Inspection Date	4/3/2019
Comments		Flag

Question	Overriding?	Answer	NA	Flag	Answer Comment
Absence of Burn Marks		1 yes			
Acceptable Smell or Heat		1 yes			
All Safety Features Present		1 yes			
Control Switches		2 Good			
Good House Keeping		1 yes			
Good Wire Labeling		1 yes			
Infrared		2 Normal			
Installation		1 Excellent			
Obsolescence		1 Current and supported			
Operating at Inspection		5 no			
Panel Labeling		1 yes			
Structural (Panel)		1 Excellent

Condition Category Good. Condition Grade 2. Minor wear.

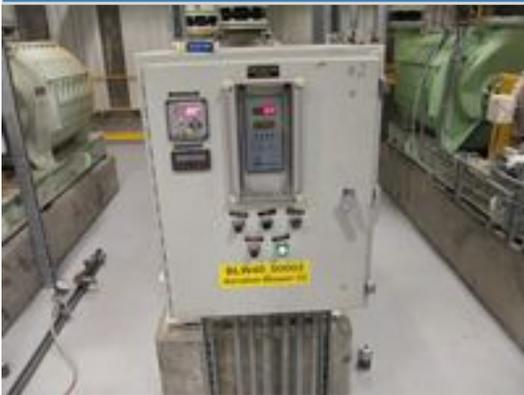
Question	Overriding?	Answer	NA	Flag	Answer Comment
Absence of Burn Marks		1 yes			
Acceptable Smell or Heat		1 yes			
All Safety Features Present		1 yes			
Control Switches		2 Good			
Good House Keeping		1 yes			
Good Wire Labeling		1 yes			
Infrared		2 Normal			
Installation		1 Excellent			
Obsolescence		1 Current and supported			
Operating at Inspection		5 no			
Panel Labeling		1 yes			
Structural (Panel)		1 Excellent

Condition Category Good. Condition Grade 2. Minor wear.

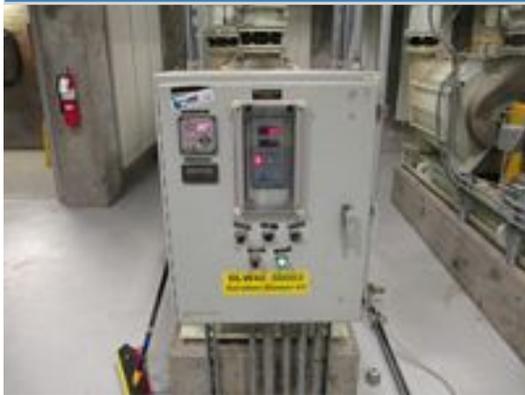
Asset Description	Aeration Blower #3 Controls	System	Secondary Treatment
Asset Type	CONTROL PANEL	Location	Process Gallery
Asset ID	PG-LCP-40-5-3	Inspection Date	4/3/2019
Comments		Flag

Question	Overriding?	Answer	NA	Flag	Answer Comment
Absence of Burn Marks		1 yes			
Acceptable Smell or Heat		1 yes			
All Safety Features Present		1 yes			
Control Switches		2 Good			
Good House Keeping		1 yes			
Good Wire Labeling		1 yes			
Infrared		2 Normal			
Installation		1 Excellent			
Obsolescence		1 Current and supported			
Operating at Inspection		5 no			
Panel Labeling		1 yes			
Structural (Panel)		1 Excellent

Condition Category Good. Condition Grade 2. Minor wear.

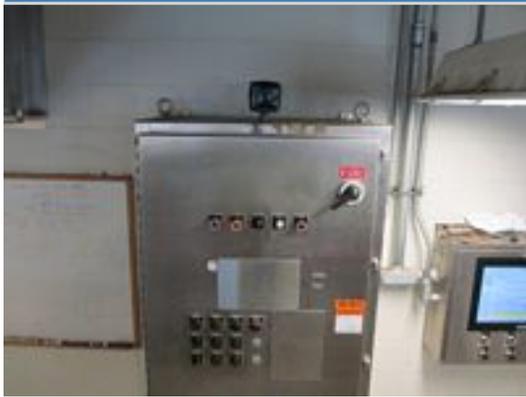
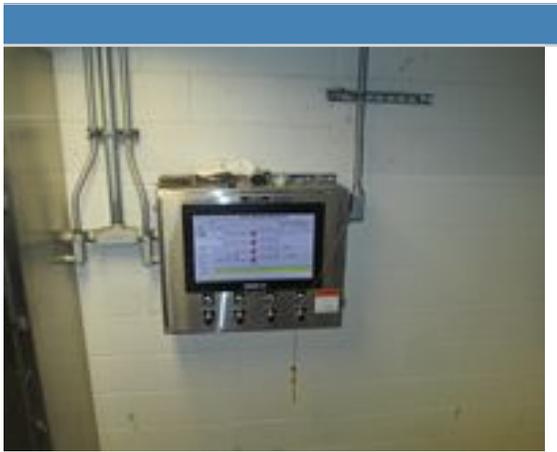
Asset Description	Gallery Control Panel	System	Secondary Treatment
Asset Type	CONTROL PANEL	Location	Process Gallery
Asset ID	PG-LCP-80-4	Inspection Date	4/5/2019
Comments		Flag

Question	Overriding?	Answer	NA	Flag	Answer Comment
Absence of Burn Marks		1 yes			
Acceptable Smell or Heat		1 yes			
All Safety Features Present		1 yes			
Control Switches		2 Good			
Good House Keeping		1 yes			
Good Wire Labeling		1 yes			
Infrared		2 Normal			
Installation		1 Excellent			
Obsolescence		3 Limited Parts Available			
Operating at Inspection		1 yes			
Panel Labeling		1 yes			
Structural (Panel)		1 Excellent

Condition Category Very good. Condition Grade 1. New or nearly new. Only normal maintenance required.

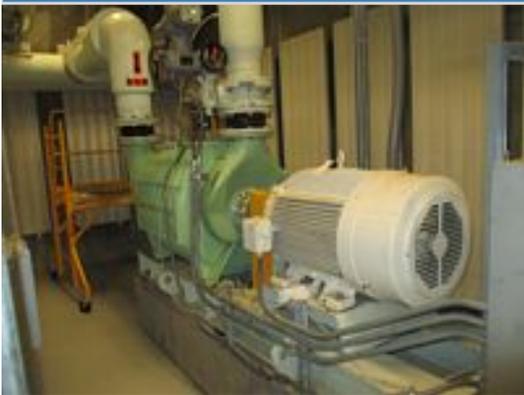
Asset Description	Aeration Basin Blower Motor #1	System	Secondary Treatment
Asset Type	MOTOR	Location	Process Gallery
Asset ID	PGB-M-40-5-1-M	Inspection Date	4/3/2019
Comments		Flag

Question	Overriding?	Answer	NA	Flag	Answer Comment
Acceptable Noise		1 yes			
Acceptable Smell or Heat		1 yes			
All Components		1 yes			
All Safety Guards Present		1 yes			
Bearings		2 Minor Wear			
Corrosion - Structural Metal Condition?		2 Minor corrosion			
Drive Shaft Alignment		1 Excellent			
Insulation Resistance	Yes		X	Not Evaluated	
Oil Level within Range			X	Non Existent	Greased bearings
Operating at Inspection		1 yes			
Structural Integrity		1 Excellent			
Vibration Analysis	Yes	2 -Good .039 - .15 inches/sec			0.13" / second

Condition Category Very good. Condition Grade 1. New or nearly new. Only normal maintenance required.

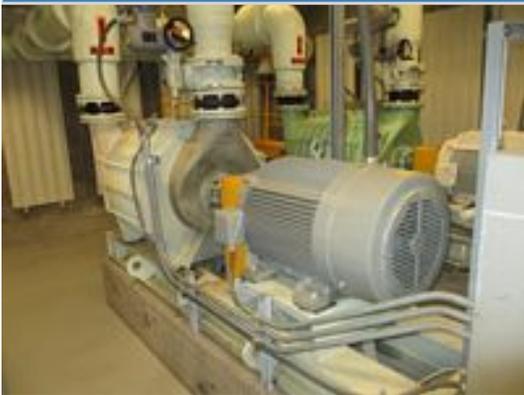
Asset Description	Aeration Basin Blower Motor #2	System	Secondary Treatment
Asset Type	MOTOR	Location	Process Gallery
Asset ID	PGB-M-40-5-2-M	Inspection Date	4/3/2019
Comments		Flag

Question	Overriding?	Answer	NA	Flag	Answer Comment
Acceptable Noise		1 yes			
Acceptable Smell or Heat		1 yes			
All Components		1 yes			
All Safety Guards Present		1 yes			
Bearings		2 Minor Wear			
Corrosion - Structural Metal Condition?		2 Minor corrosion			
Drive Shaft Alignment		1 Excellent			
Insulation Resistance	Yes		X	Not Evaluated	
Oil Level within Range			X	Non Existent	Greased bearings
Operating at Inspection		1 yes			
Structural Integrity		1 Excellent			
Vibration Analysis	Yes	2 2 -Good .039 - .15 inches/sec	X	Not Evaluated	0.14" / second

Condition Category Very good. Condition Grade 1. New or nearly new. Only normal maintenance required.

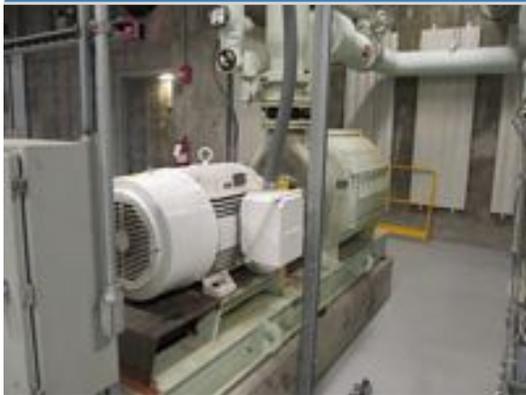
Asset Description	Aeration Basin Blower Motor #3	System	Secondary Treatment
Asset Type	MOTOR	Location	Process Gallery
Asset ID	PGB-M-40-5-3-M	Inspection Date	4/3/2019
Comments		Flag

Question	Overriding?	Answer	NA	Flag	Answer Comment
Acceptable Noise		1 yes			
Acceptable Smell or Heat		1 yes			
All Components		1 yes			
All Safety Guards Present		1 yes			
Bearings		2 Minor Wear			
Corrosion - Structural Metal Condition?		1 Like new			
Drive Shaft Alignment		1 Excellent			
Insulation Resistance	Yes		X	Not Evaluated	
Oil Level within Range			X	Non Existent	Greased bearings
Operating at Inspection		1 yes			
Structural Integrity		1 Excellent			
Vibration Analysis	Yes	2 -Good .039 - .15 inches/sec			0.11" / second

Condition Category Very good. Condition Grade 1. New or nearly new. Only normal maintenance required.
