Appendix A
JACOBS CONDITION ASSESSMENT 2019

Wilsonville Wastewater Facility Condition Assessment Report

April 2019

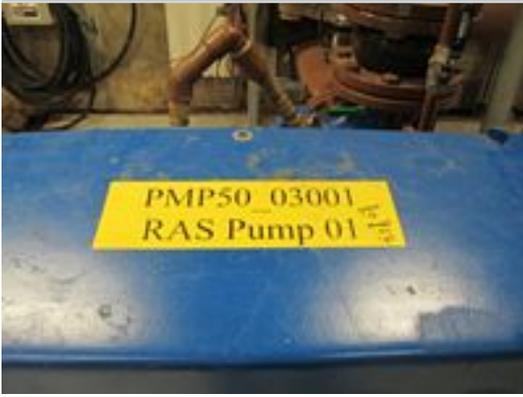
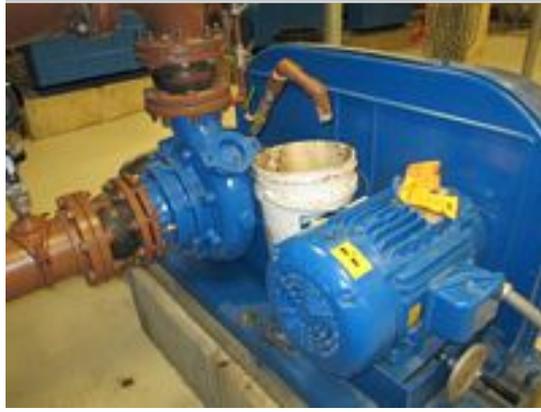
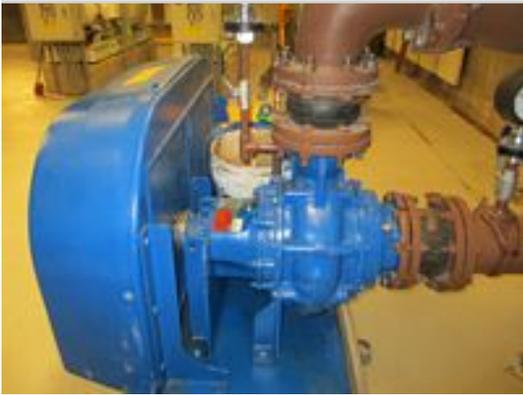
Question	Overriding?	Answer	NA	Flag	Answer Comment
Absence of Leaks		1 yes			
Absence of Pump Cavitation		1 Yes			
Acceptable Noise		1 yes			
Acceptable Smell or Heat		1 yes			
Acceptable Vibration		1 yes			
Accessibility		1 Open, Easy Access			
All Components		1 yes			
All Safety Features Present		1 yes			
Bearings		1 Excellent			
Belt/Direct Drive/Couplings		2 Minor Wear			
Check Valve		1 Opens, Closes, Seats, No Defects			
Controls		1 Excellent			
Corrosion - Metal		1 Like New			
Corrosion - Visible Coating Condition		1 Like new			
Drive Shaft			X	Non Existent	Belt driven
Gallons per kW		1 At BEP			
Gauges Operational		1 Yes			
Infrared		2 Normal			
Installation		1 Excellent			
Isolation Valves Operational		1 yes			
Lubrication OK at Inspection		1 yes			
Mounting		1 Excellent			
Obsolescence		1 Current, Supported			
Oil Seal		1 Excellent			
Packing Gland/Mechanical Seal		1 Excellent			
Pipe Alignment		1 Straight

Condition Category Very good. Condition Grade 1. New or nearly new. Only normal maintenance required.

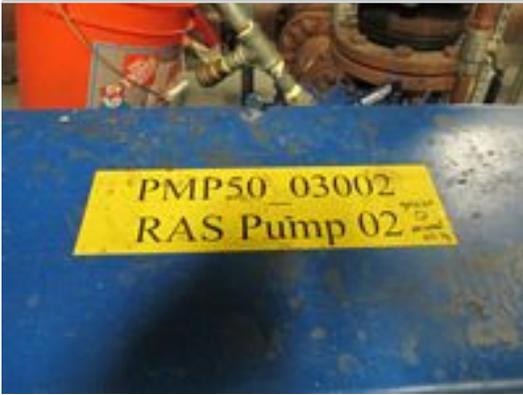
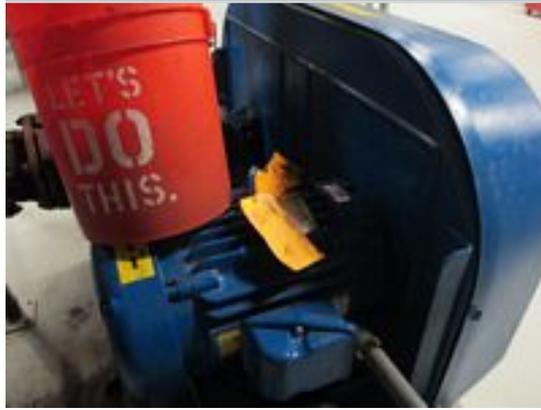
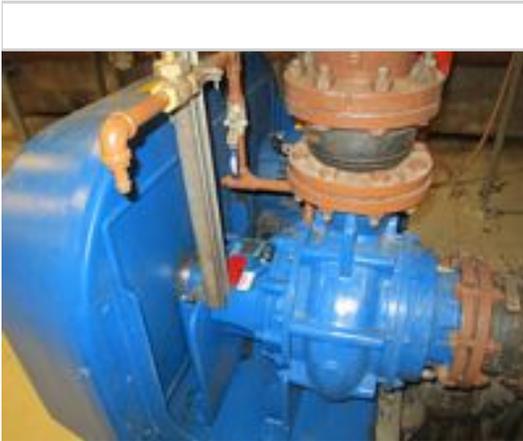
Question	Overriding?	Answer	NA	Flag	Answer Comment
Absence of Leaks		1 yes			
Absence of Pump Cavitation		1 Yes			
Acceptable Noise		1 yes			
Acceptable Smell or Heat		1 yes			
Acceptable Vibration		1 yes			
Accessibility		1 Open, Easy Access			
All Components		1 yes			
All Safety Features Present		1 yes			
Bearings		2 Minor Wear			
Belt/Direct Drive/Couplings		2 Minor Wear			
Check Valve		1 Opens, Closes, Seats, No Defects			
Controls		1 Excellent			
Corrosion - Metal		1 Like New			
Corrosion - Visible Coating Condition		1 Like new			
Drive Shaft			X	Non Existent	Belt driven
Gallons per kW		1 At BEP			
Gauges Operational		1 Yes			
Infrared		2 Normal			
Installation		1 Excellent			
Isolation Valves Operational		1 yes			
Lubrication OK at Inspection		1 yes			
Mounting		1 Excellent			
Obsolescence		1 Current, Supported			
Oil Seal		1 Excellent			
Packing Gland/Mechanical Seal		2 Normal			
Pipe Alignment		1 Straight

Condition Category Very good. Condition Grade 1. New or nearly new. Only normal maintenance required.

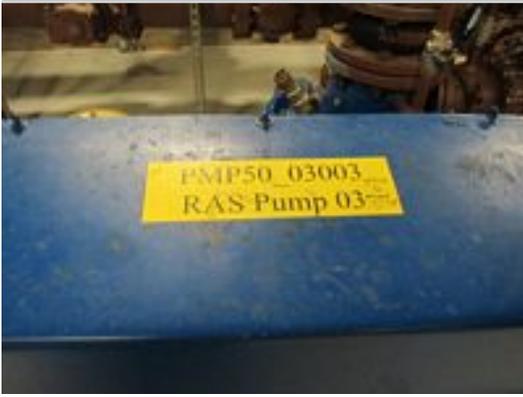
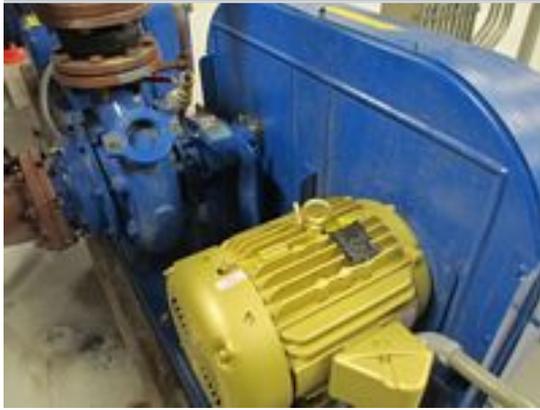
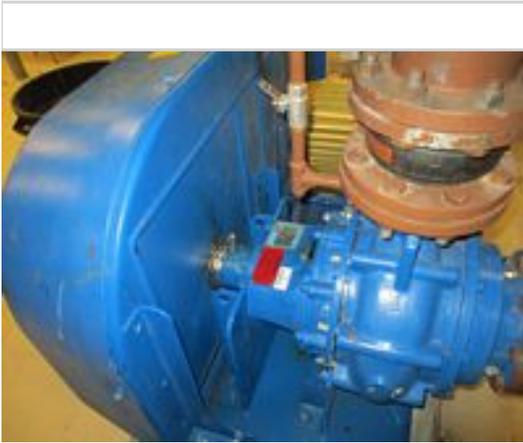
Question	Overriding?	Answer	NA	Flag	Answer Comment
Absence of Leaks		1 yes			
Absence of Pump Cavitation		1 Yes			
Acceptable Noise		1 yes			
Acceptable Smell or Heat		1 yes			
Acceptable Vibration		1 yes			
Accessibility		1 Open, Easy Access			
All Components		1 yes			
All Safety Features Present		1 yes			
Bearings		2 Minor Wear			
Belt/Direct Drive/Couplings		2 Minor Wear			
Check Valve		1 Opens, Closes, Seats, No Defects			
Controls		1 Excellent			
Corrosion - Metal		1 Like New			
Corrosion - Visible Coating Condition		1 Like new			
Drive Shaft			X	Non Existent	Belt driven
Gallons per kW		1 At BEP			
Gauges Operational		1 Yes			
Infrared		2 Normal			
Installation		1 Excellent			
Isolation Valves Operational		1 yes			
Lubrication OK at Inspection		1 yes			
Mounting		1 Excellent			
Obsolescence		1 Current, Supported			
Oil Seal		1 Excellent			
Packing Gland/Mechanical Seal		2 Normal			
Pipe Alignment		1 Straight

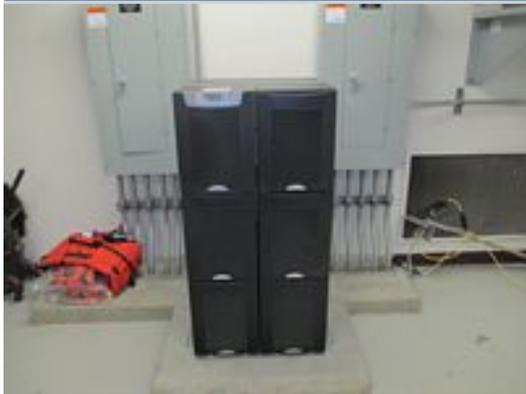
Asset Description	Sec Clarifier #3 Control Panel	System	Secondary Treatment
Asset Type	CONTROL PANEL	Location	Sand Filter Rec
Asset ID	LCP50-10103	Inspection Date	4/4/2019
Comments		Flag

Question	Overriding?	Answer	NA	Flag	Answer Comment
Absence of Burn Marks		1 yes			
Acceptable Smell or Heat		1 yes			
All Safety Features Present		1 yes			
Control Switches		2 Good			
Good House Keeping		1 yes			
Good Wire Labeling		1 yes			
Infrared		2 Normal			
Installation		1 Excellent			
Obsolescence		1 Current and supported			
Operating at Inspection		1 yes			
Panel Labeling		1 yes			
Structural (Panel)		1 Excellent

Condition Category Very good. Condition Grade 1. New or nearly new. Only normal maintenance required.

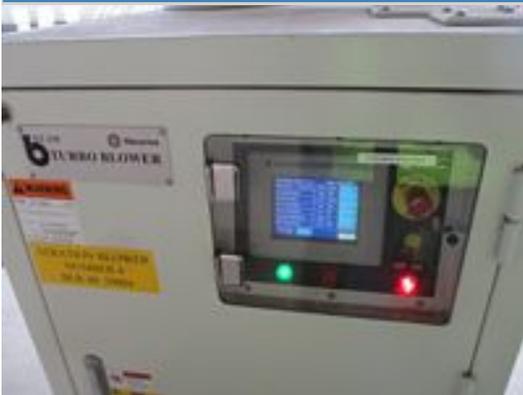
Asset Description	Aeration Blower #5	System	Secondary Treatment
Asset Type	BLOWER	Location	Sec Process
Asset ID	BLW40-50005	Inspection Date	4/3/2019
Comments		Flag

Question	Overriding?	Answer	NA	Flag	Answer Comment
Acceptable Vibration		1 yes			
Alignment			X	Non Existent	Common motor / blower shaft
All Components		1 yes			
All Safety Features Present		1 yes			
Bearings			X	Non Existent	Air foil bearings
Belt			X	Non Existent	Common motor / blower shaft
Coating		1 Excellent			
Controls		1 Excellent			
Corrosion - Structural Metal Condition?		1 Like new			
Lubrication OK at Inspection			X	Non Existent	Air foil bearings
Mounting		1 Excellent			
Obsolescence		1 Current and supported			
Oil Analysis			X	Non Existent	Air foil bearings
Vibration Analysis			X	Not Evaluated	Cannot open enclosure while in operation

Condition Category Very good. Condition Grade 1. New or nearly new. Only normal maintenance required.

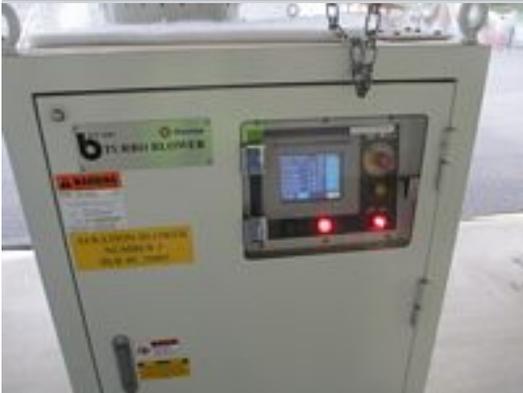
Asset Description	Aeration Blower #6	System	Secondary Treatment
Asset Type	BLOWER	Location	Sec Process
Asset ID	BLW40-50006	Inspection Date	4/3/2019
Comments		Flag

Question	Overriding?	Answer	NA	Flag	Answer Comment
Acceptable Vibration		1 yes			
Alignment			X	Non Existent	Common motor / blower shaft
All Components		1 yes			
All Safety Features Present		1 yes			
Bearings			X	Non Existent	Air foil bearings
Belt			X	Non Existent	Common motor / blower shaft
Coating		1 Excellent			
Controls		1 Excellent			
Corrosion - Structural Metal Condition?		1 Like new			
Lubrication OK at Inspection			X	Non Existent	Air foil bearings
Mounting		1 Excellent			
Obsolescence		1 Current and supported			
Oil Analysis			X	Non Existent	Air foil bearings
Vibration Analysis			X	Not Evaluated	Cannot open enclosure while in operation

Condition Category Very good. Condition Grade 1. New or nearly new. Only normal maintenance required.

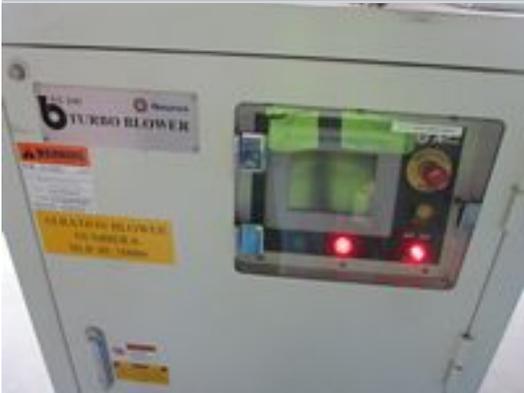
Asset Description	Blower #4 Control Panel	System	Secondary Treatment
Asset Type	CONTROL PANEL	Location	Sec Process
Asset ID	LCP40-50004	Inspection Date	4/3/2019
Comments		Flag

Question	Overriding?	Answer	NA	Flag	Answer Comment
Absence of Burn Marks		1 yes			
Acceptable Smell or Heat		1 yes			
All Safety Features Present		1 yes			
Control Switches		1 Excellent			
Good House Keeping		1 yes			
Good Wire Labeling		1 yes			
Infrared		2 Normal			
Installation		1 Excellent			
Obsolescence		1 Current and supported			
Operating at Inspection		1 yes			
Panel Labeling		1 yes			
Structural (Panel)		1 Excellent

Condition Category Very good. Condition Grade 1. New or nearly new. Only normal maintenance required.

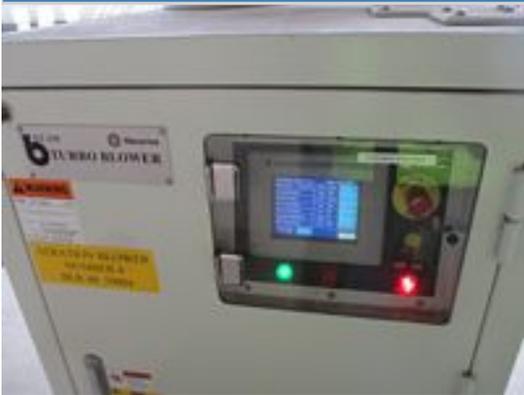
Asset Description	Blower #5 Control Panel	System	Secondary Treatment
Asset Type	CONTROL PANEL	Location	Sec Process
Asset ID	LCP40-50005	Inspection Date	4/3/2019
Comments		Flag

Question	Overriding?	Answer	NA	Flag	Answer Comment
Absence of Burn Marks		1 yes			
Acceptable Smell or Heat		1 yes			
All Safety Features Present		1 yes			
Control Switches		1 Excellent			
Good House Keeping		1 yes			
Good Wire Labeling		1 yes			
Infrared		2 Normal			
Installation		1 Excellent			
Obsolescence		1 Current and supported			
Operating at Inspection		5 no			
Panel Labeling		1 yes			
Structural (Panel)		1 Excellent

Condition Category Very good. Condition Grade 1. New or nearly new. Only normal maintenance required.

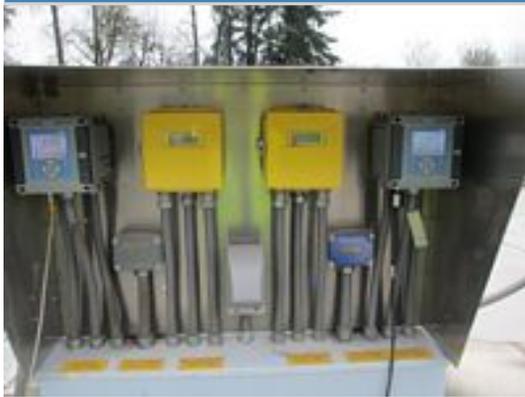
Asset Description	Flow Element 40-12002	System	Secondary Treatment
Asset Type	FLOW METER	Location	Sec Process
Asset ID	FE40-12002	Inspection Date	4/2/2019
Comments		Flag

Question	Overriding?	Answer	NA	Flag	Answer Comment
Absence of Leaks		1 yes			
All Components		1 yes			
Calibration		1 Excellent			
Corrosion - Structural Metal Condition?		2 Minor corrosion			
Grounding		1 yes			
Installation/ Accessibility		1 Excellent

Condition Category Very good. Condition Grade 1. New or nearly new. Only normal maintenance required.

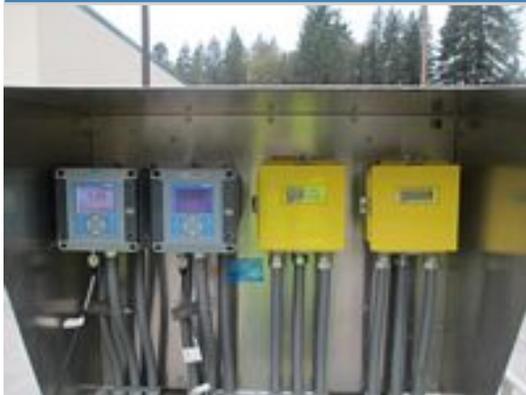
Asset Description	Flow Element 40-30001	System	Secondary Treatment
Asset Type	FLOW METER	Location	Sec Process
Asset ID	FE40-30001	Inspection Date	4/2/2019
Comments		Flag

Question	Overriding?	Answer	NA	Flag	Answer Comment
Absence of Leaks		1 yes			
All Components		1 yes			
Calibration		1 Excellent			
Corrosion - Structural Metal Condition?		2 Minor corrosion			
Grounding		1 yes			
Installation/ Accessibility		1 Excellent

Condition Category Very good. Condition Grade 1. New or nearly new. Only normal maintenance required.

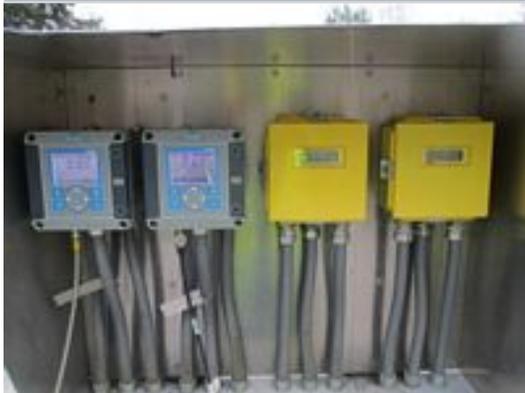
Asset Description	Flow Element 40-30002	System	Secondary Treatment
Asset Type	FLOW METER	Location	Sec Process
Asset ID	FE40-30002	Inspection Date	4/2/2019
Comments		Flag

Question	Overriding?	Answer	NA	Flag	Answer Comment
Absence of Leaks		1 yes			
All Components		1 yes			
Calibration		1 Excellent			
Corrosion - Structural Metal Condition?		2 Minor corrosion			
Grounding		1 yes			
Installation/ Accessibility		1 Excellent

Condition Category Very good. Condition Grade 1. New or nearly new. Only normal maintenance required.

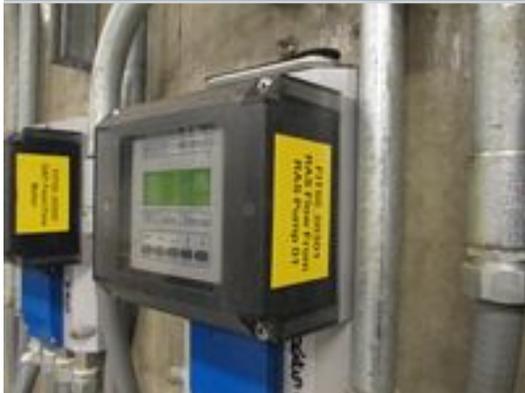
Asset Description	Flow Element 50-00301	System	Secondary Treatment
Asset Type	FLOW METER	Location	Sec Process
Asset ID	FE50-00301	Inspection Date	4/2/2019
Comments		Flag

Question	Overriding?	Answer	NA	Flag	Answer Comment
Absence of Leaks		1 yes			
All Components		1 yes			
Calibration		1 Excellent			
Corrosion - Structural Metal Condition?		1 Like new			
Grounding		1 yes			
Installation/ Accessibility		1 Excellent

Condition Category Very good. Condition Grade 1. New or nearly new. Only normal maintenance required.

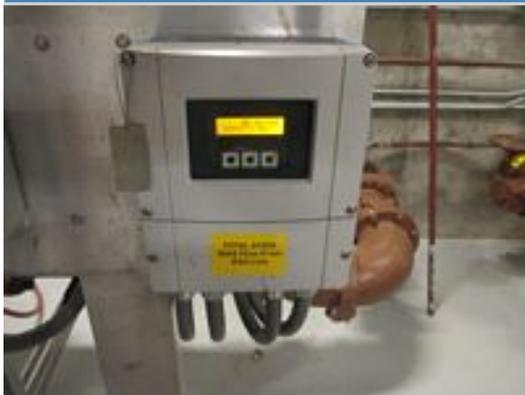
Asset Description	Flow Element 50-41000	System	Secondary Treatment
Asset Type	FLOW METER	Location	Sec Process
Asset ID	FE50-41000	Inspection Date	4/3/2019
Comments		Flag

Question	Overriding?	Answer	NA	Flag	Answer Comment
Absence of Leaks		1 yes			
All Components		1 yes			
Calibration		1 Excellent			
Corrosion - Structural Metal Condition?		1 Like new			
Grounding		1 yes			
Installation/ Accessibility		1 Excellent

Condition Category Very good. Condition Grade 1. New or nearly new. Only normal maintenance required.

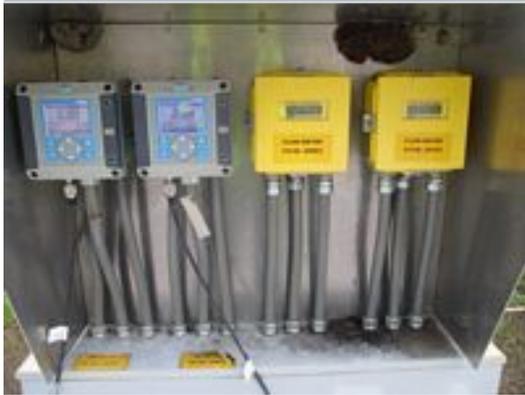
Asset Description	Flow Transmitter 40-30103	System	Secondary Treatment
Asset Type	FLOW METER	Location	Sec Process
Asset ID	FIT40-30103	Inspection Date	4/2/2019
Comments		Flag

Question	Overriding?	Answer	NA	Flag	Answer Comment
Absence of Leaks		1 yes			
All Components		1 yes			
Calibration		1 Excellent			
Corrosion - Structural Metal Condition?		2 Minor corrosion			
Grounding		1 yes			
Installation/ Accessibility		1 Excellent

Condition Category Very good. Condition Grade 1. New or nearly new. Only normal maintenance required.

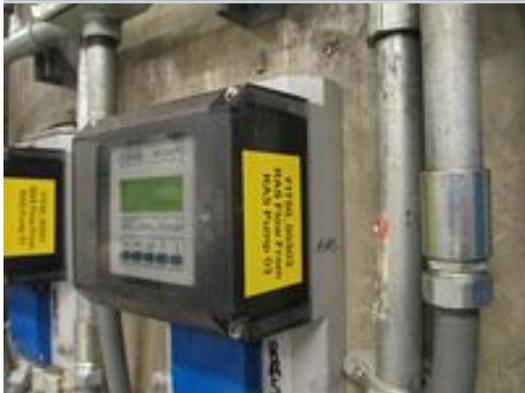
Asset Description	Flow Element 50-00303	System	Secondary Treatment
Asset Type	FLOW METER	Location	Sec Process
Asset ID	FIT50-00303	Inspection Date	4/3/2019
Comments		Flag

Question	Overriding?	Answer	NA	Flag	Answer Comment
Absence of Leaks		1 yes			
All Components		1 yes			
Calibration		1 Excellent			
Corrosion - Structural Metal Condition?		1 Like new			
Grounding		1 yes			
Installation/ Accessibility		1 Excellent

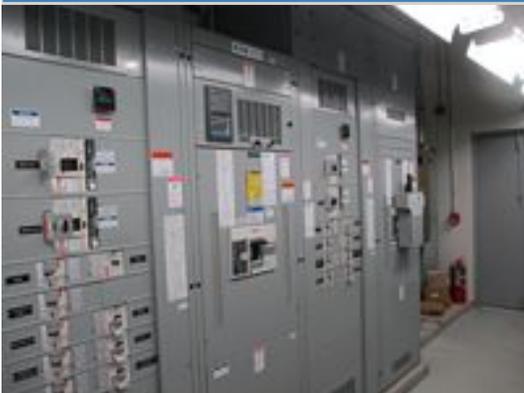
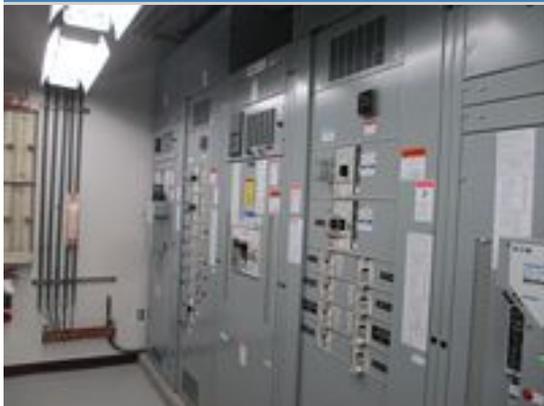
Asset Description	Switchboard SWBD40-02A	System	Secondary Treatment
Asset Type	SWITCHGEAR	Location	Sec Process
Asset ID	SWBD40-02A	Inspection Date	4/2/2019
Comments	Unable to access interior due to bolted panel, arc flash ratings exceeds corporate policy for internal inspection.		Flag

Question	Overriding?	Answer	NA	Flag	Answer Comment
Absence of Burn Marks		1 yes			
Acceptable Noise		1 yes			
Acceptable Smell or Heat		1 yes			
All Components		1 yes			
All Safety Features Present		1 yes			
Arc Flash Boundary Available and Posted		1 Yes			
Control Gauges (Hour Meters Volts & Amps)		2 Good			
Control Lamps		2 Good			
Control Switches		2 Good			
Corrosion - Metal		1 Like New			
Gauges and Meters		1 Currently Supported			
High Pot Bus			X	Not Evaluated	
High Pot Cable			X	Not Evaluated	
Infrared			X	Not Evaluated	Unable to access interior due to bolted panel, arc flash ratings exceeds corporate policy for internal inspection.
Installation/Accessibility/Serviceability		1 Excellent			
Obsolescence		1 Current, Supported			
Safety Devices		1 Excellent

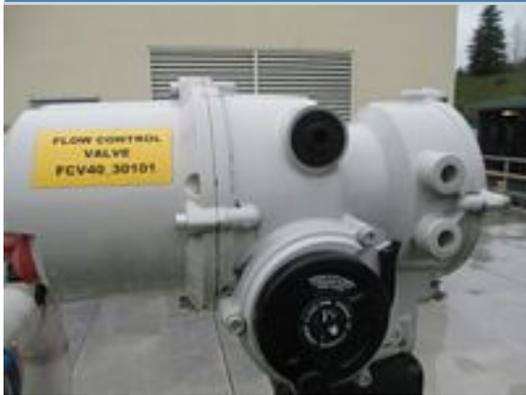
Asset Description	Flow Control Valve 40-30101	System	Secondary Treatment
Asset Type	VALVE-BUTTERFLY	Location	Sec Process
Asset ID	FCV-30101	Inspection Date	4/2/2019
Comments		Flag

Question	Overriding?	Answer	NA	Flag	Answer Comment
Absence of Leaks		1 yes			
All Components		1 yes			
Functional		1 Fully Opens/Closes, Stops on Limits, and Holds Without Assistance			
Support		1 Excellent			
Valve Isolates (Holds)		1 yes

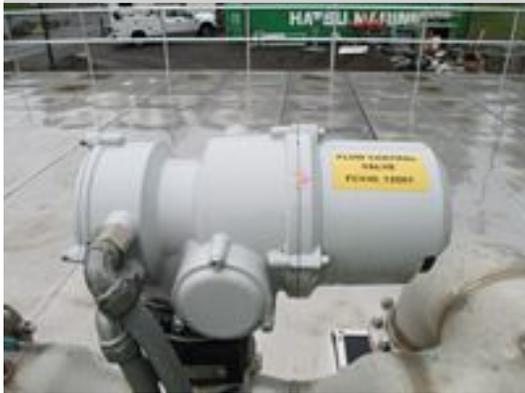
Asset Description	Flow Control Valve 40-12001	System	Secondary Treatment
Asset Type	VALVE-BUTTERFLY	Location	Sec Process
Asset ID	FCV40-12001	Inspection Date	4/2/2019
Comments		Flag

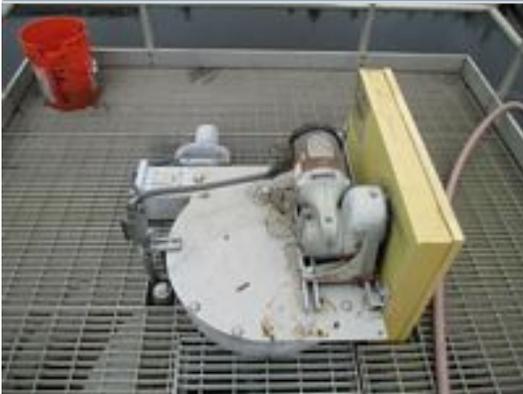
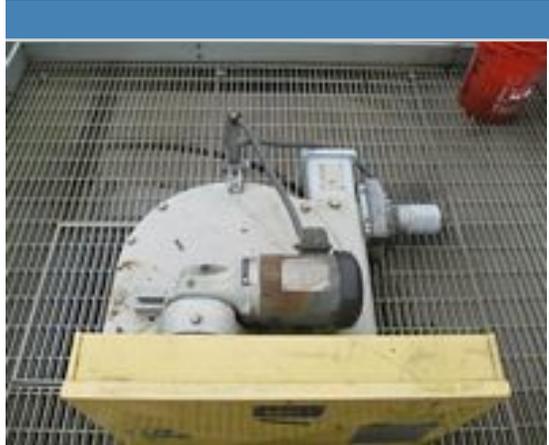
Asset Description	Secondary Clarifier, #1 Mechan	System	Secondary Treatment
Asset Type	GEARBOX	Location	Secondary Clarifier
Asset ID	SC-M-50-1-1	Inspection Date	4/2/2019
Comments		Flag

Question	Overriding?	Answer	NA	Flag	Answer Comment
Absence of Leaks		1 yes			
Acceptable Noise		1 yes			
Air Relief Valve		1 Excellent			
All Safety Features Present		1 yes			
Corrosion - Structural Metal Condition?		2 Minor corrosion			
Mounting		1 Excellent			
Obsolescence		1 Current and supported			
Oil Analysis			X	Not Evaluated	
Vibration Analysis		2 2 -Good .039 - .15 inches/sec			0.08" / second

Condition Category Very good. Condition Grade 1. New or nearly new. Only normal maintenance required.

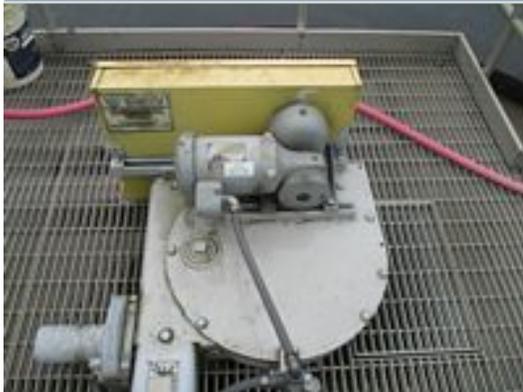
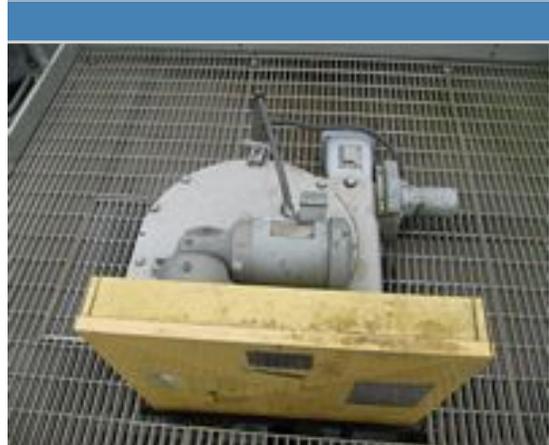
Asset Description	Secondary Clarifier, #2 Mechan	System	Secondary Treatment
Asset Type	GEARBOX	Location	Secondary Clarifier
Asset ID	SC-M-50-1-2	Inspection Date	4/2/2019
Comments		Flag

Question	Overriding?	Answer	NA	Flag	Answer Comment
Absence of Leaks		1 yes			
Acceptable Noise		1 yes			
Air Relief Valve		1 Excellent			
All Safety Features Present		1 yes			
Corrosion - Structural Metal Condition?		2 Minor corrosion			
Mounting		1 Excellent			
Obsolescence		1 Current and supported			
Oil Analysis			X	Not Evaluated	
Vibration Analysis		2 2 -Good .039 - .15 inches/sec			0.05" / second

Condition Category Very good. Condition Grade 1. New or nearly new. Only normal maintenance required.

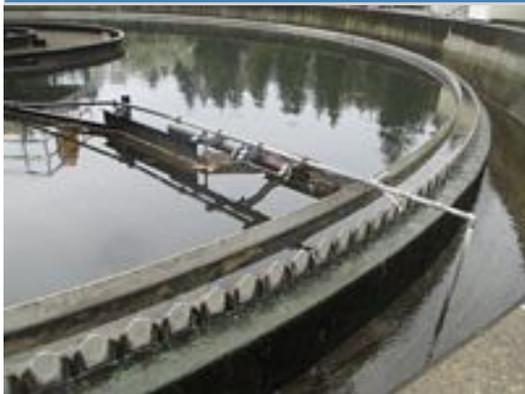
Asset Description	Sec Clarifier #1 Weir Washer	System	Secondary Treatment
Asset Type	WASHER	Location	Secondary Clarifier
Asset ID	SC-50-1-3	Inspection Date	4/2/2019
Comments		Flag

Question	Overriding?	Answer	NA	Flag	Answer Comment
Absence of Leaks		1 yes			
Corrosion - Mechanical Metals		2 Slight staining/small chips/holes in coating			
Drive Motor			X	Non Existent	
General Appearance		1 Excellent			
Hoses and Belts		3 Moderate

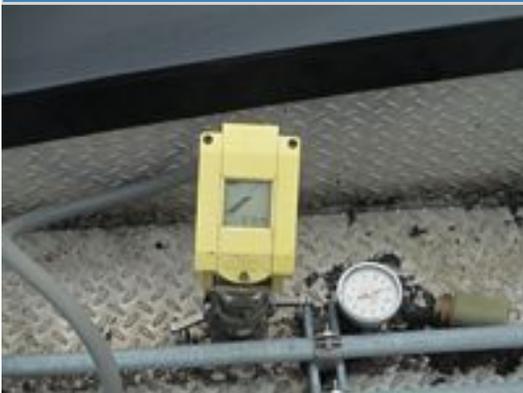
Asset Description	Bio Storage Tank Lvl Monitor 3	System	Solids Handling
Asset Type	INSTRUMENT	Location	Bio Storage Tank 3 (West)
Asset ID	BS-LE-82-1-3	Inspection Date	4/4/2019
Comments		Flag

Question	Overriding?	Answer	NA	Flag	Answer Comment
Absence of Leaks		1 yes			
Acceptable Smell or Heat		1 yes			
Acceptable Wire Labeling		1 yes			
All Components		1 yes			
Calibration		1 Excellent			
Connections Ok		1 yes			
Display Ok		1 yes			
Indicator		2 Good			
Installation/ Accessibility		1 Excellent			
Operating at Inspection		1 yes			
Tubing / Connections		2 Normal

Condition Score	1.24	Consequence Score	4.90
Risk Score	12.74	Likelihood Score	2.60

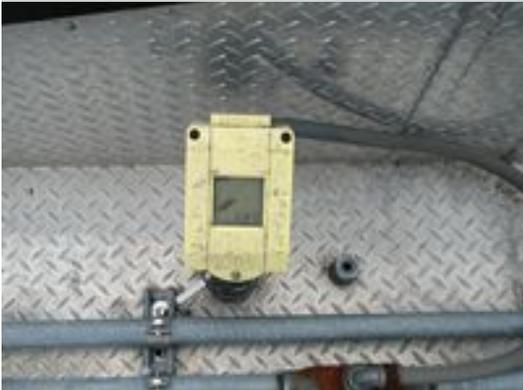
Asset Description	Bio Storage Tank Lvl Monitor 5	System	Solids Handling
Asset Type	INSTRUMENT	Location	Bio Storage Tank 5 (South)
Asset ID	BS-LE-82-1-5	Inspection Date	4/4/2019
Comments		Flag

Question	Overriding?	Answer	NA	Flag	Answer Comment
Absence of Leaks		1 yes			
Acceptable Smell or Heat		1 yes			
Acceptable Wire Labeling		1 yes			
All Components		1 yes			
Calibration		1 Excellent			
Connections Ok		1 yes			
Display Ok		1 yes			
Indicator		2 Good			
Installation/ Accessibility		1 Excellent			
Operating at Inspection		1 yes			
Tubing / Connections		2 Normal

Condition Score	1.24	Consequence Score	4.90
Risk Score	12.74	Likelihood Score	2.60

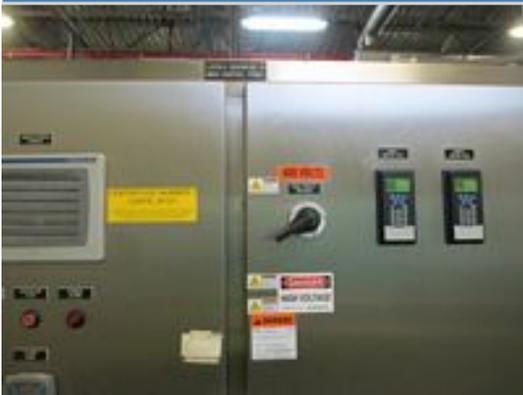
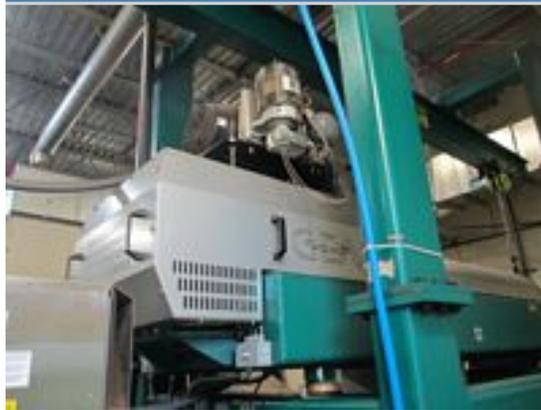
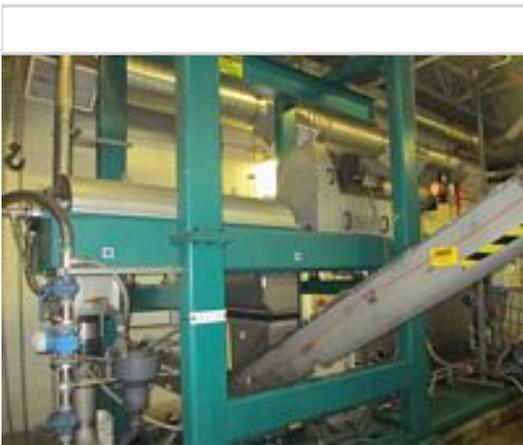
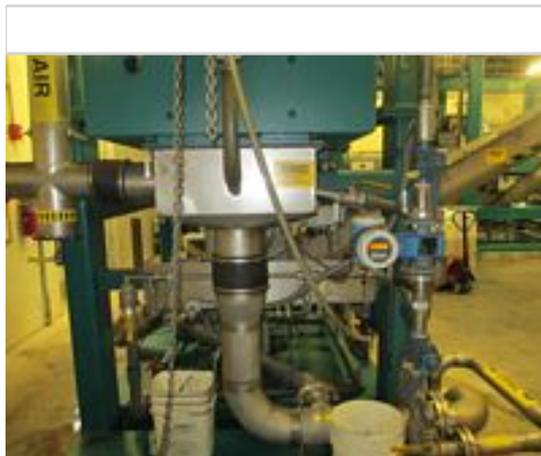
Asset Description	Centrifuge #1	System	Solids Handling
Asset Type	CENTRIFUGE	Location	D&D
Asset ID	CEN78-30101	Inspection Date	4/3/2019
Comments		Flag

Question	Overriding?	Answer	NA	Flag	Answer Comment
Absence of Leaks		1 yes			
Acceptable Drainage		1 yes			
Acceptable Vibration		1 yes			
All Safety Guards Present		1 yes			
Controls		1 Excellent			
Corrosion - Mechanical Metals		2 Slight staining/small chips/holes in coating			
Drive Motor		1 Excellent			
General Appearance		1 Excellent			
Hydraulic System		2 Minor Deficiencies

Condition Category Very good. Condition Grade 1. New or nearly new. Only normal maintenance required.

Condition Score 1.22

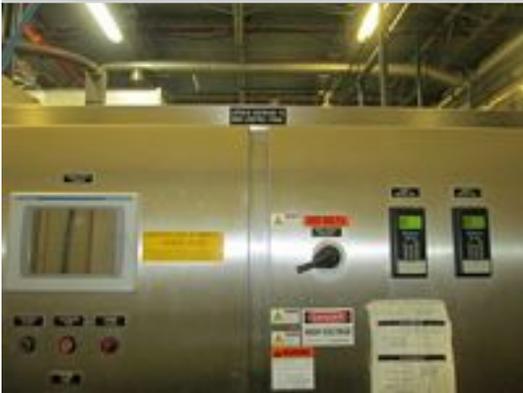
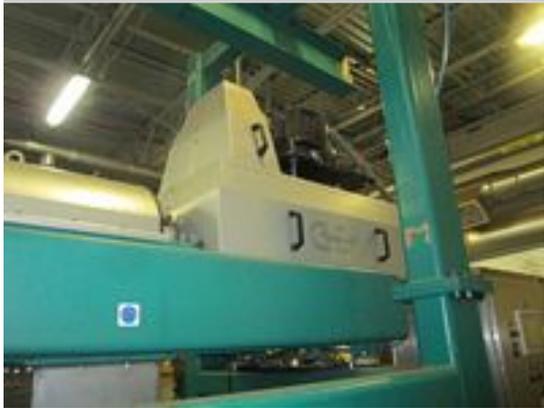
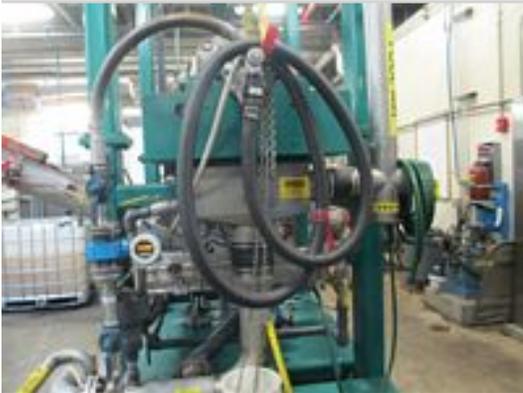
Asset Description	Centrifuge #2	System	Solids Handling
Asset Type	CENTRIFUGE	Location	D&D
Asset ID	CEN78-30102	Inspection Date	4/3/2019
Comments		Flag

Question	Overriding?	Answer	NA	Flag	Answer Comment
Absence of Leaks		1 yes			
Acceptable Drainage		1 yes			
Acceptable Vibration		1 yes			
All Safety Guards Present		1 yes			
Controls		1 Excellent			
Corrosion - Mechanical Metals		2 Slight staining/small chips/holes in coating			
Drive Motor		1 Excellent			
General Appearance		1 Excellent			
Hydraulic System		2 Minor Deficiencies

Condition Category Very good. Condition Grade 1. New or nearly new. Only normal maintenance required.

Condition Score	1.22	Consequence Score	4.90
Risk Score	8.33	Likelihood Score	1.70

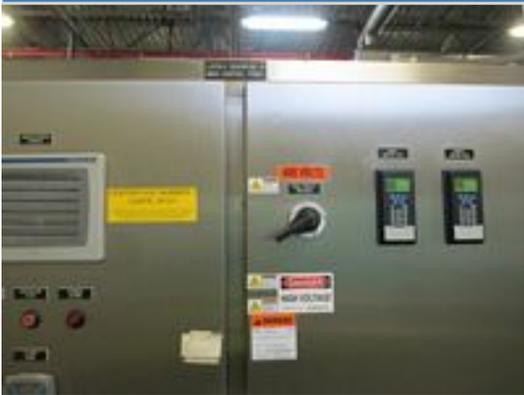
Asset Description	Centrifuge #1 Control Panel	System	Solids Handling
Asset Type	CONTROL PANEL	Location	D&D
Asset ID	LCP78-11	Inspection Date	4/2/2019
Comments		Flag

Question	Overriding?	Answer	NA	Flag	Answer Comment
Absence of Burn Marks		1 yes			
Acceptable Smell or Heat		1 yes			
All Safety Features Present		1 yes			
Control Switches		2 Good			
Good House Keeping		1 yes			
Good Wire Labeling		1 yes			
Infrared		2 Normal			
Installation		1 Excellent			
Obsolescence		1 Current and supported			
Operating at Inspection		1 yes			
Panel Labeling		1 yes			
Structural (Panel)		1 Excellent

Condition Category Very good. Condition Grade 1. New or nearly new. Only normal maintenance required.

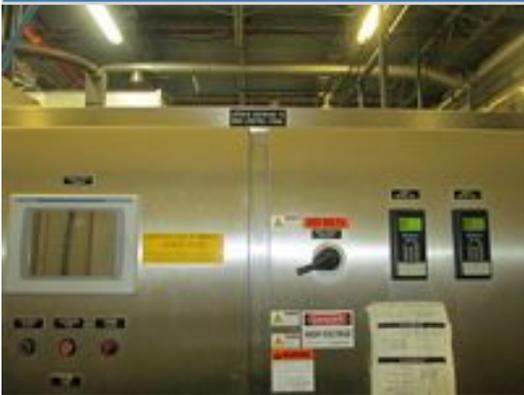
Asset Description	Centrifuge #2 Control Panel	System	Solids Handling
Asset Type	CONTROL PANEL	Location	D&D
Asset ID	LCP78-12	Inspection Date	4/2/2019
Comments		Flag

Question	Overriding?	Answer	NA	Flag	Answer Comment
Absence of Burn Marks		1 yes			
Acceptable Smell or Heat		1 yes			
All Safety Features Present		1 yes			
Control Switches		2 Good			
Good House Keeping		1 yes			
Good Wire Labeling		1 yes			
Infrared		2 Normal			
Installation		1 Excellent			
Obsolescence		1 Current and supported			
Operating at Inspection		1 yes			
Panel Labeling		1 yes			
Structural (Panel)		1 Excellent

Condition Category Very good. Condition Grade 1. New or nearly new. Only normal maintenance required.

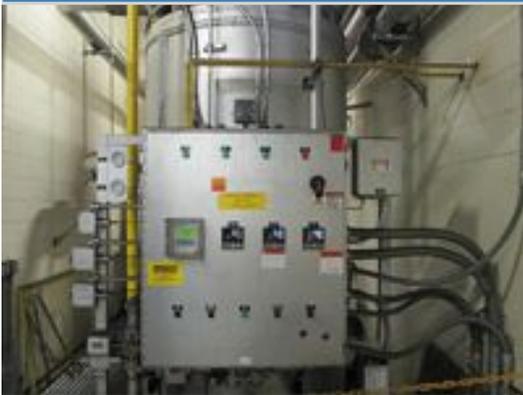
Asset Description	Thermal Heater Control Panel	System	Solids Handling
Asset Type	CONTROL PANEL	Location	D&D
Asset ID	LCP78-20400	Inspection Date	4/2/2019
Comments		Flag

Question	Overriding?	Answer	NA	Flag	Answer Comment
Absence of Burn Marks		1 yes			
Acceptable Smell or Heat		1 yes			
All Safety Features Present		1 yes			
Control Switches		2 Good			
Good House Keeping		1 yes			
Good Wire Labeling		1 yes			
Infrared		2 Normal			
Installation		1 Excellent			
Obsolescence		1 Current and supported			
Operating at Inspection		1 yes			
Panel Labeling		1 yes			
Structural (Panel)		1 Excellent

Condition Category Very good. Condition Grade 1. New or nearly new. Only normal maintenance required.

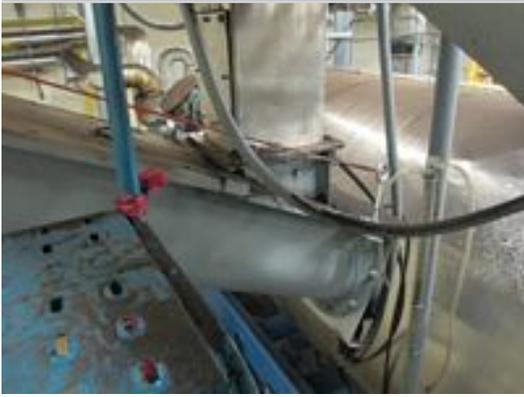
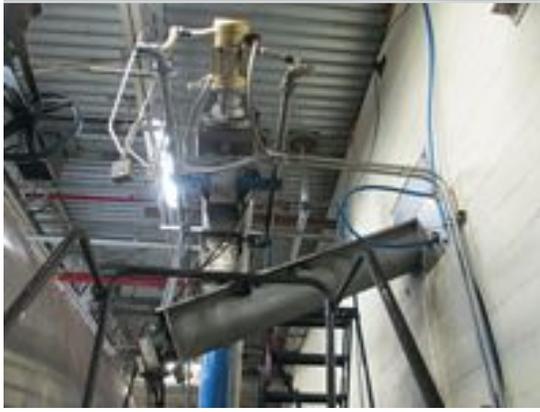
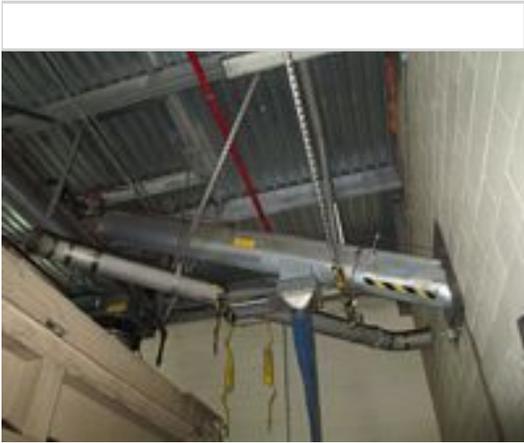
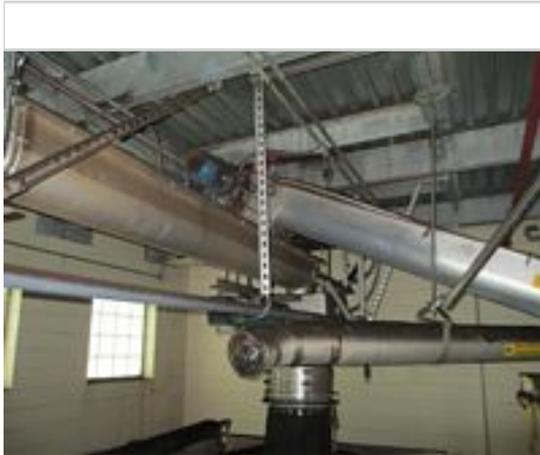
Question	Overriding?	Answer	NA	Flag	Answer Comment
Absence of Leaks		1 yes			
Acceptable Hydraulic Pressure			X	Non Existent	Motor driven conveyor
Acceptable Noise		1 yes			
Acceptable Oil/Grease		1 yes			
Acceptable Smell or Heat		1 yes			
Acceptable Vibration		1 yes			
All Components		1 yes			
All Safety Features Present		1 yes			
Auger Wear - Structural Metal Condition		3 Pitting And Some Metal Loss			
Bearings		2 Minor Wear			
Belt/Chain			X	Non Existent	Direct driven
Controls		1 Excellent			
Corrosion - Metal		2 Minor Corrosion			
Drive Assembly		1 Excellent			
Motor Coupling		2 Minor Wear But No Misalignment			
Obsolescence		1 Current, Supported			
Rollers and Tracking System			X	Non Existent	Screw type conveyor
Support		1 Excellent			
Trough Wear - Structural Metal Condition		3 Moderate Deterioration

Condition Category Very good. Condition Grade 1. New or nearly new. Only normal maintenance required.

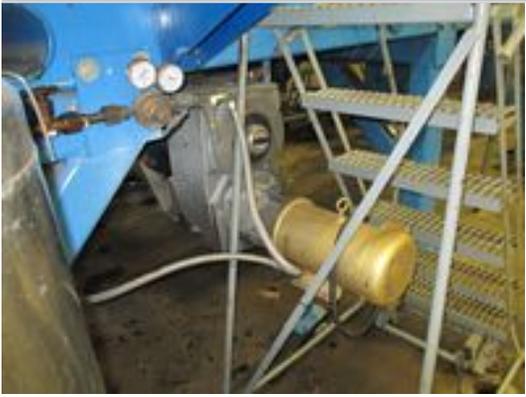
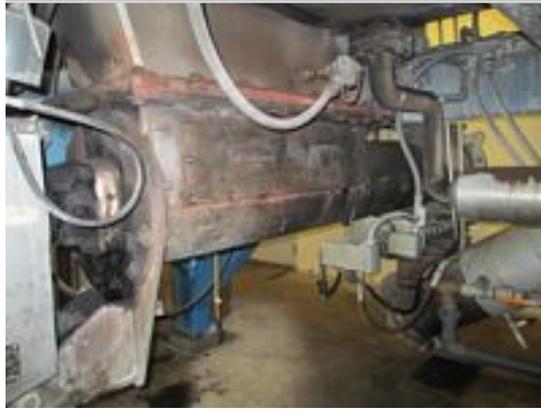
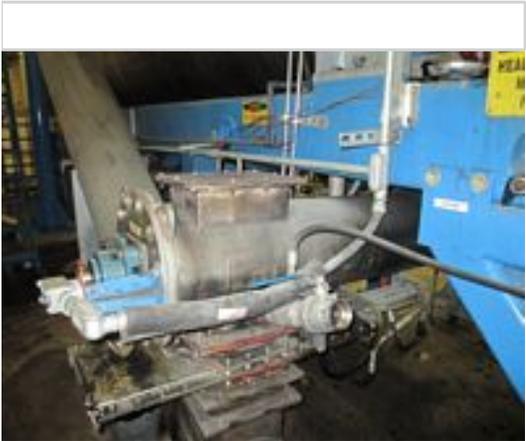
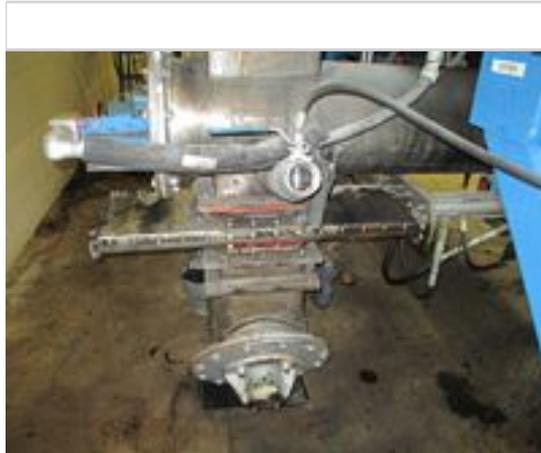
Question	Overriding?	Answer	NA	Flag	Answer Comment
Absence of Leaks		5 no			
Acceptable Hydraulic Pressure			X	Non Existent	Motor driven conveyor
Acceptable Noise		5 no			Shaft is bent
Acceptable Oil/Grease		1 yes			
Acceptable Smell or Heat		5 no			
Acceptable Vibration		5 no			
All Components		1 yes			
All Safety Features Present		1 yes			
Auger Wear - Structural Metal Condition		5 Severe Pitting			
Bearings		2 Minor Wear			
Belt/Chain			X	Non Existent	Direct driven
Controls		1 Excellent			
Corrosion - Metal		5 Severe Pitting			
Drive Assembly		3 Moderate Wear			
Motor Coupling		4 Major Wear			
Obsolescence		5 Obsolete, Not Supported			
Rollers and Tracking System			X	Non Existent	Screw type conveyor
Support		1 Excellent			
Trough Wear - Structural Metal Condition		5 Failure Imminent

Condition Category Poor. Condition Grade 4. Unable to meet level of service life. Failure imminent.

Condition Score 3.38 Consequence Score 4.60

Risk Score 23.00 Likelihood Score 5.00

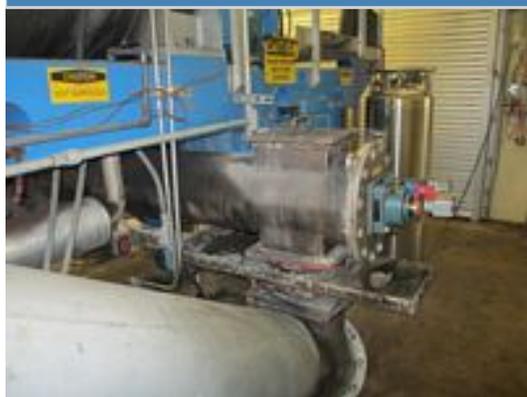
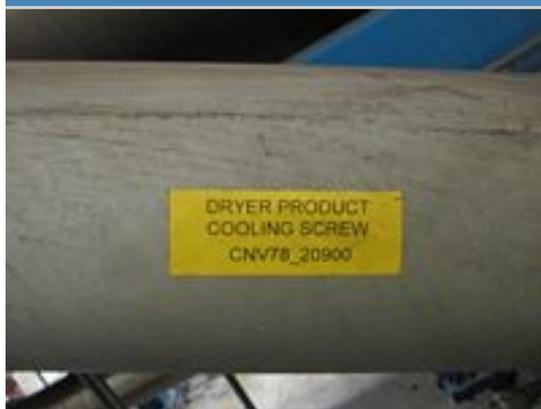
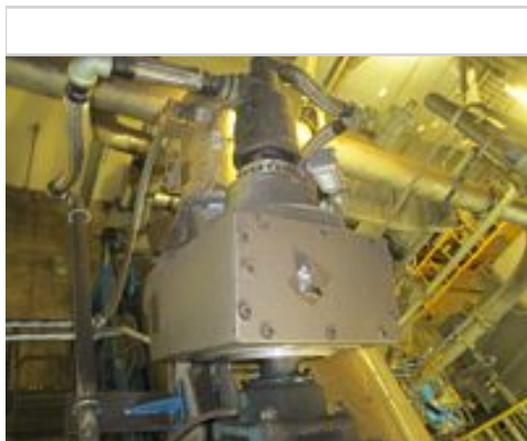
Asset Description	Dry Product Cooling Conveyor	System	Solids Handling
Asset Type	CONVEYOR	Location	D&D
Asset ID	CNV78-20900	Inspection Date	4/3/2019
Comments	The first 9 feet of the conveyor flight was replaced a few year's back. The entire conveyor auger is in need of replacement. The gear box could not be removed during the last repair, and will have to be replaced with the next repair.		Flag

Question	Overriding?	Answer	NA	Flag	Answer Comment
Absence of Leaks		5 no			
Acceptable Hydraulic Pressure			X	Non Existent	Motor driven conveyor
Acceptable Noise		5 no			
Acceptable Oil/Grease		1 yes			
Acceptable Smell or Heat		5 no			
Acceptable Vibration		5 no			
All Components		1 yes			
All Safety Features Present		1 yes			
Auger Wear - Structural Metal Condition		5 Severe Pitting			
Bearings		4 Major Wear			
Belt/Chain			X	Non Existent	Direct driven
Controls		1 Excellent			
Corrosion - Metal		5 Severe Pitting			
Drive Assembly		3 Moderate Wear			
Motor Coupling		2 Minor Wear But No Misalignment			
Obsolescence		1 Current, Supported			
Rollers and Tracking System			X	Non Existent	Screw type conveyor
Support		1 Excellent			
Trough Wear - Structural Metal Condition		5 Failure Imminent

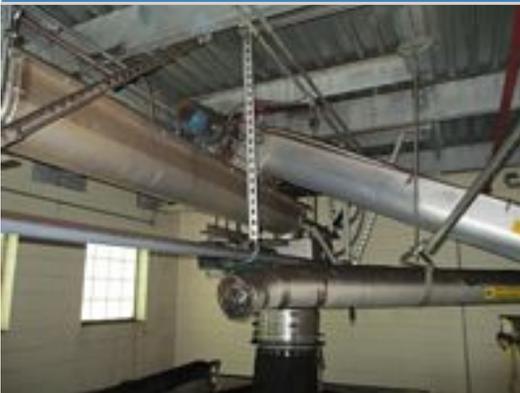
Question	Overriding?	Answer	NA	Flag	Answer Comment
Absence of Leaks		1 yes			
Acceptable Hydraulic Pressure			X	Non Existent	Motor driven conveyor
Acceptable Noise		1 yes			
Acceptable Oil/Grease		1 yes			
Acceptable Smell or Heat		1 yes			
Acceptable Vibration		1 yes			
All Components		1 yes			
All Safety Features Present		1 yes			
Auger Wear - Structural Metal Condition			X	Non Existent	Retractable chute
Bearings		2 Minor Wear			
Belt/Chain		2 Minor Wear			
Controls		1 Excellent			
Corrosion - Metal		2 Minor Corrosion			
Drive Assembly		1 Excellent			
Motor Coupling		2 Minor Wear But No Misalignment			
Obsolescence		1 Current, Supported			
Rollers and Tracking System			X	Non Existent	Retractable chute
Support		1 Excellent			
Trough Wear - Structural Metal Condition			X	Non Existent	Retractable chute

Condition Category Very good. Condition Grade 1. New or nearly new. Only normal maintenance required.

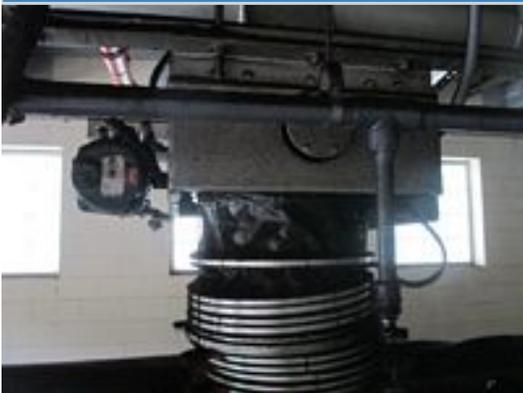
Asset Description	Retractable Loadout Chute #2	System	Solids Handling
Asset Type	CONVEYOR	Location	D&D
Asset ID	CTE78-10202	Inspection Date	4/3/2019
Comments		Flag

Question	Overriding?	Answer	NA	Flag	Answer Comment
Absence of Leaks		1 yes			
Acceptable Hydraulic Pressure			X	Non Existent	Motor driven conveyor
Acceptable Noise		1 yes			
Acceptable Oil/Grease		1 yes			
Acceptable Smell or Heat		1 yes			
Acceptable Vibration		1 yes			
All Components		1 yes			
All Safety Features Present		1 yes			
Auger Wear - Structural Metal Condition			X	Non Existent	Retractable chute
Bearings		2 Minor Wear			
Belt/Chain		2 Minor Wear			
Controls		1 Excellent			
Corrosion - Metal		2 Minor Corrosion			
Drive Assembly		1 Excellent			
Motor Coupling		2 Minor Wear But No Misalignment			
Obsolescence		1 Current, Supported			
Rollers and Tracking System			X	Non Existent	Retractable chute
Support		1 Excellent			
Trough Wear - Structural Metal Condition			X	Non Existent	Retractable chute

Condition Category Very good. Condition Grade 1. New or nearly new. Only normal maintenance required.

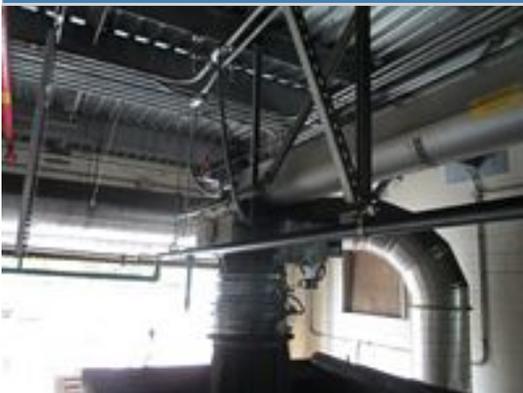
Asset Description	Retractable Loadout Chute #3	System	Solids Handling
Asset Type	CONVEYOR	Location	D&D
Asset ID	CTE78-10203	Inspection Date	4/3/2019
Comments	Load out chute 3 is failed, and left in the "up" position to facilitate trailer movement.	Flag

Question	Overriding?	Answer	NA	Flag	Answer Comment
Absence of Leaks		1 yes			
Acceptable Hydraulic Pressure			X	Non Existent	Motor driven conveyor
Acceptable Noise		5 no			
Acceptable Oil/Grease		1 yes			
Acceptable Smell or Heat		1 yes			
Acceptable Vibration		5 no			
All Components		5 no			
All Safety Features Present		1 yes			
Auger Wear - Structural Metal Condition			X	Non Existent	Retractable chute
Bearings		2 Minor Wear			
Belt/Chain		2 Minor Wear			
Controls		1 Excellent			
Corrosion - Metal		2 Minor Corrosion			
Drive Assembly		5 Failure Imminent			
Motor Coupling		2 Minor Wear But No Misalignment			
Obsolescence		1 Current, Supported			
Rollers and Tracking System			X	Non Existent	Retractable chute
Support		1 Excellent			
Trough Wear - Structural Metal Condition			X	Not Evaluated	Retractable chute

Condition Category Good. Condition Grade 2. Minor wear.

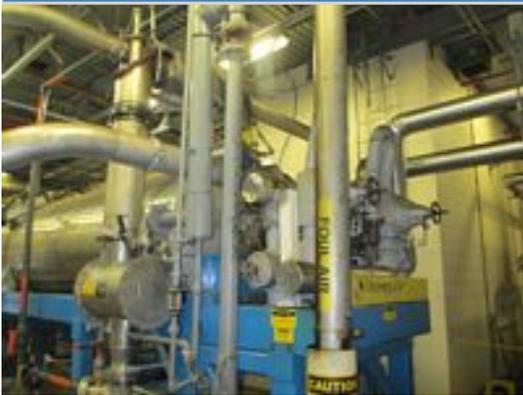
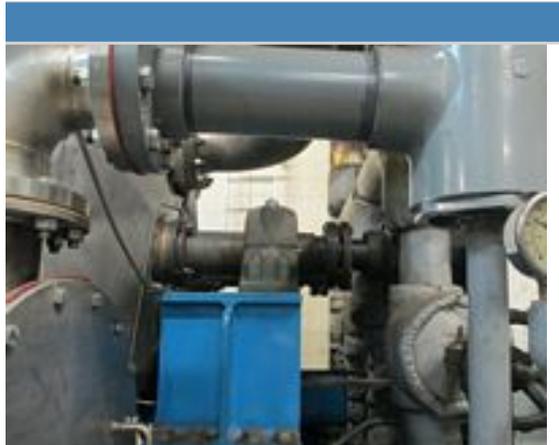
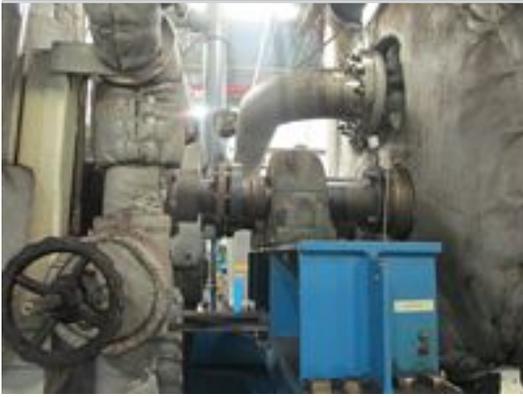
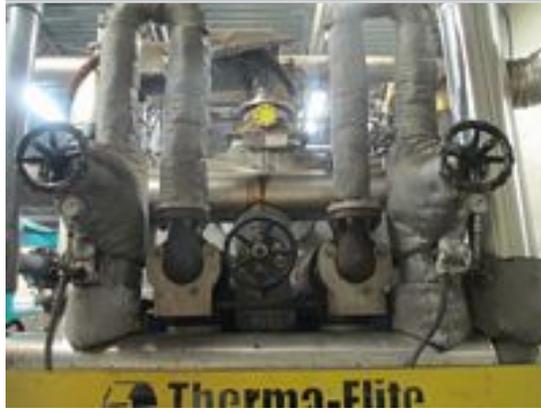
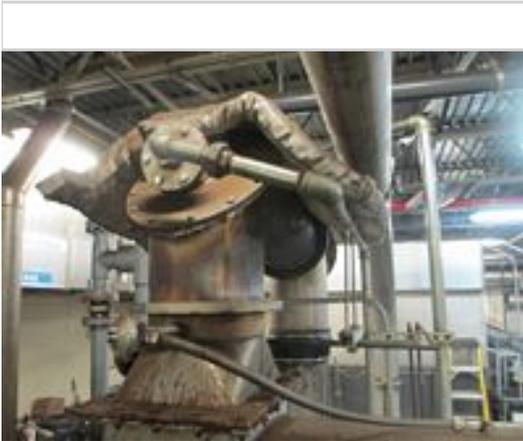
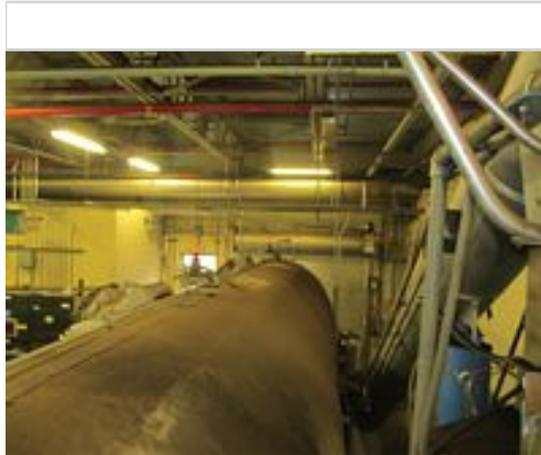
Asset Description	Bio Solids Dryer	System	Solids Handling
Asset Type	DRYER	Location	D&D
Asset ID	CNV78-20700	Inspection Date	4/3/2019
Comments	<p>The dryer shell has eroded and corroded through in several areas, and is currently patched with high temperature silicon sealant and muffler tape. Hardware and welds have rotted away. The scroll is heavily pitted, bearings, seals are at the end of their service life. While the dryer is still operable, a catastrophic failure may happen at any time.</p>		Flag

Question	Overriding?	Answer	NA	Flag	Answer Comment
Absence of Leaks		5 no			
All Components		1 yes			
All Safety Features Present		1 yes			
Conduit and Supports		5 Very Poor			
Control Switches		2 Good			
Corrosion - Metal		5 Severe Pitting			
Drain System Clogs		5 Clogged Or Inadequate, Backed Up			
Drive Assembly		3 Moderate Wear			
Obsolescence		5 Obsolete, Not Supported			
Pipe System		5 Failure Imminent			
Tubing/Connections		5 Obstructed/Loose

Condition Category Fair. Condition Grade 3. Major wear impacting level of service.

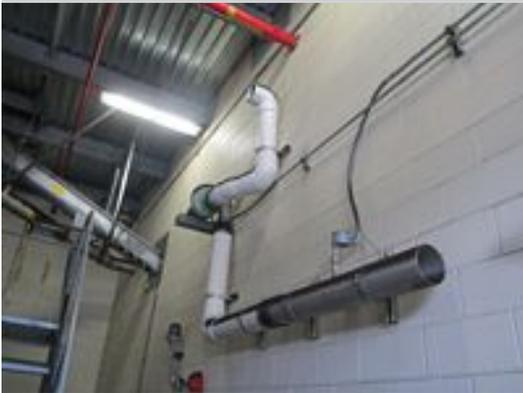
Asset Description	Visibility / Dust Monitor	System	Solids Handling
Asset Type	INSTRUMENT	Location	D&D
Asset ID	AE_AIT78-10600	Inspection Date	4/4/2019
Comments	This instrument is functional but useless.	Flag

Question	Overriding?	Answer	NA	Flag	Answer Comment
Absence of Leaks		1 yes			
Acceptable Smell or Heat		1 yes			
Acceptable Wire Labeling		1 yes			
All Components		1 yes			
Calibration		5 Unable to Calibrate or not Calibrated			
Connections Ok		1 yes			
Display Ok		1 yes			
Indicator		2 Good			
Installation/ Accessibility		1 Excellent			
Operating at Inspection		1 yes			
Tubing / Connections		2 Normal

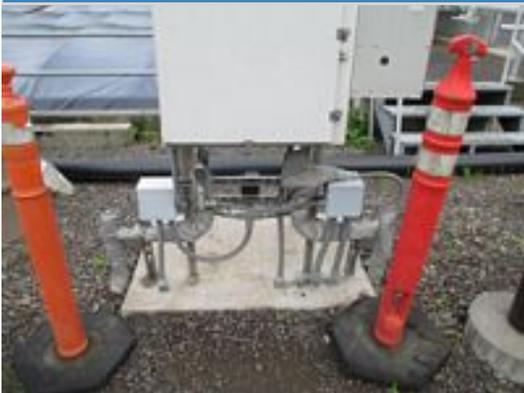
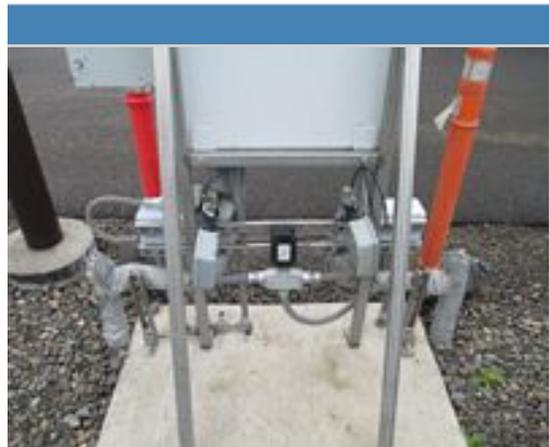
Asset Description	Foul Air Humidifier	System	Solids Handling
Asset Type	ODOR EQUIP	Location	D&D
Asset ID	HUM91-11500	Inspection Date	4/3/2019
Comments		Flag

Question	Overriding?	Answer	NA	Flag	Answer Comment
Absence of Leaks		1 yes			
Acceptable Drainage		1 yes			
Acceptable Smell or Heat		1 yes			
All Components		1 yes			
All Safety Features Present		1 yes			
Coating Condition			X	Non Existent	
Controls		1 Excellent			
Corrosion - Concrete		2 Staining			
Corrosion - Metal		2 Minor Corrosion			
Duct Work			X	Non Existent	
Fan and Fan Motor			X	Non Existent	
Installation/Accessibility		1 Installed properly, easy to access			
Valves		1 Excellent

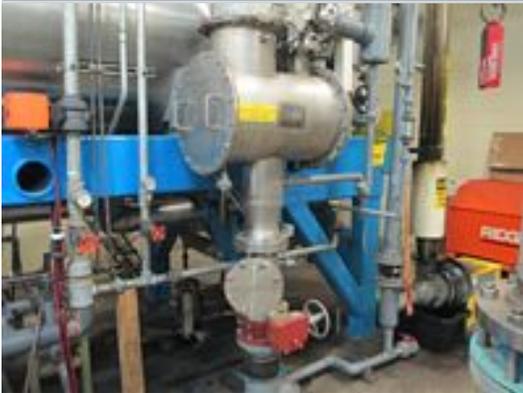
Asset Description	Vent Scrubber / Condenser	System	Solids Handling
Asset Type	ODOR EQUIP	Location	D&D
Asset ID	SCB78-20600	Inspection Date	4/3/2019
Comments		Flag

Question	Overriding?	Answer	NA	Flag	Answer Comment
Absence of Leaks		1 yes			
Acceptable Drainage		1 yes			
Acceptable Smell or Heat		1 yes			
All Components		1 yes			
All Safety Features Present		1 yes			
Coating Condition			X	Non Existent	
Controls		1 Excellent			
Corrosion - Concrete			X	Non Existent	
Corrosion - Metal		2 Minor Corrosion			
Duct Work		1 Excellent			
Fan and Fan Motor			X	Non Existent	
Installation/Accessibility		1 Installed properly, easy to access			
Valves		1 Excellent
