Appendix A
JACOBS CONDITION ASSESSMENT 2019

Wilsonville Wastewater Facility Condition Assessment Report

April 2019

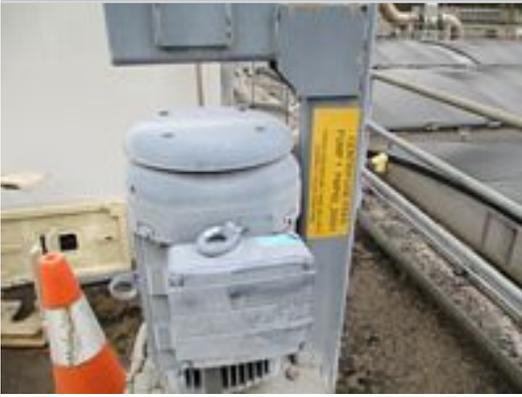
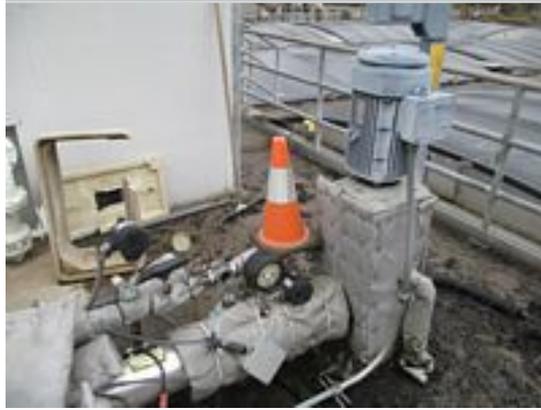
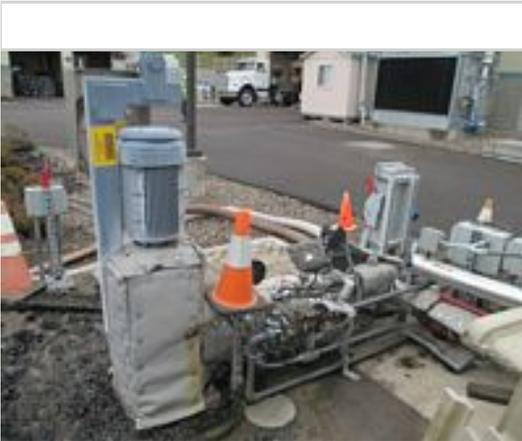
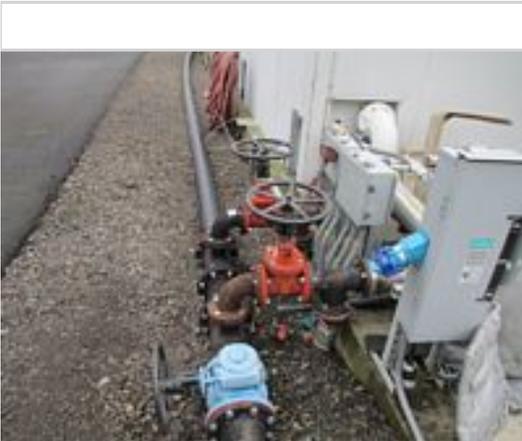
Condition Category	Very poor. Grade 5. Requires complete rehabilitation or replacement. Failed.		
Condition Score	5.00	Consequence Score	5.65
Risk Score	38.70	Likelihood Score	6.85

These vertical, submersed progressing cavity pumps were undersized (50 GPM). Are currently unused, replaced with Vogelsang rotary lobe pumps.

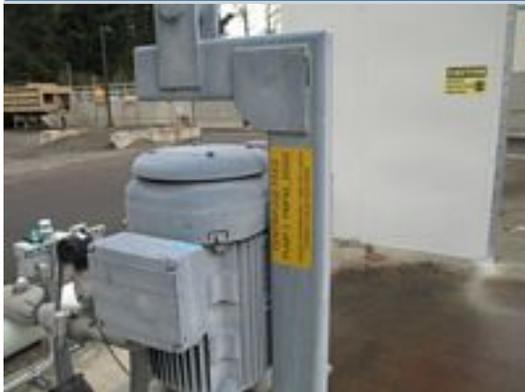
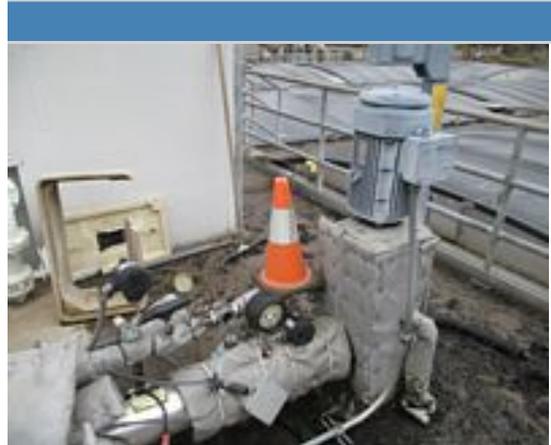
Asset Description	Centrifuge Feed Pump #2	System	Solids Handling
Asset Type	PUMP-PROG CAV	Location	D&D
Asset ID	PMP82-20002	Inspection Date	4/3/2019
Comments	These vertical, submersed progressing cavity pumps were undersized (50 GPM). Are currently unused, replaced with Vogelsang rotary lobe pumps.	Flag

Question	Overriding?	Answer	NA	Flag	Answer Comment
Absence of Leaks		5 no			
Acceptable Noise			X		
Acceptable Smell or Heat			X		
All Safety Features Present			X		
Coating Condition			X		
Corrosion			X		
Drive Assembly			X		
Obsolescence			X		
Tubing/Connections			X

Condition Category Very poor. Grade 5. Requires complete rehabilitation or replacement. Failed.

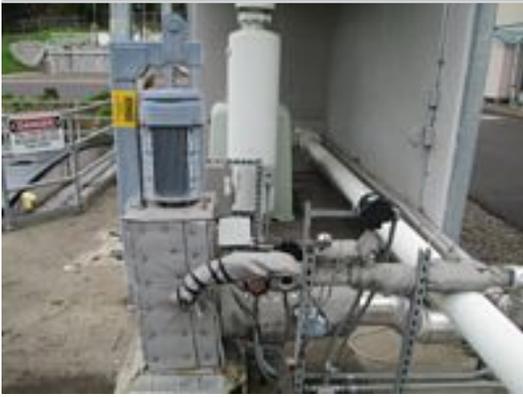
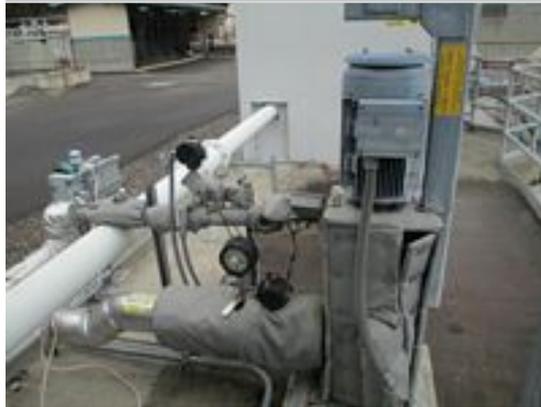
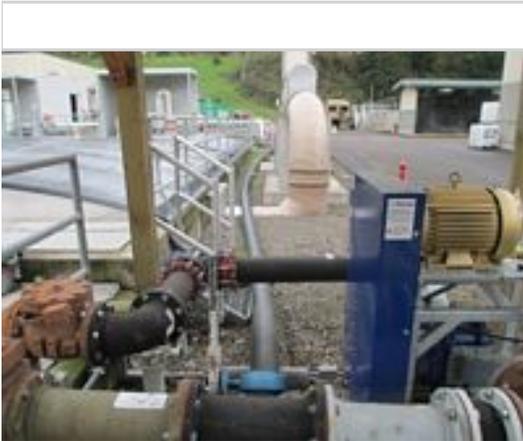
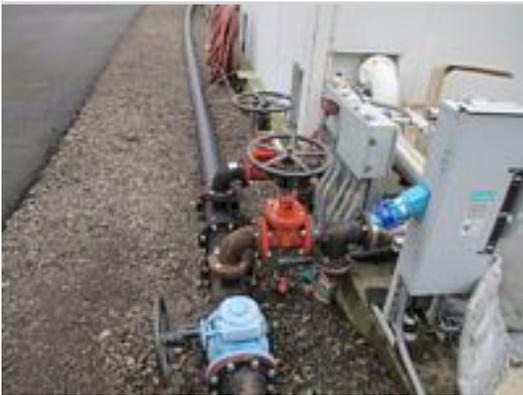
These vertical, submersed progressing cavity pumps were undersized (50 GPM). Are currently unused, replaced with Vogelsang rotary lobe pumps.

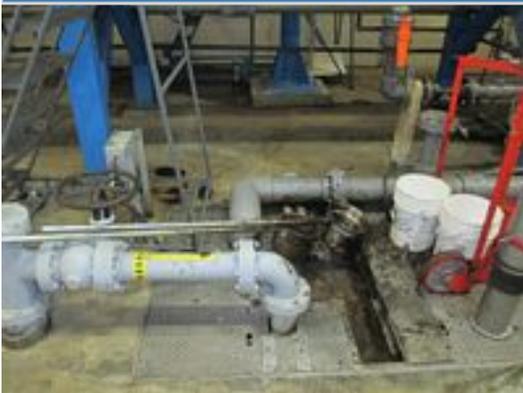
Question	Overriding?	Answer	NA	Flag	Answer Comment
Absence of Cavitation		1 yes			
Absence of Leaks		1 yes			
Acceptable Noise		1 yes			
Acceptable Vibration		1 yes			
All Components		1 yes			
All Safety Features Present		1 yes			
Amperage Draw		1 Below Nameplate			
Chain/Cables/Rails		2 Minor Wear			
Check Valve Operates Properly		1 Excellent			
Connections Ok		1 yes			
Corrosion - Metal		2 Minor Corrosion			
Discharge Piping Condition		1 Corrosion Free, No Known Issues			
Festoon and Power Cable Condition		1 Excellent			
Installation		2 Normal			
Insulation Resistance (10 Meg Ohm)	Yes	1 > 10.0 Meg Ohm			500 Meg Ohms
Obsolescence		1 Current, Supported			
Oil OK at Inspection		1 yes			
Perfromance History		1 Yes			
Pump Rails		1 Excellent			
Valves		1 Excellent			
Volt and Amp Balance		1 V < +/- 1% ; A < +/- 5% FLA

Condition Category Very good. Condition Grade 1. New or nearly new. Only normal maintenance required.

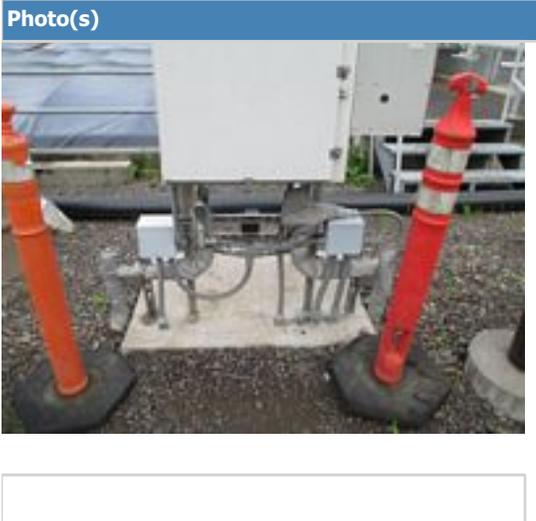
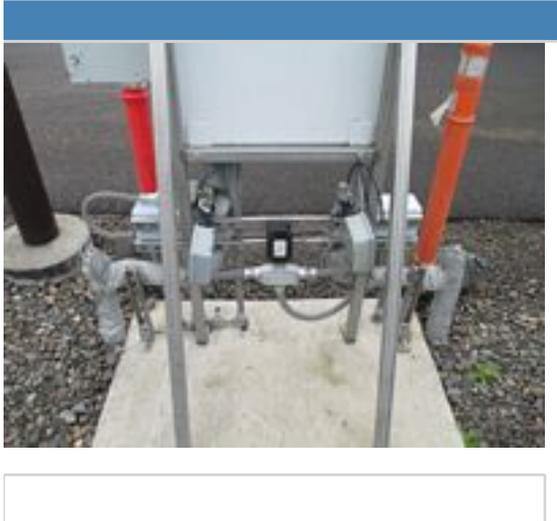
Asset Description	Humidifier Flow Valve	System	Solids Handling
Asset Type	VALVE-BUTTERFLY	Location	D&D
Asset ID	FV91-11600	Inspection Date	4/3/2019
Comments		Flag

Question	Overriding?	Answer	NA	Flag	Answer Comment
Absence of Leaks		1 yes			
All Components		1 yes			
Functional		1 Fully Opens/Closes, Stops on Limits, and Holds Without Assistance			
Support		1 Excellent			
Valve Isolates (Holds)		1 yes

Condition Category Very good. Condition Grade 1. New or nearly new. Only normal maintenance required.

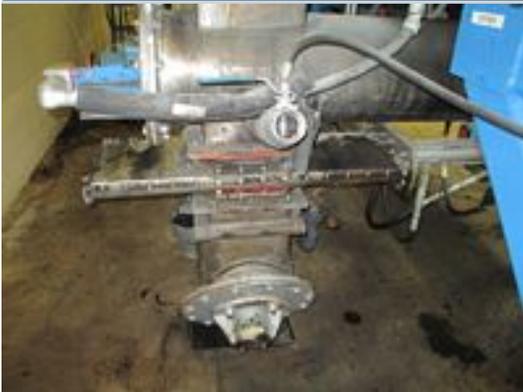
Question	Overriding?	Answer	NA	Flag	Answer Comment
Absence of Leaks		1 yes			
Acceptable Oil/Grease		1 yes			
Actuator		2 Minor			
All Components		1 yes			
Coating Condition			X	Non Existent	Stainless steel
Corrosion - Concrete			X	Non Existent	
Corrosion - Mechanical Metals		2 Slight staining/small chips/holes in coating			
Corrosion - Metal		2 Minor Corrosion			
Exercise Program		1 Adequate schedule and met			
Functional		2 Fully Opens/Closes with Some Assistance			
Lubrication OK at Inspection		1 yes			
Manual Operator			X	Non Existent	
Metal Condition		2 Corrosion Staining			
Mounting		1 Excellent			
Valve Isolates (Holds)		1 yes

Condition Category Very good. Condition Grade 1. New or nearly new. Only normal maintenance required.

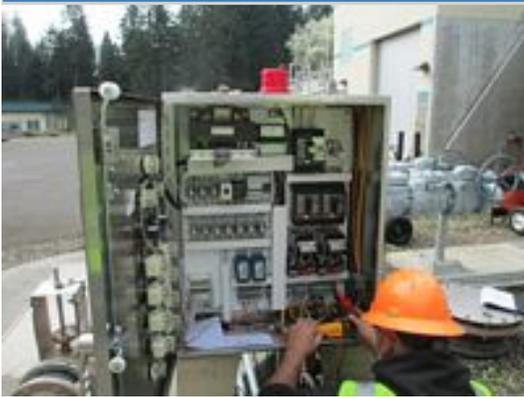
Asset Description	Plant Drain Pump Control Panel	System	Support Equipment
Asset Type	CONTROL PANEL	Location	Plant Drain
Asset ID	LCP96-10000	Inspection Date	4/1/2019
Comments		Flag

Question	Overriding?	Answer	NA	Flag	Answer Comment
Absence of Burn Marks		1 yes			
Acceptable Smell or Heat		1 yes			
All Safety Features Present		1 yes			
Control Switches		2 Good			
Good House Keeping		1 yes			
Good Wire Labeling		1 yes			
Infrared		2 Normal			
Installation		1 Excellent			
Obsolescence		1 Current and supported			
Operating at Inspection		1 yes			
Panel Labeling		1 yes			
Structural (Panel)		1 Excellent

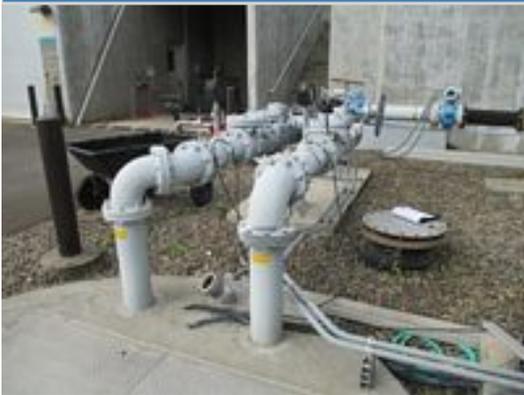
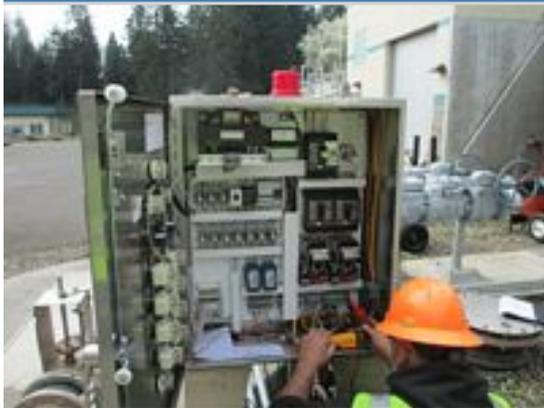
Asset Description	Plant Drain Pump #2	System	Support Equipment
Asset Type	PUMP-SUB	Location	Plant Drain
Asset ID	PMP96-10002	Inspection Date	4/1/2019
Comments		Flag

Question	Overriding?	Answer	NA	Flag	Answer Comment
Absence of Cavitation		1 yes			
Absence of Leaks		1 yes			
Acceptable Noise		1 yes			
Acceptable Vibration		1 yes			
All Components		1 yes			
All Safety Features Present		1 yes			
Amperage Draw		3 At Nameplate			
Chain/Cables/Rails		2 Minor Wear			
Check Valve Operates Properly		1 Excellent			
Connections Ok		1 yes			
Corrosion - Metal		2 Minor Corrosion			
Discharge Piping Condition		1 Corrosion Free, No Known Issues			
Festoon and Power Cable Condition		2 Minor Wear/deterioration			
Installation		1 Excellent			
Insulation Resistance (10 Meg Ohm)	Yes	5 < 1.5 Meg Ohm			0.3 Meg Ohms
Obsolescence		1 Current, Supported			
Oil OK at Inspection			X	Not Evaluated	
Performance History		1 Yes			
Pump Rails		3 Mild Deterioration			
Valves		1 Excellent			
Volt and Amp Balance		1 V < +/- 1% ; A < +/- 5% FLA

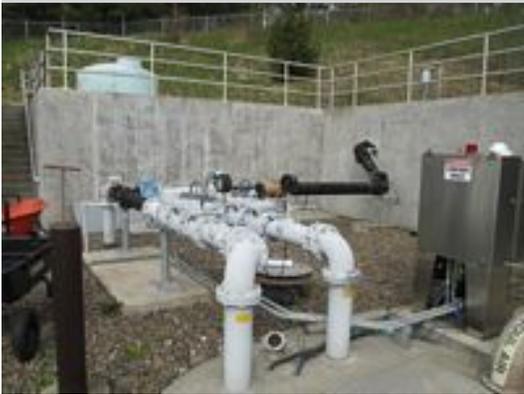
Asset Description	Air Release Valve 96-12001	System	Support Equipment
Asset Type	VALVE-ARV	Location	Plant Drain
Asset ID	ARV96-12001	Inspection Date	4/1/2019
Comments		Flag

Question	Overriding?	Answer	NA	Flag	Answer Comment
Absence of Leaks		1 yes			
Acceptable Noise		1 yes			
All Components		1 yes			
Connections Ok		1 yes			
Corrosion - Metal		2 Minor Corrosion			
Functional		1 Fully Opens/Closes, Stops on Limits, and Holds Without Assistance			
Functioning Correctly		1 Yes			
Installation		2 Normal			
Installation/Accessibility/Enclosure		1 Excellent			
Media Depth and Condition			X	Non Existent	
PRV Tubing Condition		1 PRV Control Tubing, Connections Excellent			
Site Access		1 Very Good			
Support		2 Minor			
Valve Isolates (Holds)		1 yes			
Vault Cover			X	Non Existent

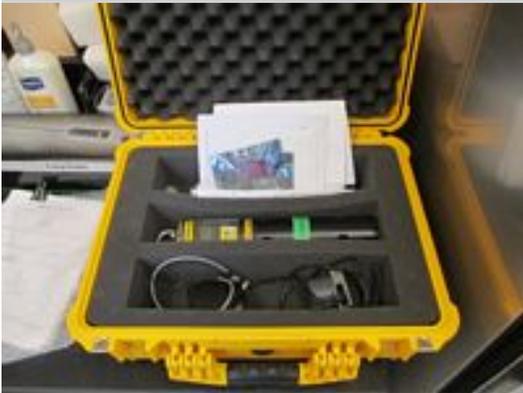
Asset Description	Biosystems Gas Monitor	System	Support Equipment
Asset Type	INSTRUMENT	Location	Process Control Laboratory
Asset ID	GAS-M-70-1	Inspection Date	4/4/2019
Comments		Flag

Question	Overriding?	Answer	NA	Flag	Answer Comment
Absence of Leaks		1 yes			
Acceptable Smell or Heat		1 yes			
Acceptable Wire Labeling		1 yes			
All Components		1 yes			
Calibration		2 Occasionally Found Out of Calibration			
Connections Ok		1 yes			
Display Ok		1 yes			
Indicator		2 Good			
Installation/ Accessibility		1 Excellent			
Operating at Inspection		1 yes			
Tubing / Connections		2 Normal

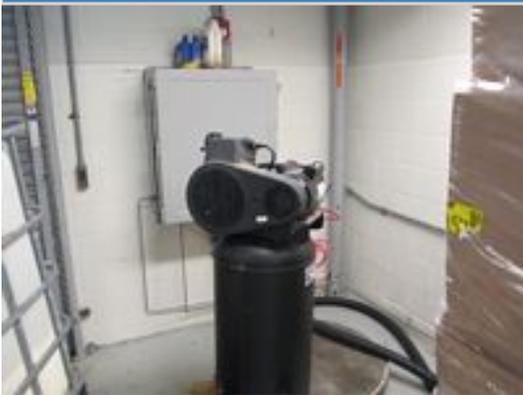
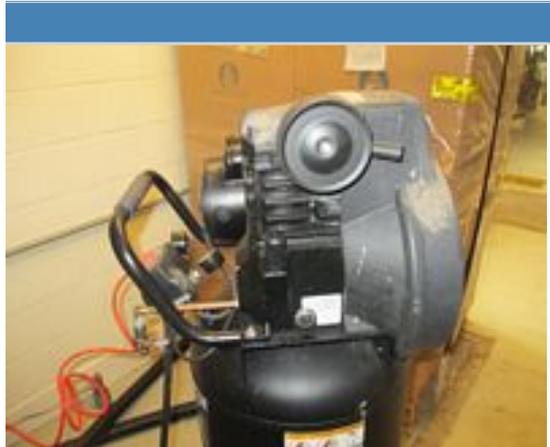
Asset Description	Plant Drain Air Compressor	System	Support Equipment
Asset Type	AIR COMPRESSOR	Location	Process Gallery
Asset ID	PD-PG-1AKB9	Inspection Date	4/5/2019
Comments		Flag

Question	Overriding?	Answer	NA	Flag	Answer Comment
Absence of Leaks		1 yes			
Acceptable Smell or Heat		1 yes			
Acceptable Vibration		1 yes			
All Components		1 yes			
Auto Bleed Valve			X	Non Existent	
Belt		2 Minor Wear			
Control Gauges (Hour Meters Volts & Amps)		2 Good			
Corrosion - Structural Metal Condition?		1 Like new			
Day Tank		1 Excellent			
Operating at Inspection		1 yes			
Structural Integrity		1 Excellent			
Tubing / Connections		2 Normal

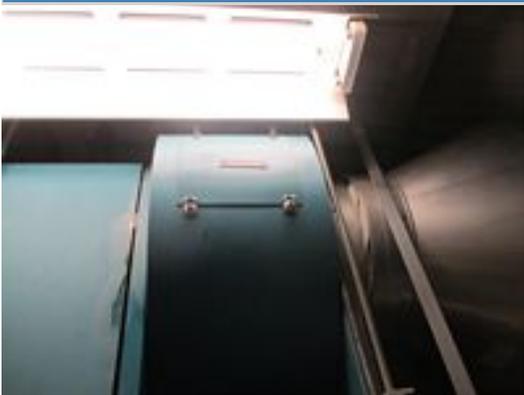
Asset Description	Process Gallery Exhaust fan #1	System	Support Equipment
Asset Type	FAN	Location	Process Gallery
Asset ID	PG-40-EF-01	Inspection Date	4/4/2019
Comments		Flag

Question	Overriding?	Answer	NA	Flag	Answer Comment
Acceptable Noise		1 yes			
Acceptable Oil/Grease		1 yes			
Acceptable Smell or Heat		1 yes			
Acceptable Vibration		1 yes			
All Components		1 yes			
All Safety Guards Present		1 yes			
Belt		2 Minor Wear			
Controls		1 Excellent			
Corrosion - Structural Metal Condition?		2 Minor corrosion			
Duct Work		1 Excellent			
Fan and Fan Motor		1 Excellent			
Installation/ Accessibility		1 Excellent			
Structural Integrity		1 Excellent			
Support		1 Excellent

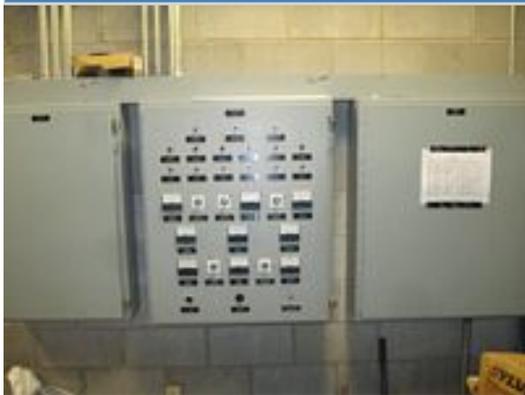
Asset Description	Galley Air Control Unit	System	Support Equipment
Asset Type	HVAC	Location	Process Gallery
Asset ID	PG-40-ACU-1	Inspection Date	4/4/2019
Comments		Flag

Question	Overriding?	Answer	NA	Flag	Answer Comment
Absence of Leaks		1 yes			
All Components		1 yes			
Corrosion		2 Minor			
Operating at Inspection		1 yes

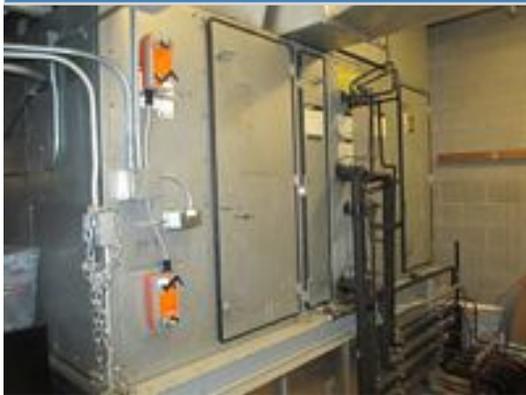
Asset Description	Gallery Air Supply Unit #1	System	Support Equipment
Asset Type	HVAC	Location	Process Gallery
Asset ID	PG-40-ASU-1	Inspection Date	4/4/2019
Comments		Flag

Question	Overriding?	Answer	NA	Flag	Answer Comment
Absence of Leaks		1 yes			
All Components		1 yes			
Corrosion		2 Minor			
Operating at Inspection		1 yes

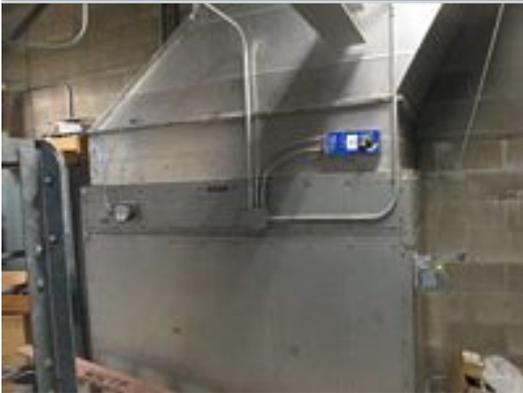
Asset Description	Gallery Air Supply Unit #2	System	Support Equipment
Asset Type	HVAC	Location	Process Gallery
Asset ID	PG-40-ASU-2	Inspection Date	4/4/2019
Comments		Flag

Question	Overriding?	Answer	NA	Flag	Answer Comment
Absence of Leaks		1 yes			
All Components		1 yes			
Corrosion		2 Minor			
Operating at Inspection		1 yes

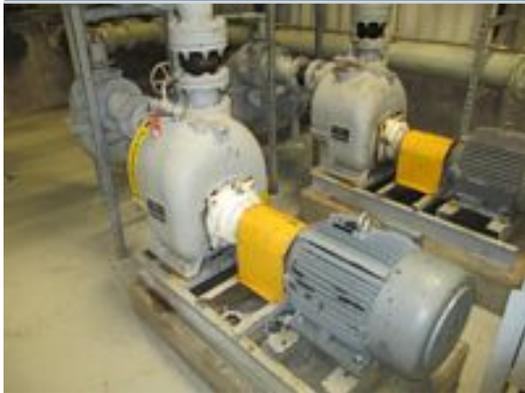
Asset Description	Plant Drain Pump #1	System	Support Equipment
Asset Type	PUMP CENT	Location	Process Gallery
Asset ID	PGB-P-45-2-1	Inspection Date	4/5/2019
Comments		Flag

Question	Overriding?	Answer	NA	Flag	Answer Comment
Absence of Leaks		1 yes			
Absence of Pump Cavitations		1 yes			
Acceptable Noise		1 yes			
All Safety Guards Present		1 yes			
Corrosion - Structural Metal Condition?		2 Minor corrosion			
Mounting		1 Excellent			
Vibration Analysis		2 -Good .039 - .15 inches/sec			0.12" / second

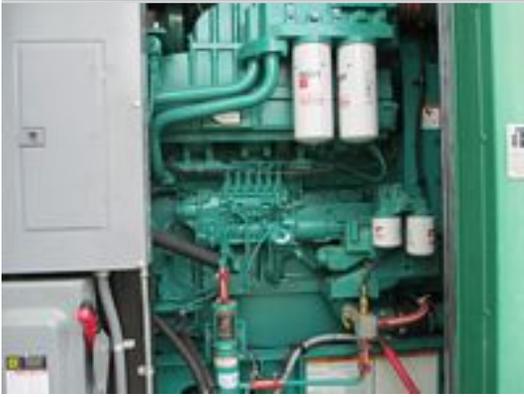
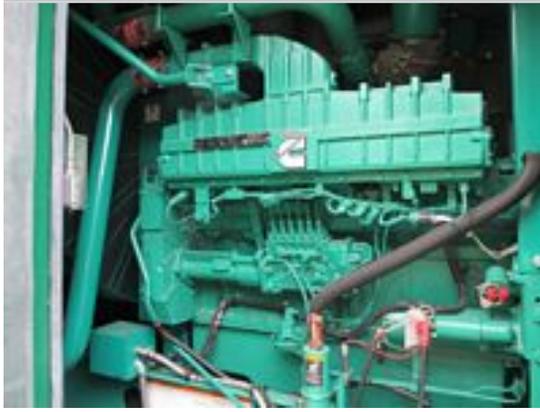
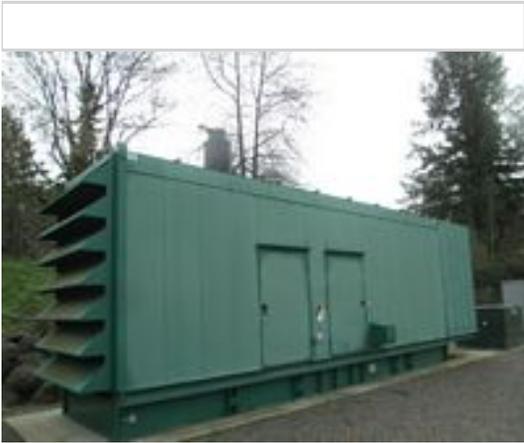
Question	Overriding?	Answer	NA	Flag	Answer Comment
Acceptable Noise		1 yes			
Acceptable Oil/Grease		1 yes			
Acceptable Smell or Heat		1 yes			
Acceptable Vibration		1 yes			
Air Filter		1 Excellent			
All Components		1 yes			
All Safety Guards Present		1 yes			
Automatic Transfer Switch		1 Excellent			
Battery/ Charging System		1 Excellent			
Control Gauges (Hour Meters Volts & Amps)		2 Good			
Control Switches		2 Good			
Cooling System		1 Proper Coolant Additives No Corrosion			
Corrosion - Structural Metal Condition?		1 Like new			
Exhaust System		1 Excellent			
Heater Jacket		1 Excellent			
Hoses and Belts		1 Excellent			
Monitoring Panel		1 Excellent			
Oil OK at Inspection					
Oil Pressure		1 Good			
Running at Inspection		1 yes			
Starting System		1 Proper Operation

Condition Category Incomplete

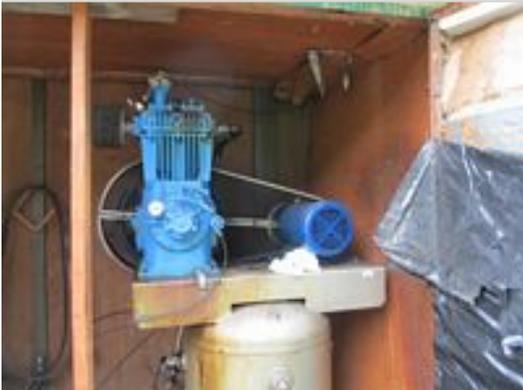
Asset Description	Plant Air compressor #1	System	Support Equipment
Asset Type	AIR COMPRESSOR	Location	Shop
Asset ID	SHOP-M-30-2-1	Inspection Date	4/4/2019
Comments	Compressor failed, hole in side of block due to failed connecting rod	Flag

Question	Overriding?	Answer	NA	Flag	Answer Comment
Absence of Leaks		5 no			
Acceptable Smell or Heat			X		
Acceptable Vibration			X		
All Components			X		
Auto Bleed Valve			X		
Belt			X		
Control Gauges (Hour Meters Volts & Amps)			X		
Corrosion - Structural Metal Condition?			X		
Day Tank			X		
Operating at Inspection			X		
Structural Integrity			X		
Tubing / Connections			X

Condition Category Very poor. Grade 5. Requires complete rehabilitation or replacement. Failed.

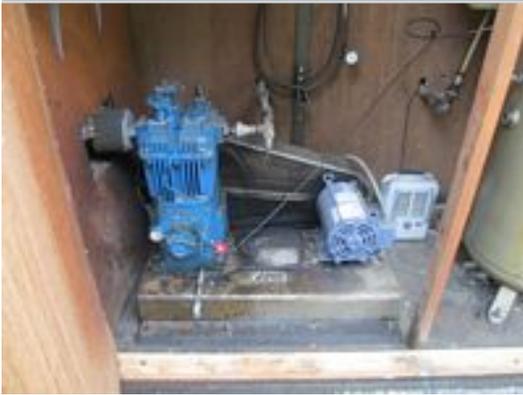
Asset Description	Plant Air Compressor #2	System	Support Equipment
Asset Type	AIR COMPRESSOR	Location	Shop
Asset ID	SHOP-M-30-2-2	Inspection Date	4/4/2019
Comments		Flag

Question	Overriding?	Answer	NA	Flag	Answer Comment
Absence of Leaks		5 no			Minor seepage
Acceptable Smell or Heat		1 yes			
Acceptable Vibration		1 yes			
All Components		1 yes			
Auto Bleed Valve		2 2			
Belt		2 Minor Wear			
Control Gauges (Hour Meters Volts & Amps)		2 Good			
Corrosion - Structural Metal Condition?		2 Minor corrosion			
Day Tank		1 Excellent			
Operating at Inspection		1 yes			
Structural Integrity		1 Excellent			
Tubing / Connections		2 Normal

Condition Category Good. Condition Grade 2. Minor wear.

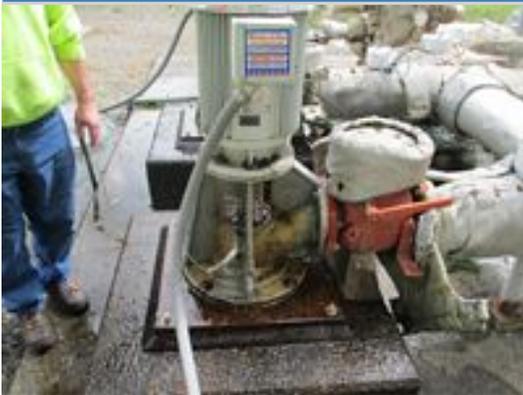
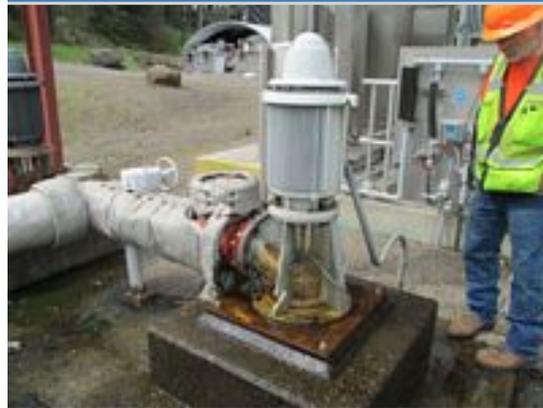
Question	Overriding?	Answer	NA	Flag	Answer Comment
Acceptable Noise		1 yes			
Acceptable Smell or Heat		5 no			Running warmer than normal
All Components		1 yes			
All Safety Guards Present		1 yes			
Bearings		2 Minor Wear			
Corrosion - Structural Metal Condition?		2 Minor corrosion			
Drive Shaft Alignment		1 Excellent			
Insulation Resistance	Yes		X	Not Evaluated	Monitored by VFD
Oil Level within Range			X	Non Existent	Greased bearings
Operating at Inspection		1 yes			
Structural Integrity		1 Excellent			
Vibration Analysis	Yes	2 2 -Good .039 - .15 inches/sec			0.08" / second

Condition Category Good. Condition Grade 2. Minor wear.

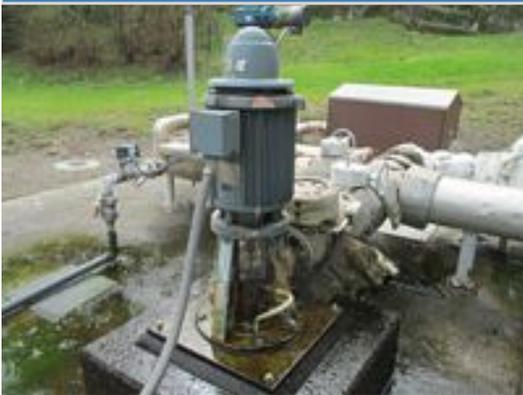
Asset Description	W-3 Pump #2 Motor	System	Support Equipment
Asset Type	MOTOR	Location	W-3 Reuse Station
Asset ID	W3-M-90-1-2	Inspection Date	4/2/2019
Comments		Flag

Question	Overriding?	Answer	NA	Flag	Answer Comment
Acceptable Noise		1 yes			
Acceptable Smell or Heat		5 no			Running warmer than normal
All Components		1 yes			
All Safety Guards Present		1 yes			
Bearings		2 Minor Wear			
Corrosion - Structural Metal Condition?		2 Minor corrosion			
Drive Shaft Alignment		1 Excellent			
Insulation Resistance	Yes		X	Not Evaluated	Monitored by VFD
Oil Level within Range			X	Non Existent	Greased bearings
Operating at Inspection		1 yes			
Structural Integrity		1 Excellent			
Vibration Analysis	Yes	2 -Good .039 - .15 inches/sec			0.10" / second

Condition Category Good. Condition Grade 2. Minor wear.

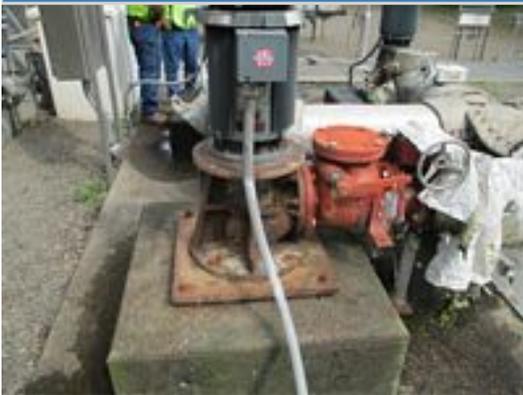
Asset Description	W-3 Pump #3 Motor	System	Support Equipment
Asset Type	MOTOR	Location	W-3 Reuse Station
Asset ID	W3-M-90-1-3	Inspection Date	4/2/2019
Comments		Flag

Question	Overriding?	Answer	NA	Flag	Answer Comment
Acceptable Noise		1 yes			
Acceptable Smell or Heat		5 no			Running warmer than normal
All Components		1 yes			
All Safety Guards Present		1 yes			
Bearings		2 Minor Wear			
Corrosion - Structural Metal Condition?		2 Minor corrosion			
Drive Shaft Alignment		1 Excellent			
Insulation Resistance	Yes		X	Not Evaluated	Monitored by VFD
Oil Level within Range			X	Non Existent	Greased bearings
Operating at Inspection		1 yes			
Structural Integrity		1 Excellent			
Vibration Analysis	Yes	2 -Good .039 - .15 inches/sec			0.06" / second

Condition Category Good. Condition Grade 2. Minor wear.

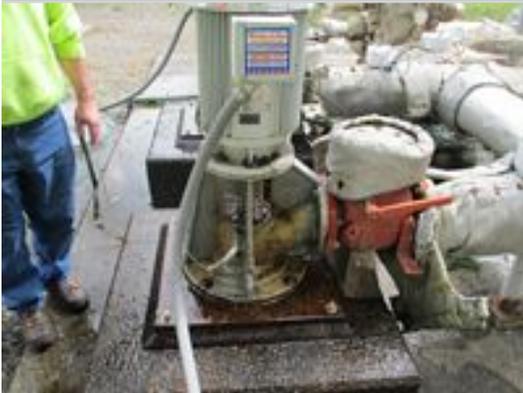
Question	Overriding?	Answer	NA	Flag	Answer Comment
Absence of Cavitation		1 yes			
Absence of Leaks		5 no			Leaking at packing
All Safety Features Present		1 yes			
Coating Condition		3 Moderate Defects			
Corrosion - Metal		2 Minor Corrosion			
Gallons per kW		1 At BEP			
Motor Coupling		2 Minor Wear But No Misalignment			
Packing Gland		3 Maintenance Overdue			
Vibration Analysis (0.10 in/sec)		1 Smooth, < 0.10 in/sec			0.08" / second

Condition Category Good. Condition Grade 2. Minor wear.

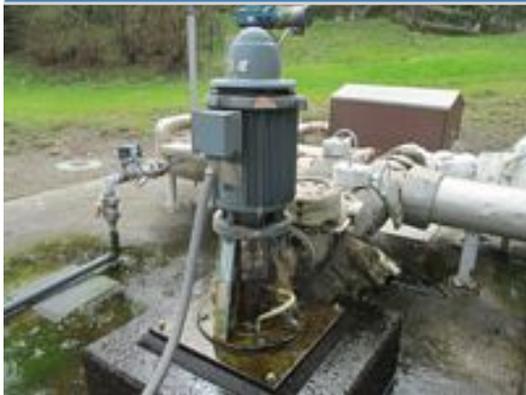
Asset Description	W-3 Pump #2	System	Support Equipment
Asset Type	PUMP-VERT TURBINE	Location	W-3 Reuse Station
Asset ID	W3-P-90-1-2	Inspection Date	4/2/2019
Comments		Flag

Question	Overriding?	Answer	NA	Flag	Answer Comment
Absence of Cavitation		1 yes			
Absence of Leaks		1 yes			
All Safety Features Present		1 yes			
Coating Condition		3 Moderate Defects			
Corrosion - Metal		2 Minor Corrosion			
Gallons per kW		1 At BEP			
Motor Coupling		2 Minor Wear But No Misalignment			
Packing Gland		4 Maintenance Required			
Vibration Analysis (0.10 in/sec)		2 Good, 0.10 - 0.20 in/sec			0.10" / second

Condition Category Good. Condition Grade 2. Minor wear.

Excessive leakage from packing area

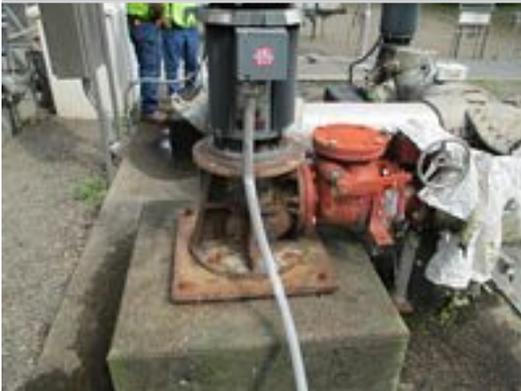
Asset Description	W-3 Pump #3	System	Support Equipment
Asset Type	PUMP-VERT TURBINE	Location	W-3 Reuse Station
Asset ID	W3-P-90-1-3	Inspection Date	4/2/2019
Comments		Flag

Question	Overriding?	Answer	NA	Flag	Answer Comment
Absence of Cavitation		1 yes			
Absence of Leaks		1 yes			
All Safety Features Present		1 yes			
Coating Condition		5 Complete Coating Failure			
Corrosion - Metal		4 Significant Metal Loss			
Gallons per kW		1 At BEP			
Motor Coupling		2 Minor Wear But No Misalignment			
Packing Gland		2 Normal			
Vibration Analysis (0.10 in/sec)		1 Smooth, < 0.10 in/sec			0.06" / second

Condition Category Good. Condition Grade 2. Minor wear.

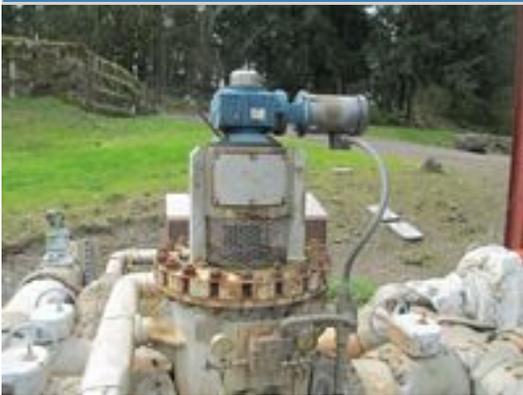
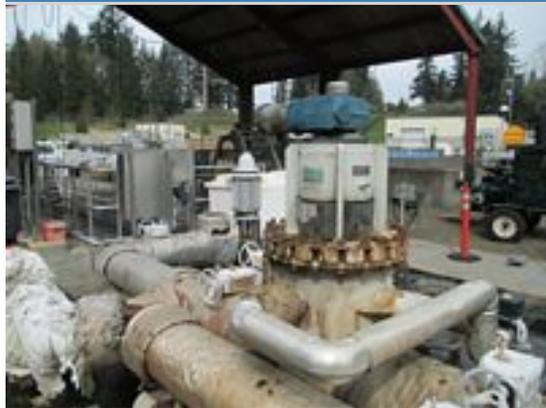
Asset Description **W-3 Strainer / Motor**

Question	Overriding?	Answer	NA	Flag	Answer Comment
Absence of Leaks		1 yes			
All Components		1 yes			
All Safety Features Present		1 yes			
Controls		1 Excellent			
Corrosion		3 Moderate			
Drive Motor		1 Excellent			
Gearbox		1 Excellent			
General Appearance		3 Maintenance Required			
Isolation Valves Operational		1 yes			
Lubrication		2 Normal			
Piping Condition		3 Slight Deterioration

Condition Category Good. Condition Grade 2. Minor wear.

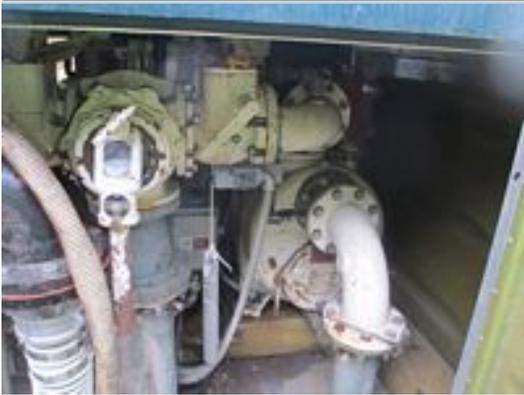
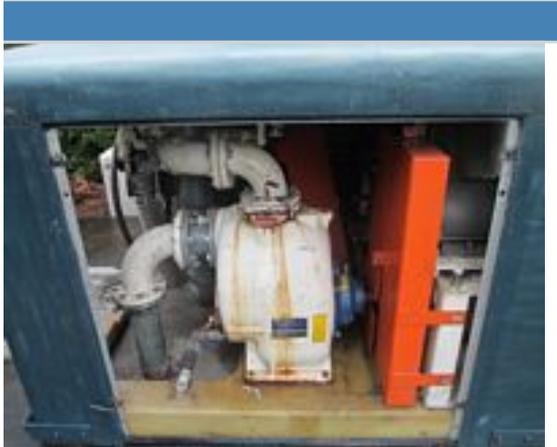
Asset Description	Town Center Lift Pump #1	System	Town Center LS
Asset Type	PUMP CENT	Location	Town Center Liftstation
Asset ID	TOWNCENTER-LS-02-P-1	Inspection Date	4/3/2019
Comments		Flag

Question	Overriding?	Answer	NA	Flag	Answer Comment
Absence of Leaks		1 yes			
Absence of Pump Cavitations		1 yes			
Acceptable Noise		1 yes			
All Safety Guards Present		1 yes			
Corrosion - Structural Metal Condition?		2 Minor corrosion			
Mounting		1 Excellent			
Vibration Analysis		2 -Good .039 - .15 inches/sec			0.10" / second

Condition Category Very good. Condition Grade 1. New or nearly new. Only normal maintenance required.

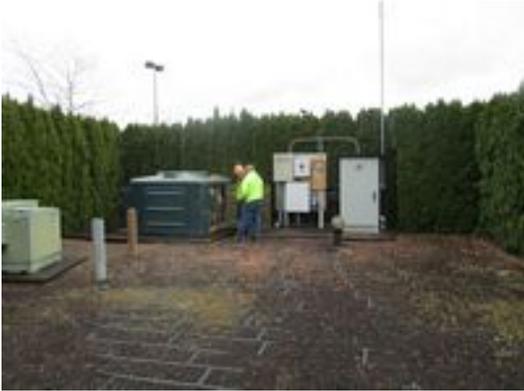
Condition Category Good. Condition Grade 2. Minor wear.
