# City of Wilsonville Triennial Inspection Report

Wilsonville WWTP and  
Wastewater Lift Stations:

Project Title: On-Call Civil Engineering and Related Services,  
Triennial Inspection of the Wilsonville WWTP and Nine Lift Stations

Subject: 2019 Triennial Inspection of the Wilsonville WWTP  
and Sewage Lift Stations

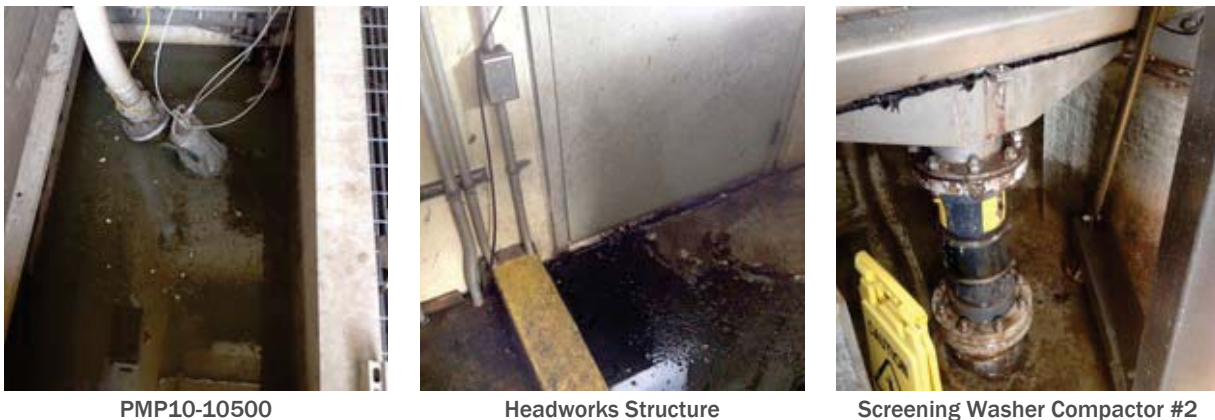
Figure 3-1. Area 10 Preliminary Treatment

Asset No.	Asset Name	Condition Score	Performance Score	Comments
10BLD-01	Headworks Structure	2	2	Water leakage
FV10-20101	Flow Valve 10-20101	1	1	No immediate action required
FV10-20102	Flow Valve 10-20102	1	1	No leaks observed
GCL10-31500	Grit Classifier 31500	2	1	Leakage from top cover
GTE10-12500	Influent Channel Gate #1	1	1	No immediate action required
GTE10-12501	Influent Channel Gate #2	1	1	Confirm asset number
GTE10-12502	Influent Channel Gate 12502	1	1	Confirm asset number
GTE10-12601	Screen Channel Inf Gate #1	1	1	No immediate action required
GTE10-12602	Screen Channel Inf Gate #2	1	1	No immediate action required

Table 3-1. Area 10 Headworks Equipment and Facilities				
Asset No.	Asset Name	Condition Score	Performance Score	Comments
GTE10-12603	Screen Channel Inf Gate #3	1	1	No immediate action required
GTE10-12701	Screen Channel Eff Gate #1	1	1	No immediate action required
GTE10-12702	Screen Channel Eff Gate #2	2	1	Channel seal collapsed
GTE10-12703	Screen Channel Eff Gate #3	2	1	Channel seal collapsed
GTE10-32101	Grit Basin Influent Gate	1	1	No immediate action required
GTE10-32102	Grit Basin Effluent Gate	2	1	Drive chain rusted and lacking lube
GTE10-32103	Grit Basin Bypass Gate	1	1	No immediate action required
GV10-19301	Influent Channel 1 Valve	1	1	No immediate action required
GV10-19302	Influent Channel 2 Valve	1	1	No immediate action required
GYC10-31100	Grit Cyclone 31100	2	1	Duct tape of effluent hose
MXR10-30100	Grit Basin Mixer	2	1	Some external coating missing, cover next to mixer missing
PMP10-10500	Vactor Sump Pump	4	5	Schedule corrective work action

PMP10-30500	Grit Pump 30500	1	1	No visible leaks, oil level good
SAM10-11000	Composite Sampler #1	2	1	Part of door seal is missing, cooling fan vents partially plugged
SCR10-13001	Manual Bar Screen	2	1	Unable to see
SCR10-13002	Influent Screen #2	2	1	Discharge chute boot cracking, appears to be leaking, channel seals collapsed
SCR10-13003	Influent Screen #3	2	1	Discharge chute boot cracking, no leakage observed, channel seals collapsed
SWC10-20501	Screenings Washer Compactor #1	2	1	Leaking oil between gearbox and auger
SWC10-20502	Screenings Washer Compactor #2	2	1	Leaking water from bottom inspection doors

In general, the Area 10 headworks equipment appeared to be in good working order. The items noted below do not currently impact the reliable operation for the facilities but, if left un-corrected, may result in a reduced equipment life expectancy and impact efficient operation of systems.

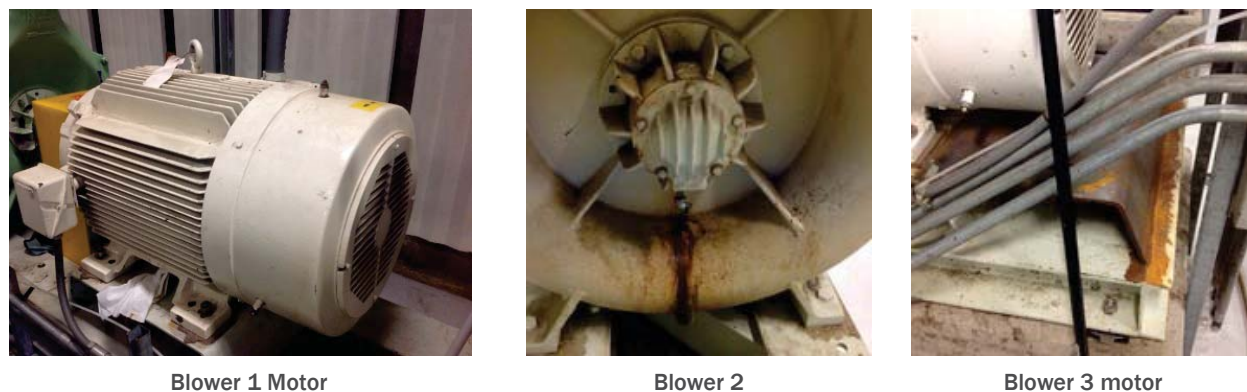
Figure 3-2. Area 40 Aeration Blowers

Table 3-3. Area 40 Process Gallery Equipment and Facilities				
Asset No.	Asset Name	Condition Score	Performance Score	Comments
PGB-M-40-5-1	Aeration Basin Blower #1	2	1	Excessive grease on outboard bearing or seal is leaking
PGB-M-40-5-1-M	Aeration Basin Blower Motor #1	2	1	No immediate action required
PGB-M-40-5-2	Aeration Basin Blower #2	2	1	Both bearings have excessive grease or seals are leaking
PGB-M-40-5-2-M	Aeration Basin Blower Motor #2	2	1	No immediate action required
PGB-M-40-5-3	Aeration Basin Blower #3	2	1	Outboard bearing seal appears to be starting to fail, grease leaking from discharge valve stem
PGB-M-40-5-3-M	Aeration Basin Blower Motor #3	2	1	Part of base has no coating

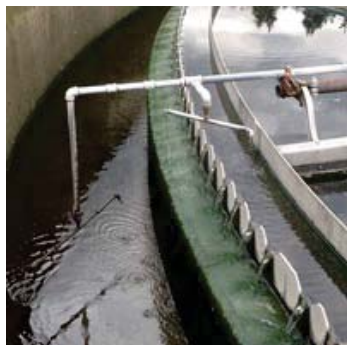
Secondary clarifier 1 weir washer

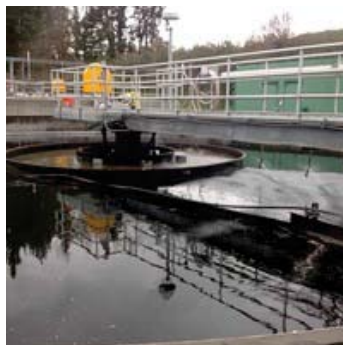
Secondary clarifier 1

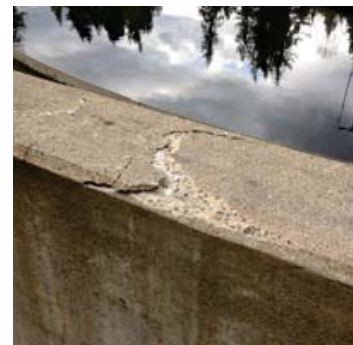
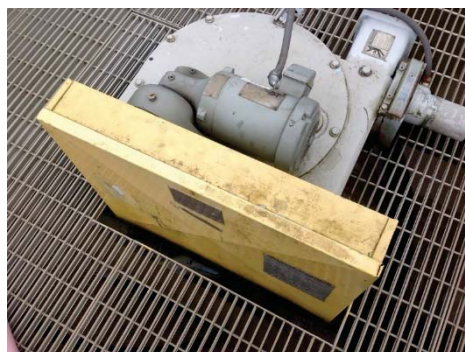
SC-M-50-1-2	Secondary Clarifier, #2 Mechanism	2	1	Middle gearbox appears to be leaking oil into the process, torque meter at 40

Secondary clarifier 2

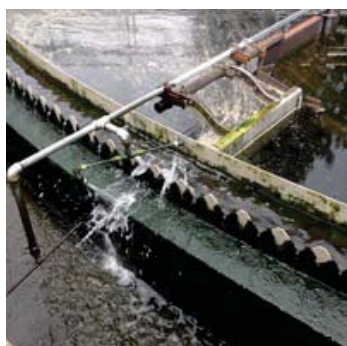
Secondary clarifier 2 weir washer

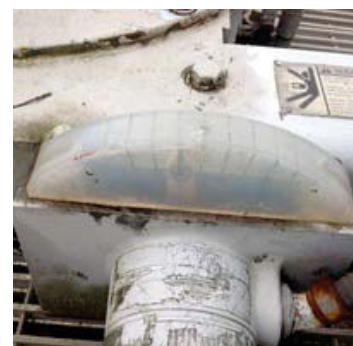
Secondary clarifier 2 torque meter

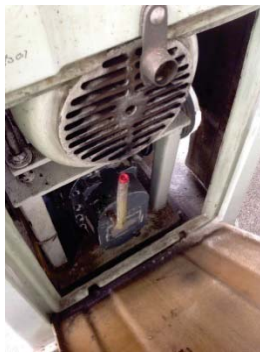
Biosolids storage blower 2

Table 3-11. Area 82 Biosolids Equipment				
Asset No.	Asset Name	Condition Score	Performance Score	Comments
BS-M-82-1-1	Biosolids Storage Blower #1	2	1	No immediate action required
BS-M-82-1-2	Biosolids Storage Blower #2	2	1	Slight oil leak
PMP82-10003	Vogelsang GBT Feed Pump #1	1	1	Grease or oil from motor area look like residue
PMP82-10004	Vogelsang GBT Feed Pump #2	2	1	Oil leaking from pump
PMP82-20001	Centrifuge Feed Pump #1	5	4	Appears that the pump experienced major process leak. Insulation would need to be removed to determine location of leak.
PMP82-20002	Centrifuge Feed Pump #2	2	1	Signs of minor oil leaks. Insulation would need to be removed to determine location of leak. Loose bolt on fan motor guard.

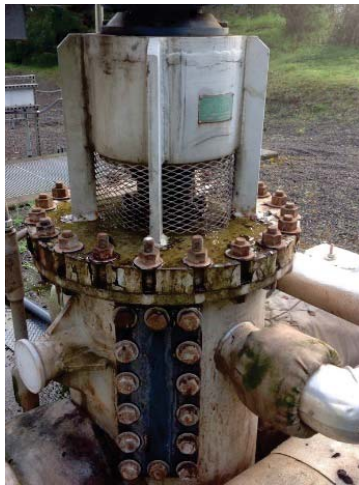
W-3 Strainer

Table 3-12. Area 90 W3 Reuse System Equipment				
Asset No.	Asset Name	Condition Score	Performance Score	Comments
W3-M-90-1	W-3 Strainer/Motor	3	1	Coating system failed, back flush water discharge line leaking
W3-M-90-1-1	W-3 Pump #1 Motor	2	1	No immediate action required
W3-M-90-1-2	W-3 Pump #2 Motor	2	1	No immediate action required
W3-M-90-1-3	W-3 Pump #3 Motor	2	1	No immediate action required
W3-P-90-1-1	W-3 Submersible Pump #1	3	2	Packing Water Leaking Excessively
W3-P-90-1-2	W-3 Submersible Pump #2	3	2	Coating system failed
W3-P-90-1-3	W-3 Submersible Pump #3	3	2	Coating system failed

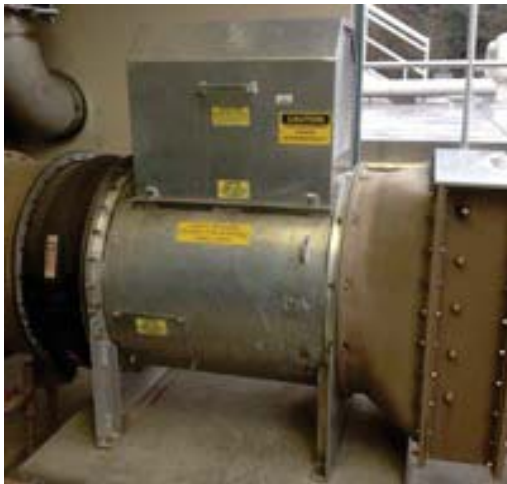
Aeration Basin Emergency Bypass Fan

Table 3-13. Area 91 Odor Control Equipment				
Asset No.	Asset Name	Condition Score	Performance Score	Comments
FAN91-10501	Odor Control Fan 1	2	1	Dripping oily substance from solids dryer, initiate more detailed inspection
FAN91-10502	Odor Control Fan 2	2	1	Dripping oily substance from solids dryer, initiate more detailed inspection, coating on sound enclosure has deteriorated
FAN91-30501	Aeration Basin Ex Fan 30501	2	1	No immediate action required
FAN91-30502	Aeration Basin Em Bypass Fan	2	2	Fan noise and vibrating

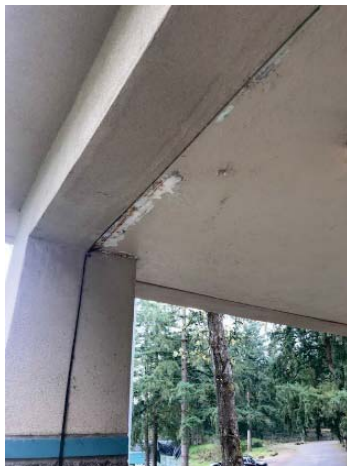
Operations Building ceiling

Table 3-14. Areas 95 Operations Building				
Asset No.	Asset Name	Condition Score	Performance Score	Comments
95BLD-01	Operations Building	3	1	<ul style="list-style-type: none"> <li>• Gutters are full</li> <li>• Stucco finish deteriorating at entrance</li> <li>• Floor tiles damaged</li> <li>• Stain on lab ceiling</li> <li>• Several pieces on baseboard in corners missing</li> <li>• Several window leaks in break area</li> <li>• No backflow device on hose bib in back of building</li> </ul>

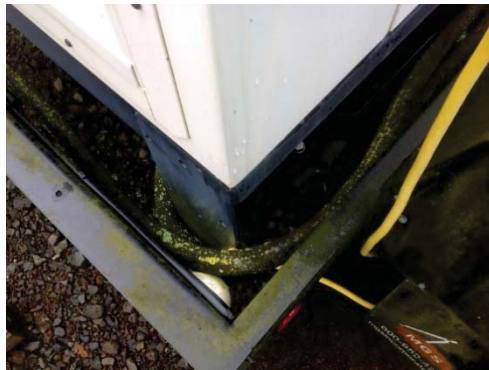
Generator CAT Olympian

Table 3-15. Areas 99 and 100 Backup Power Systems Equipment				
Asset No.	Asset Name	Condition Score	Performance Score	Comments
GEN99-01	1500kW Generator Set	2	1	Suppliers under generator enclosure
GEN-M-100-1	Plant Backup Generator (Large)	1	1	No immediate action required
GEN-M-100-3	Generator Cat Olympian	2	1	Moss growing on cable
GEN-M-100-4	Onan Portable Gas Generator	3	1	Coating system failing

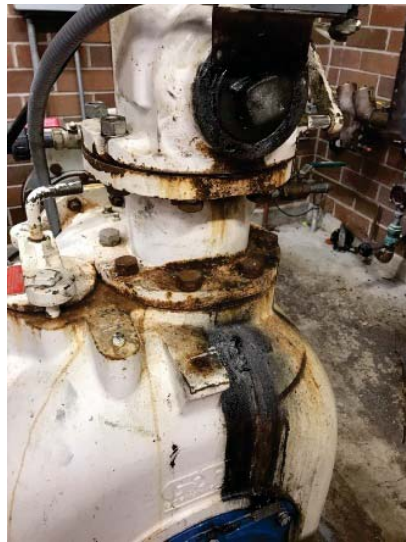
Table 4-1. Canyon Creek Lift Station				
Asset No.	Asset Name	Condition Score	Performance Score	Comments
CANC-LS-07	Canyon Creek Lift Station	2	1	<ul style="list-style-type: none"> <li>Housekeeping issues</li> <li>No back flow devices on hose bibs</li> <li>Roof insulation starting to fall down</li> <li>No confined space sign on wet well</li> <li>Check 120/208 volt transformer temperature</li> </ul>
CANC-LS-07-AUX	Canyon Creek Auxiliary Engine	3	1	<ul style="list-style-type: none"> <li>Corroded electrical terminals</li> <li>Battery held in place with wire ties and bailing wire</li> <li>No cover over battery posts</li> </ul>
CANC-LS-07-P-1	Canyon Creek Lift Pump #1	2	1	<ul style="list-style-type: none"> <li>Check valve inspection cover leaking</li> </ul>
CANC-LS-07-P-2	Canyon Creek Lift Pump #2	2	1	<ul style="list-style-type: none"> <li>Some rust on foundation</li> </ul>

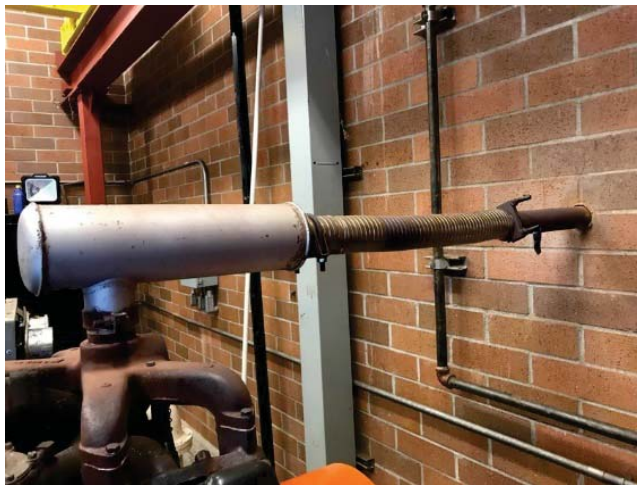
Auxiliary engine

Table 4-2. Charbonneau Lift Station				
Asset No.	Asset Name	Condition Score	Performance Score	Comments
CHAR-LS-01-AUX	Charbonneau Auxiliary Engine	2	1	<ul style="list-style-type: none"> <li>Slight oil leak from top of engine</li> <li>Battery has no cover over posts</li> <li>Gas line is not supported by engine</li> </ul>
CHAR-LS-01-P-1	Charbonneau Lift Pump #1	2	1	<ul style="list-style-type: none"> <li>Oil leaking from vent cap</li> <li>Oil is draining for floor drain</li> <li>Vent line held in place by bungee</li> </ul>
CHAR-LS-01-P-2	Charbonneau Lift Pump #2	2	2	<ul style="list-style-type: none"> <li>Oil leaking from vent cap</li> <li>Oil is draining for floor drain</li> </ul>

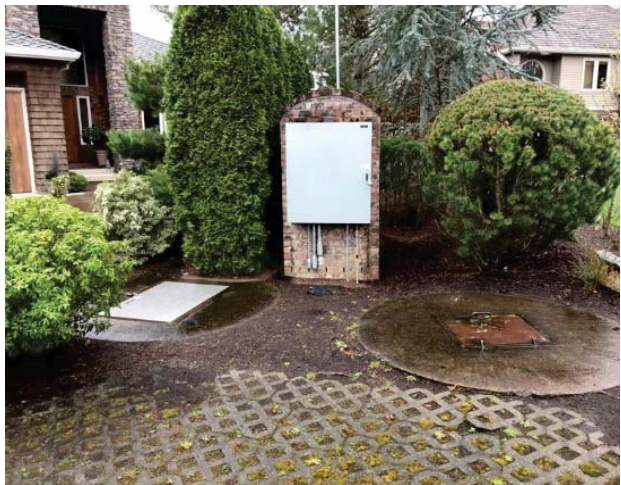
Lift station

Table 4-3. Corral Creek Lift Station				
Asset No.	Asset Name	Condition Score	Performance Score	Comments
CORC-LS-06	Corral Creek Lift Station	2	1	<ul style="list-style-type: none"> <li>• No fall protection on wet well</li> <li>• Large hole in power control structure where antenna wire passes</li> <li>• No cover over battery posts</li> <li>• Replacement fuses on dirt</li> <li>• Corrosion noted on bottom of control panel</li> <li>• No confined space sign on wet well</li> </ul>
CORCRK-LS-1	Corral Creek Lift Pump #1	2	1	Unable to inspect submersible pump
CORCRK-LS-2	Corral Creek Lift Pump #2	2	1	Unable to inspect submersible pump

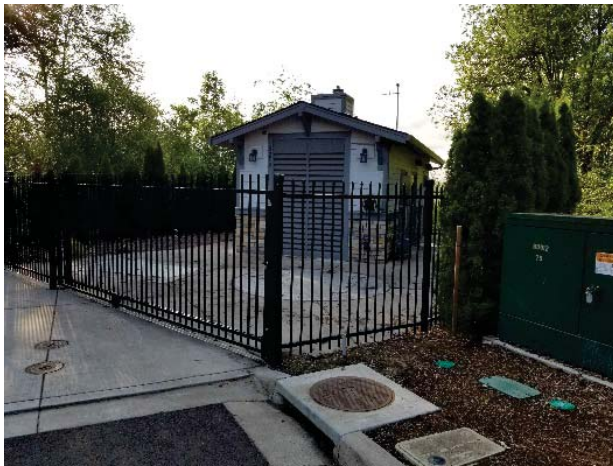
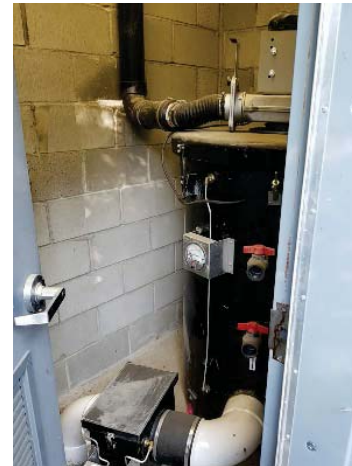
The Grande Pointe Lift station, shown in Figure 4-4, appeared to be in very good condition and required no immediate actions.

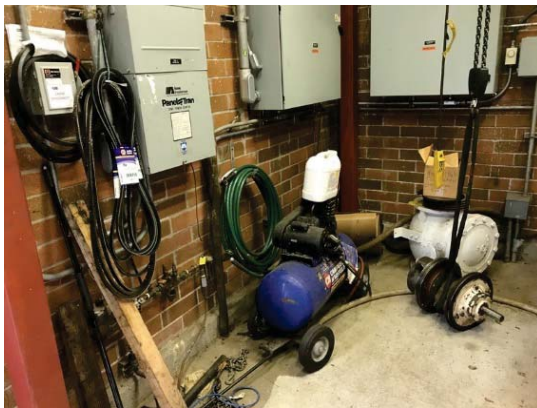
Interior

Table 4-5. Memorial Park Lift Station				
Asset No.	Asset Name	Condition Score	Performance Score	Comments
MEMP-LCP-03	Memorial Park Control Panel	1	1	<ul style="list-style-type: none"> <li>Material stored on top of panel should be removed</li> </ul>
MEMP-LS-03	Memorial Park Lift Station	2	1	<ul style="list-style-type: none"> <li>Housekeeping issues</li> <li>Cutting oil on top of 480 volt breaker panel</li> <li>Louvers to generator stuck open</li> <li>Belts hanging on crane disconnect</li> <li>New rotating unit stored on the floor connected to drain and is subject to pump vibration that could affect bearings</li> </ul>
MEMP-LS-03-AUX	Memorial Park Auxiliary Engine	2	1	<ul style="list-style-type: none"> <li>Cover needs to re-installed</li> </ul>
MEMP-LS-03-P-1	Memorial Park Lift Pump #1	2	1	<ul style="list-style-type: none"> <li>Vent line supported with wire and wrapped in tape</li> </ul>
MEMP-LS-03-P-2	Memorial Park Lift Pump #2	2	1	<ul style="list-style-type: none"> <li>Belt guard bracket has come loose or was not installed. It is laying next to pump.</li> </ul>

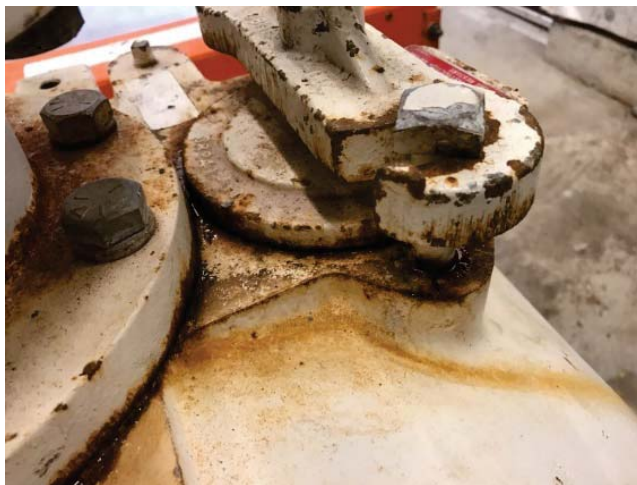
Table 4-6. Morey's Landing Lift Station				
Asset No.	Asset Name	Condition Score	Performance Score	Comments
MORL-LS-8	Morey's Landing Lift Station	2	1	<ul style="list-style-type: none"> <li>• Housekeeping issues</li> <li>• Junction box for pump and check valve instrumentation not in place</li> <li>• Insulation falling down</li> <li>• Plastic cover on ceiling is coming down</li> <li>• No confined space entry sign on wet well</li> <li>• Hose running from inside pump station to soaker system for trees</li> </ul>
MORL-LS-08-AUX	Morey's Landing Auxiliary Engine	3	1	<ul style="list-style-type: none"> <li>• Electrical connections corroded</li> <li>• Battery not tied down</li> <li>• No cover over battery posts</li> <li>• Frame corroded</li> <li>• Gas line not supported well</li> </ul>
MORL-LS-08-P1	Morey's Landing Lift Pump #1	3	1	<ul style="list-style-type: none"> <li>• Pump mounting frame corroded</li> <li>• Leak on inspection cover</li> </ul>

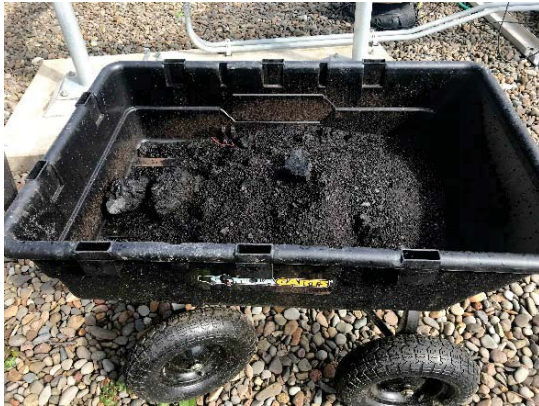
Overall, the plant appears to be in good condition, which should be expected given the age of some of the equipment. As described in Section 3.9, there have been operational problems with the biosolids drying system and associated odor control system that are of concern.

The photos in Figure 5-1 show burnt solids that appear to be from a dryer fire and oily residue leaking from one of the two odor control fans

Burnt Solids

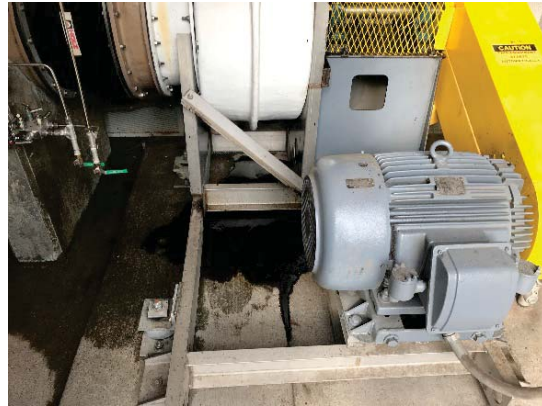
Oily residue at odor control fan

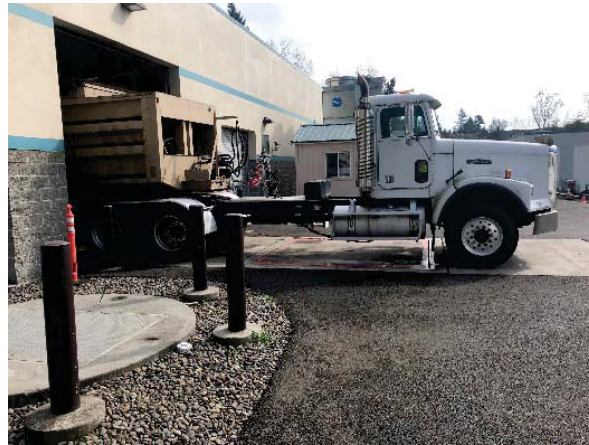
Figure 5-2. Dried Product Loadout

The truck loadout is another potential odor and dust source. Fugitive odors and dust are a concern with the roll-up door open during loading operations as shown in Figure 5-2.

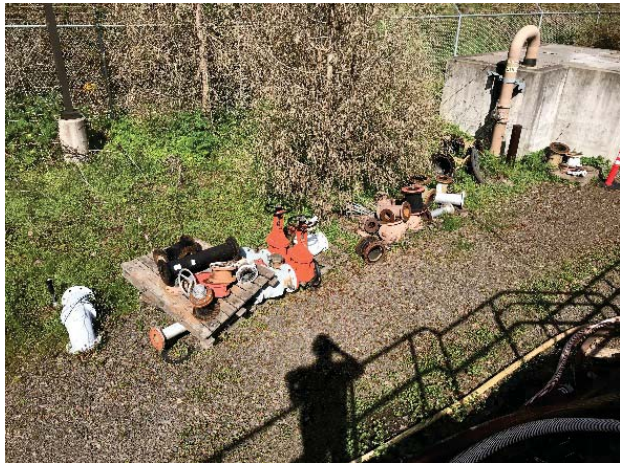
A final issue of note is general housekeeping. Figure 5-3 shows storage of materials and equipment outside or in temporary facilities.

Outside storage

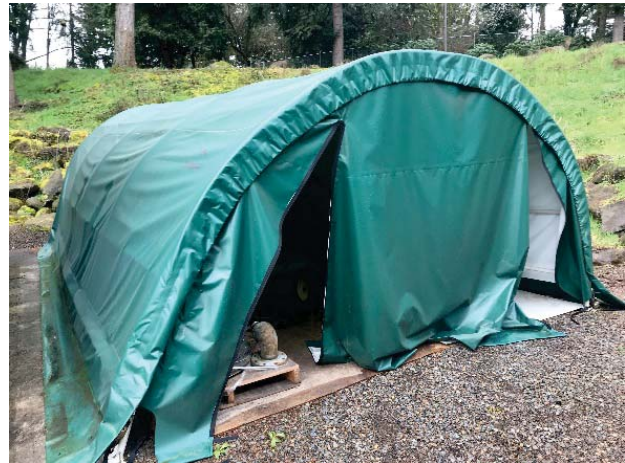
Temporary storage facilities

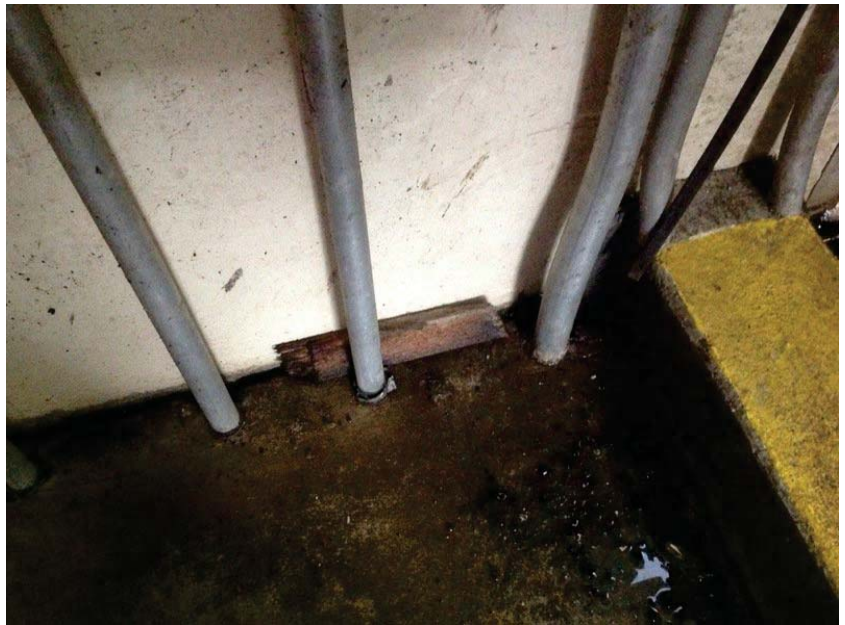
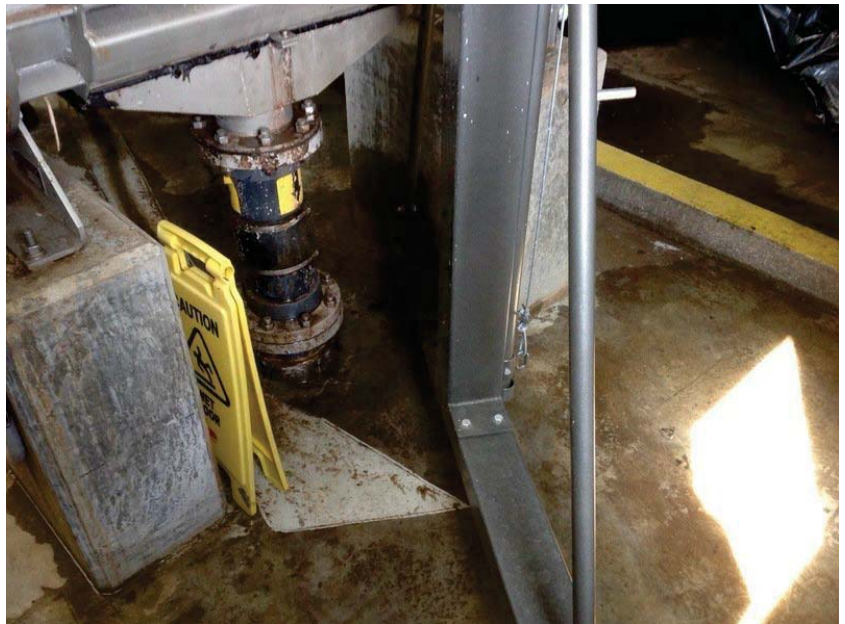
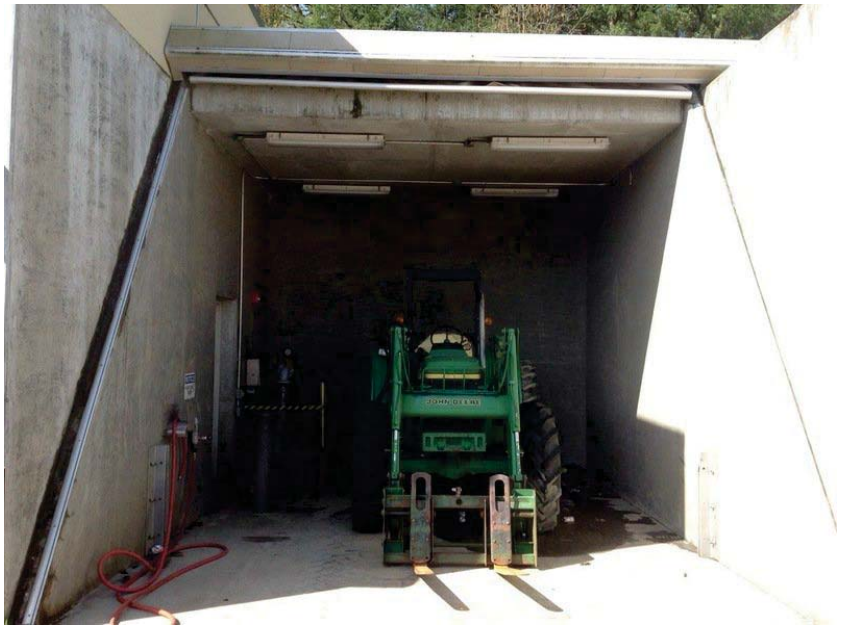
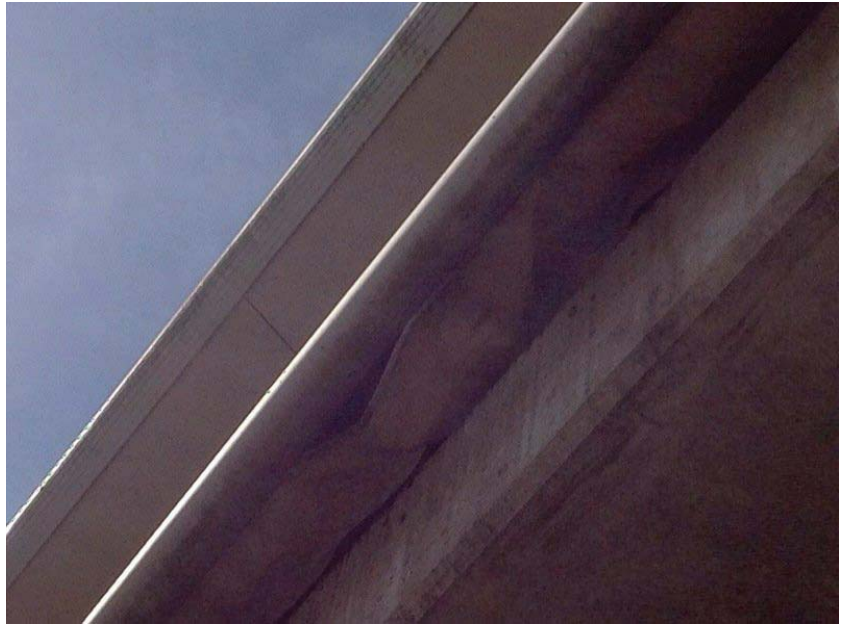
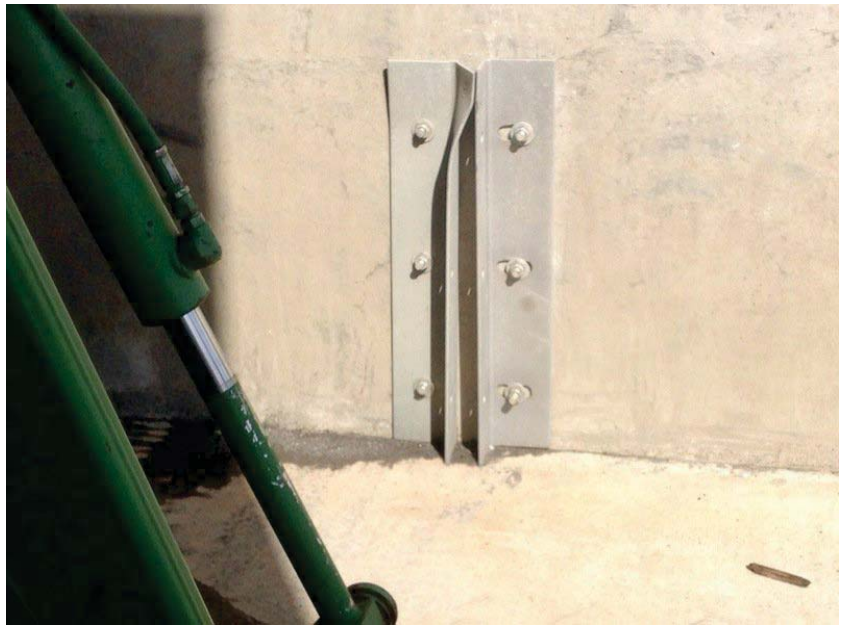
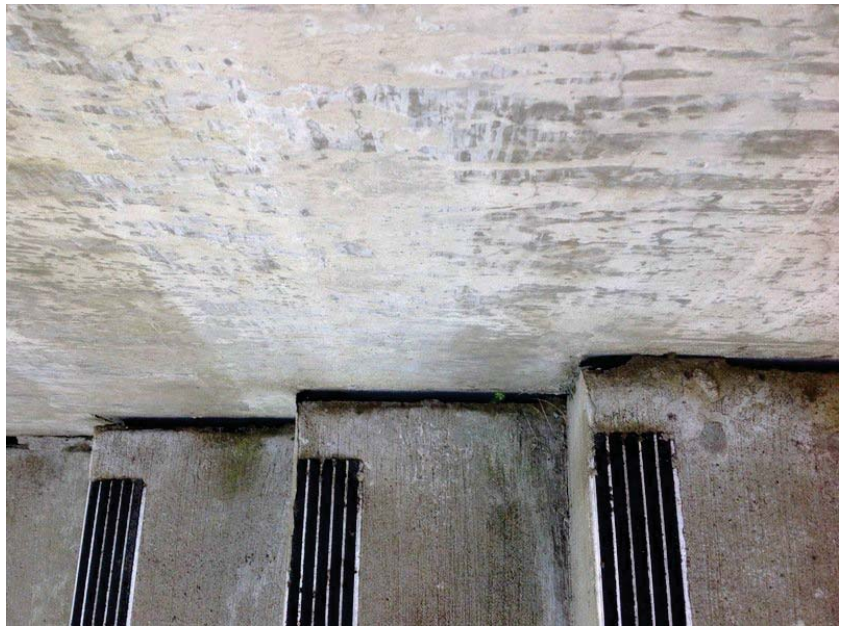
Field Observations	Leaking
Condition Score	2 - Slight Visible Degradation
Performance Score	2 - In Service, but higher than Expected O&M
Recommendation	Schedule corrective action work order near term
Field Observations/Comments	Water leaking in under door by grit bin Joint compound is missing in several areas or the joints have become bigger and the compound no longer covers the joint

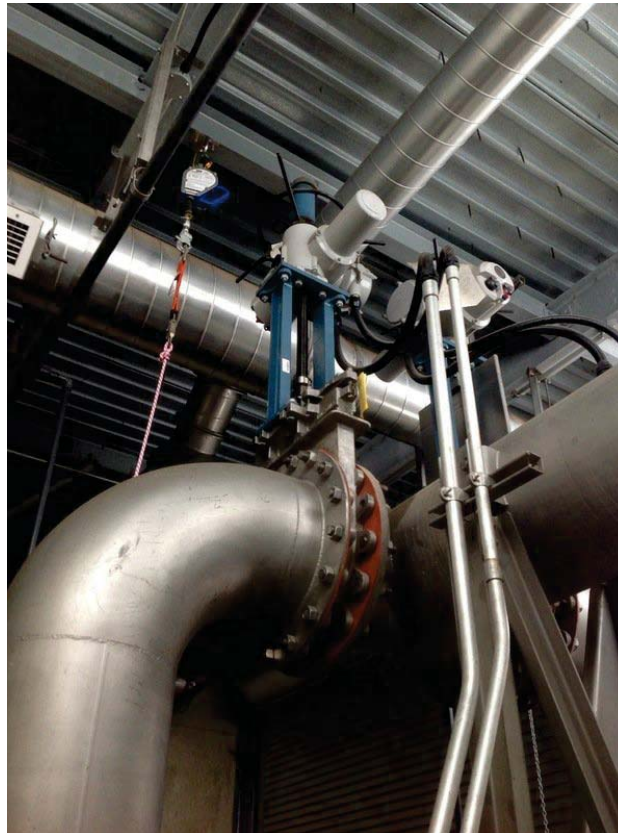
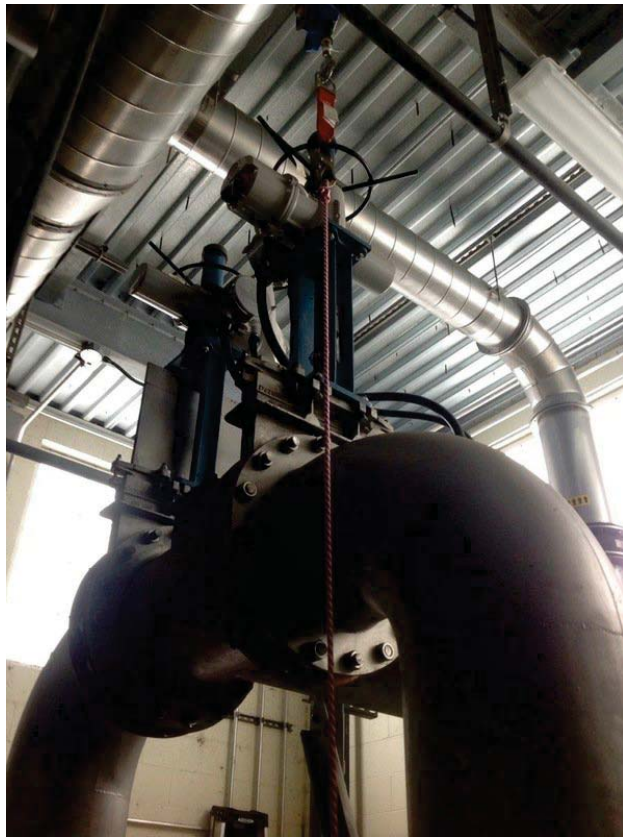
Field Observations	Good condition
Condition Score	1 - Excellent
Performance Score	1 - Component Functioning as Intended
Recommendation	No immediate action required
Field Observations/Comments	Knife gate closed No leaks

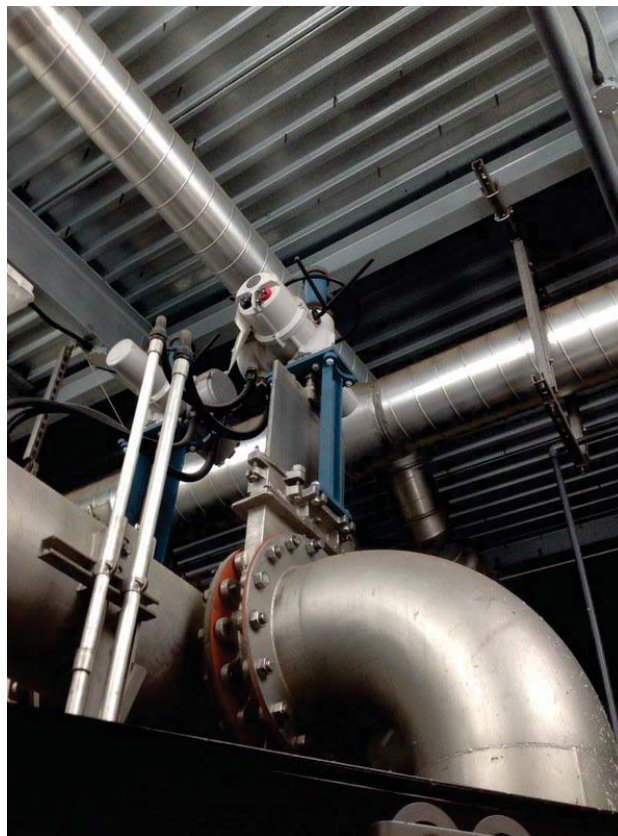
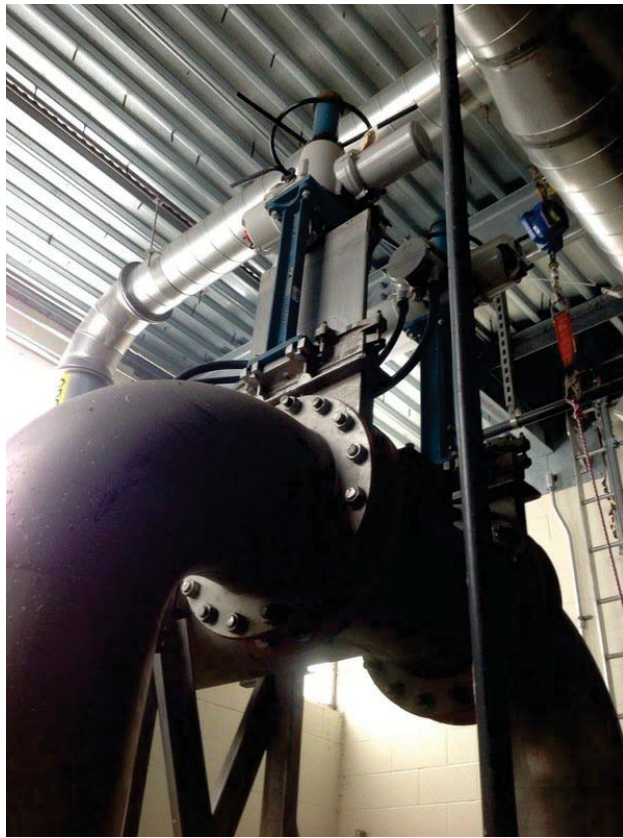
Field Observation	Good Condition
Condition Score	1 - Excellent
Performance Score	1 - Component Functioning as Intended
Reliability Assessment	No Significant Attention Required
Field Observation Comments	Knife gate open No leaks

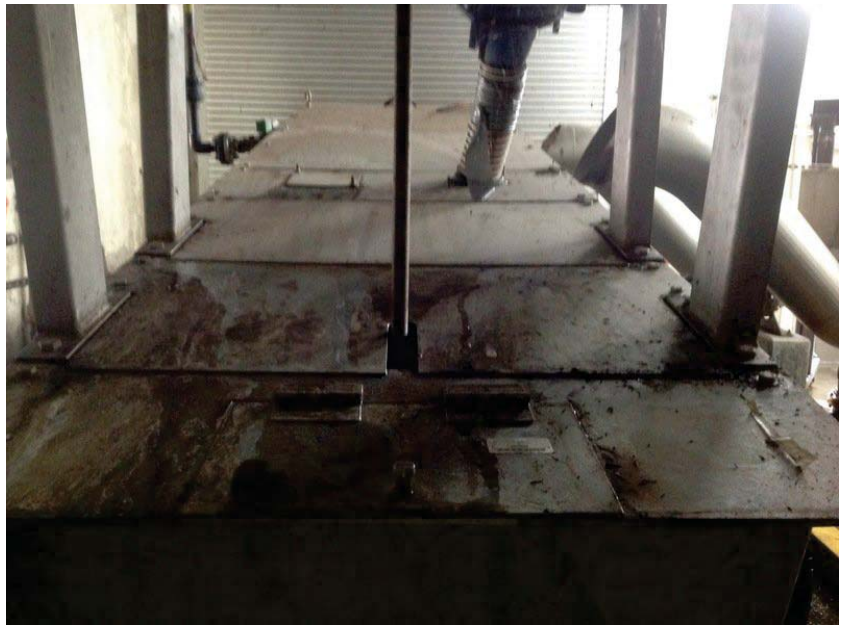
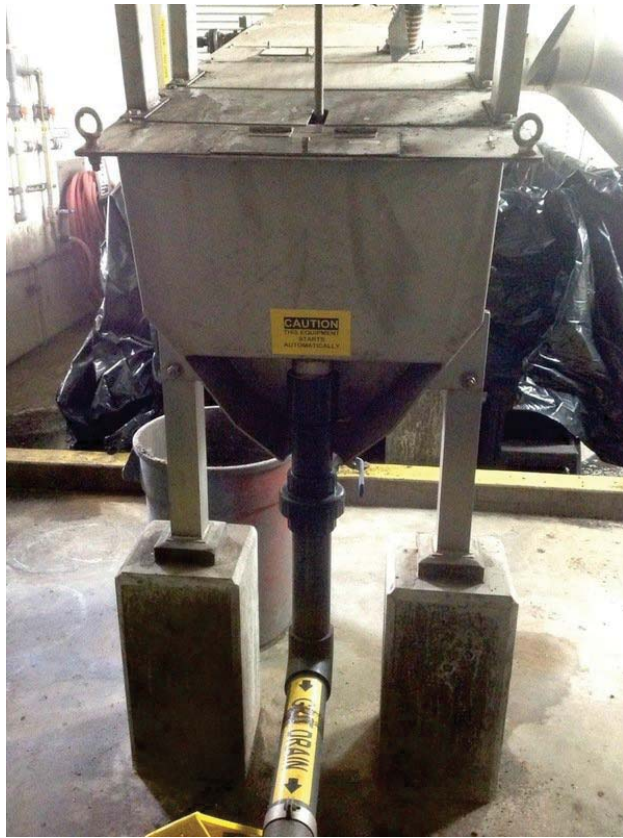
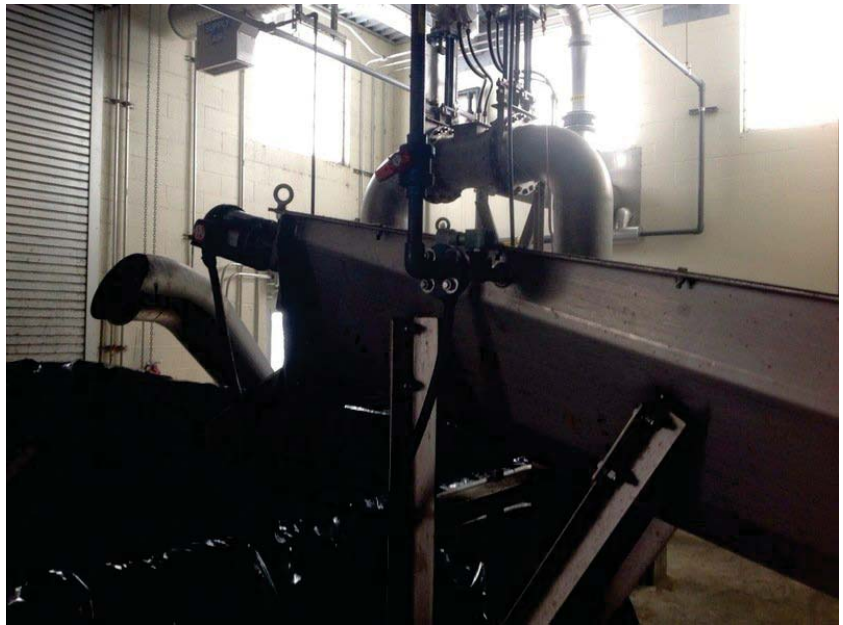
Field Observations	Leaking
Condition Score	2 - Slight Visible Degradation
Performance Score	1 - Component Functioning as Intended
Recommendation	Schedule corrective action work order near term
Field Observations/Comments	Not in operation during site visit Some water leaking out of top inspection cover

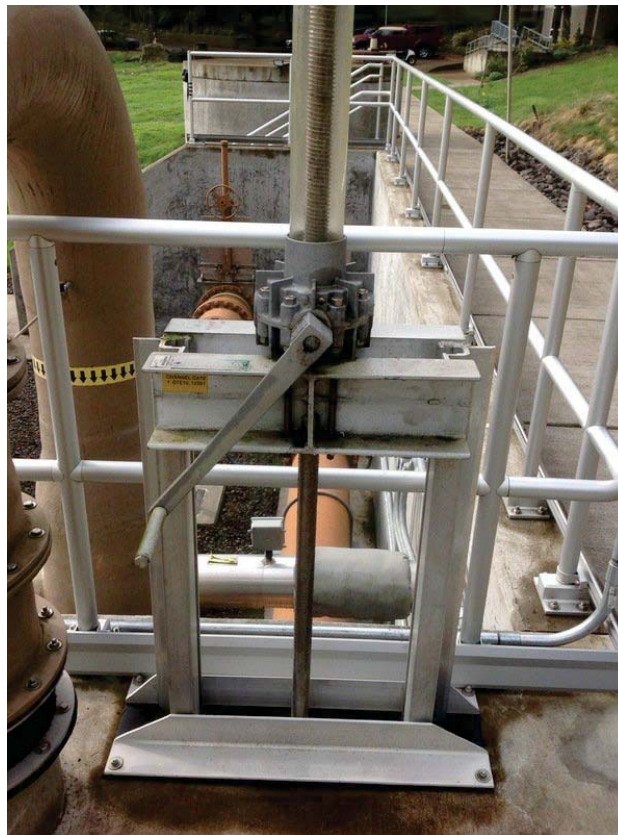
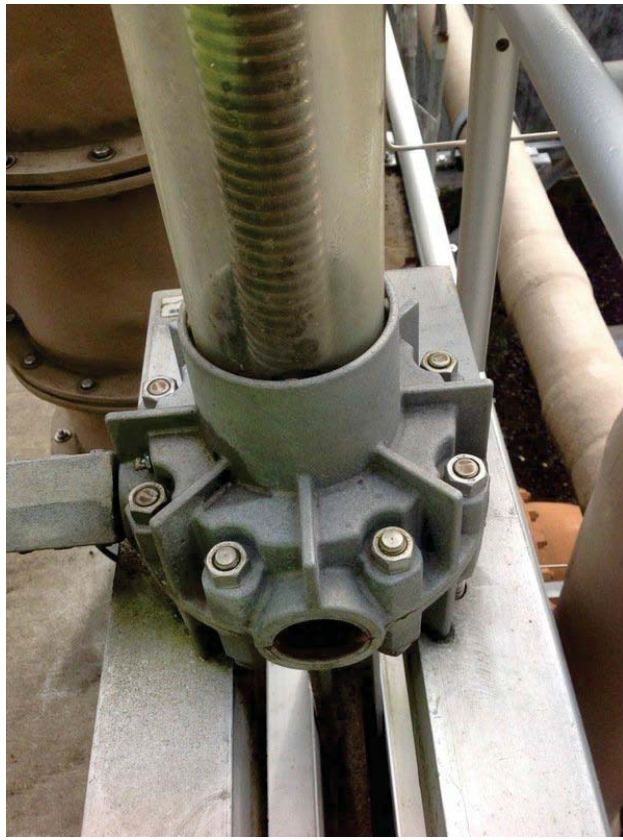
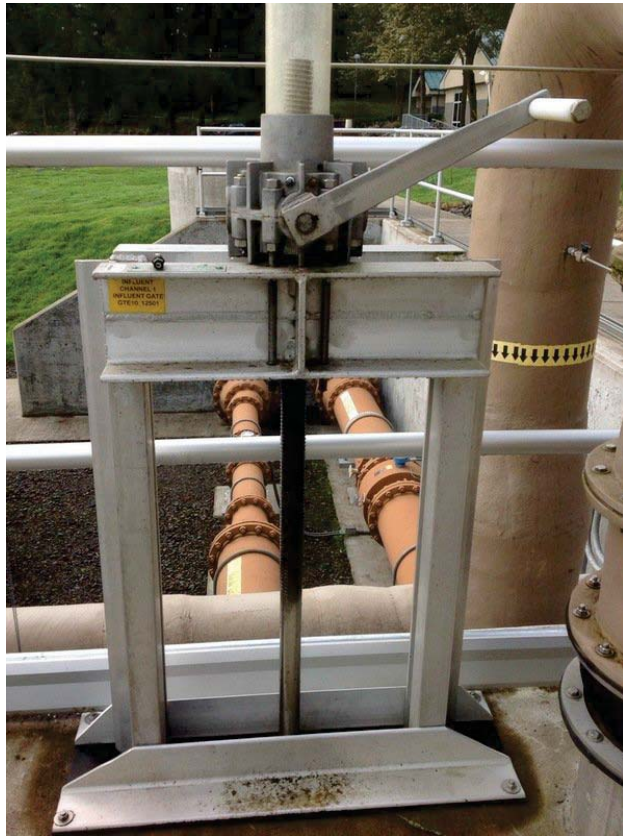
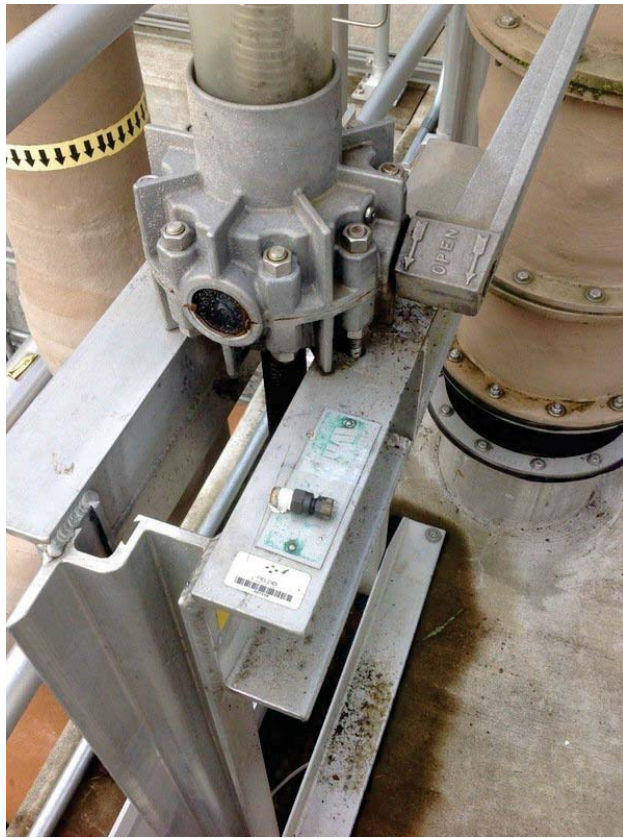
Field Observations	Good condition
Condition Score	1 - Excellent
Performance Score	1 - Component Functioning as Intended
Recommendation	No immediate action required
Field Observations/Comments	Influent Channel Gate open Influent Channel 1 influent gate closed Botha have same asset number

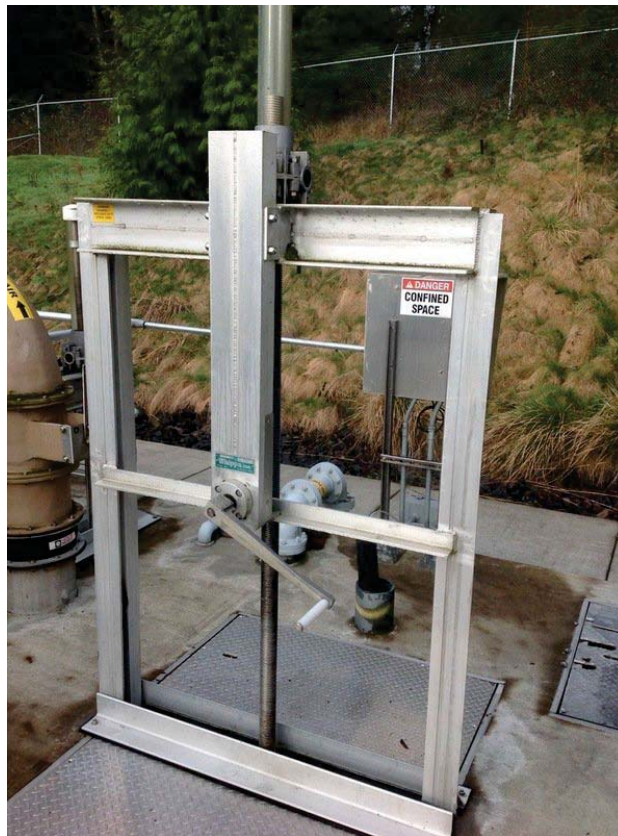
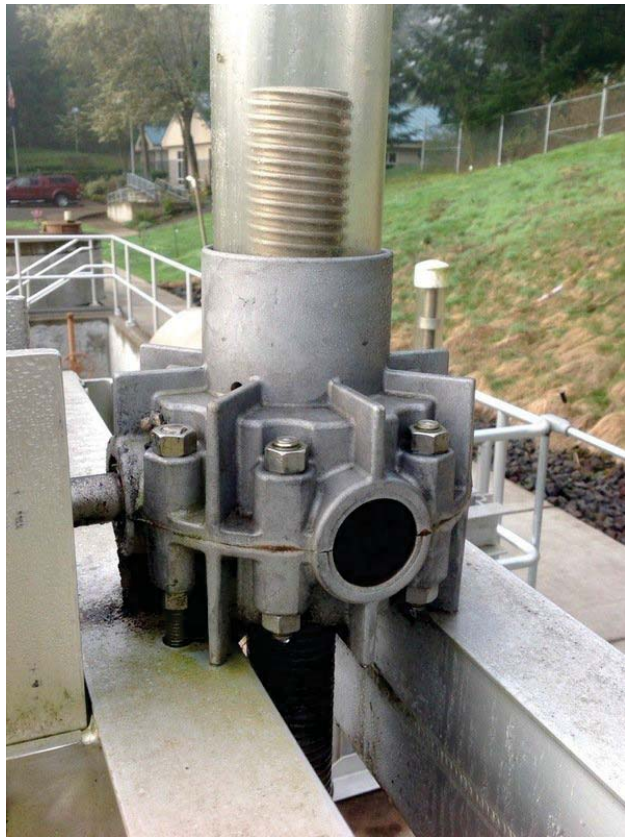
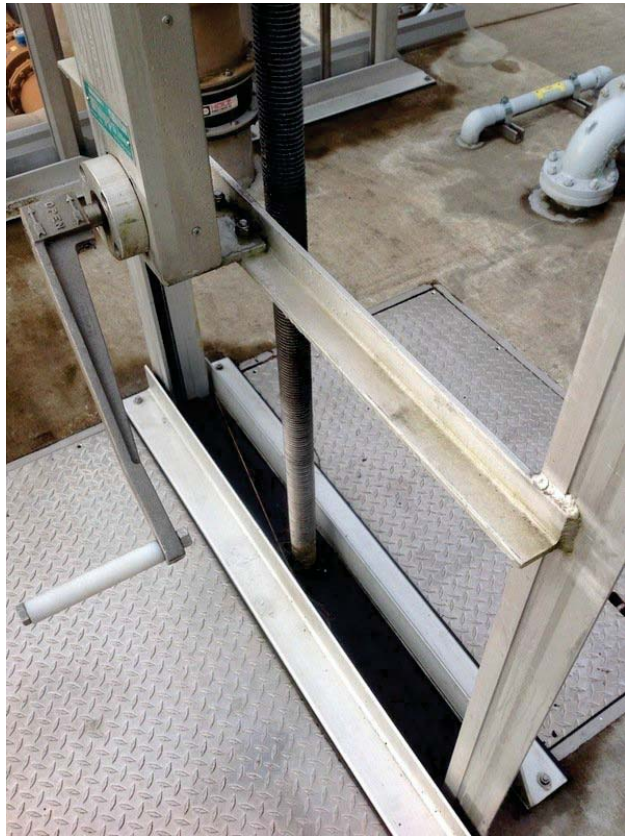
Field Observations	Good condition
Condition Score	1 - Excellent
Performance Score	1 - Component Functioning as Intended
Recommendation	No immediate action required
Field Observations/Comments	Gate in closed position

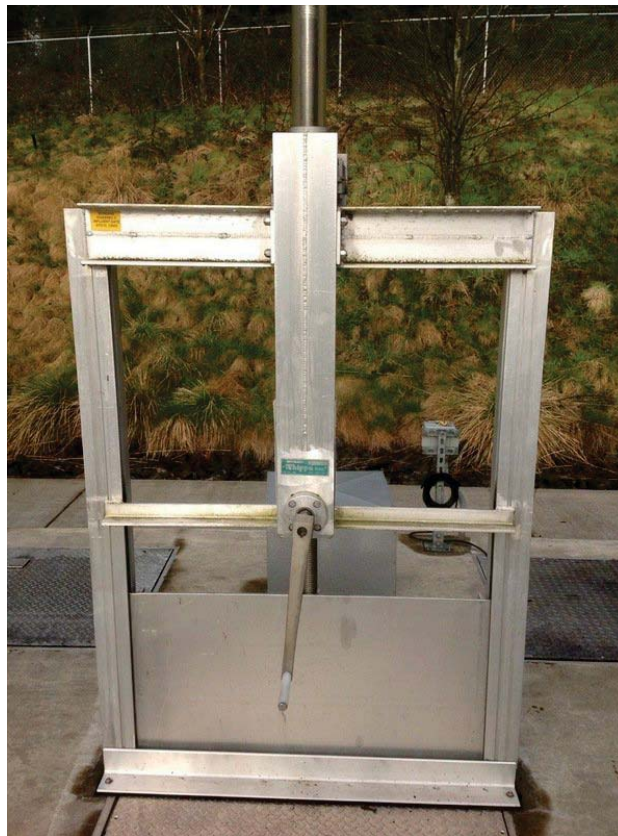
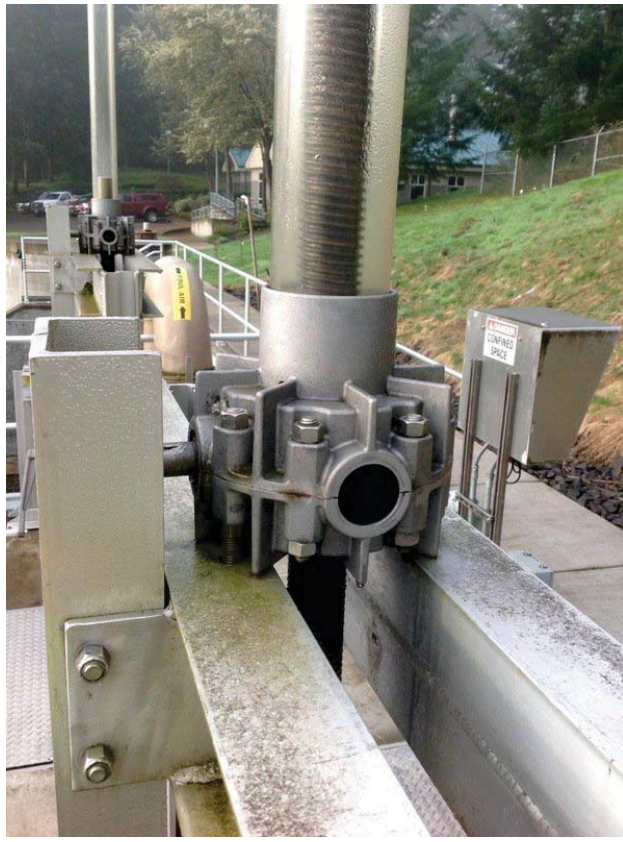
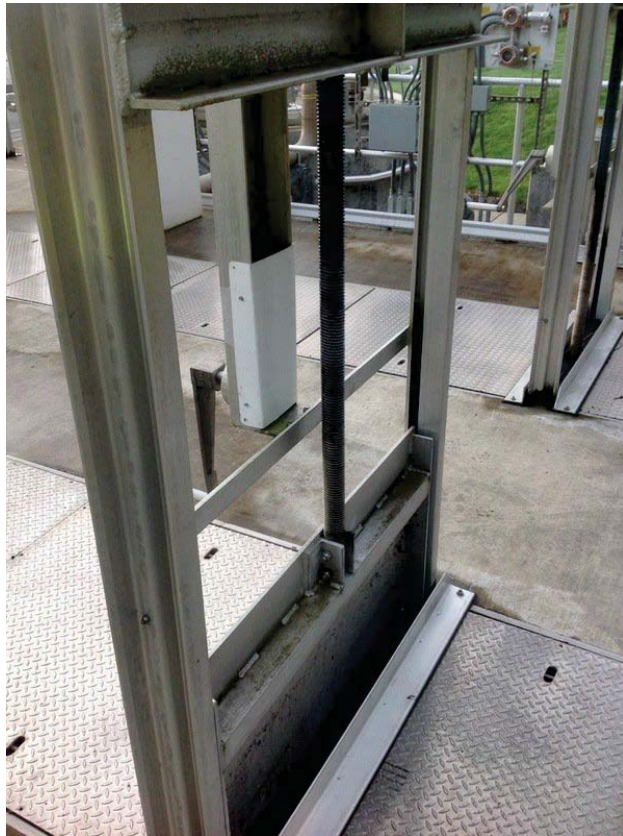
Field Observations	Good condition
Condition Score	1 - Excellent
Performance Score	1 - Component Functioning as Intended
Recommendation	No immediate action required
Field Observations/Comments	Gate in open position
