# City of Wilsonville Triennial Inspection Report

Wilsonville WWTP and  
Wastewater Lift Stations:

Project Title: On-Call Civil Engineering and Related Services,  
Triennial Inspection of the Wilsonville WWTP and Nine Lift Stations

Subject: 2019 Triennial Inspection of the Wilsonville WWTP  
and Sewage Lift Stations

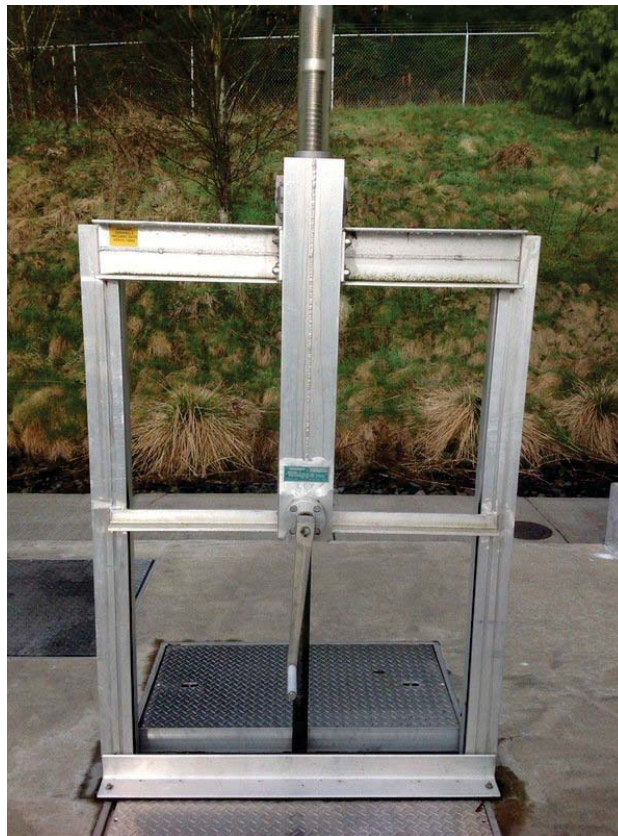
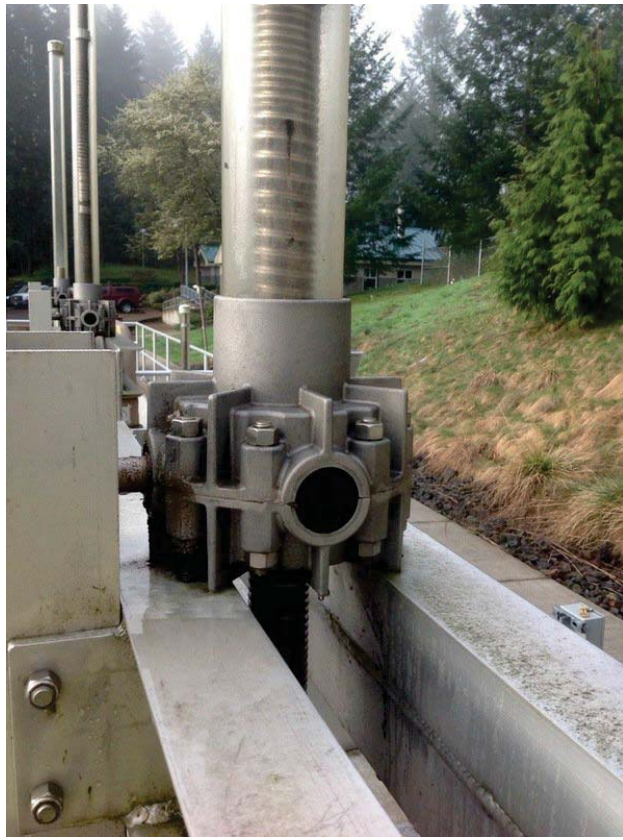
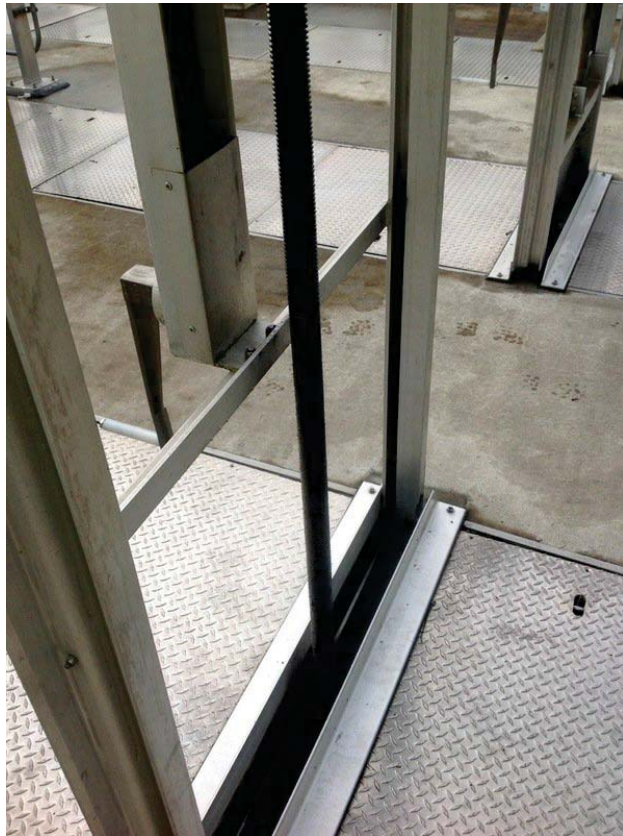
Field Observations	Good condition
Condition Score	1 - Excellent
Performance Score	1 - Component Functioning as Intended
Recommendation	No immediate action required
Field Observations/Comments	Gate partially open

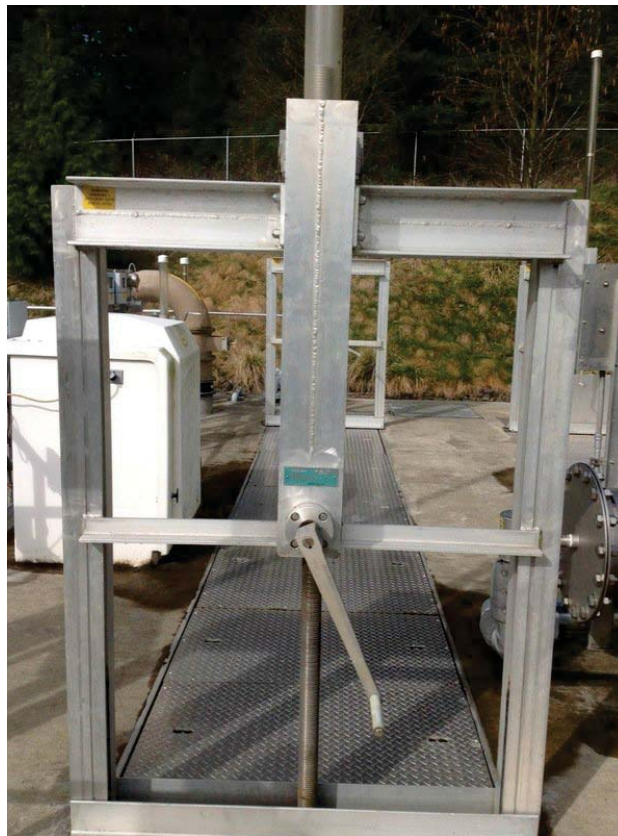
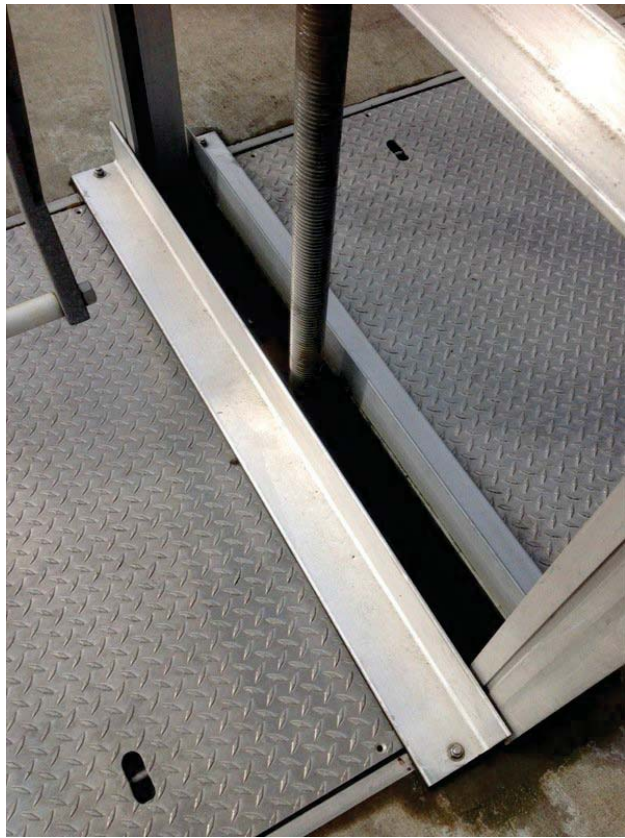
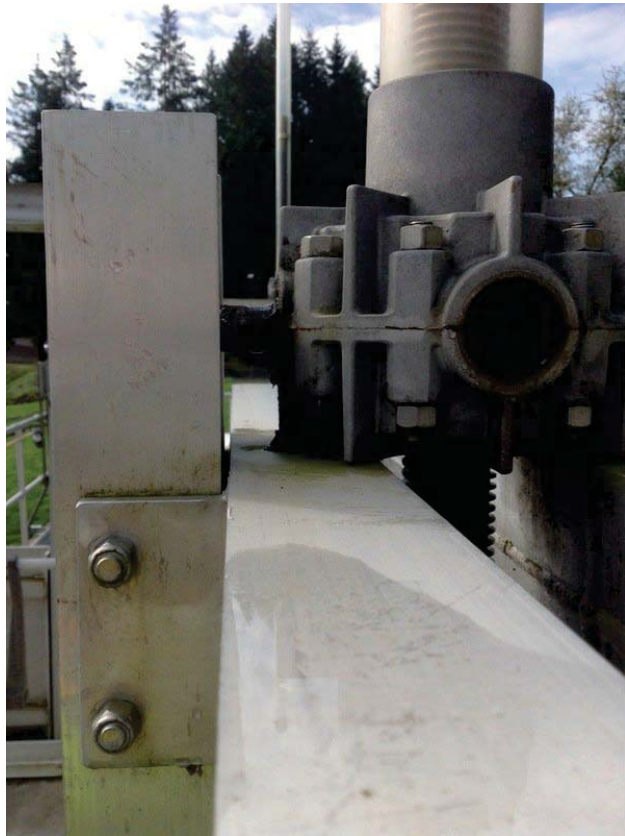
Field Observations	Good condition
Condition Score	1 - Excellent
Performance Score	1 - Component Functioning as Intended
Recommendation	No immediate action required
Field Observations/Comments	Gate closed

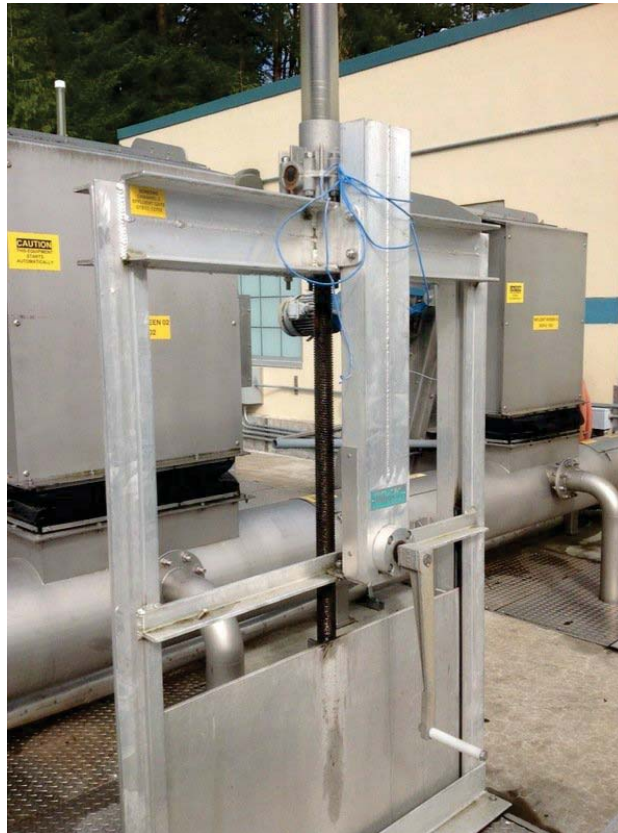
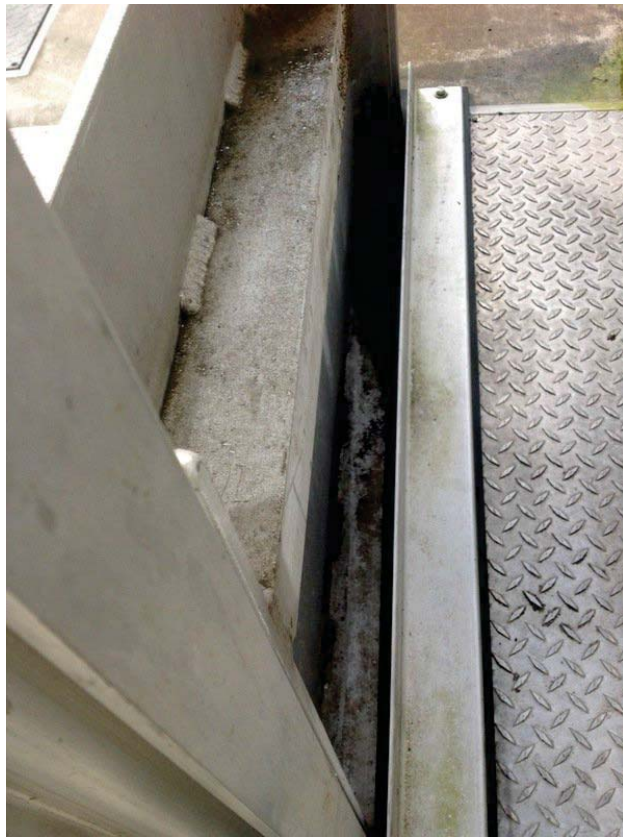
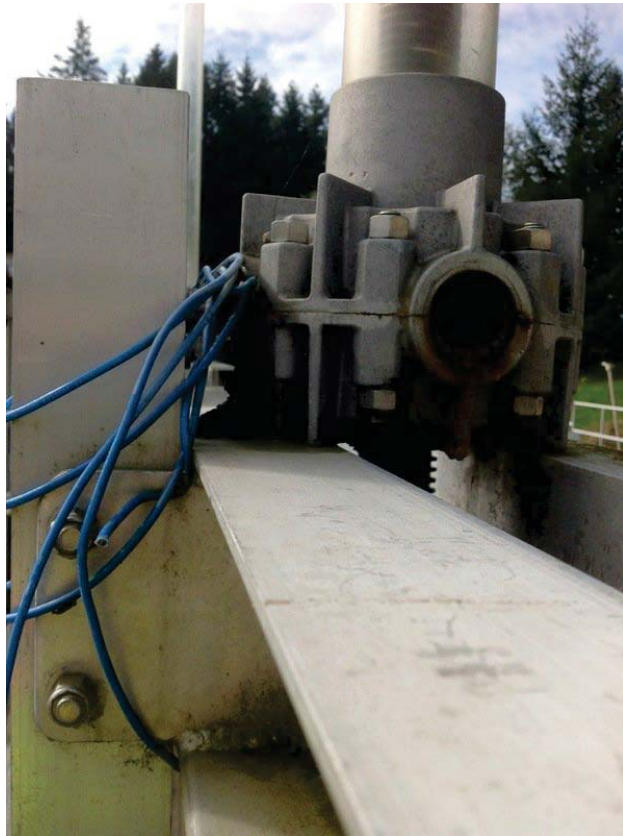
Field Observations	Good condition
Condition Score	2 - Slight Visible Degradation
Performance Score	1 - Component Functioning as Intended
Recommendation	Schedule corrective action work order near term
Field Observations/Comments	Gate open Channel seal collapsed

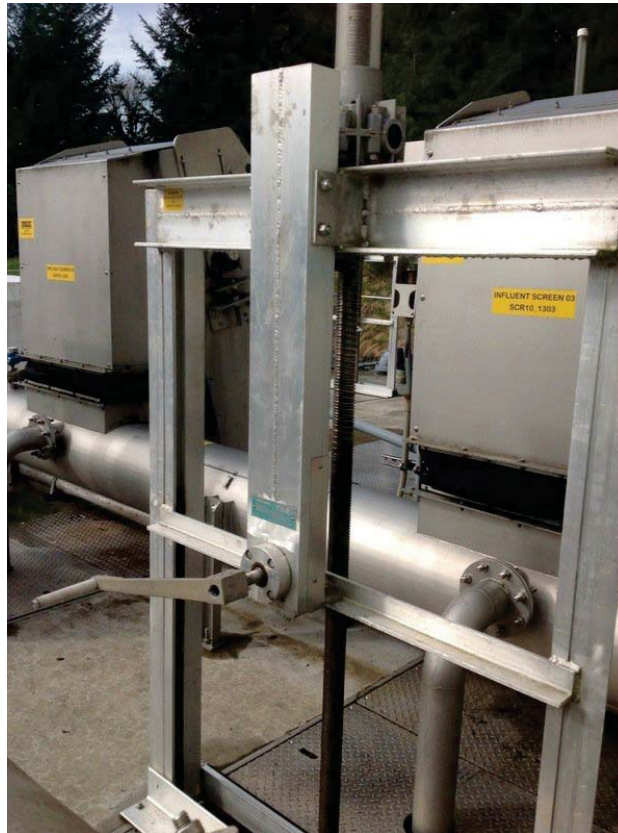
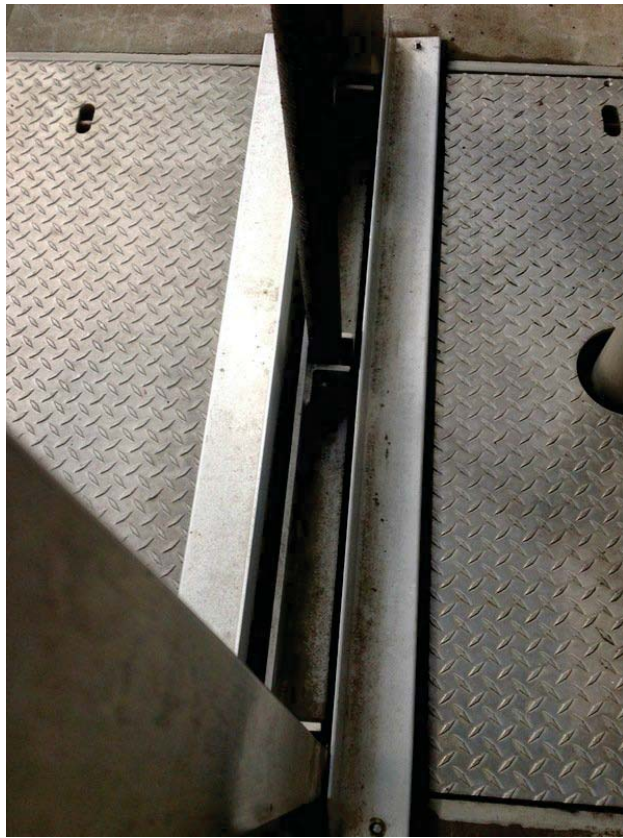
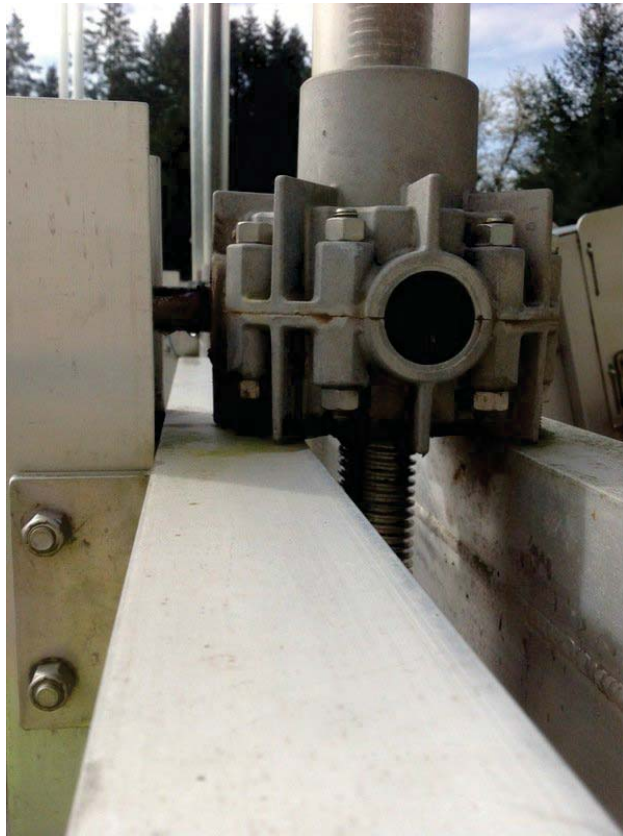
Field Observations	Good condition
Condition Score	2 - Slight Visible Degradation
Performance Score	1 - Component Functioning as Intended
Recommendation	Schedule corrective action work order near term
Field Observations/Comments	Gate closed Channel seal missing

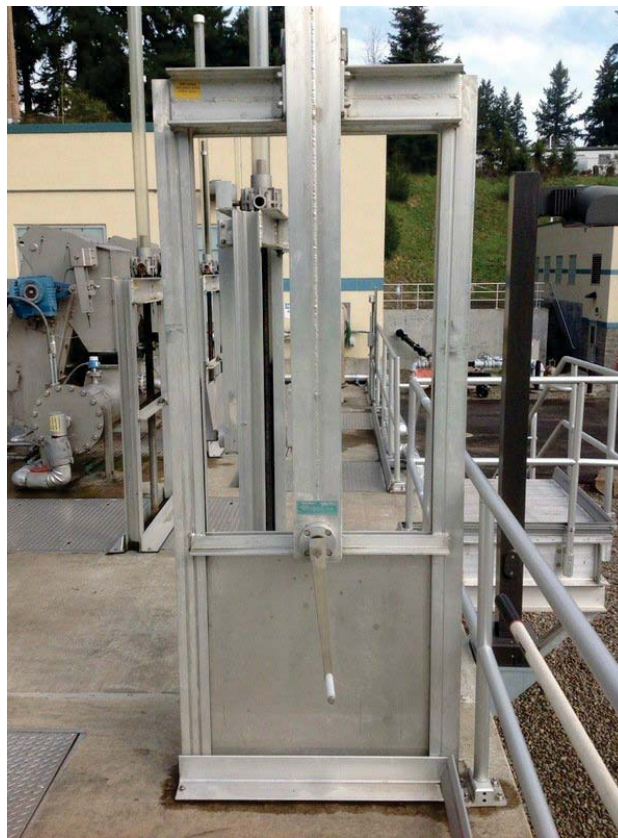
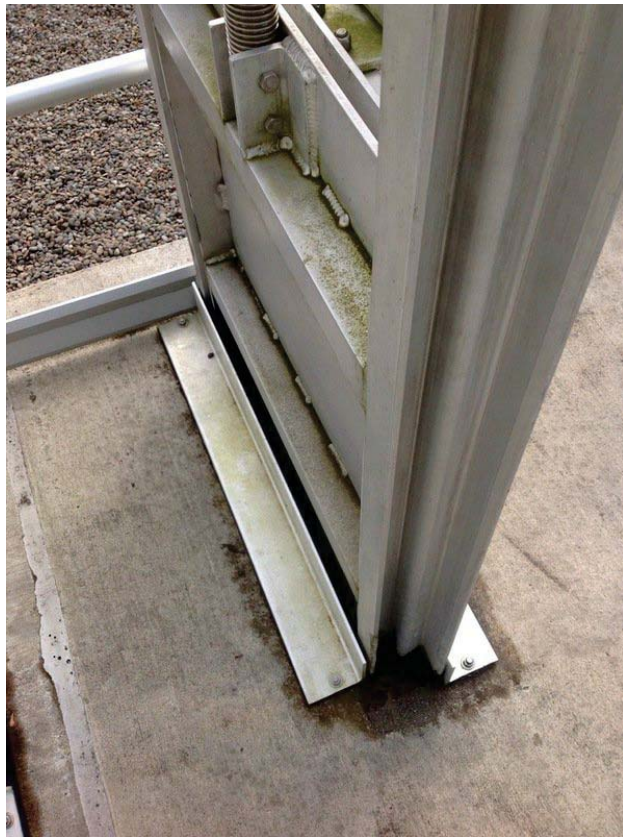
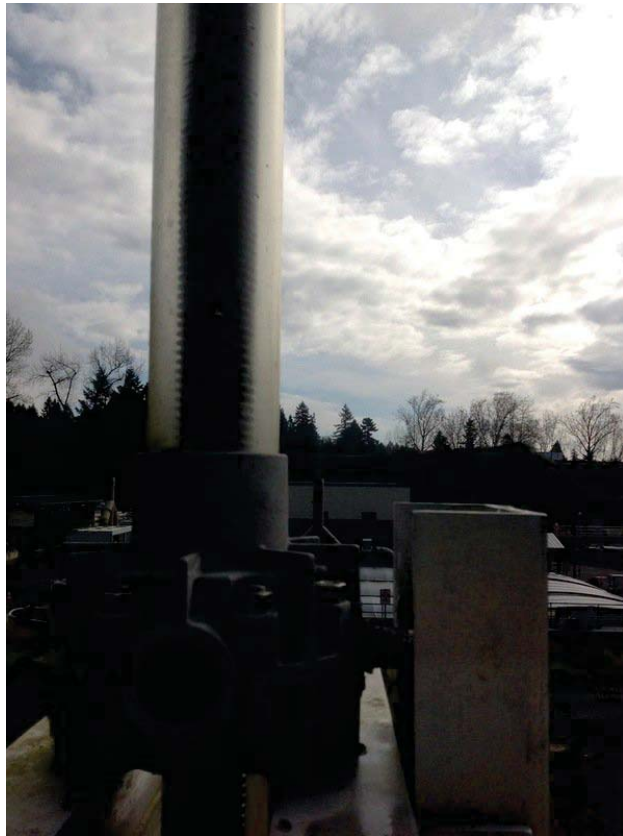
Created	2019-03-27 00:11:21 UTC by Tony Van Haverbeke
Updated	2019-05-28 20:09:47 UTC by Simon Watson
Location	0.0, 0.0
Date	2019-03-28
Time	10:37
Area or Function	Preliminary Treatment
Station ID	GTE10-32101
What type of Asset?	Valves
Condition Score	1 - Excellent
Performance Score	1 - Component Functioning as Intended
Recommendation	No immediate action required
Field Observations/Comments	Gate open

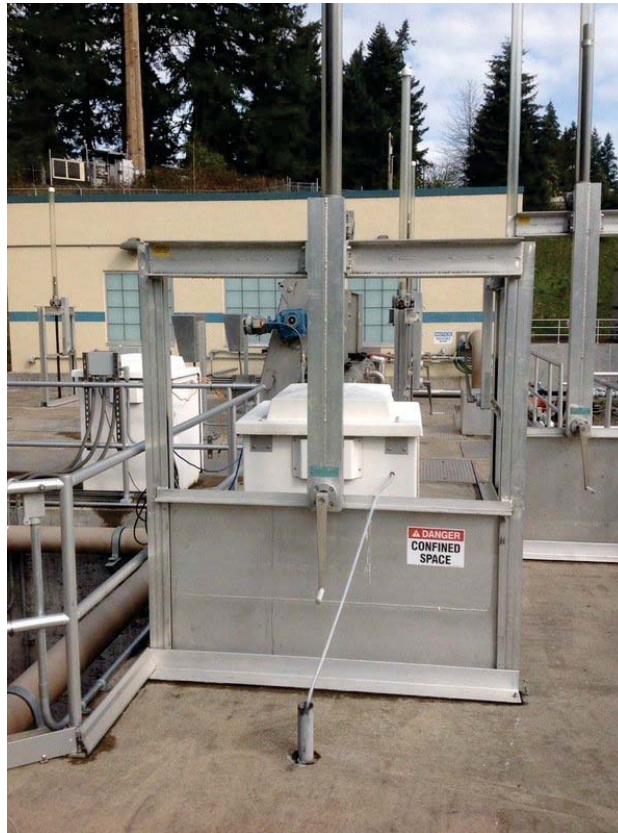
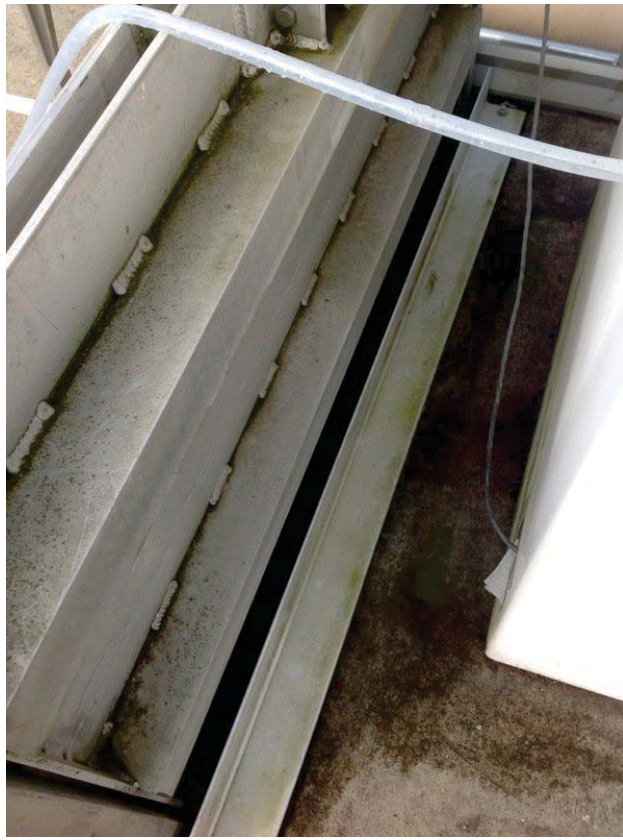
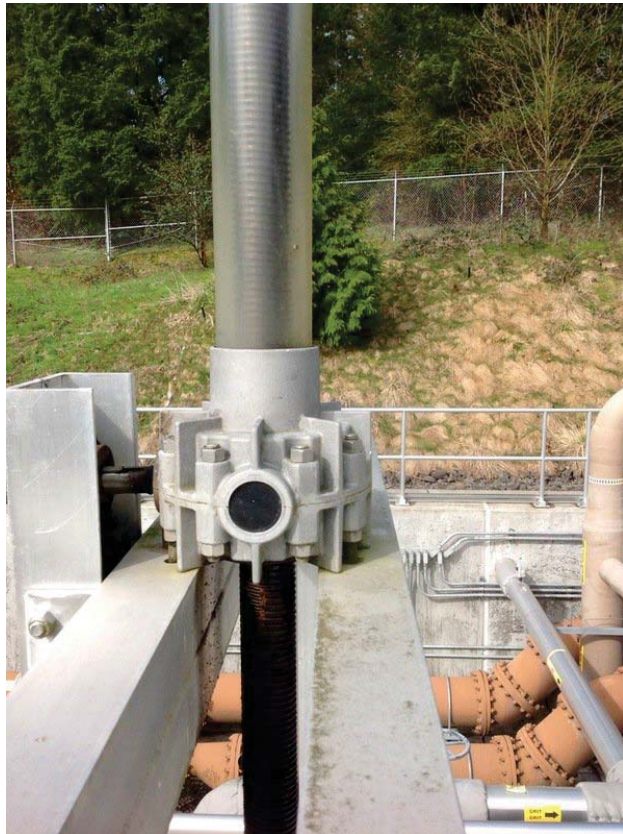
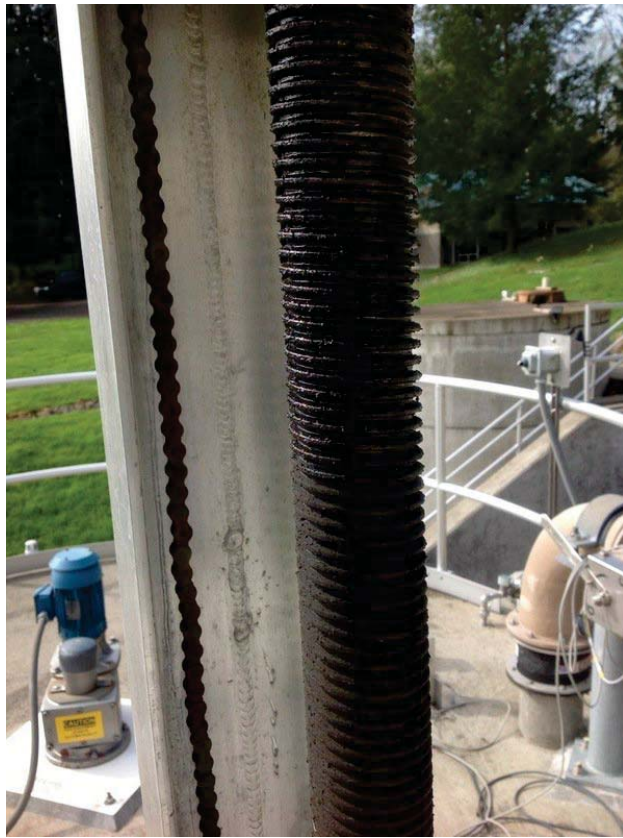
Field Observations	Good condition
Condition Score	2 - Slight Visible Degradation
Performance Score	1 - Component Functioning as Intended
Recommendation	Schedule corrective action work order near term
Field Observations/Comments	Gate open Drive chain rusted and lacking lube

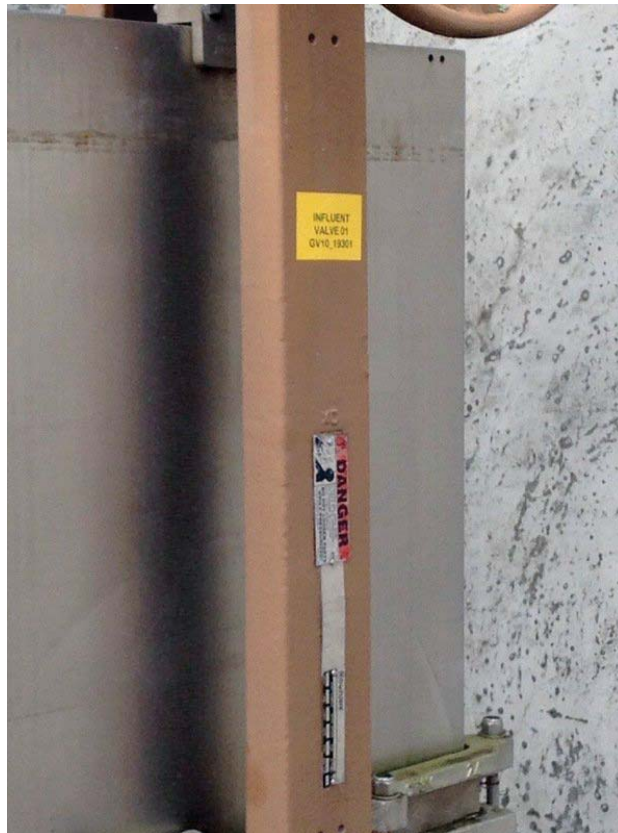
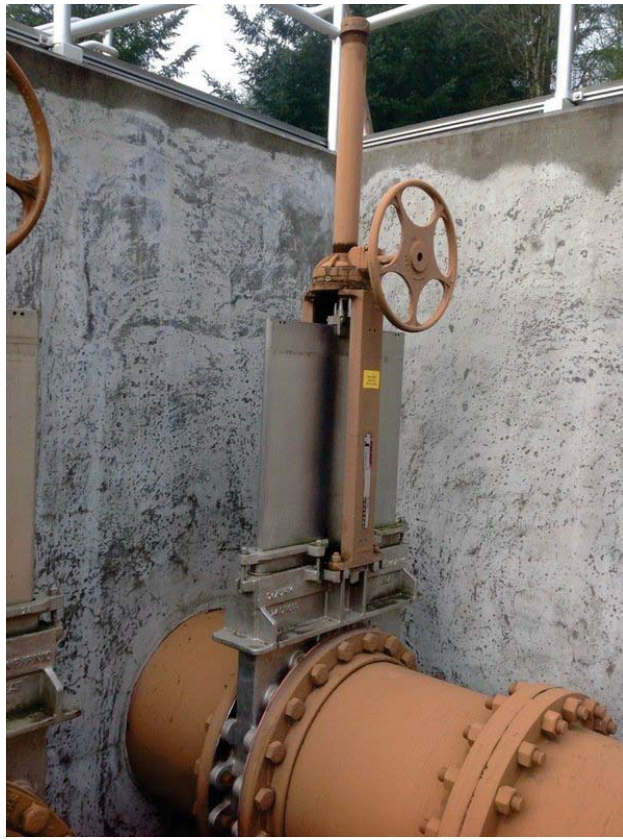
Field Observations	Good condition
Condition Score	1 - Excellent
Performance Score	1 - Component Functioning as Intended
Recommendation	No immediate action required
Field Observations/Comments	No issues

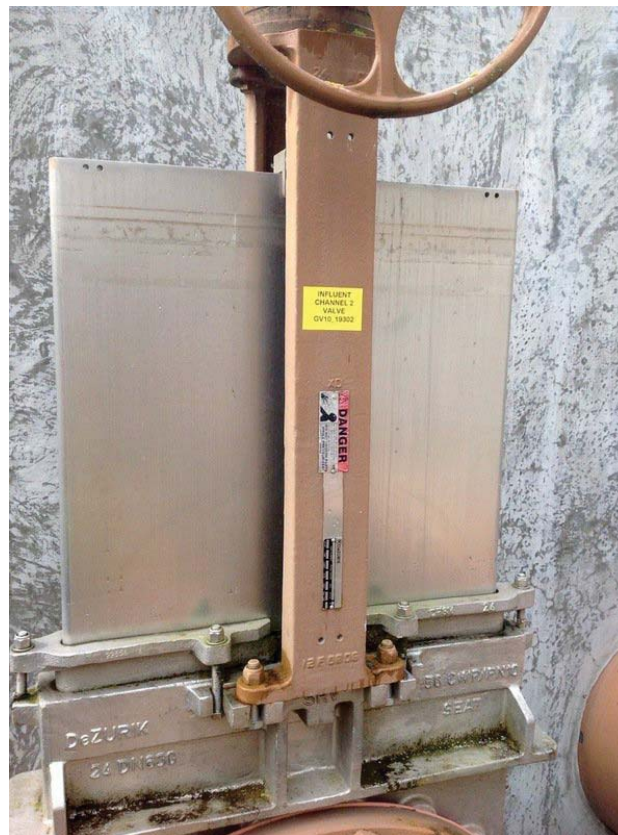
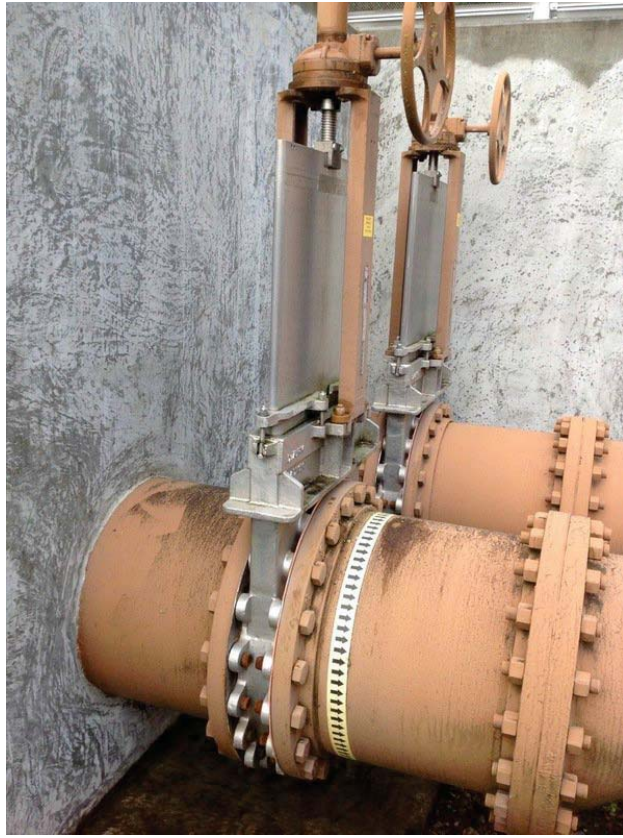
Manufacturer	DeZurik
Field Observations	Good condition
Condition Score	1 - Excellent
Performance Score	1 - Component Functioning as Intended
Recommendation	No immediate action required

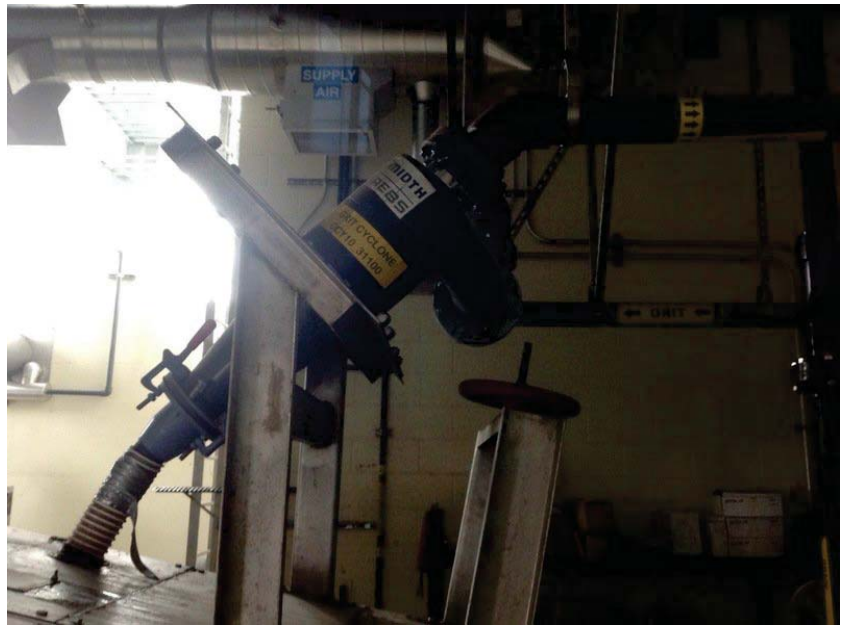
Created	2019-03-27 00:10:52 UTC by Tony Van Haverbeke
Updated	2019-05-28 20:04:51 UTC by Simon Watson
Location	0.0, 0.0
Date	2019-03-28
Time	11:16
Area or Function	Preliminary Treatment
Station ID	GYC10-31100
Asset Description	Grit Cyclone 31100
What type of Asset?	Mechanical
Condition Score	2 - Slight Visible Degradation
Performance Score	1 - Component Functioning as Intended
Recommendation	No immediate action required
Field Observations/Comments	Not in operation during site visit Duct tape on effluent hose

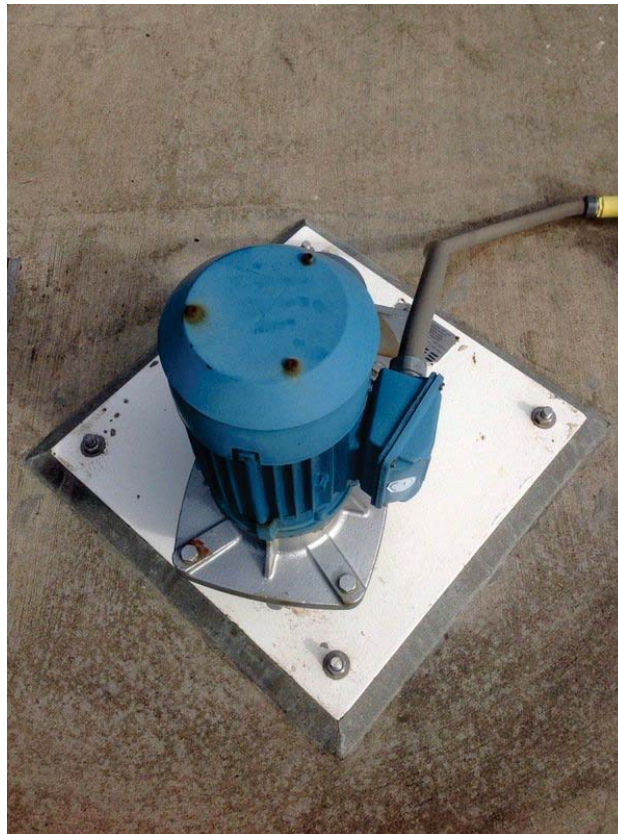
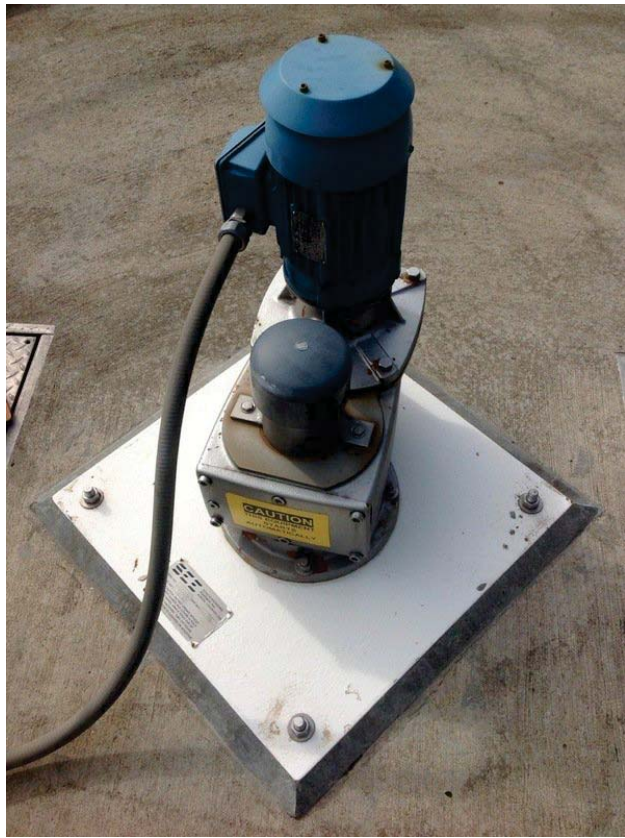
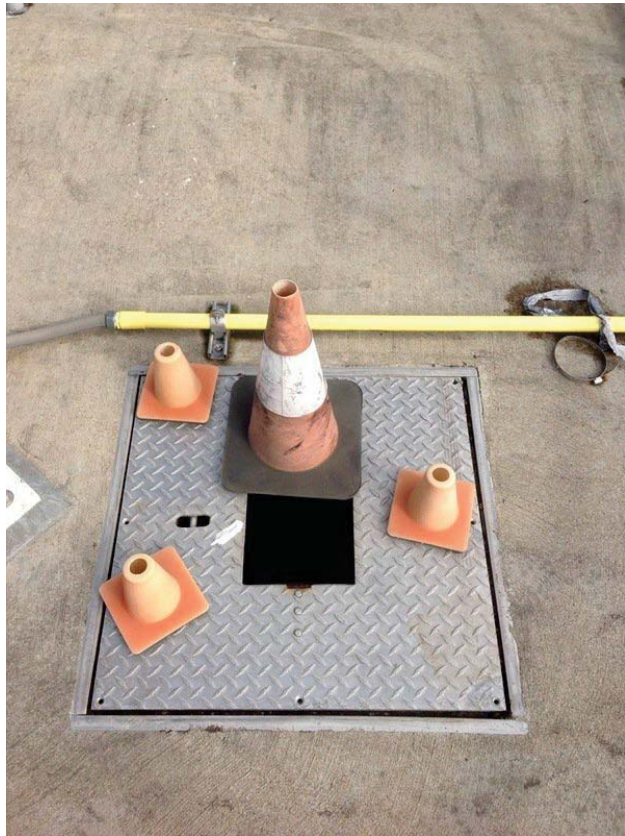
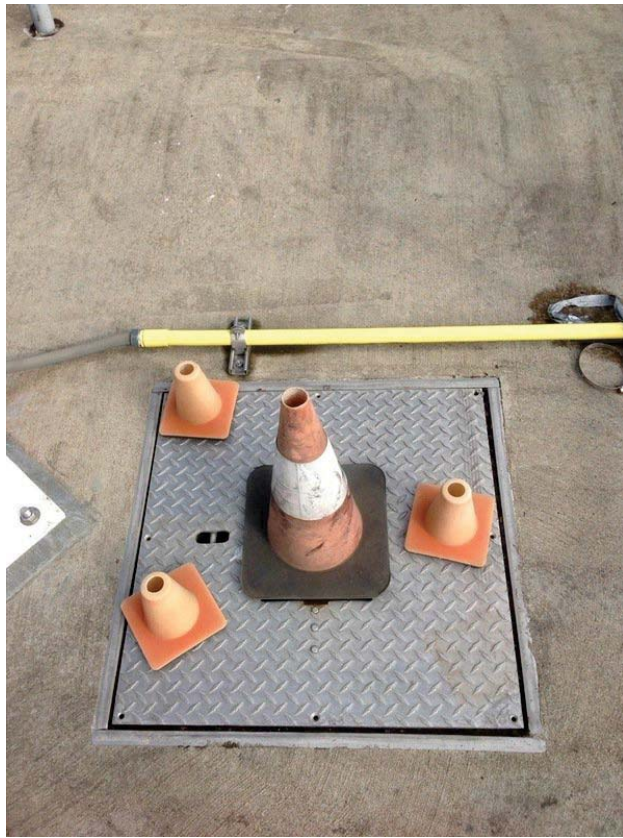
Created	2019-03-27 00:10:53 UTC by Tony Van Haverbeke
Updated	2019-05-28 20:08:44 UTC by Simon Watson
Location	0.0, 0.0
Date	2019-03-28
Time	10:44
Area or Function	Preliminary Treatment
Station ID	MXR10-30100
Asset Description	Grit Basin Mixer
What type of Asset?	Mechanical
Condition Score	2 - Slight Visible Degradation
Performance Score	1 - Component Functioning as Intended
Recommendation	No immediate action required
Field Observations/Comments	Mixer running No leaks Some external coating is missing Cover missing next to mixer

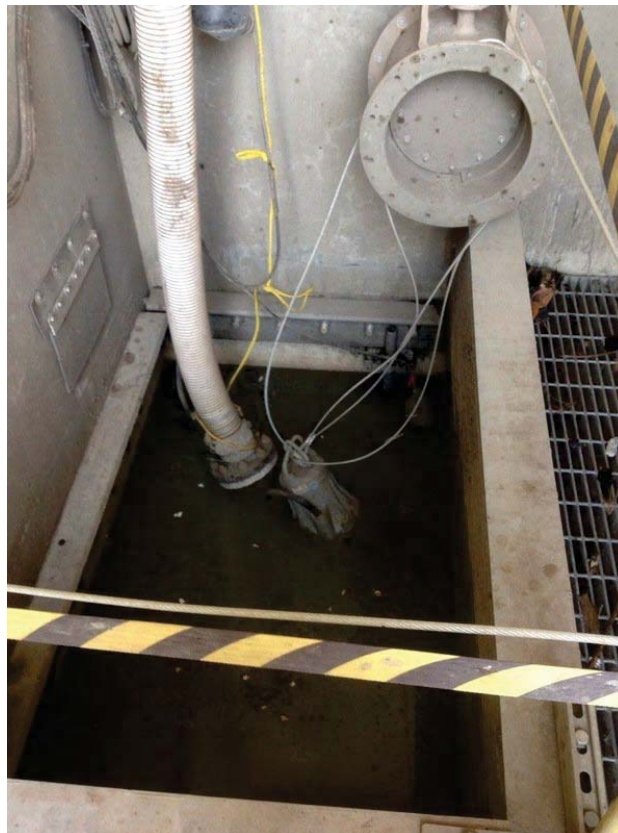
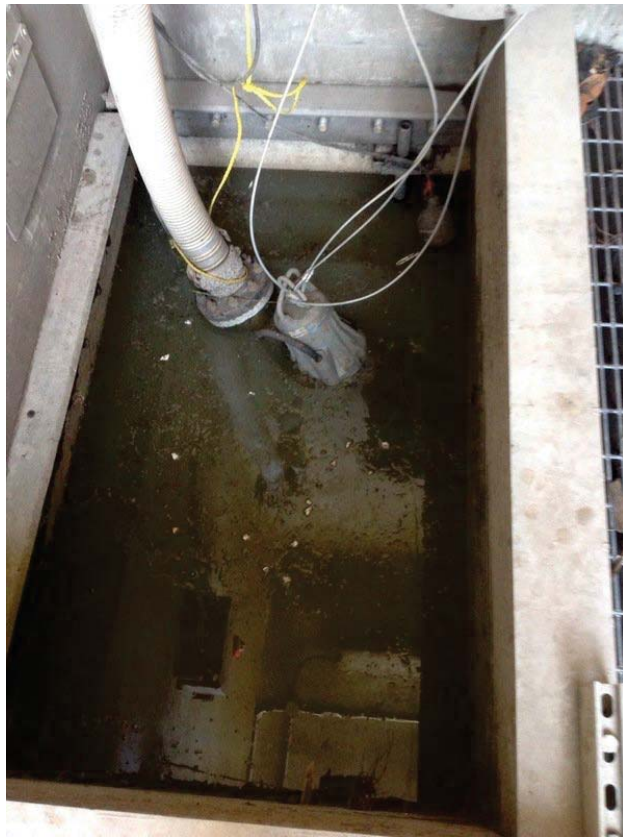
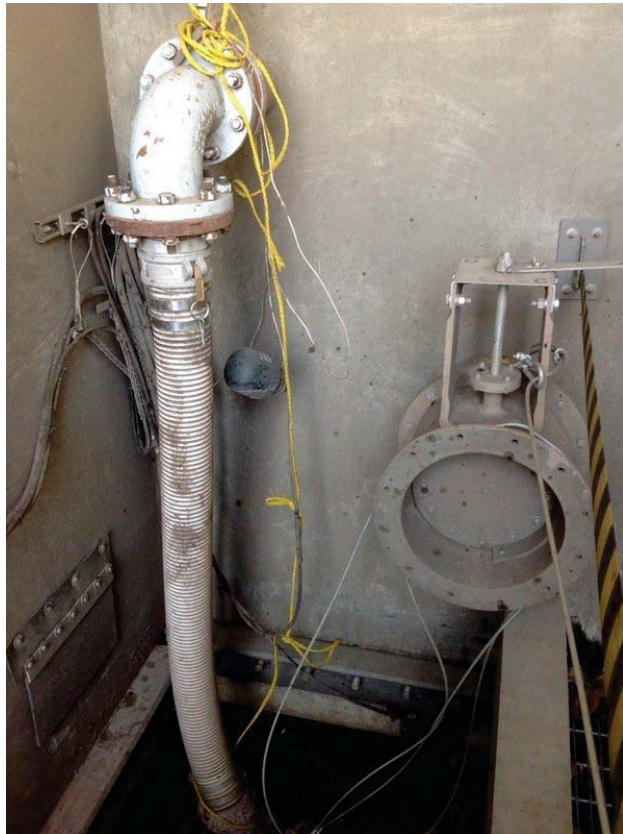
Created	2019-03-27 00:11:04 UTC by Tony Van Haverbeke
Updated	2019-05-28 19:55:47 UTC by Simon Watson
Location	0.0, 0.0
Date	2019-03-28
Time	12:03
Area or Function	Preliminary Treatment
Station ID	PMP10-10500
What type of Asset?	Pumps and Motors
Condition Score	4 - Integrity of Component Moderately Compromised
Performance Score	5 - Component is not Functioning as Intended
Recommendation	Schedule corrective action work order near term
Field Observations/Comments	Appears to be out of service If needed for normal operations a corrective work order needs to be submitted

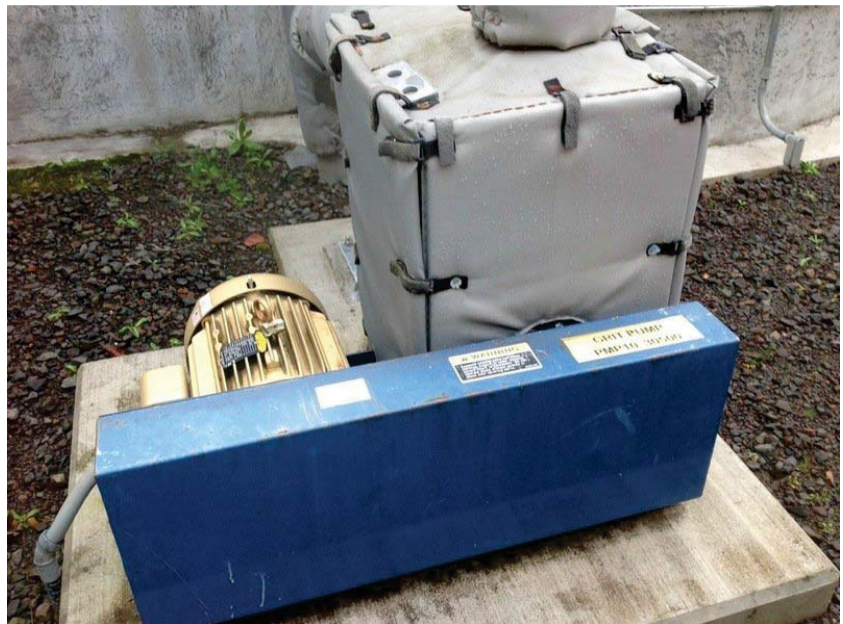
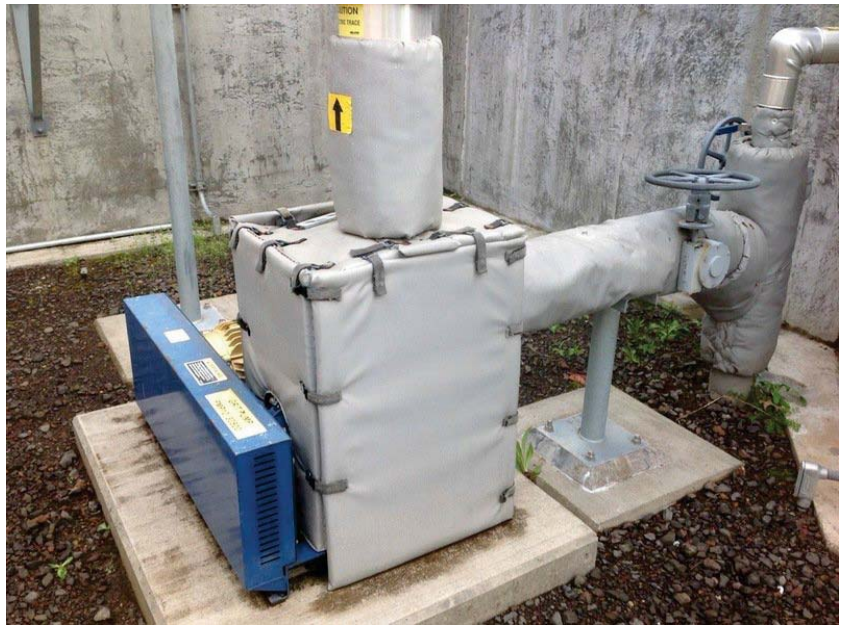
Created	2019-03-27 00:11:04 UTC by Tony Van Haverbeke
Updated	2019-05-28 23:15:37 UTC by Simon Watson
Location	0.0, 0.0
Date	2019-03-28
Time	08:12
Area or Function	Preliminary Treatment
Station ID	PMP10-30500
What type of Asset?	Pumps and Motors
Condition Score	1 - Excellent
Performance Score	1 - Component Functioning as Intended
Recommendation	No immediate action required
Field Observations/Comments	Was not in operation when onsite. Heat tracing working No visible leaks Oil level good

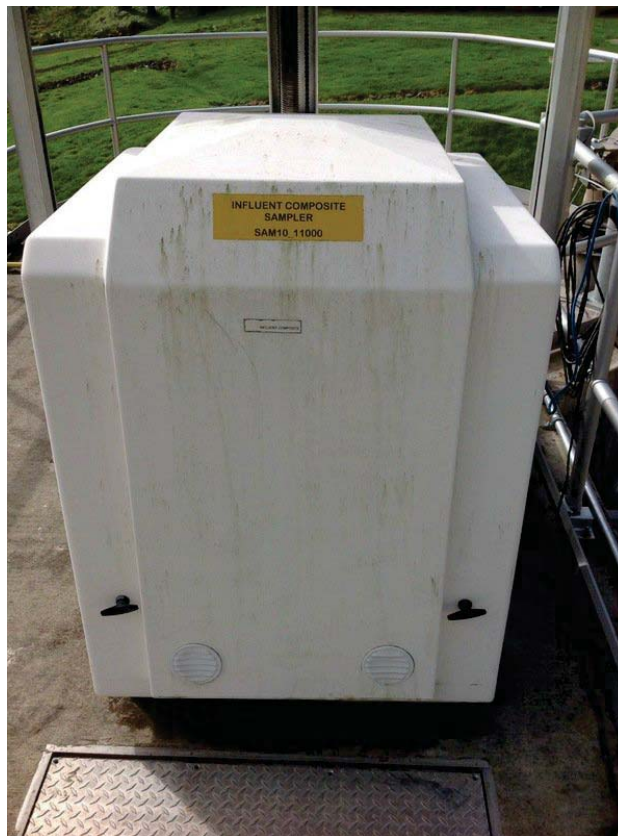
Created	2019-03-27 00:10:56 UTC by Tony Van Haverbeke
Updated	2019-05-28 22:43:11 UTC by Simon Watson
Location	0.0, 0.0
Date	2019-03-28
Time	10:46
Area or Function	Water Quality Monitoring
Station ID	SAM10-11000
Asset Description	Composite Sampler #1
What type of Asset?	Mechanical
Condition Score	2 - Slight Visible Degradation
Performance Score	1 - Component Functioning as Intended
Recommendation	Schedule corrective action work order near term
Field Observations/Comments	Part of the door seal is missing Cooling fan vents partially plugged need cleaning. Fans were not operating

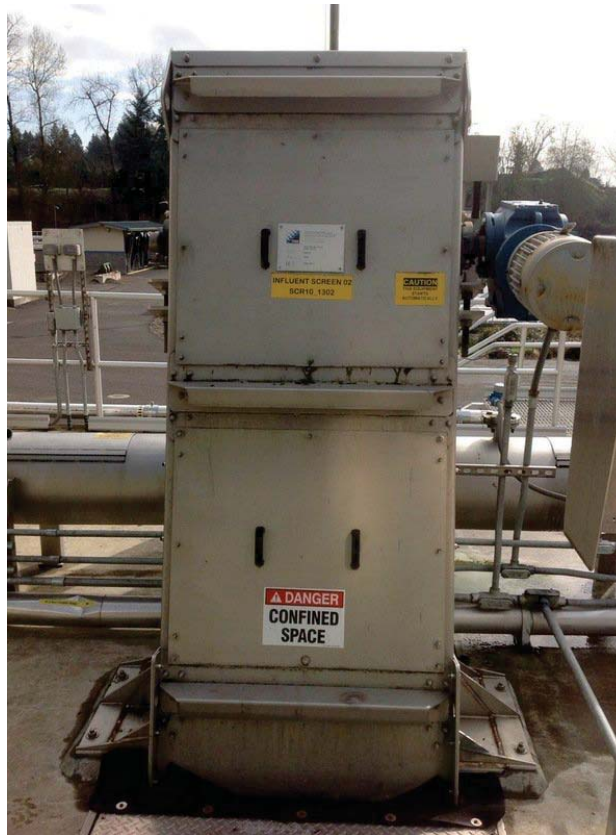
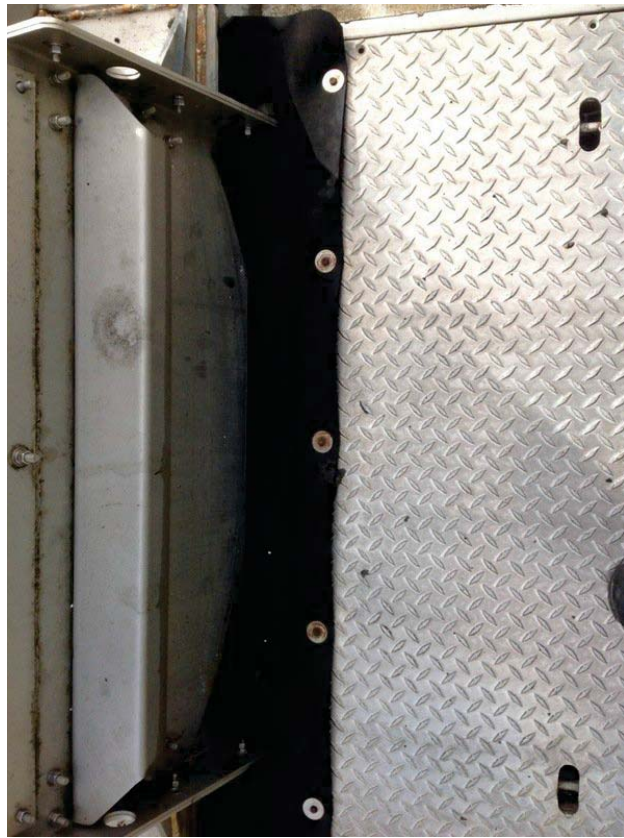
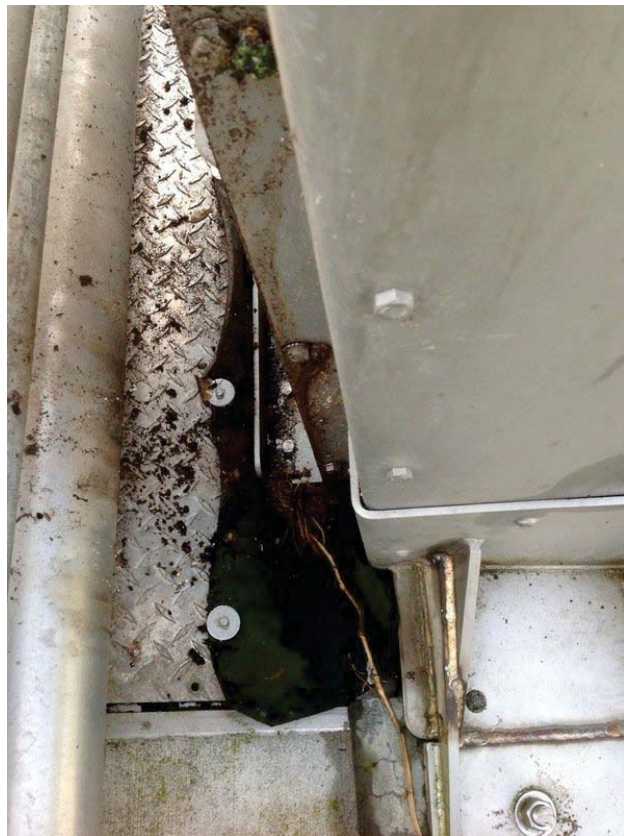
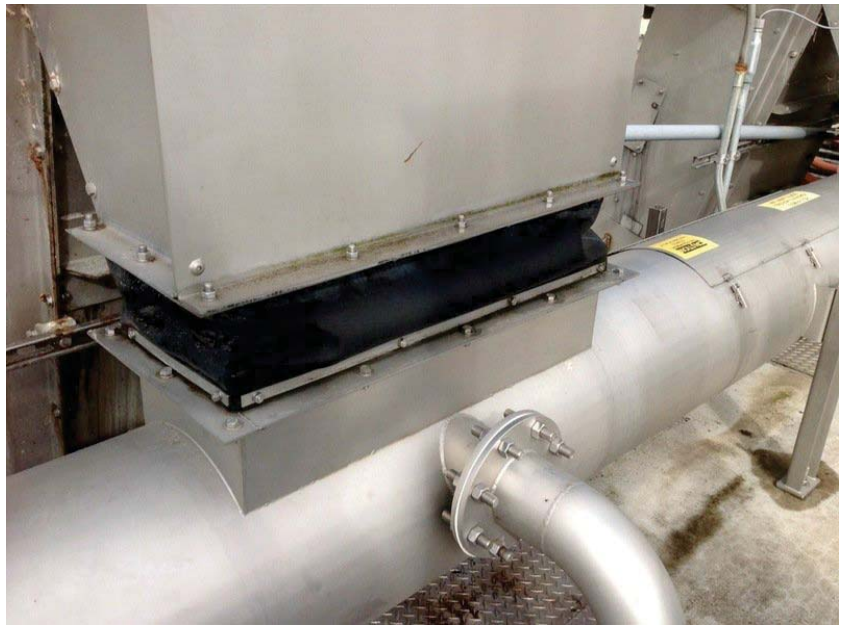
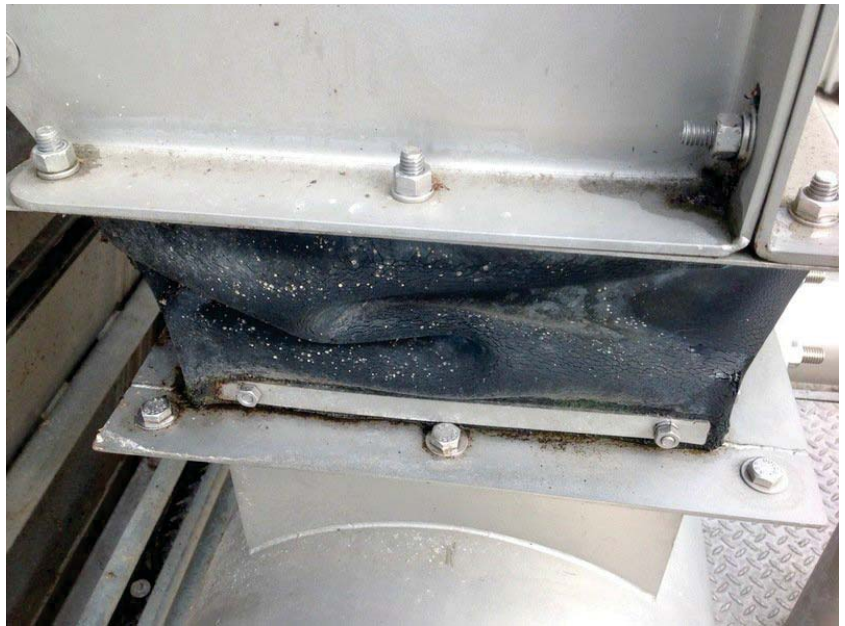
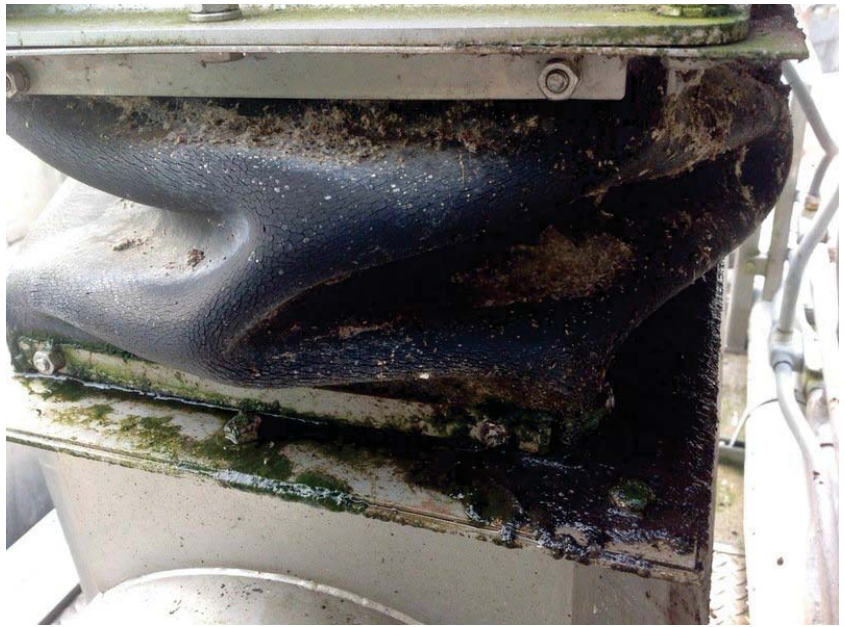
Created	2019-03-27 00:10:57 UTC by Tony Van Haverbeke
Updated	2019-05-28 20:38:40 UTC by Simon Watson
Location	0.0, 0.0
Date	2019-03-28
Time	10:15
Area or Function	Preliminary Treatment
Station ID	SCR10-13002
Asset Description	Influent Screen #2
What type of Asset?	Mechanical
Condition Score	2 - Slight Visible Degradation
Performance Score	1 - Component Functioning as Intended
Recommendation	Schedule corrective action work order near term
Field Observations/Comments	Not in service during site visit Discharge Shoot boot cracking and appears to be leaking around the top Channel seals around the base of the unit have collapsed
