# City of Wilsonville Triennial Inspection Report

Wilsonville WWTP and  
Wastewater Lift Stations:

Project Title: On-Call Civil Engineering and Related Services,  
Triennial Inspection of the Wilsonville WWTP and Nine Lift Stations

Subject: 2019 Triennial Inspection of the Wilsonville WWTP  
and Sewage Lift Stations

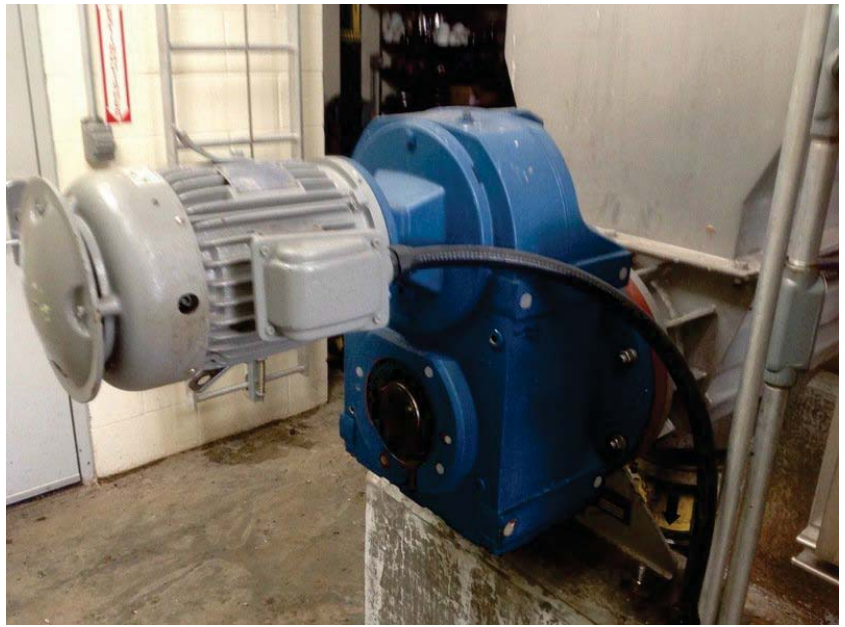
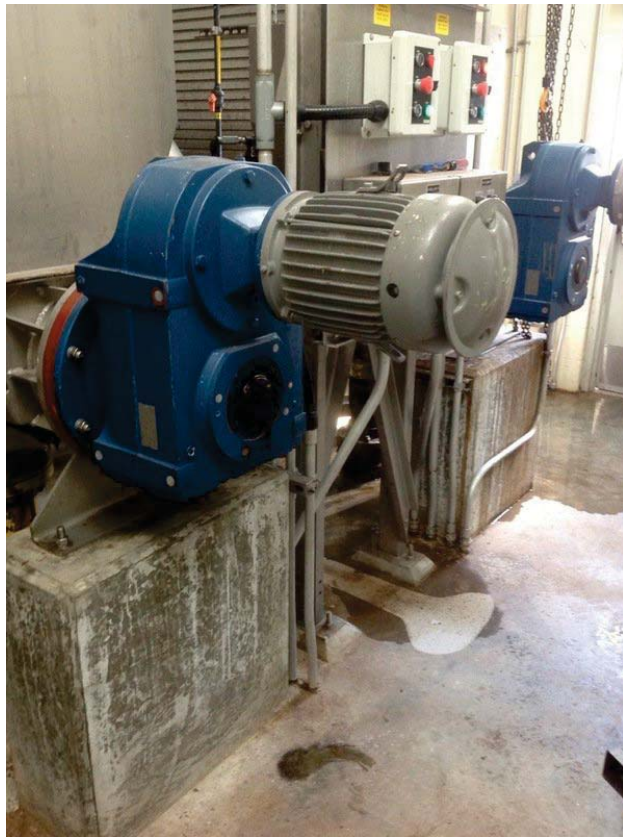
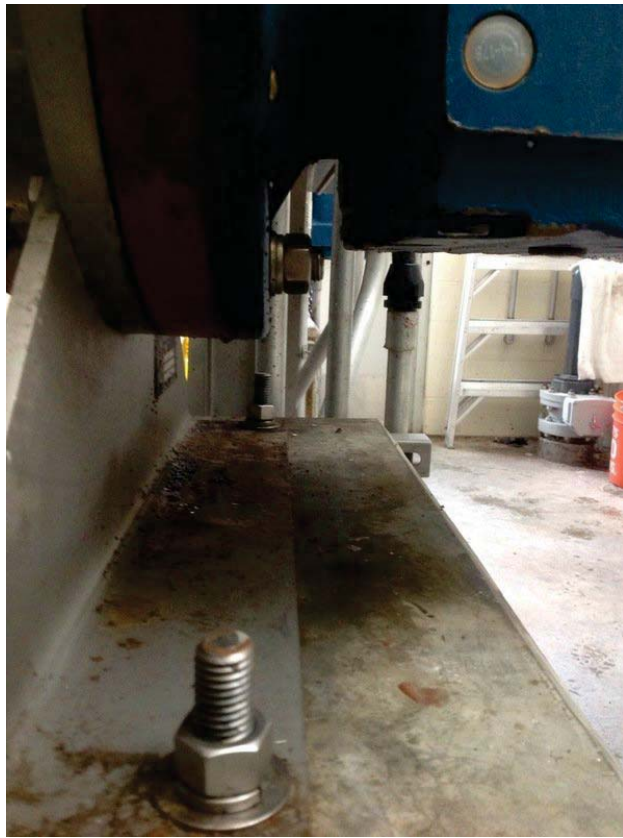
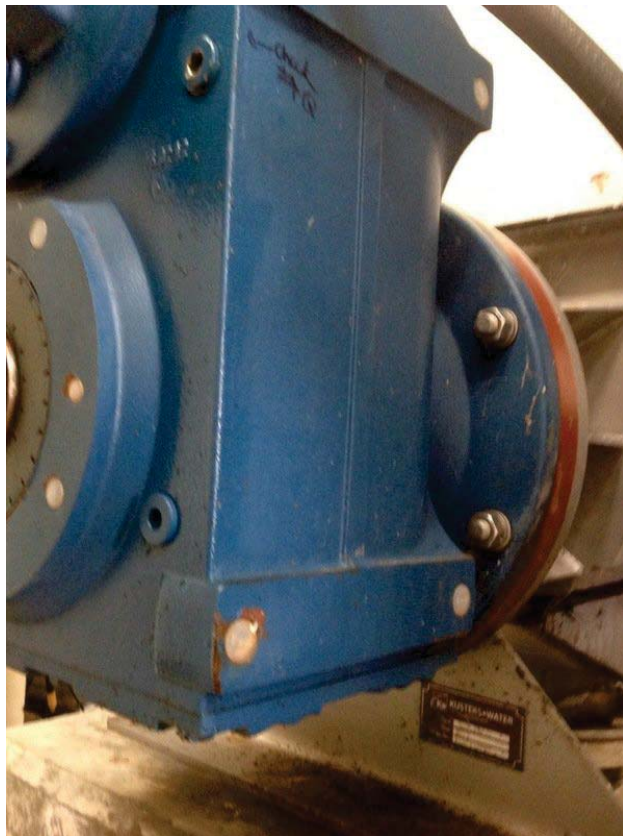
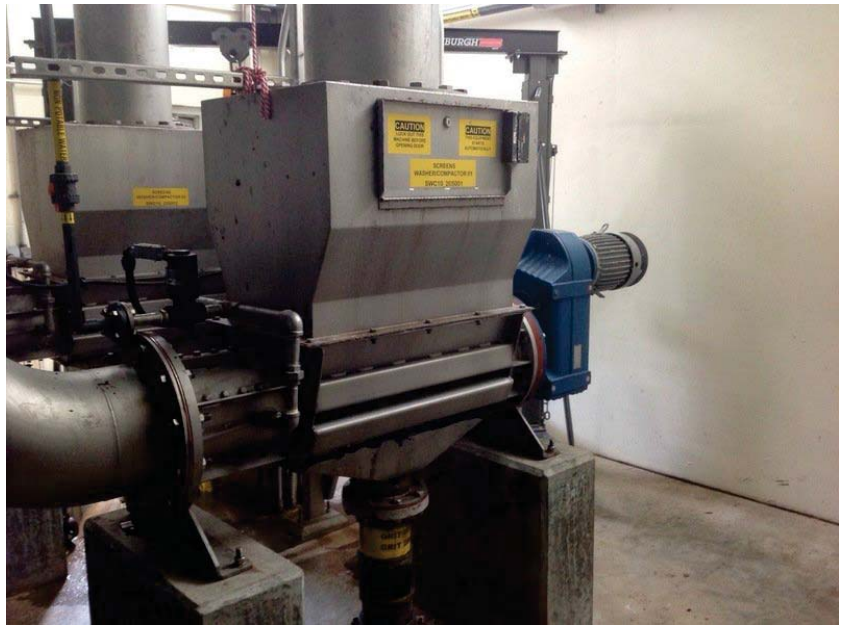
Field Observations	Leaking
Condition Score	2 - Slight Visible Degradation
Performance Score	1 - Component Functioning as Intended
Recommendation	Schedule corrective action work order near term
Field Observations/Comments	Not in operation while onsite Leaking oil between gearbox and auger Appears to be leaking oil from fill plug

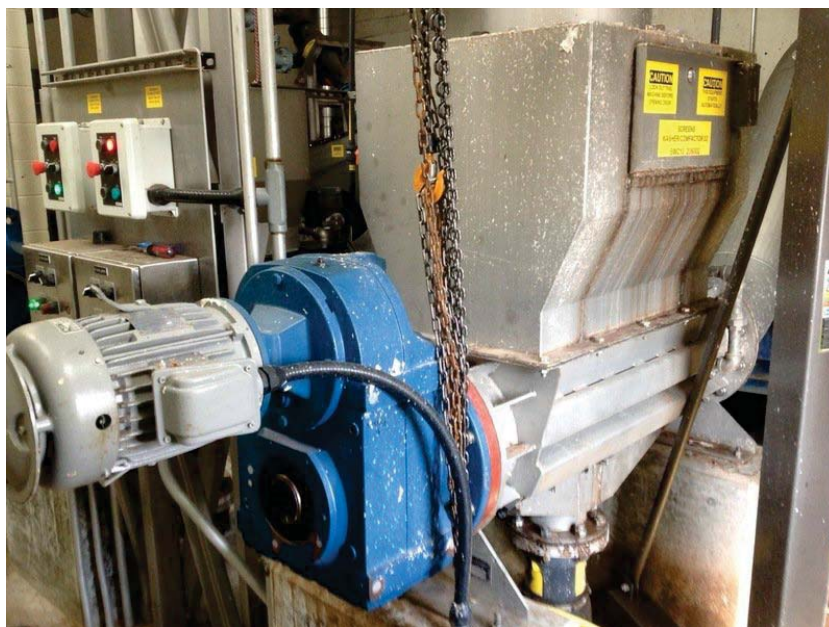
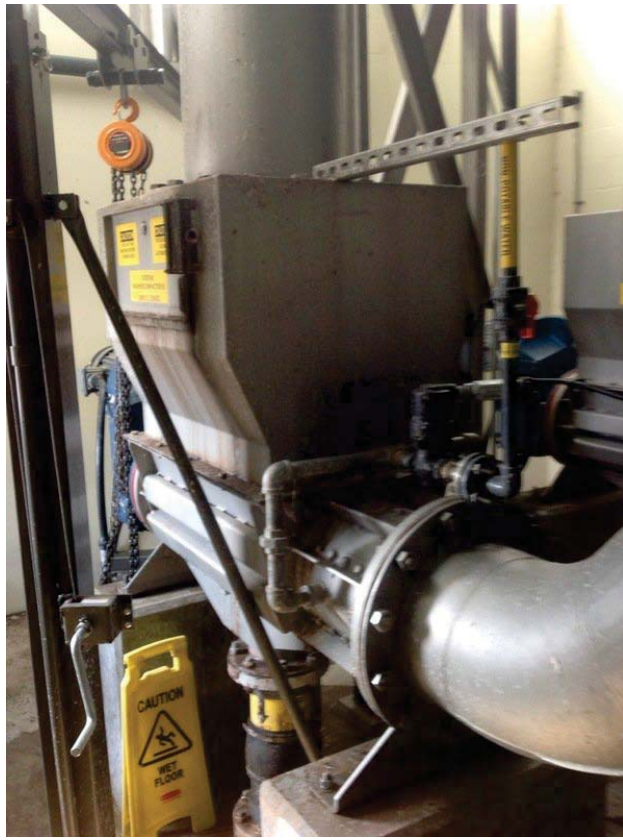
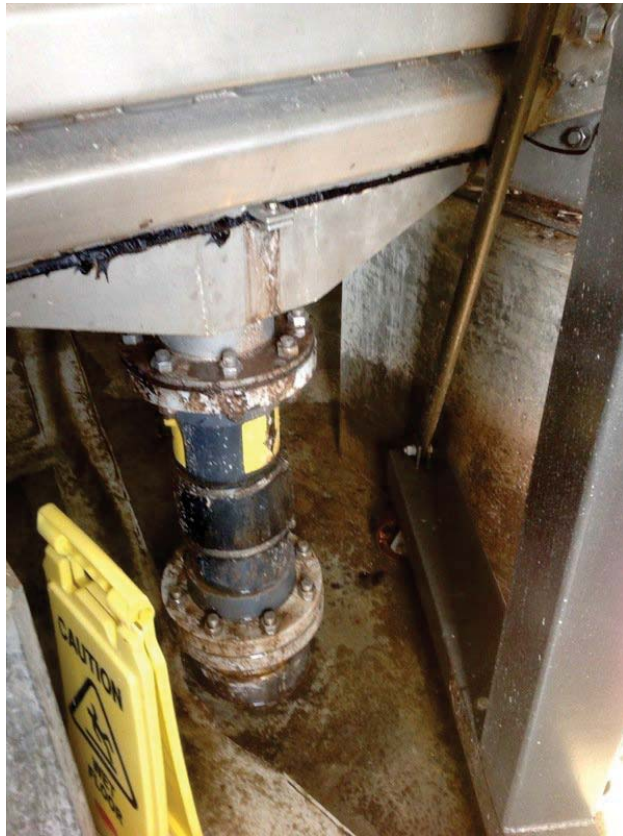
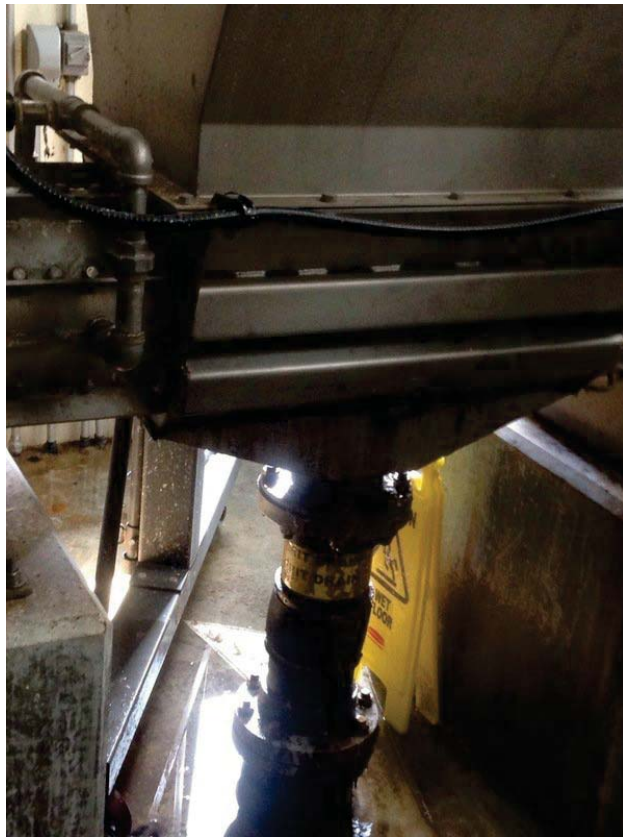
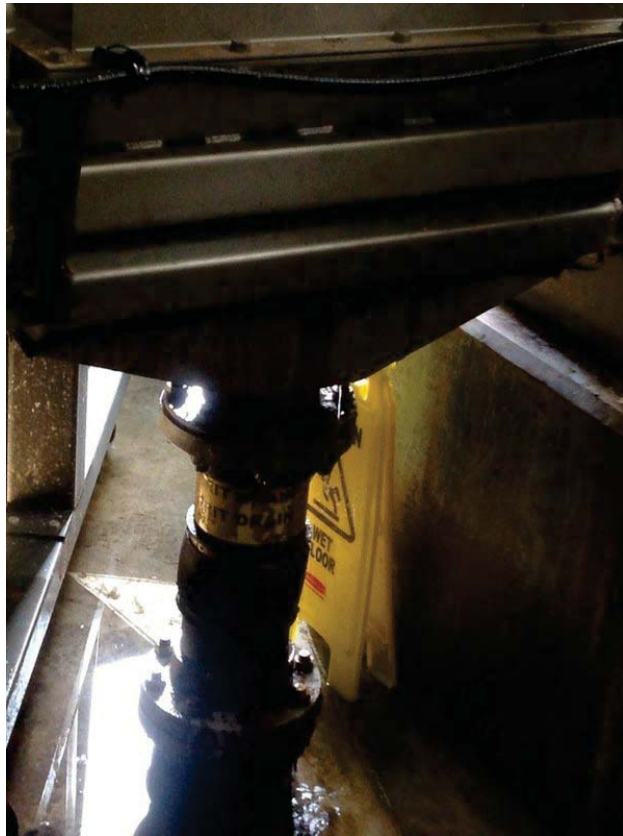
Field Observations	Leaking
Condition Score	2 - Slight Visible Degradation
Performance Score	1 - Component Functioning as Intended
Recommendation	Schedule corrective action work order near term
Field Observations/Comments	In operation Leaking water from bottom inspection doors

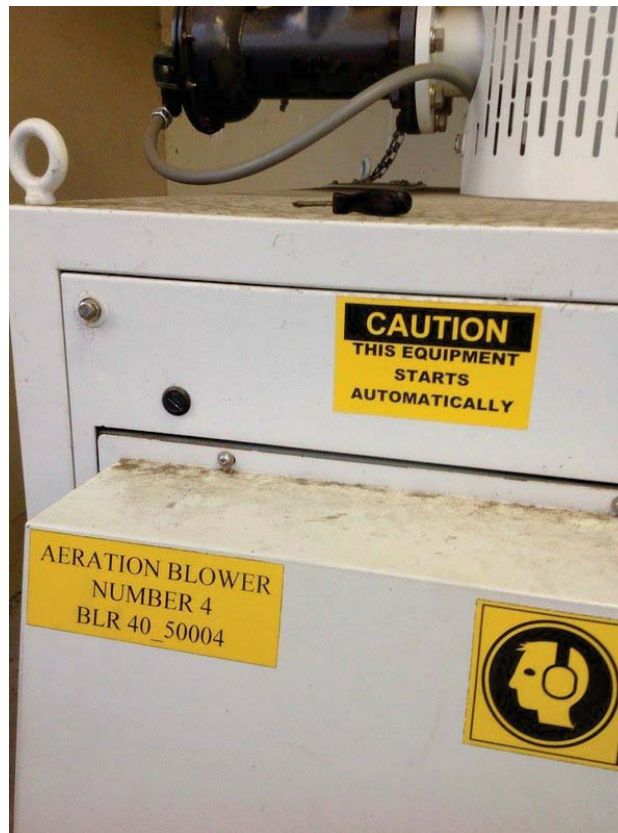
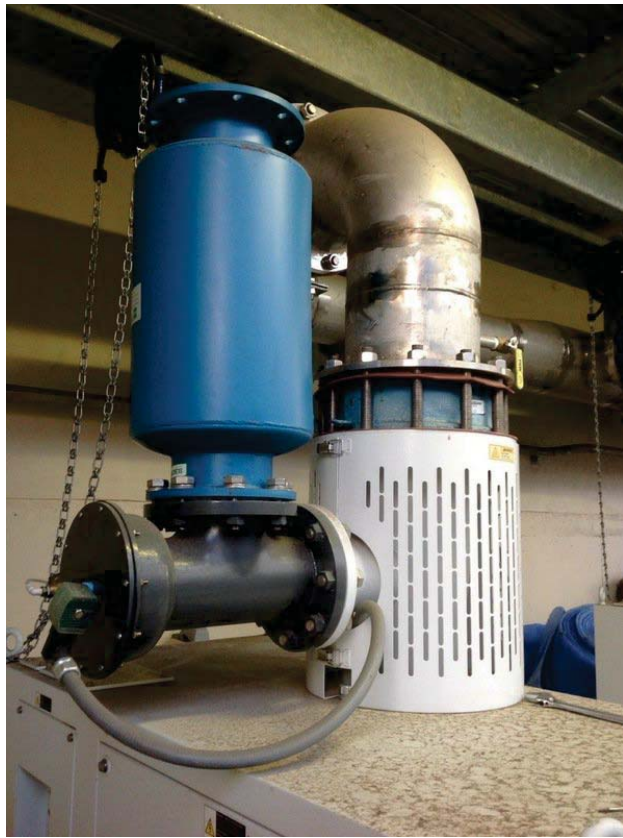
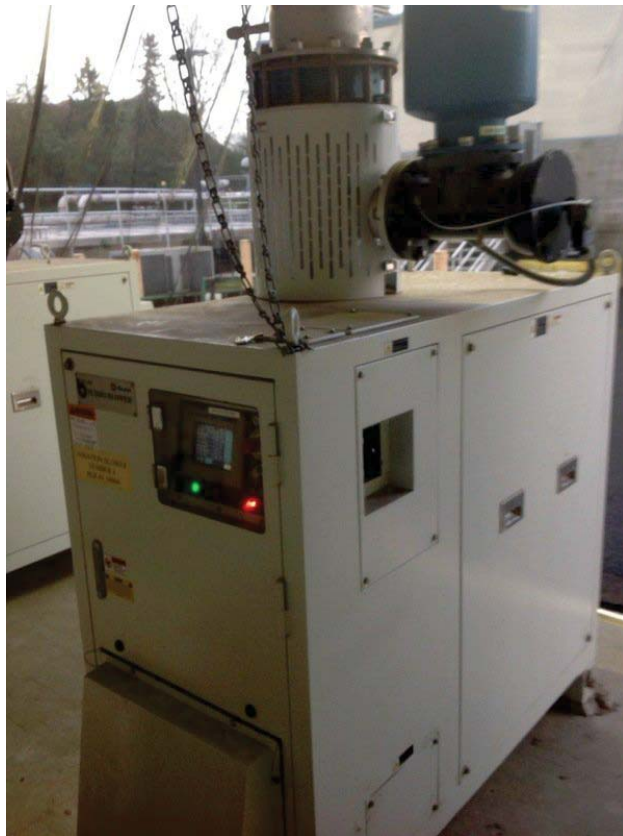
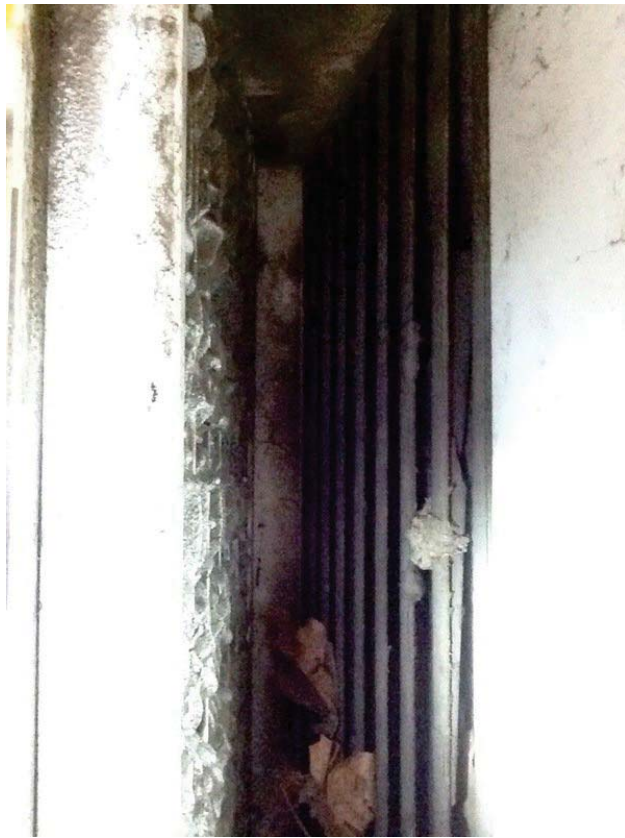
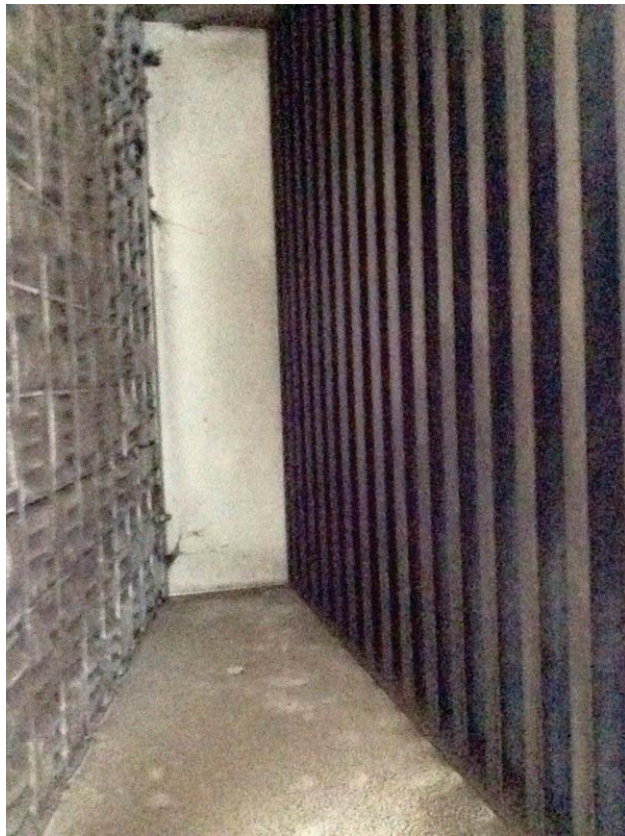
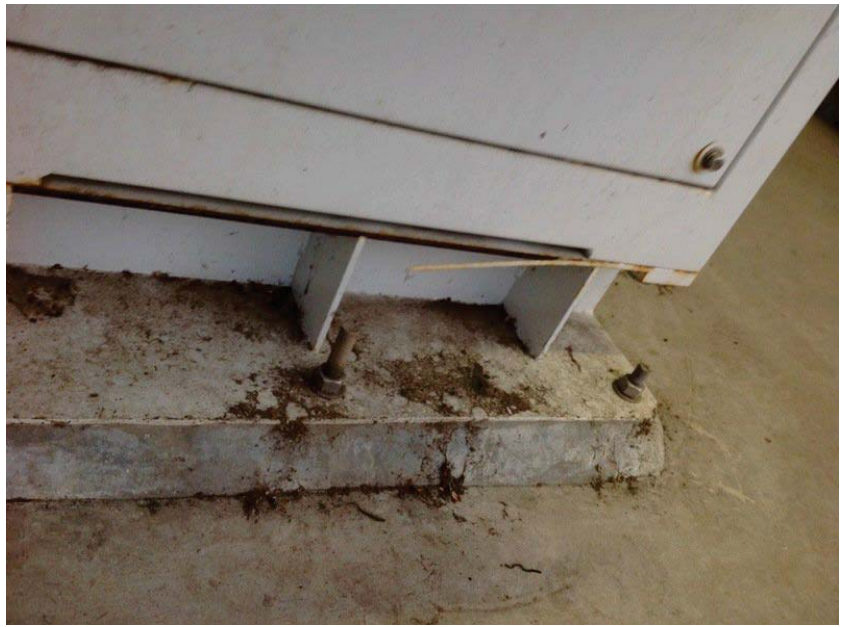
Created	2019-03-27 00:10:47 UTC by Tony Van Haverbeke
Updated	2019-05-28 19:42:32 UTC by Simon Watson
Location	0.0, 0.0
Date	2019-03-29
Time	07:37
Area or Function	Secondary Treatment
Station ID	BLW40-50004
Asset Description	Aeration Blower #4
What type of Asset?	Mechanical
Condition Score	2 - Slight Visible Degradation
Performance Score	1 - Component Functioning as Intended
Recommendation	No immediate action required
Field Observations/Comments	In operation Unable to inspect inside Rear filter louvers dirt filter media seems fine Some coating coming off

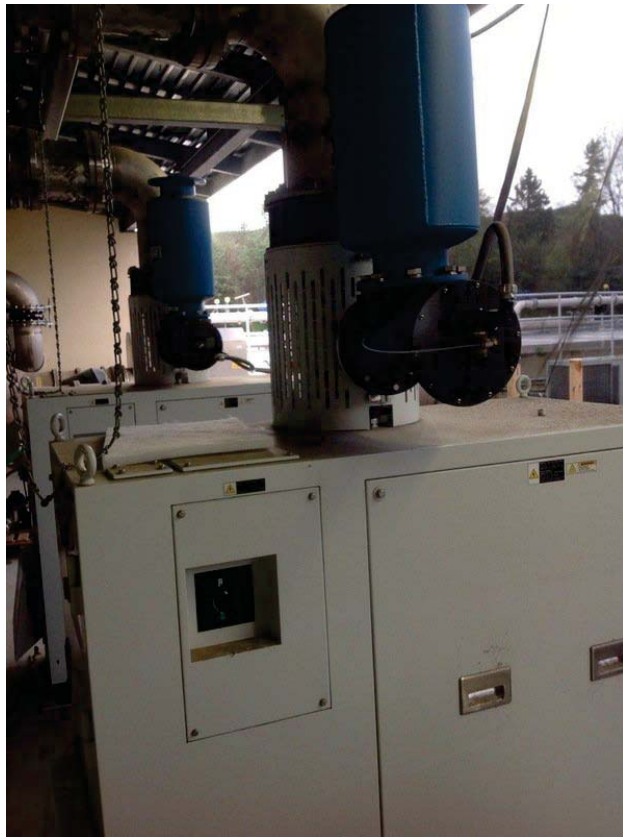
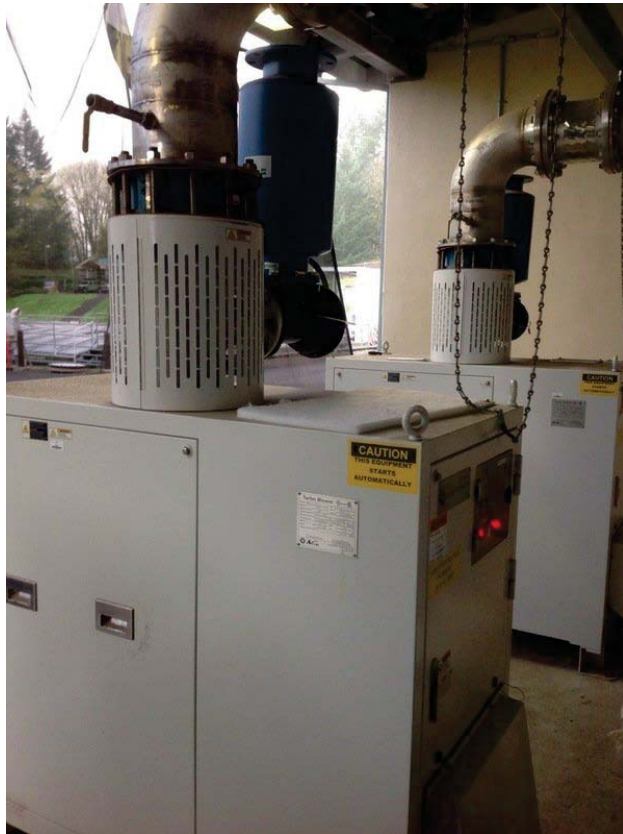
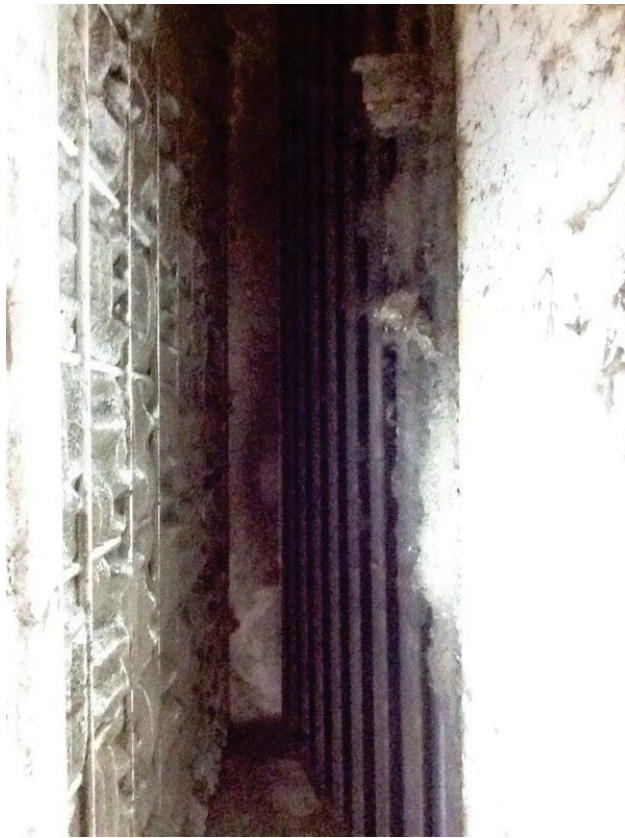
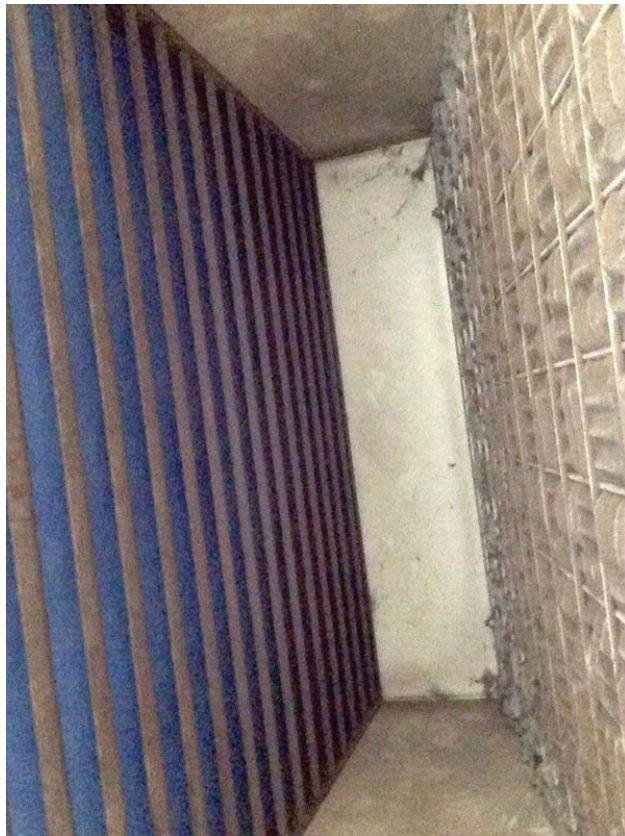
Created	2019-03-27 00:10:47 UTC by Tony Van Haverbeke
Updated	2019-05-28 19:43:30 UTC by Simon Watson
Location	0.0, 0.0
Date	2019-03-29
Time	07:44
Area or Function	Secondary Treatment
Station ID	BLW40-50005
Asset Description	Aeration Blower #5
What type of Asset?	Mechanical
Condition Score	2 - Slight Visible Degradation
Performance Score	1 - Component Functioning as Intended
Recommendation	Initiate more detailed inspection
Field Observations/Comments	Not in operation Unable to inspect inside Rear filter louvers and media are dirty

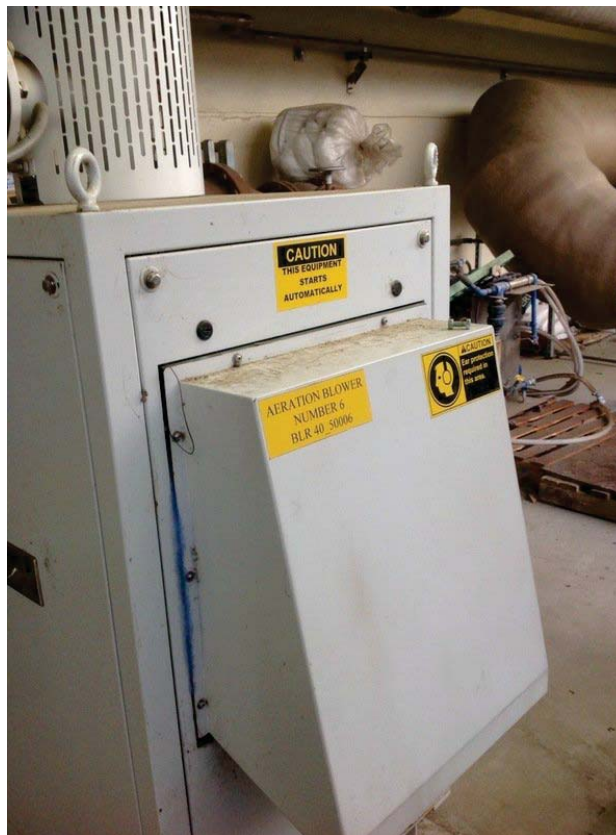
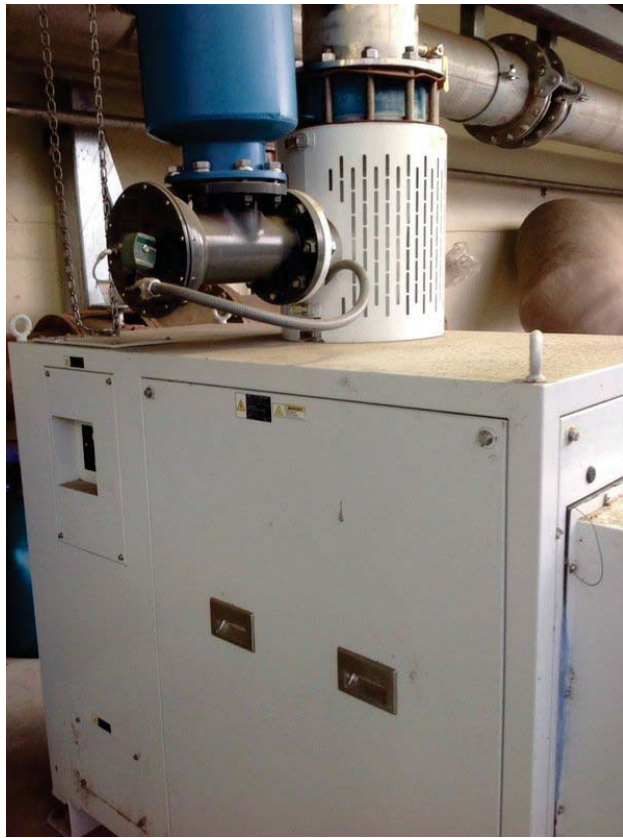
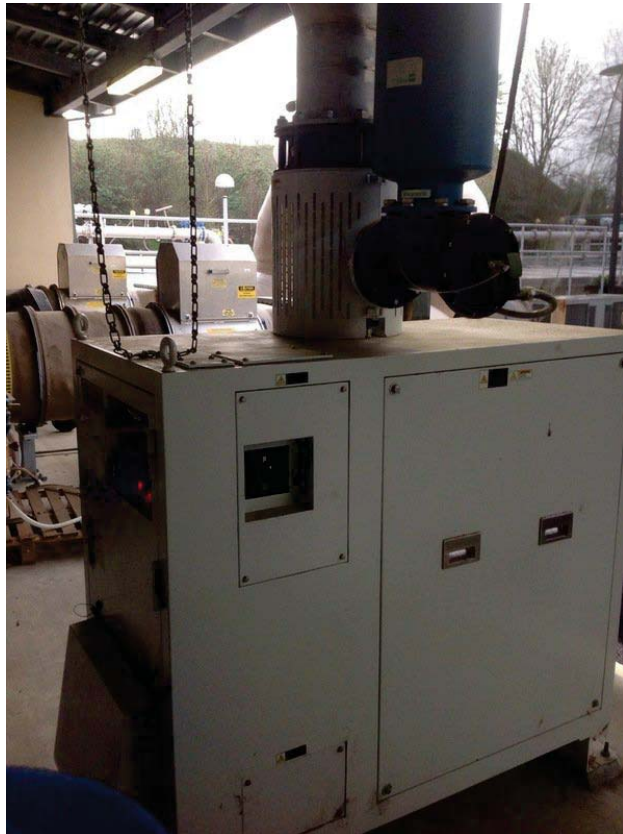
Created	2019-03-27 00:10:47 UTC by Tony Van Haverbeke
Updated	2019-05-28 19:43:05 UTC by Simon Watson
Location	0.0, 0.0
Date	2019-03-29
Time	07:48
Area or Function	Secondary Treatment
Station ID	BLW40-50006
Asset Description	Aeration Blower #6
What type of Asset?	Mechanical
Condition Score	2 - Slight Visible Degradation
Performance Score	1 - Component Functioning as Intended
Recommendation	Initiate more detailed inspection
Field Observations/Comments	Not in operation Unable to inspect inside Rear filter louvers and media are dirty

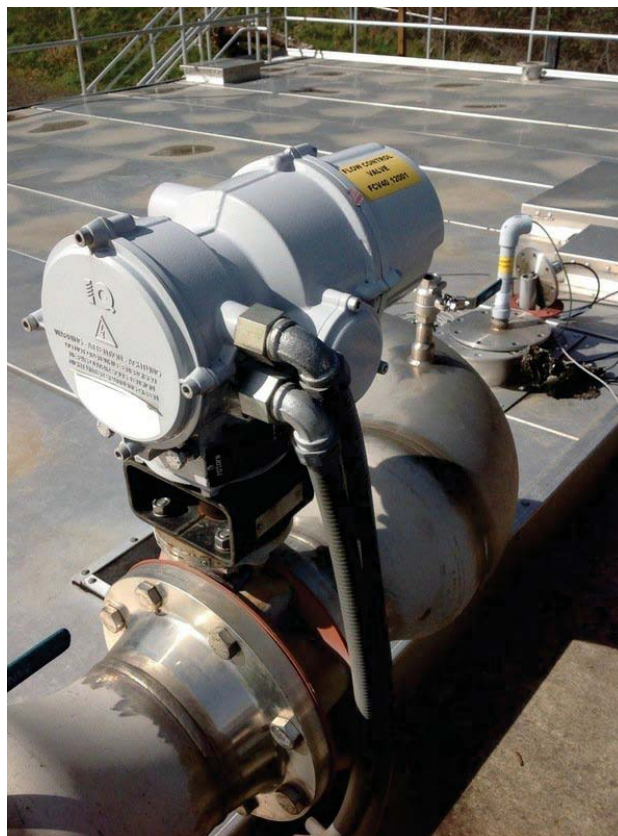
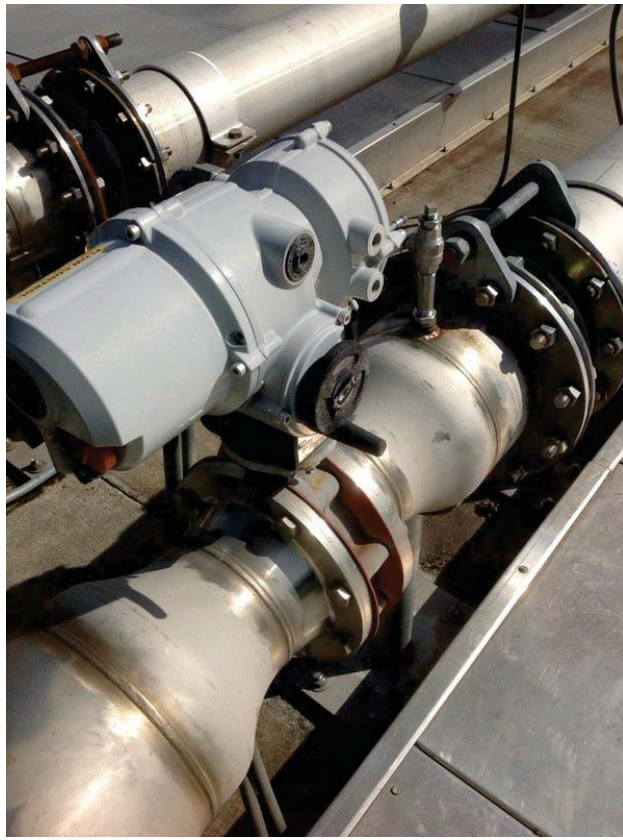
Field Observations	Good condition
Condition Score	2 - Slight Visible Degradation
Performance Score	1 - Component Functioning as Intended
Recommendation	No immediate action required

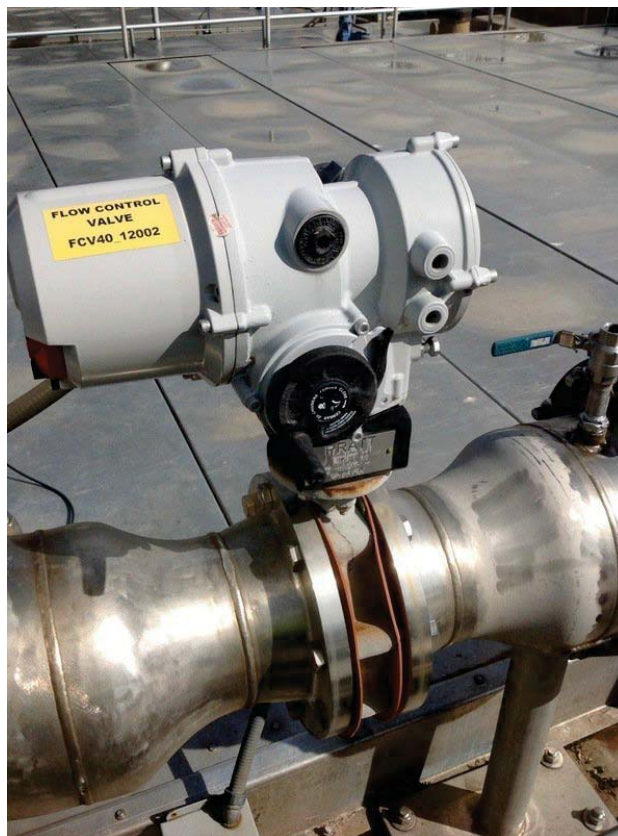
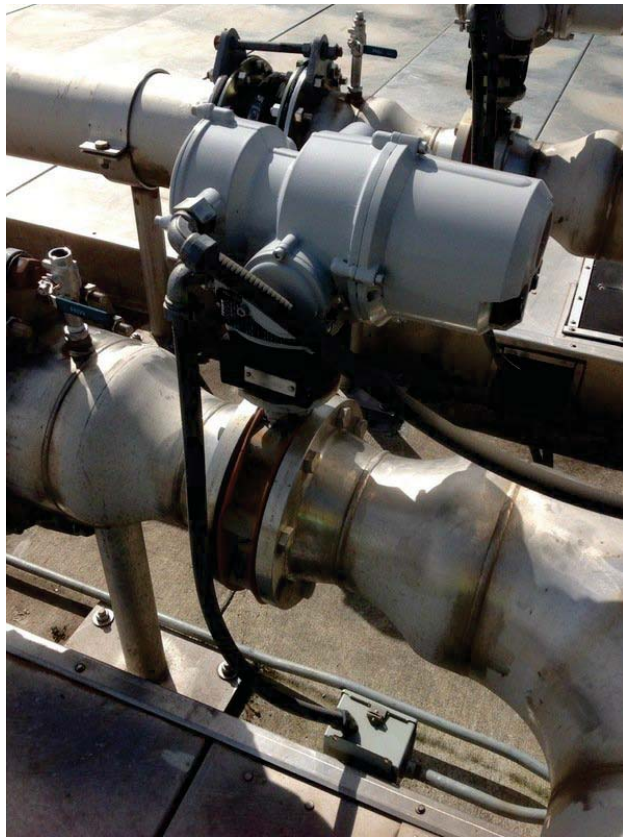
Field Observations	Good condition
Condition Score	2 - Slight Visible Degradation
Performance Score	1 - Component Functioning as Intended
Recommendation	No immediate action required

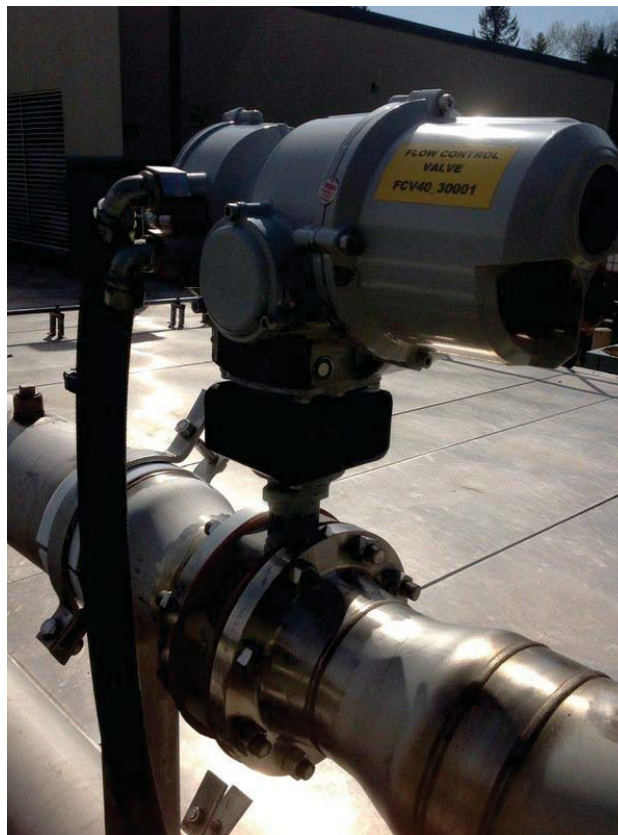
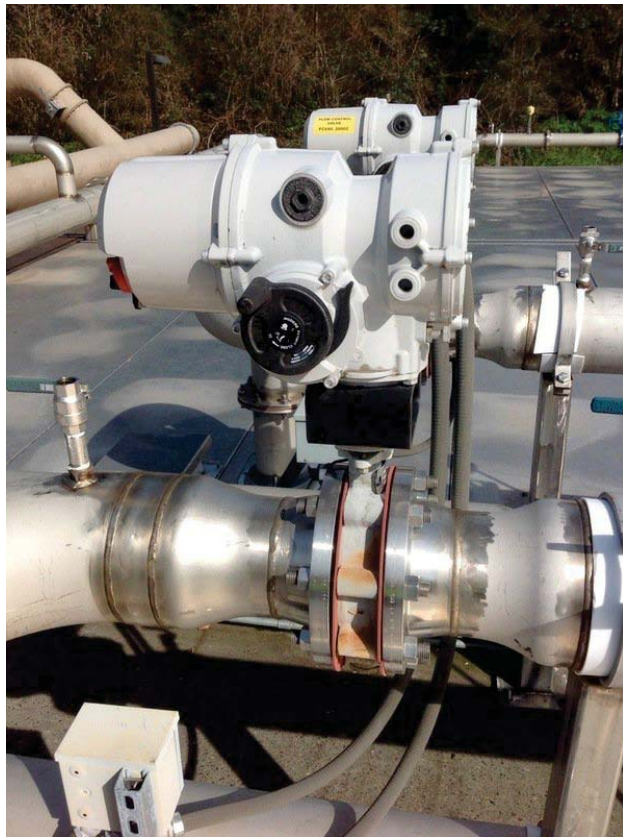
Field Observations	Good condition
Condition Score	2 - Slight Visible Degradation
Performance Score	1 - Component Functioning as Intended
Recommendation	No immediate action required

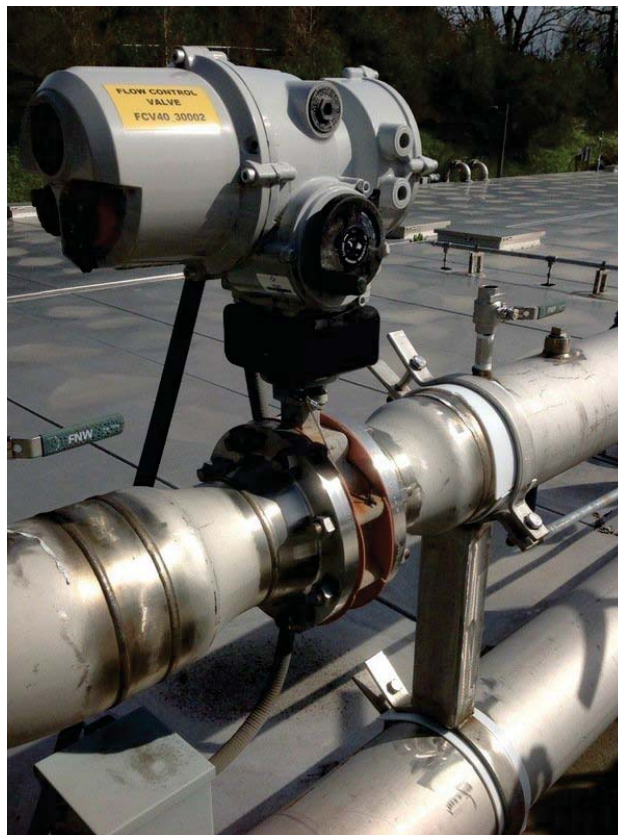
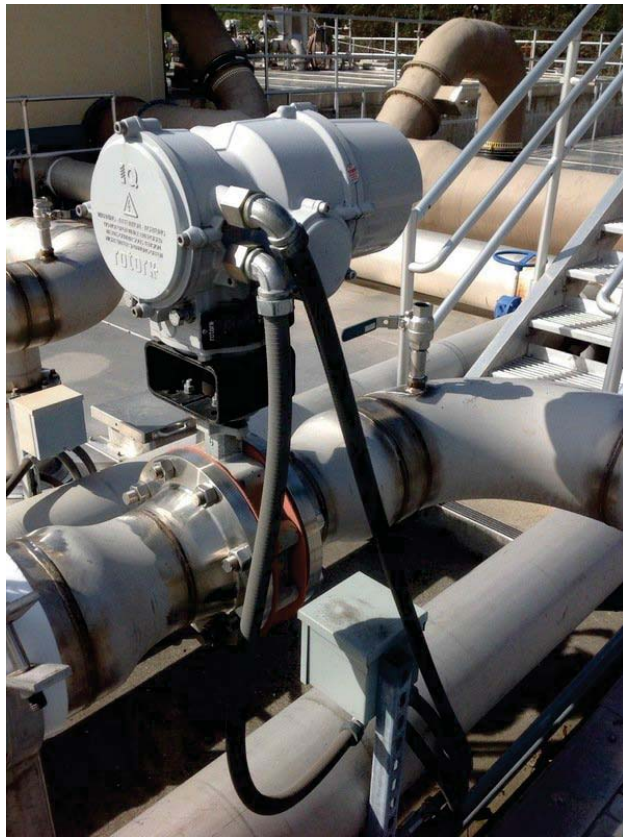
Field Observations	Good condition
Condition Score	2 - Slight Visible Degradation
Performance Score	1 - Component Functioning as Intended
Recommendation	No immediate action required

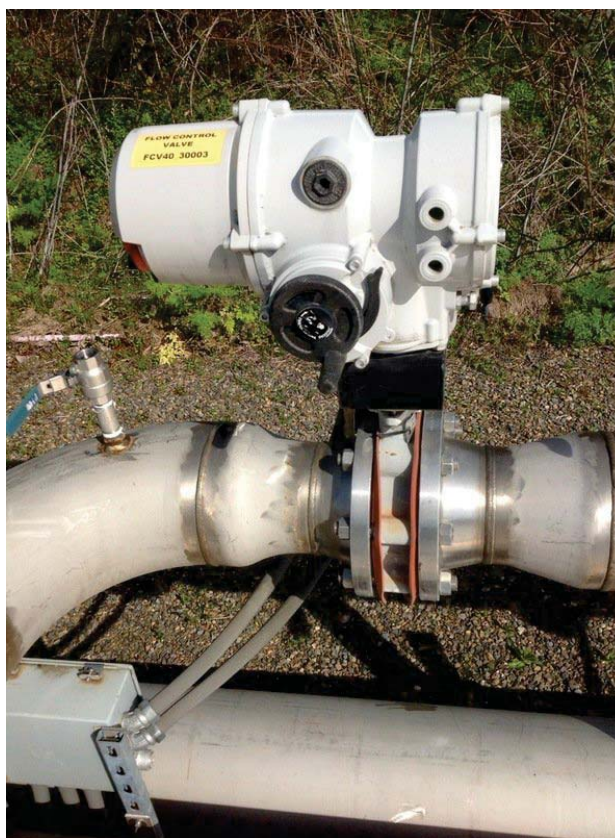
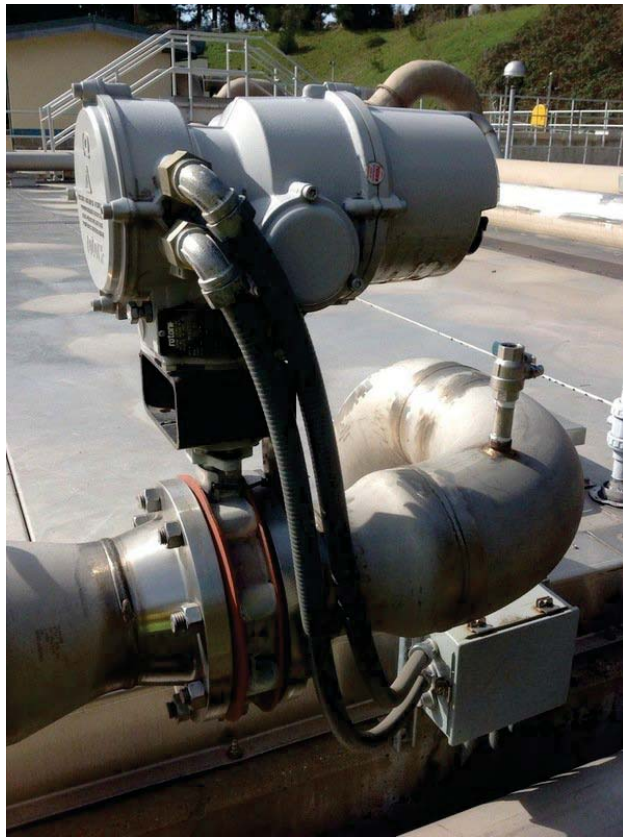
Field Observations	Good condition
Condition Score	2 - Slight Visible Degradation
Performance Score	1 - Component Functioning as Intended
Recommendation	No immediate action required

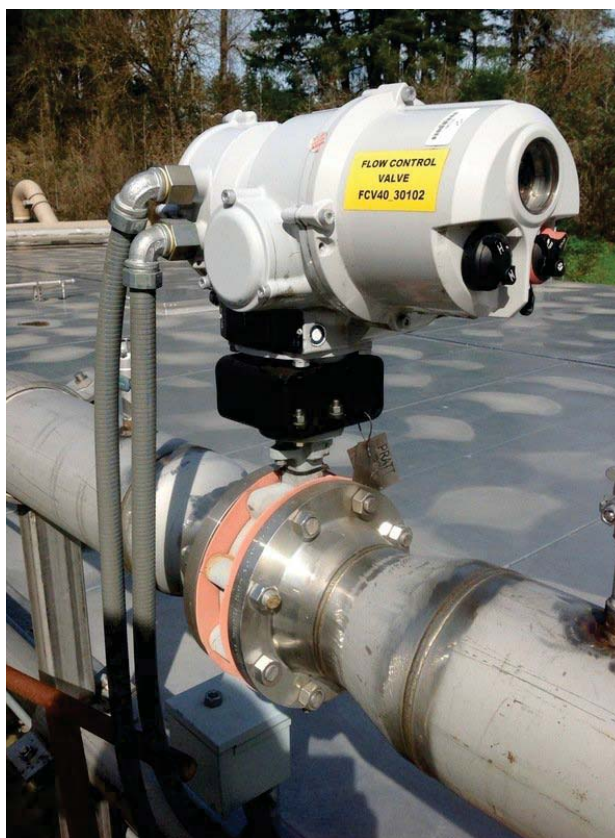
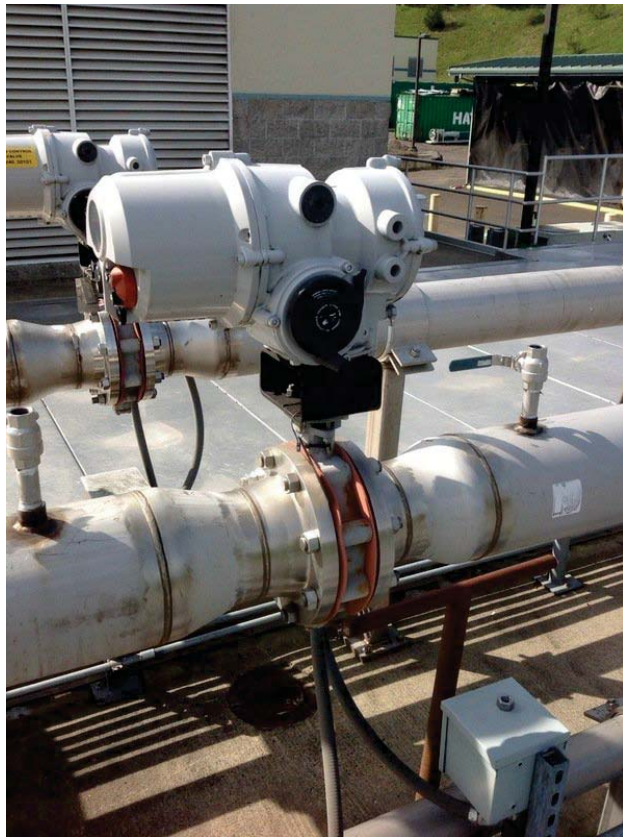
Visual Observations	Good condition
Condition Score	2 - Slight Visible Degradation
Performance Score	1 - Component Functioning as Intended
Recommendation	No immediate action required

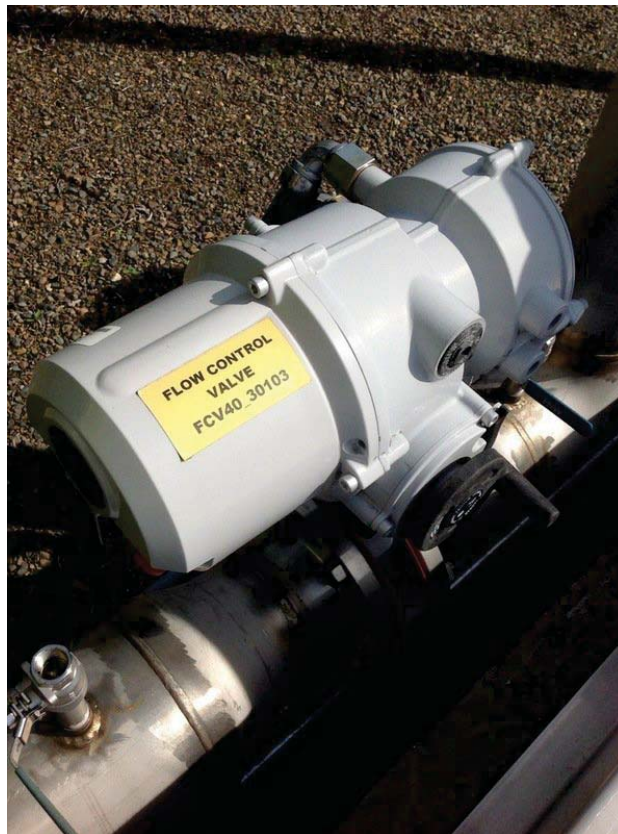
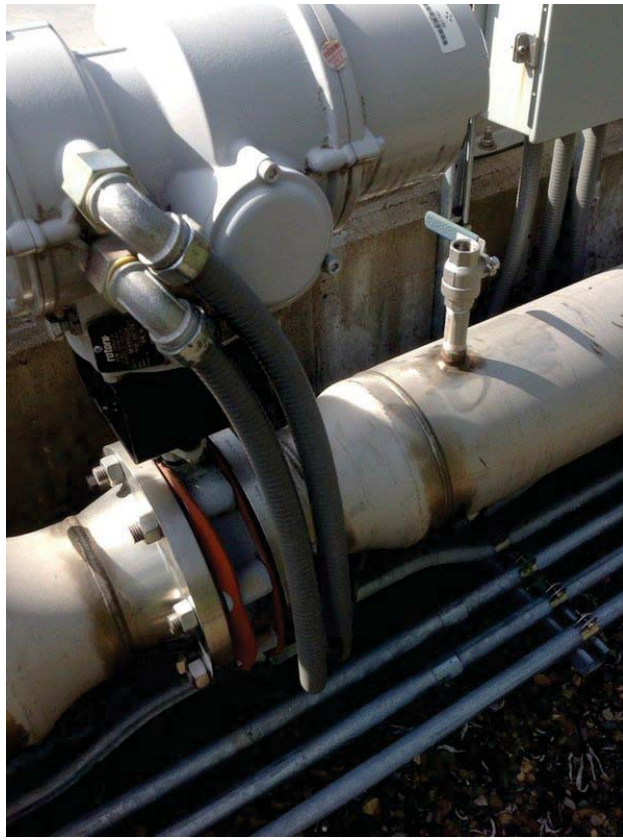
Field Observations	Good condition
Condition Score	2 - Slight Visible Degradation
Performance Score	1 - Component Functioning as Intended
Recommendation	No immediate action required

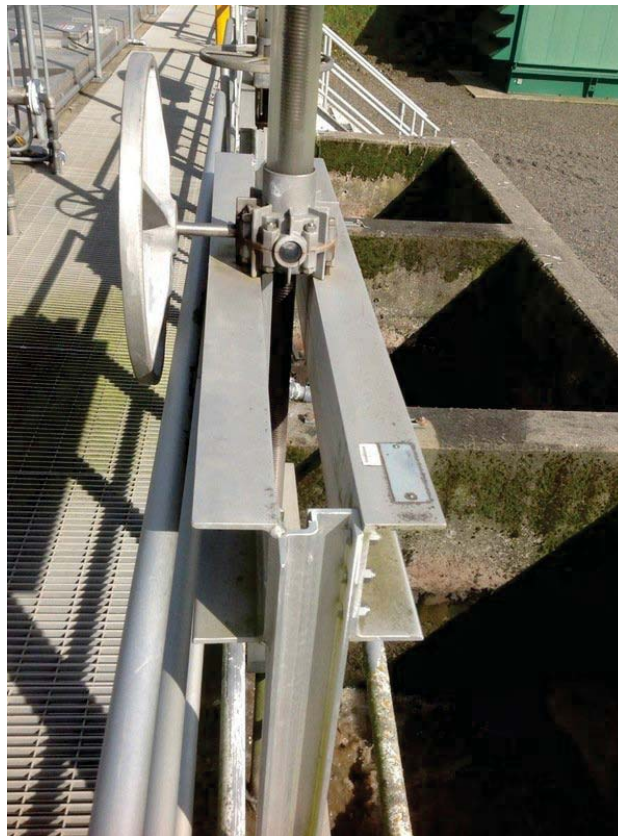
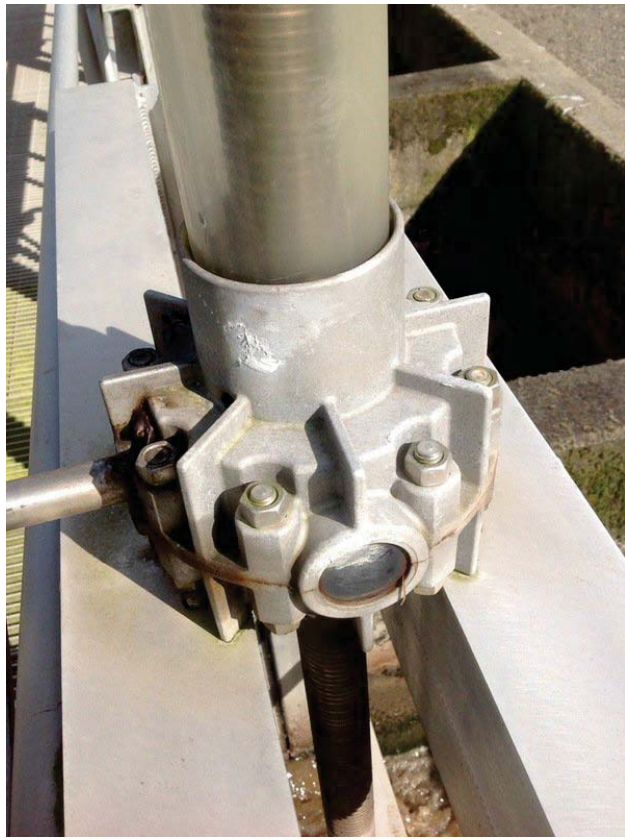
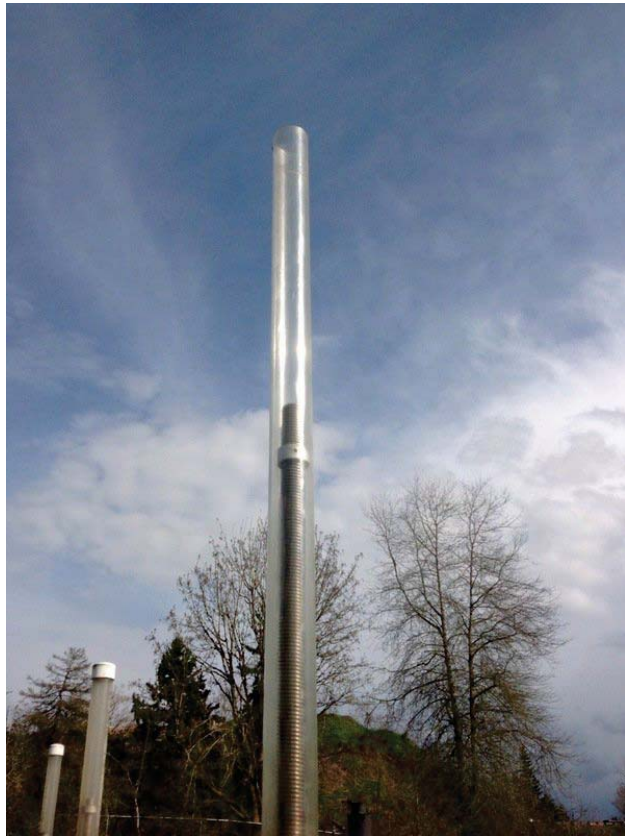
Field Observations	Good condition
Condition Score	2 - Slight Visible Degradation
Performance Score	1 - Component Functioning as Intended
Recommendation	Schedule corrective action work order near term
Field Observations/Comments	Missing cap on valve stem cover

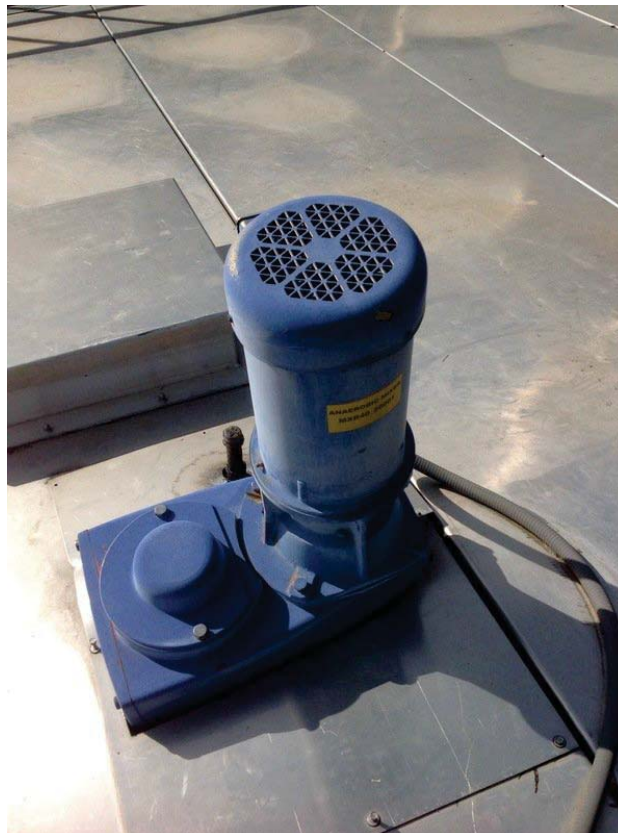
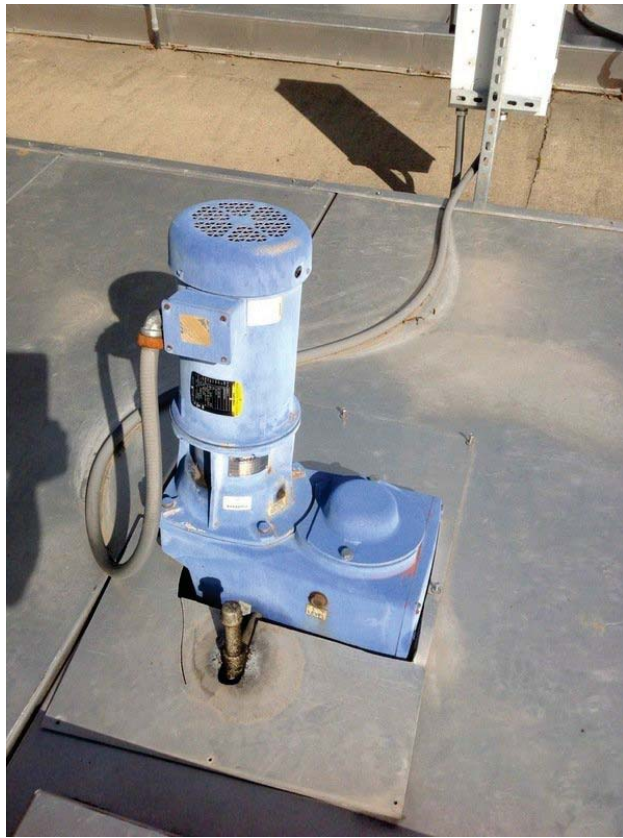
Created	2019-03-28 22:40:19 UTC by Simon Watson
Updated	2019-05-28 19:48:09 UTC by Simon Watson
Location	45.2962724589, -122.770965815
Date	2019-03-28
Time	15:40
Area or Function	Secondary Treatment
Station ID	Mxr40_20002
What type of Asset?	Mechanical
Condition Score	2 - Slight Visible Degradation
Performance Score	1 - Component Functioning as Intended
Recommendation	Schedule corrective action work order near term
Field Observations/Comments	Oil leaking from fill pipe Not in operation
