# City of Wilsonville Triennial Inspection Report

Wilsonville WWTP and  
Wastewater Lift Stations:

Project Title: On-Call Civil Engineering and Related Services,  
Triennial Inspection of the Wilsonville WWTP and Nine Lift Stations

Subject: 2019 Triennial Inspection of the Wilsonville WWTP  
and Sewage Lift Stations

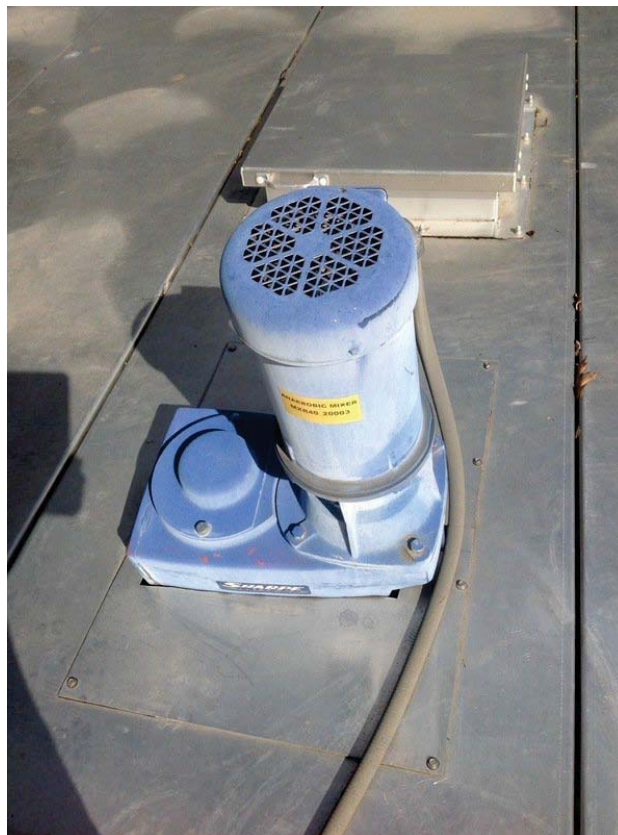
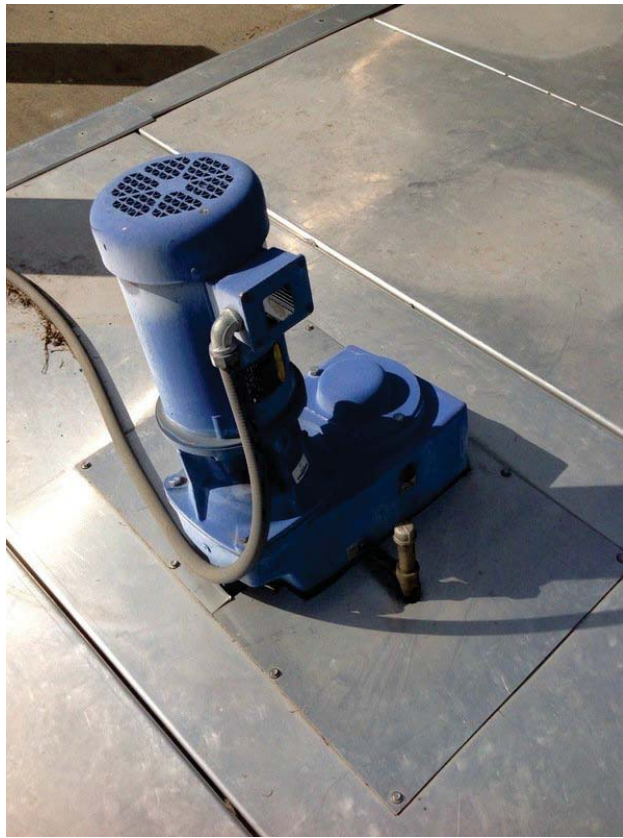
Created	2019-03-28 22:42:30 UTC by Simon Watson
Updated	2019-05-28 19:46:51 UTC by Simon Watson
Location	45.2953085715, -122.770130973
Date	2019-03-28
Time	15:42
Area or Function	Secondary Treatment
Station ID	Mxr40_20003
What type of Asset?	Mechanical
Condition Score	2 - Slight Visible Degradation
Performance Score	1 - Component Functioning as Intended
Recommendation	No immediate action required
Field Observations/Comments	Not in operation

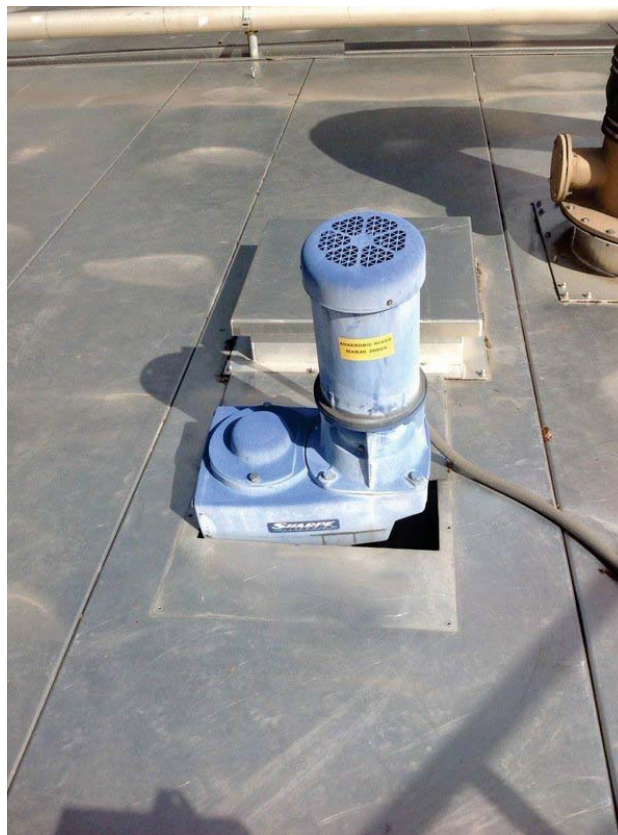
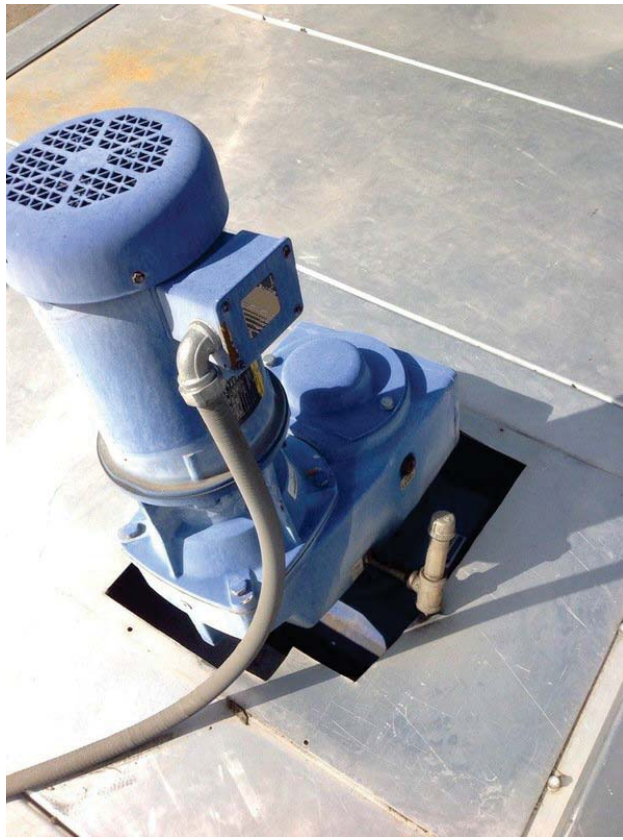
Secondary Treatment	Anaerobic Mixer #4, MXR40-20004
Station ID	MXR40-20004
Asset Description	Anaerobic Mixer #4
What type of Asset?	Mechanical
Condition Score	2 - Slight Visible Degradation
Performance Score	1 - Component Functioning as Intended
Recommendation	No immediate action required
Field Observations/Comments	Not in operation

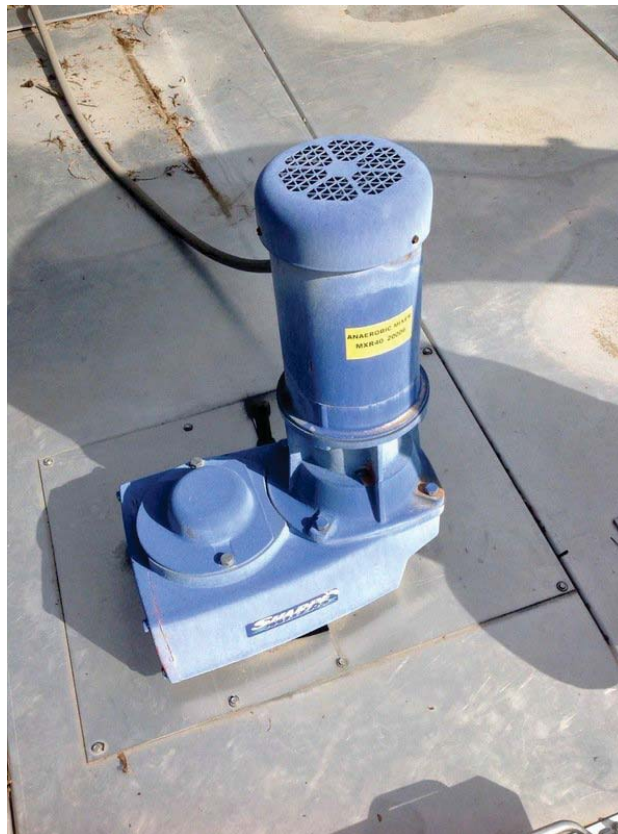
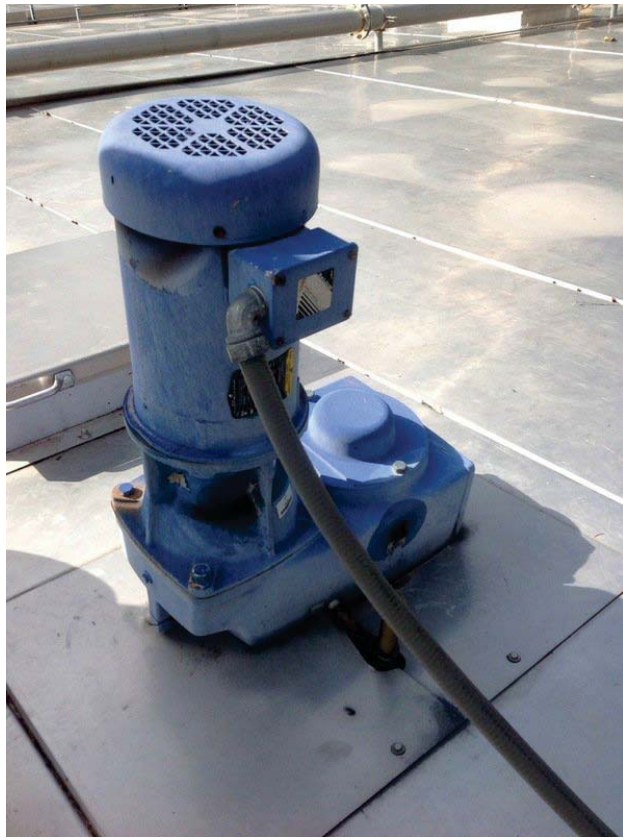
Secondary Treatment	Anaerobic Mixer #6, MXR40-20006
Station ID	MXR40-20006
Asset Description	Anaerobic Mixer #6
What type of Asset?	Mechanical
Condition Score	2 - Slight Visible Degradation
Performance Score	1 - Component Functioning as Intended
Recommendation	No immediate action required
Field Observations/Comments	Not in operation Damp around sight glass

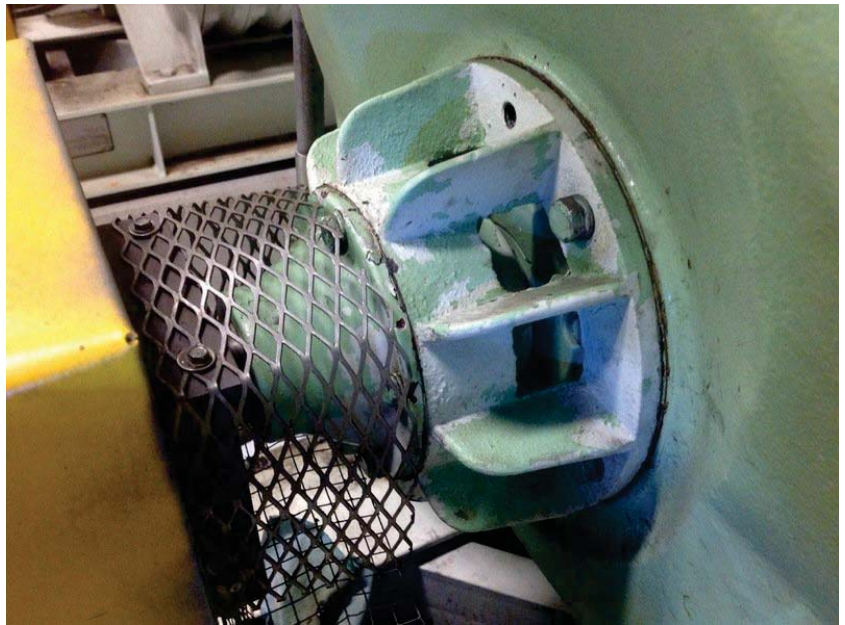
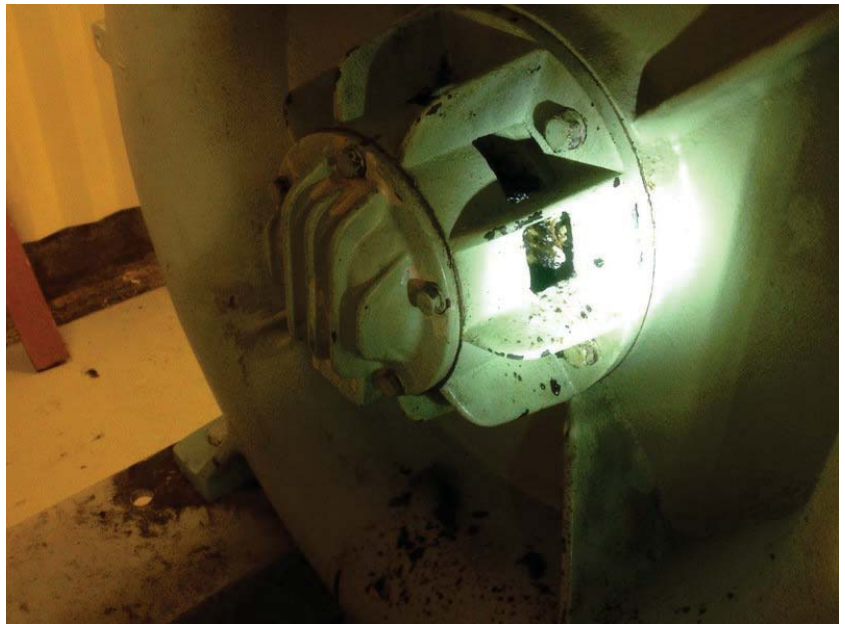
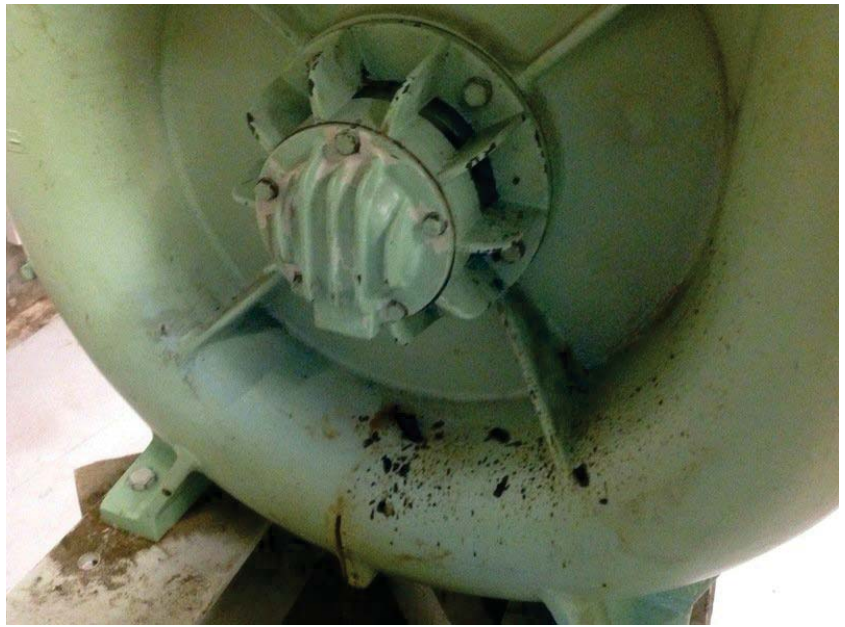
Secondary Treatment	Aeration Basin Blower #1, PGB-M-40-5-1
Station ID	PGB-M-40-5-1
Asset Description	Aeration Basin Blower #1
What type of Asset?	Mechanical
Condition Score	2 - Slight Visible Degradation
Performance Score	1 - Component Functioning as Intended
Recommendation	No immediate action required
Field Observations/Comments	Excessive grease on outboard bearing or seal is leaking Not in operation

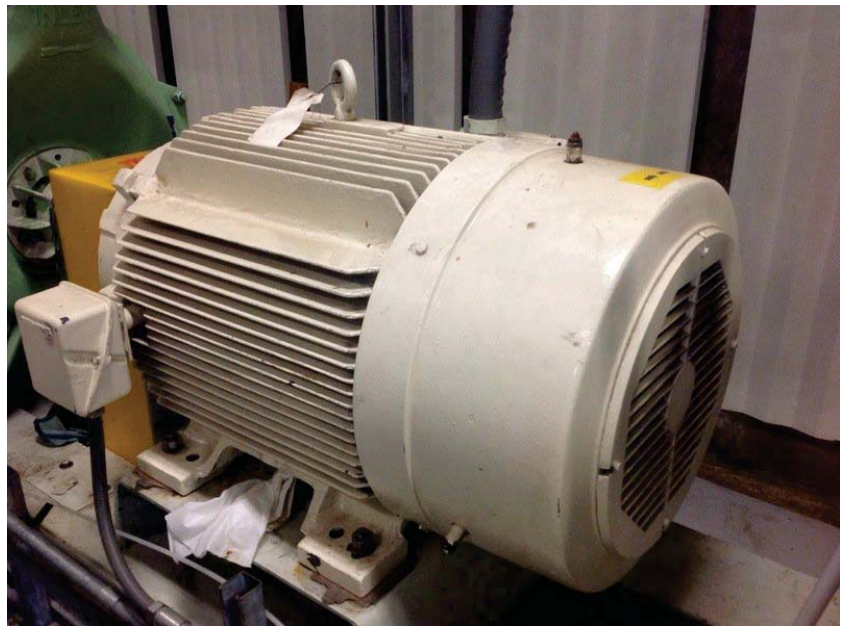
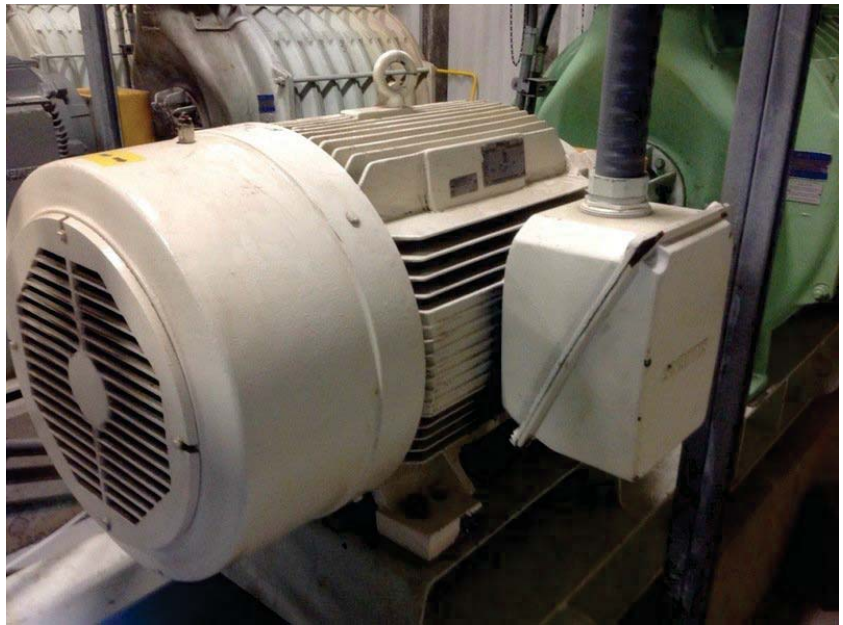
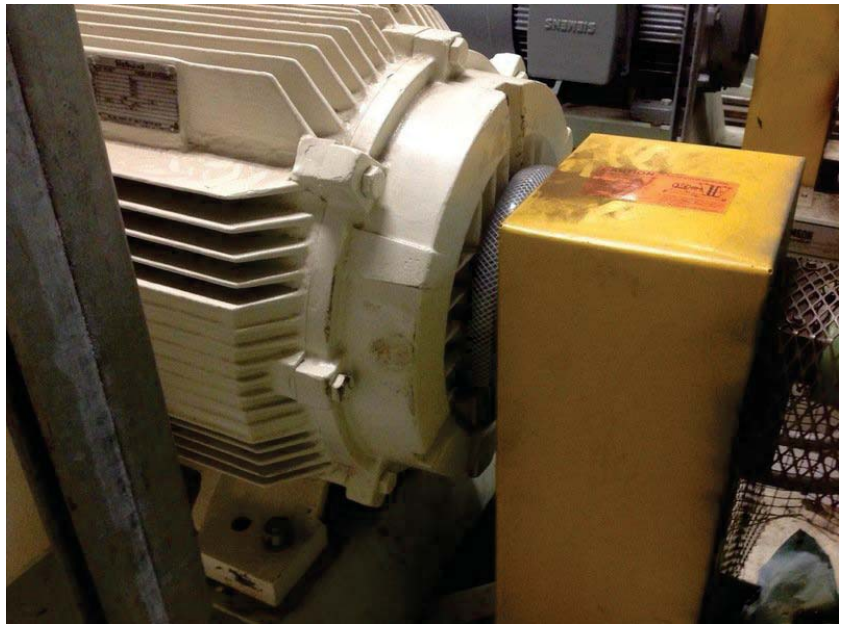
Description	Aeration Basin Blower Motor #1
Condition Score	2 - Slight Visible Degradation
Performance Score	1 - Component Functioning as Intended
Recommendation	No immediate action required
Field Observations/Comments	Not in operation

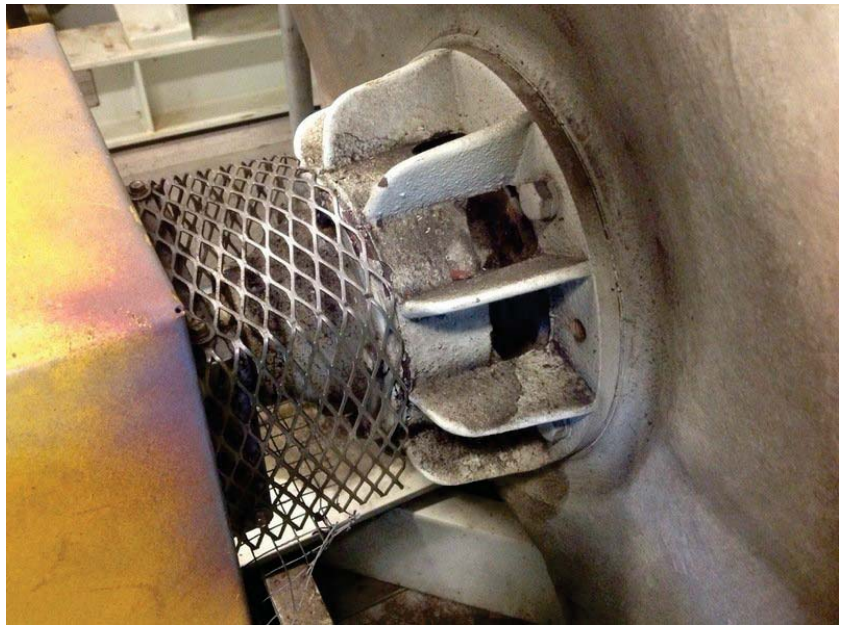
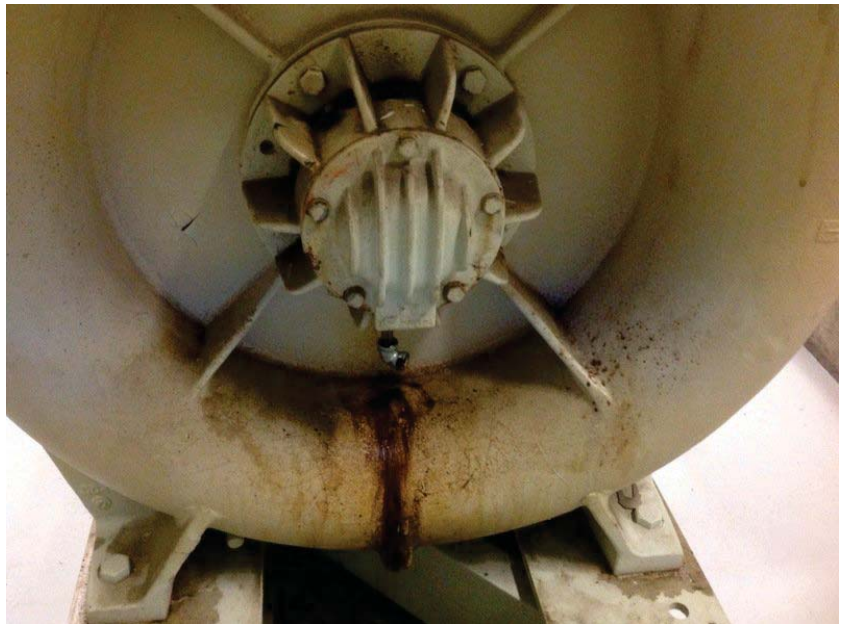
Field observations	Leaking
Condition Score	2 - Slight Visible Deterioration
Performance Score	1 - Component Functioning as Intended
Recommendation	Schedule corrective action work order near term
Field observations & Comments	Out of operation Both bearings have excessive grease or seals are leaking Not sure why open drain line is on the outboard bearing Grease leaking from discharge valve stem

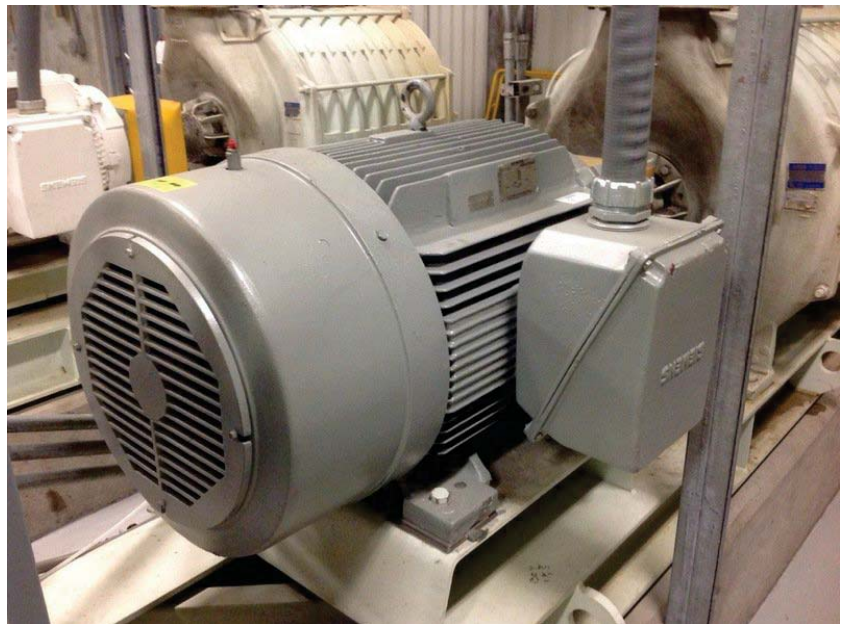
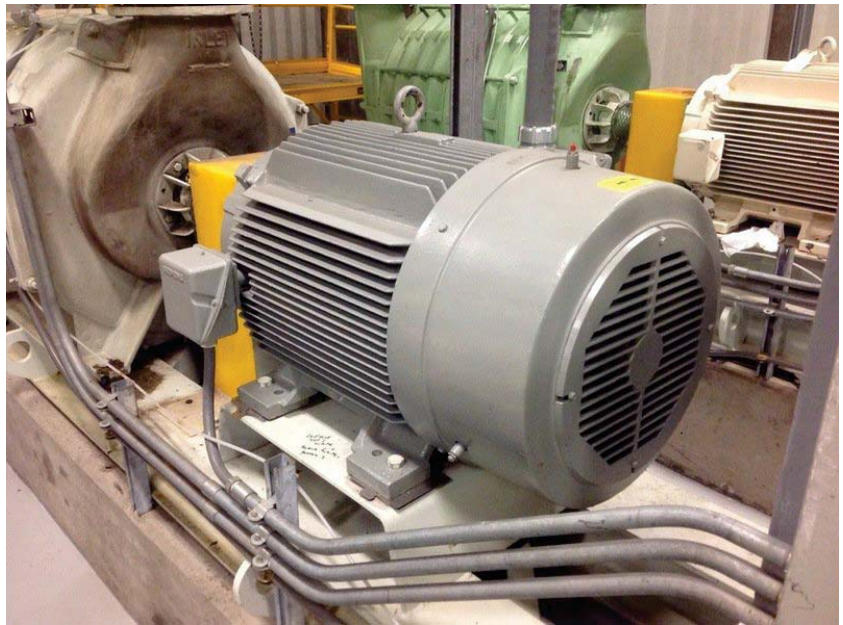
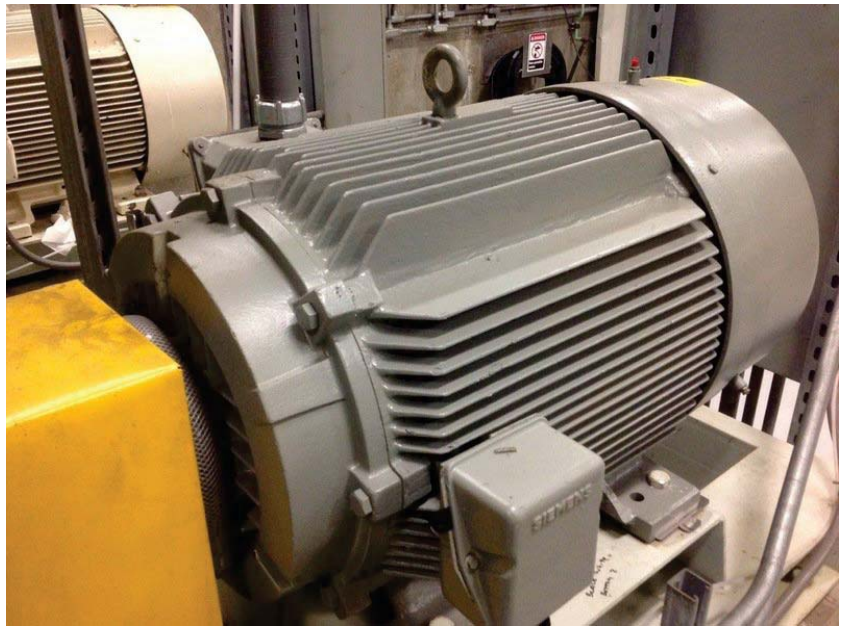
Description	Aeration Basin Blower Motor #2
Condition Score	2 - Slight Visible Degradation
Performance Score	1 - Component Functioning as Intended
Recommendation	No immediate action required
Field Observations/Comments	Not in operation

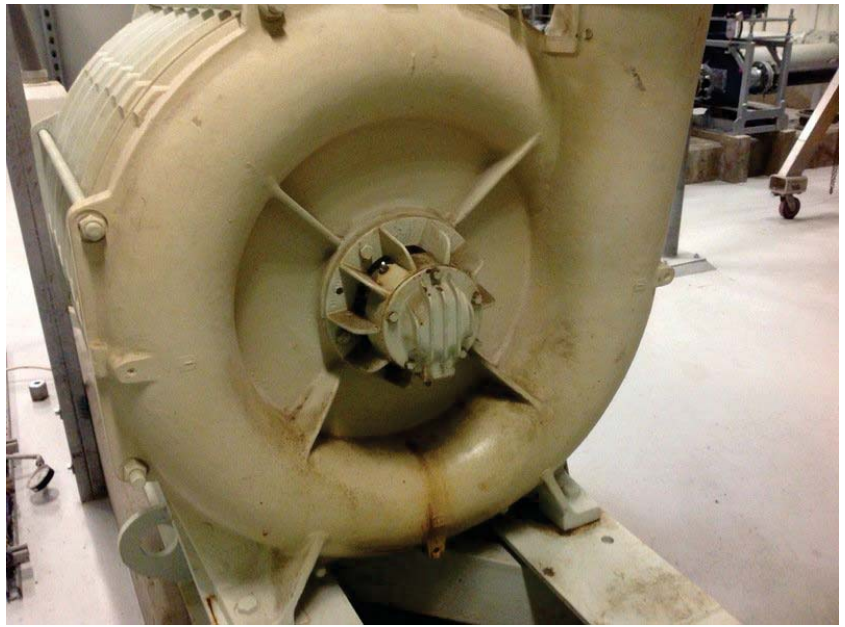
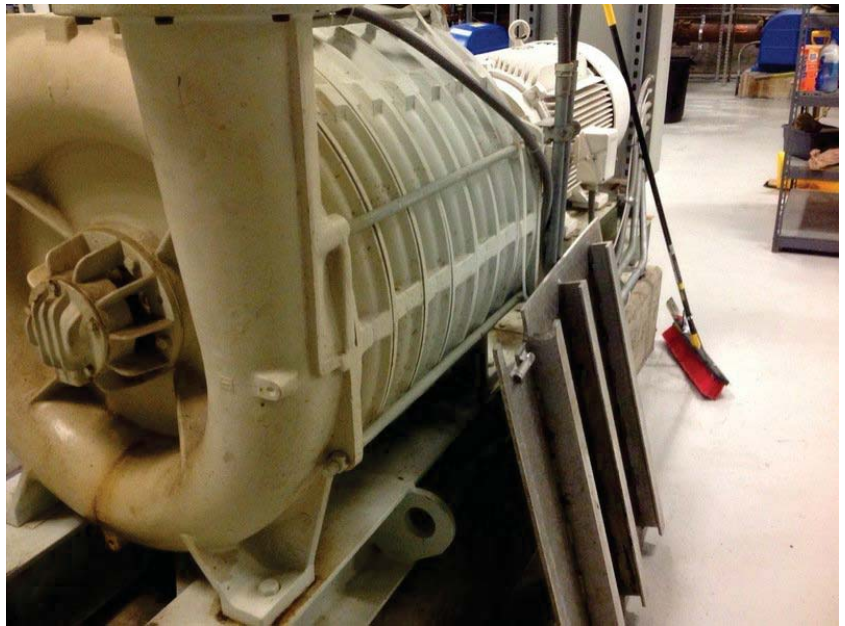
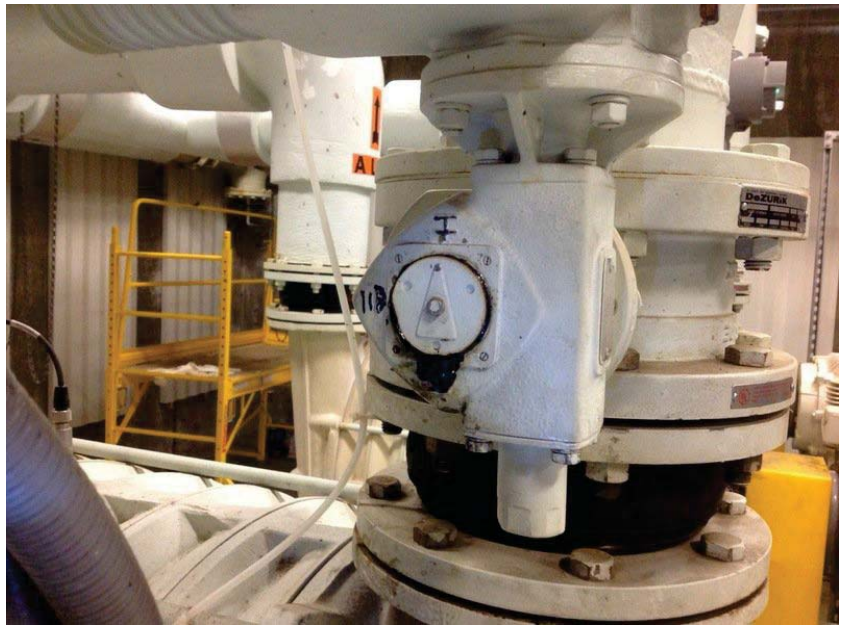
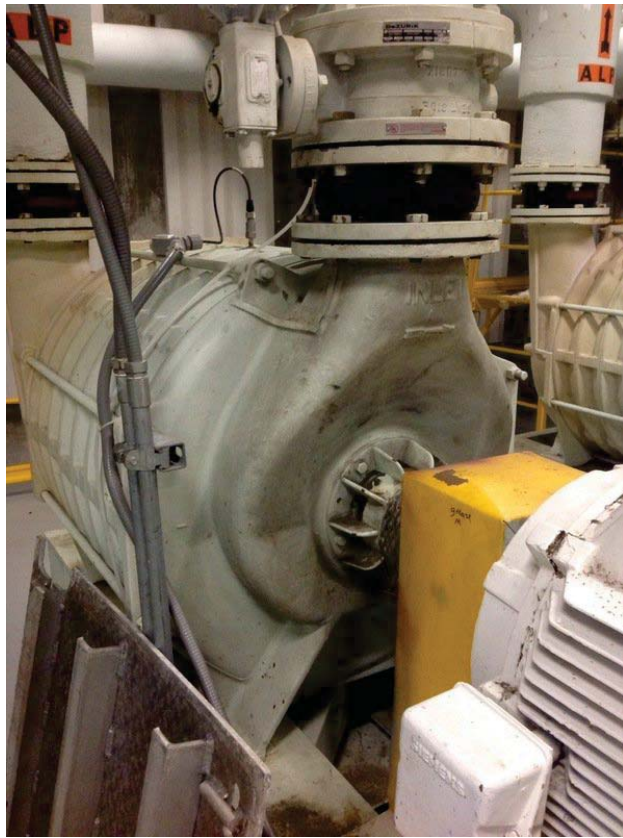
Field Observations	Leaking
Condition Score	2 - Slight Visible Degradation
Performance Score	1 - Component Functioning as Intended
Recommendation	No immediate action required
Field Observations/Comments	Outboard bearing seal appears to be starting to fail Grease leaking from discharge valve stem Not in operation

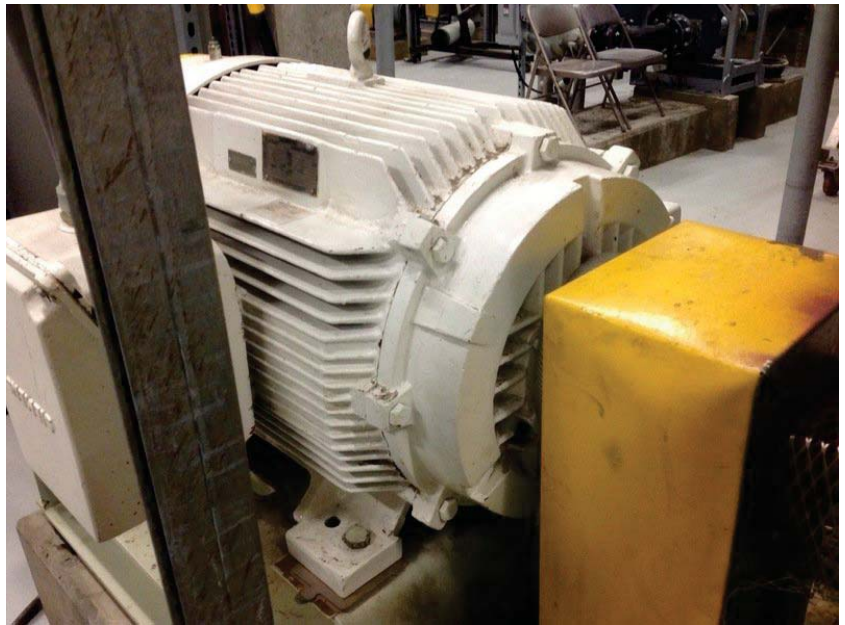
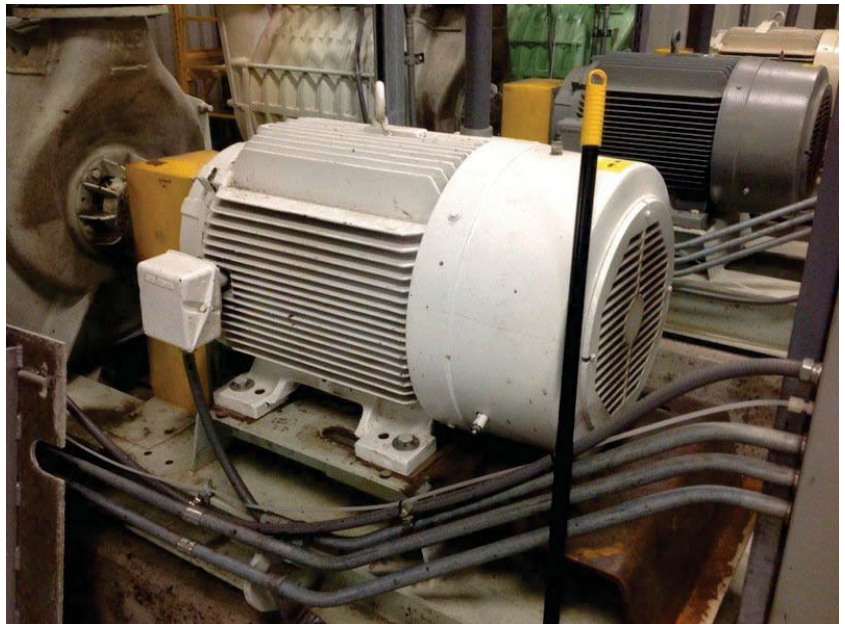
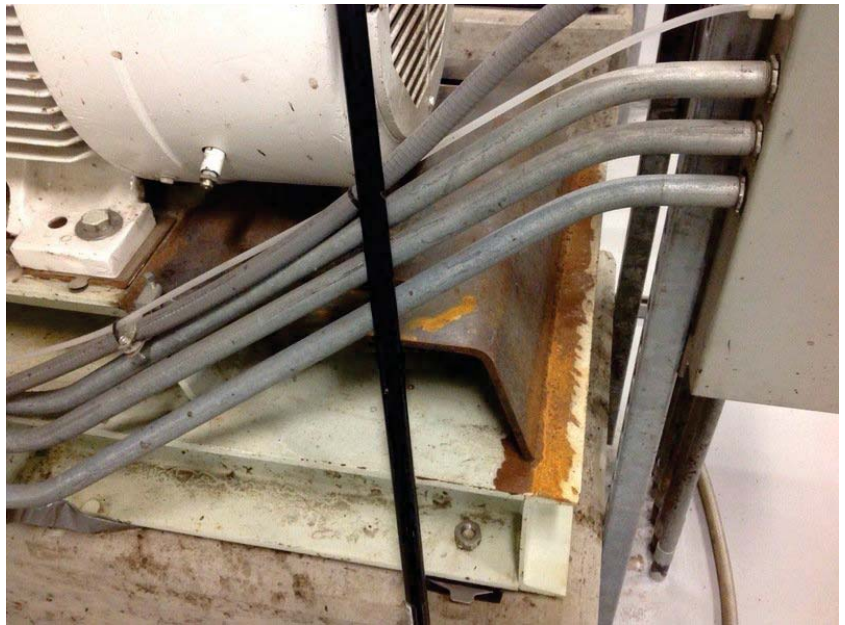
Description	Aeration Basin Blower Motor #3
Field observations	Corrosion
Condition Score	2 - Slight Visible Degradation
Performance Score	1 - Component Functioning as Intended
Recommendation	Schedule corrective action work order near term
Field observations/Comments	Part of base has no coating Out in operation

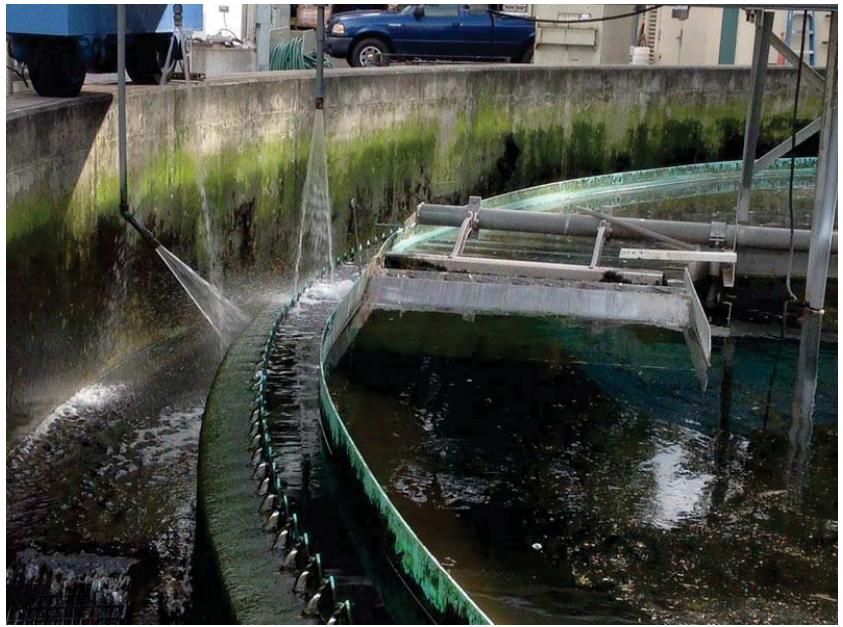
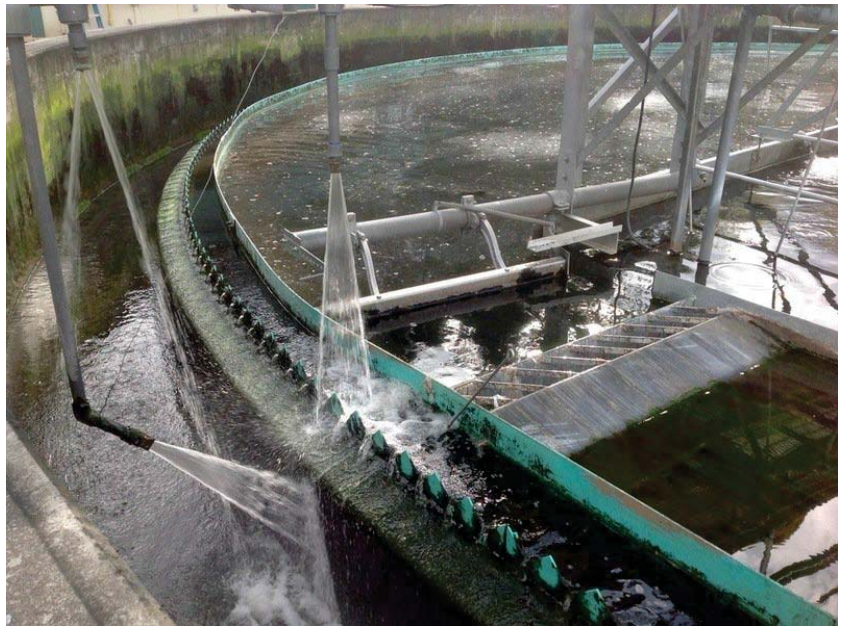
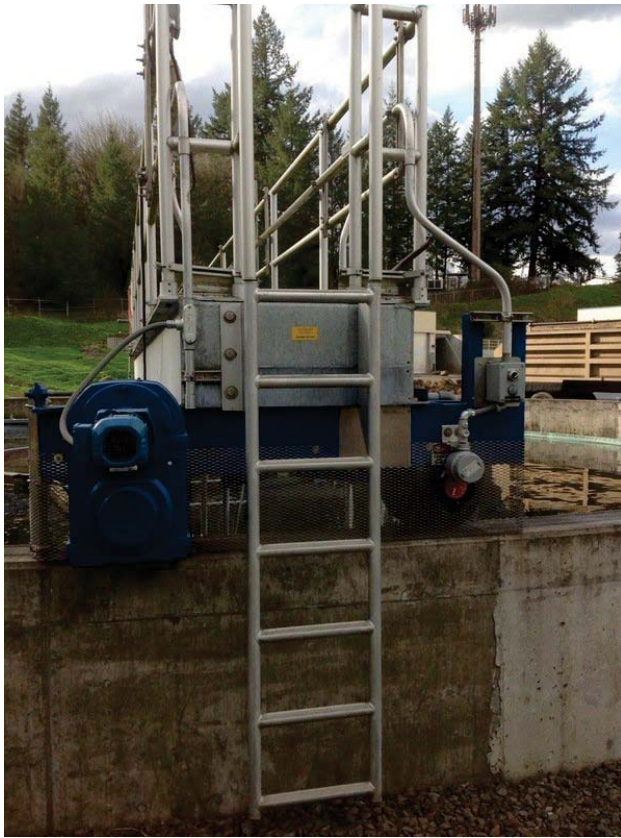
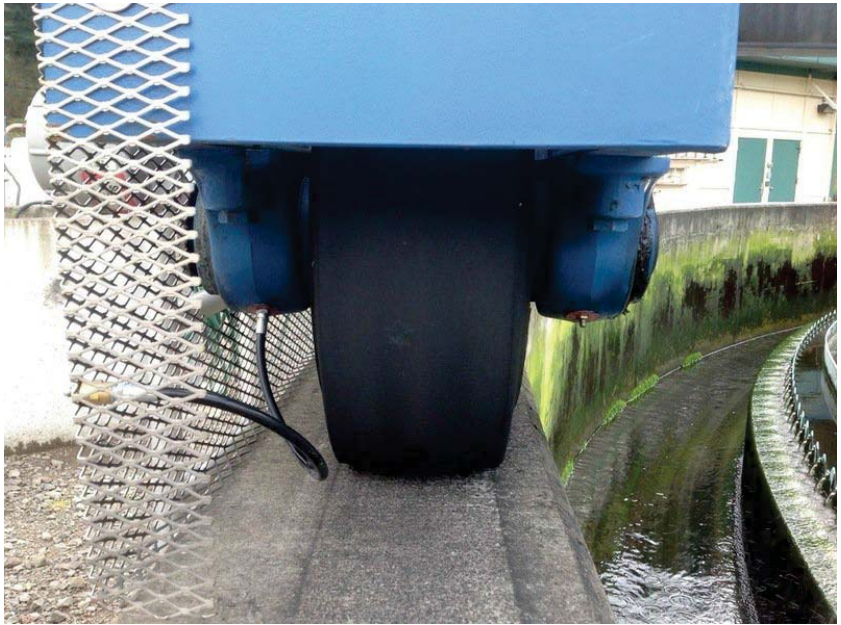
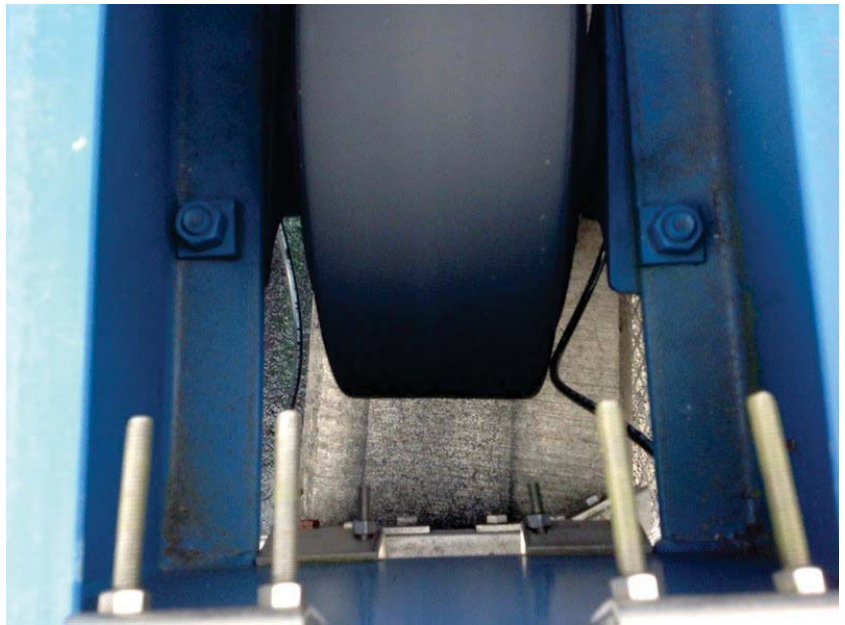
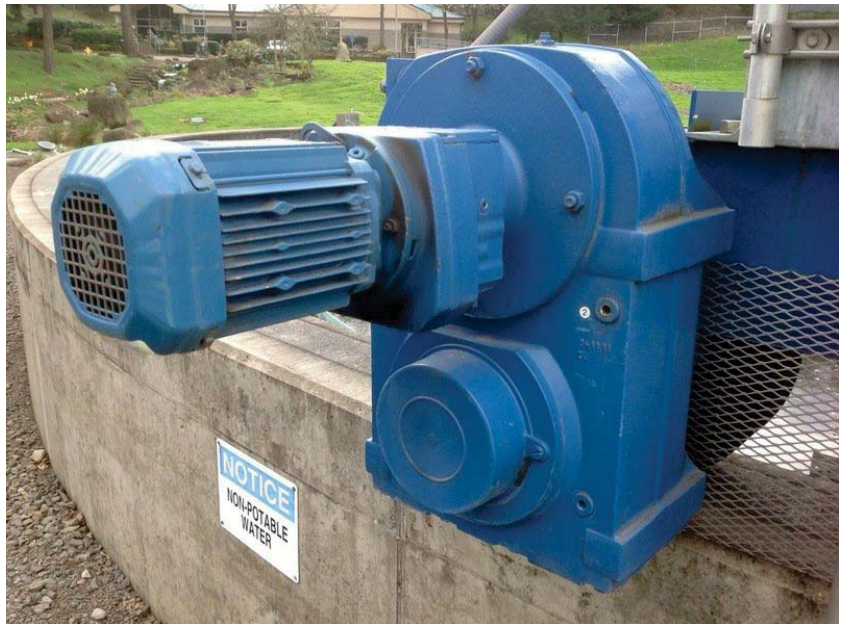
Secondary Treatment	Secondary Clarifier #3, CLR50-00103
Station ID	CLR50-00103
Asset Description	Secondary Clarifier #3
What type of Asset?	Mechanical
Condition Score	2 - Slight Visible Degradation
Performance Score	1 - Component Functioning as Intended
Recommendation	No immediate action required
Field Observations/Comments	Slight oil leak between motor and gearbox

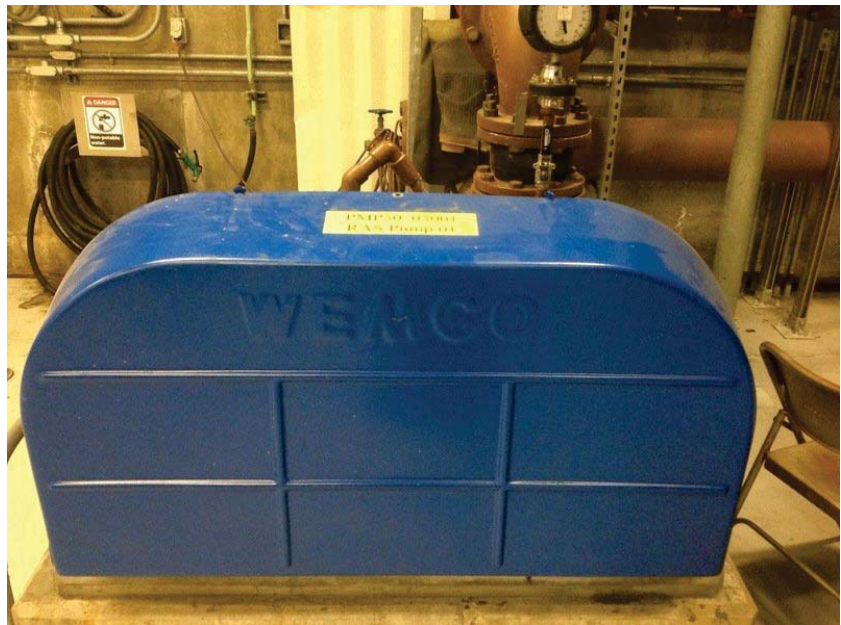
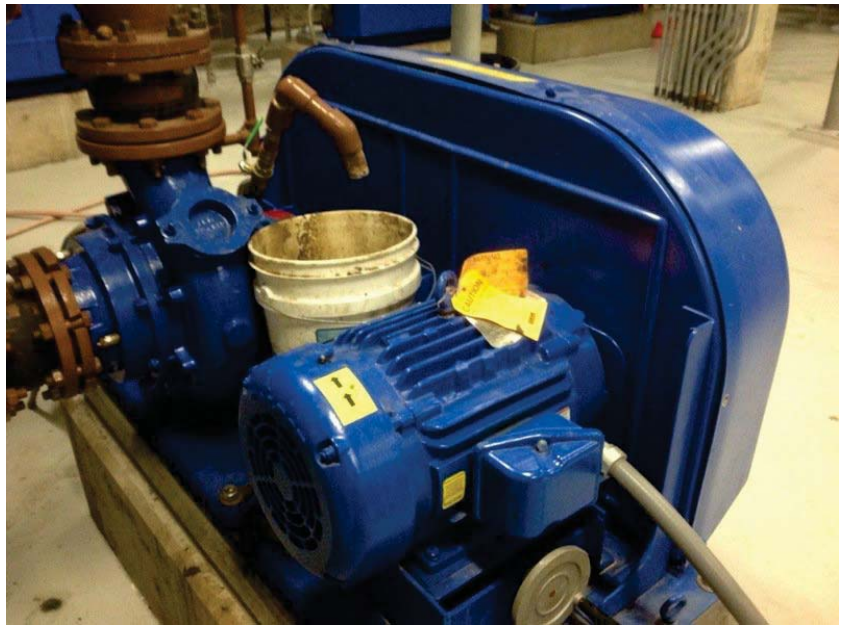
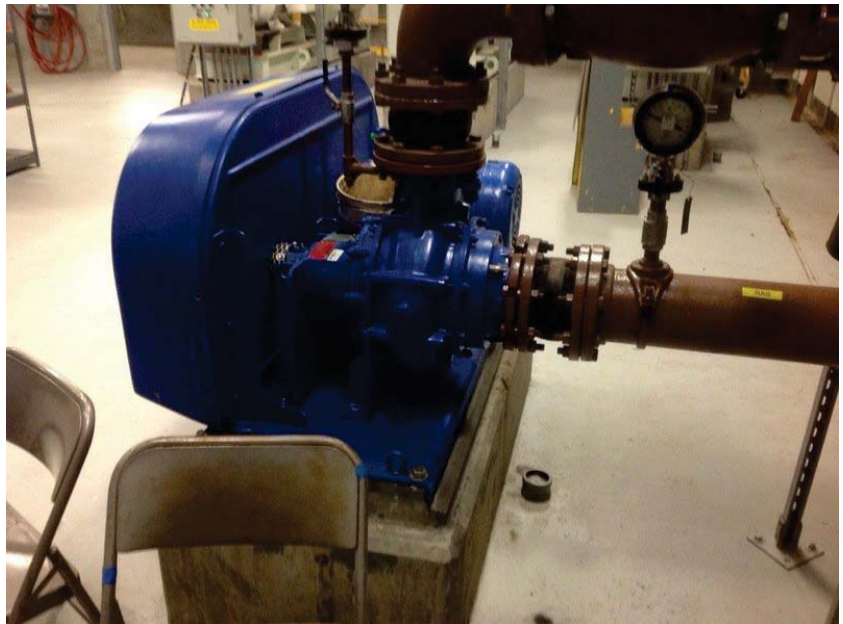
Secondary Treatment	RAS Pump #1, PMP50-03001
Station ID	PMP50-03001
What type of Asset?	Pumps and Motors
Condition Score	2 - Slight Visible Degradation
Performance Score	1 - Component Functioning as Intended
Recommendation	No immediate action required
Field Observations/Comments	No issues

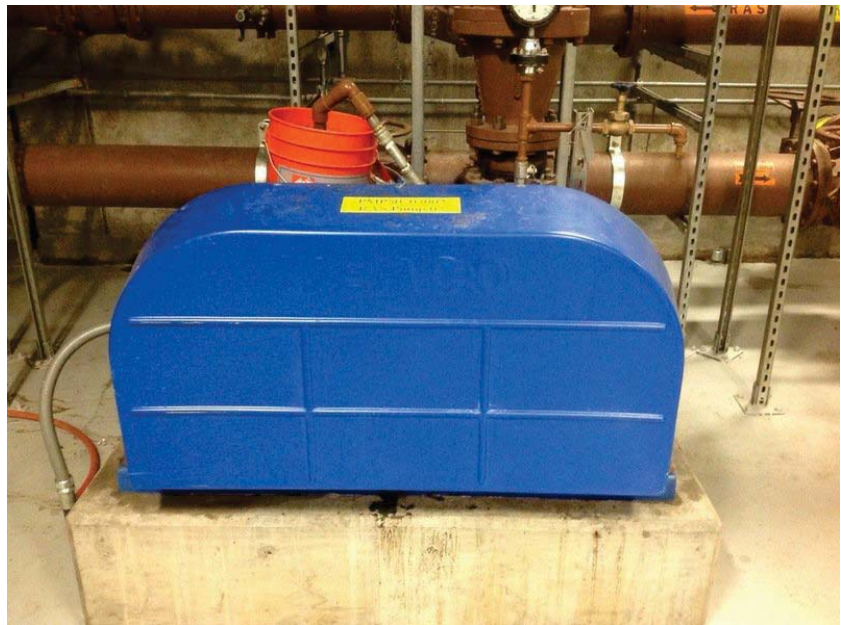
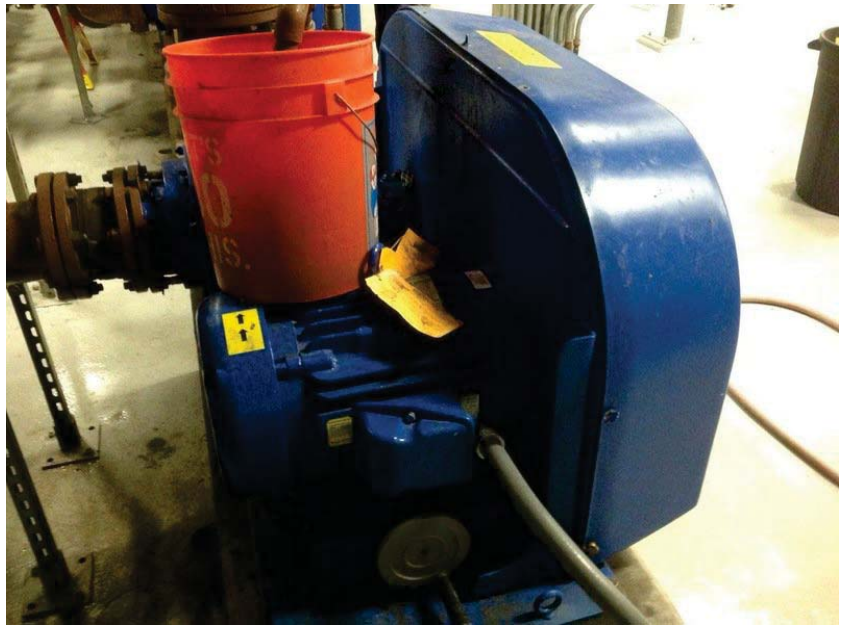
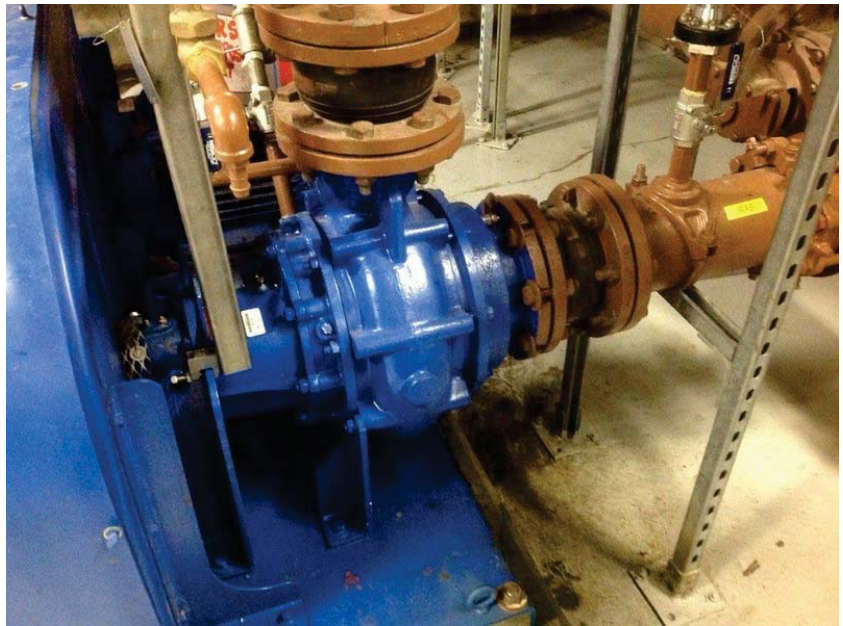
Secondary Treatment	RAS Pump #2, PMP50-03002
Station ID	PMP50-03002
What type of Asset?	Pumps and Motors
Condition Score	2 - Slight Visible Degradation
Performance Score	1 - Component Functioning as Intended
Recommendation	No immediate action required
Field Observations/Comments	No Issues

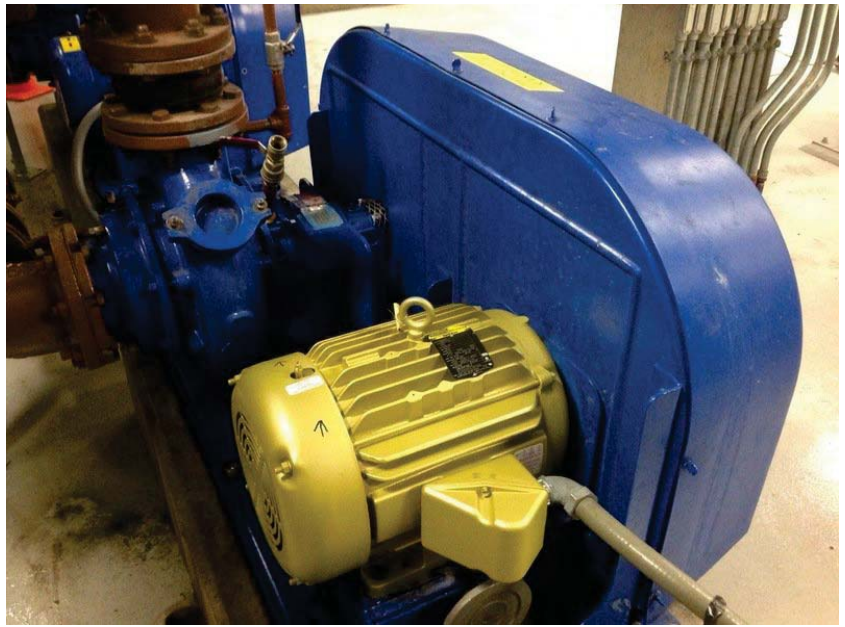
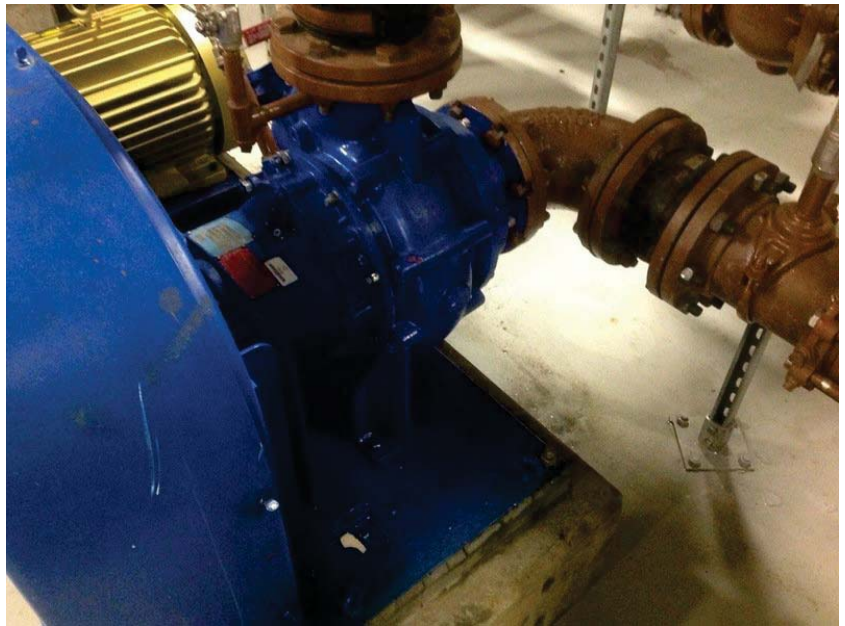
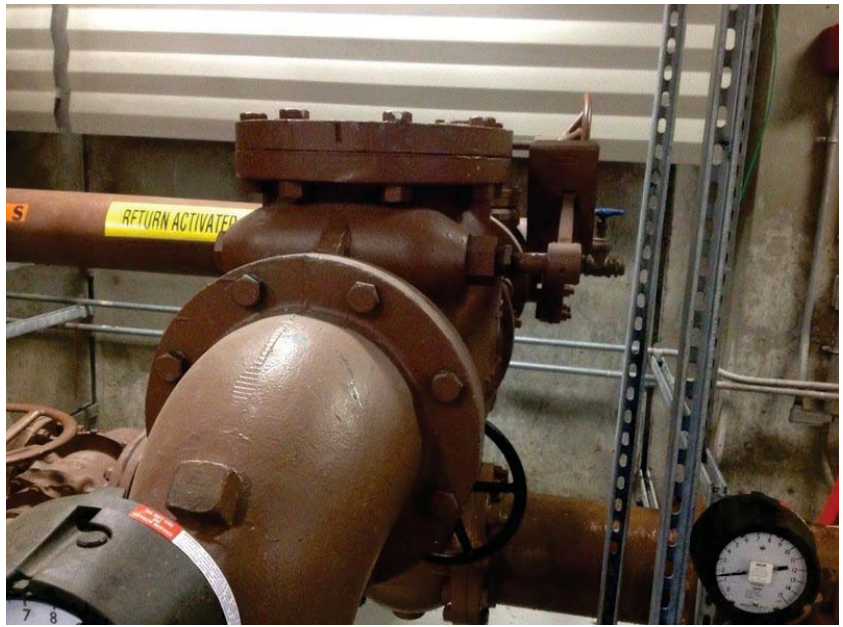
Secondary Treatment	RAS Pump #3, PMP50-03003
Station ID	PMP50-03003
What type of Asset?	Pumps and Motors
Condition Score	2 - Slight Visible Degradation
Performance Score	1 - Component Functioning as Intended
Recommendation	No immediate action required
Field Observations/Comments	Slight leak on check valve packing

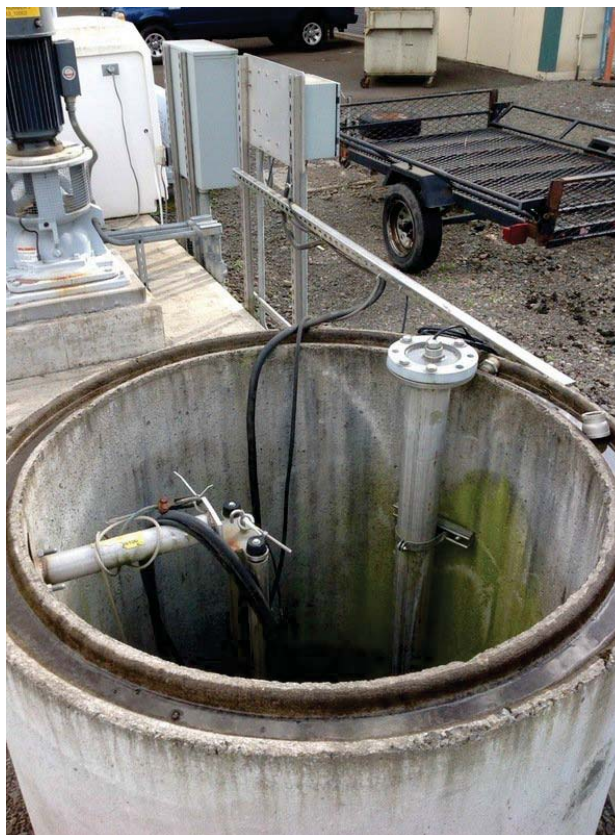
Secondary Treatment	Scum Pump, PMP50-20100
Station ID	PMP50-20100
What type of Asset?	Pumps and Motors
Condition Score	2 - Slight Visible Degradation
Performance Score	1 - Component Functioning as Intended
Recommendation	No immediate action required
Field Observations/Comments	Not operating
