# City of Wilsonville Triennial Inspection Report

Wilsonville WWTP and  
Wastewater Lift Stations:

Project Title: On-Call Civil Engineering and Related Services,  
Triennial Inspection of the Wilsonville WWTP and Nine Lift Stations

Subject: 2019 Triennial Inspection of the Wilsonville WWTP  
and Sewage Lift Stations

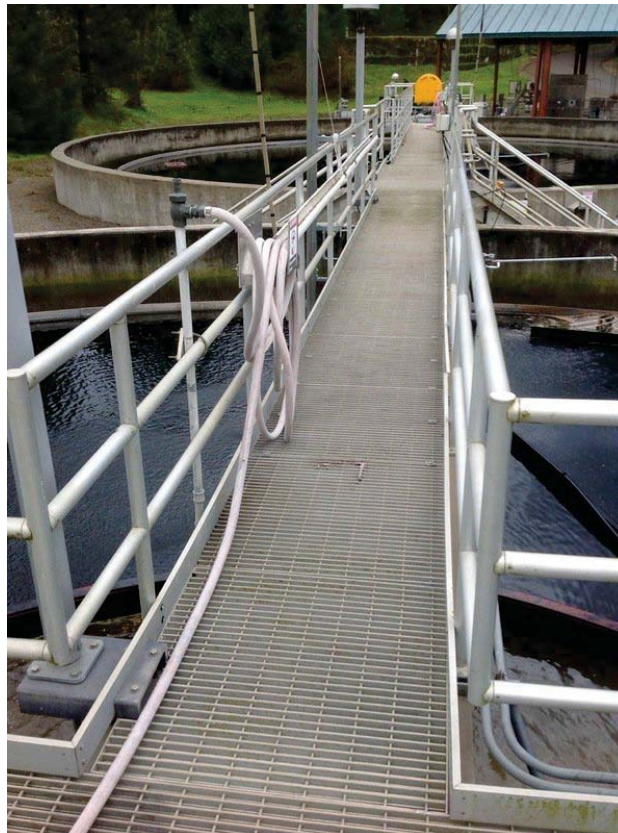
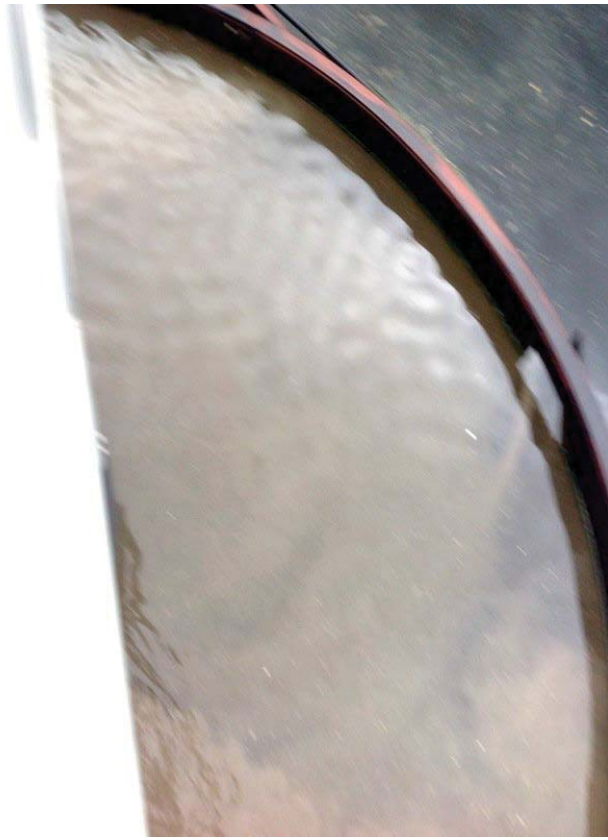
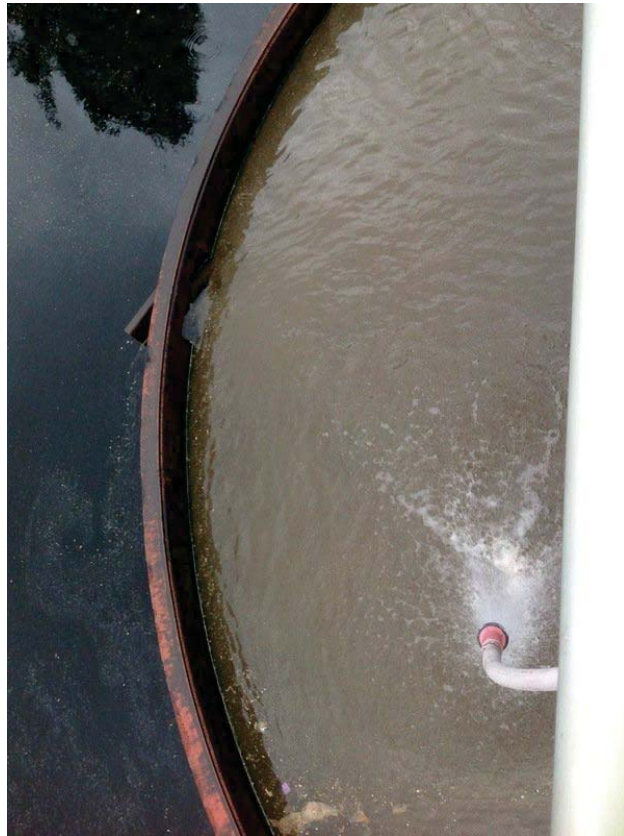
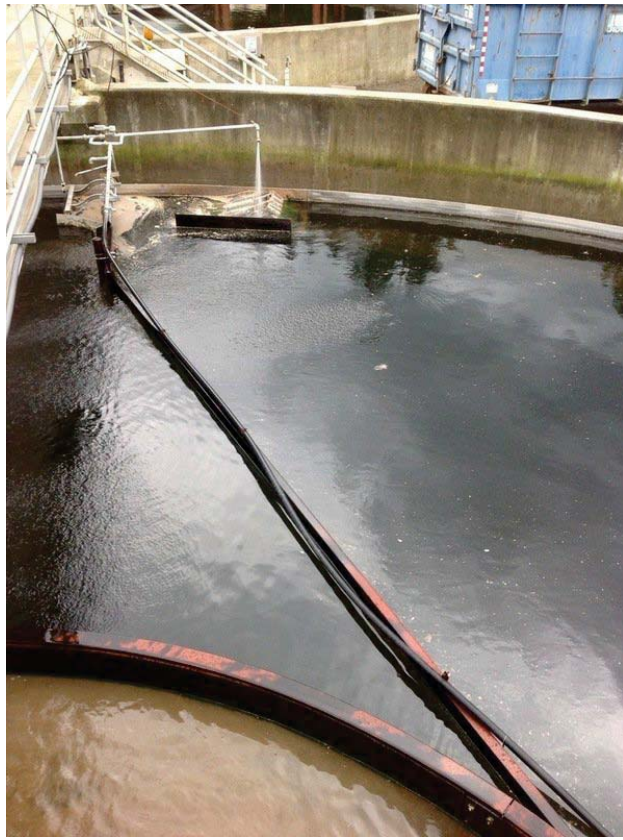
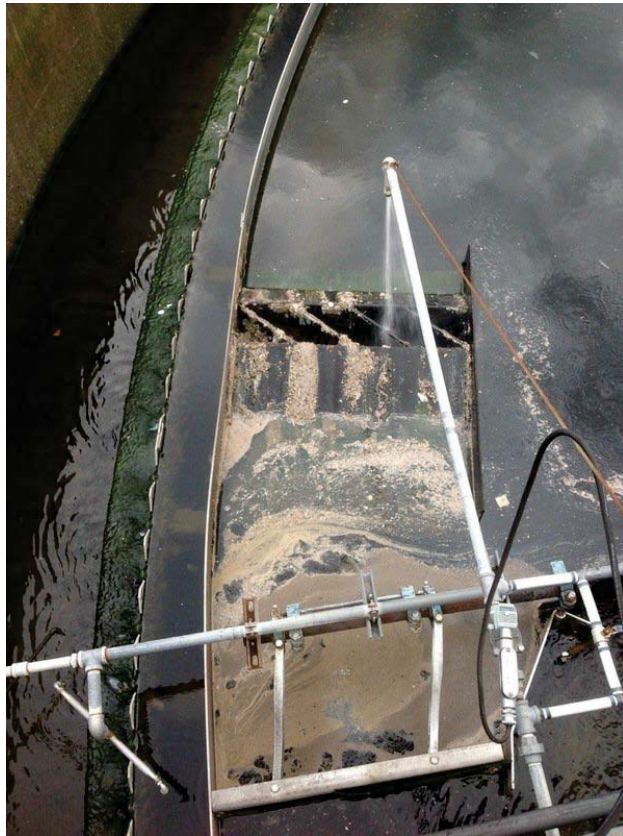
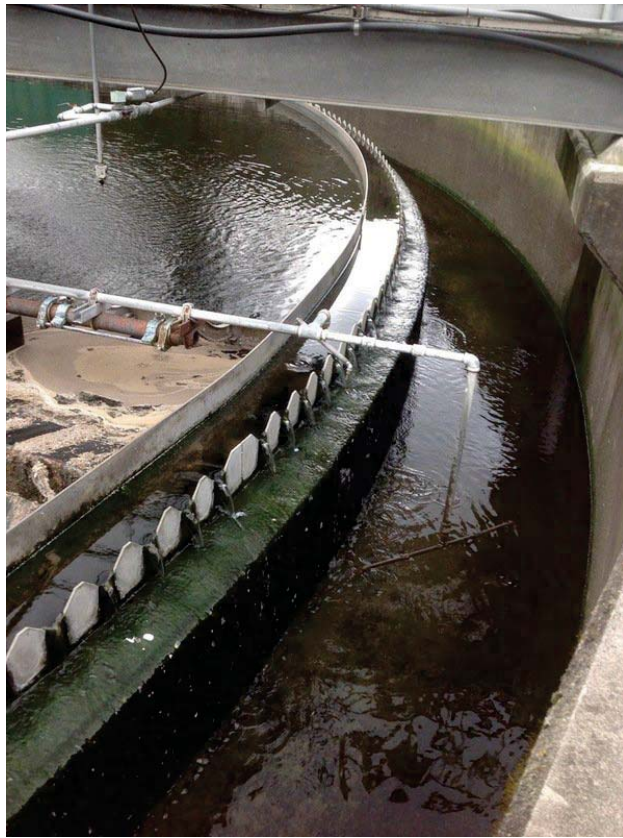
Secondary Treatment	Secondary Clarifier #1, SC-50-1-1
Station ID	SC-50-1-1
Asset Description	Secondary Clarifier #1
What type of Asset?	Mechanical
Condition Score	2 - Slight Visible Degradation
Performance Score	2 - In Service, but higher than Expected O&M
Recommendation	Schedule corrective action work order near term
Field Observations/Comments	Weir washers not working

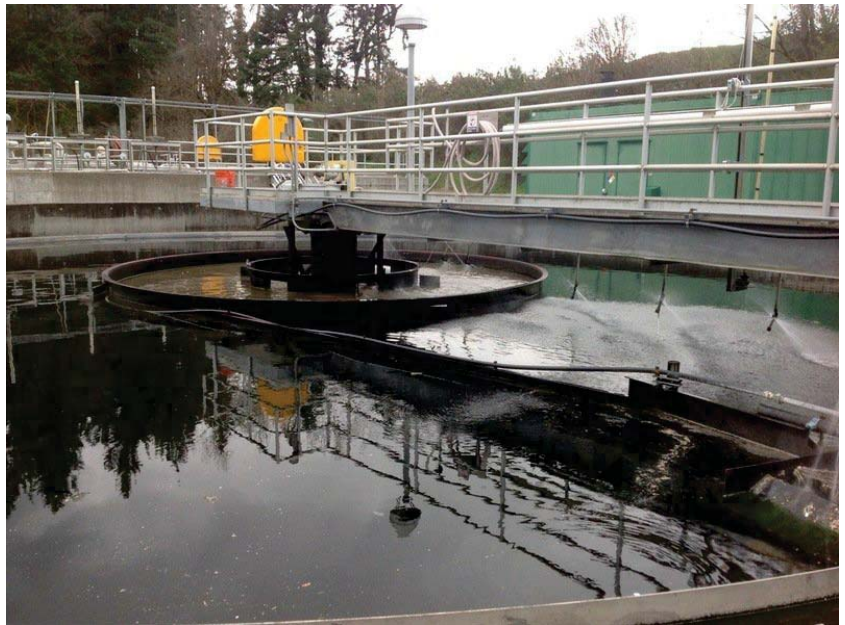
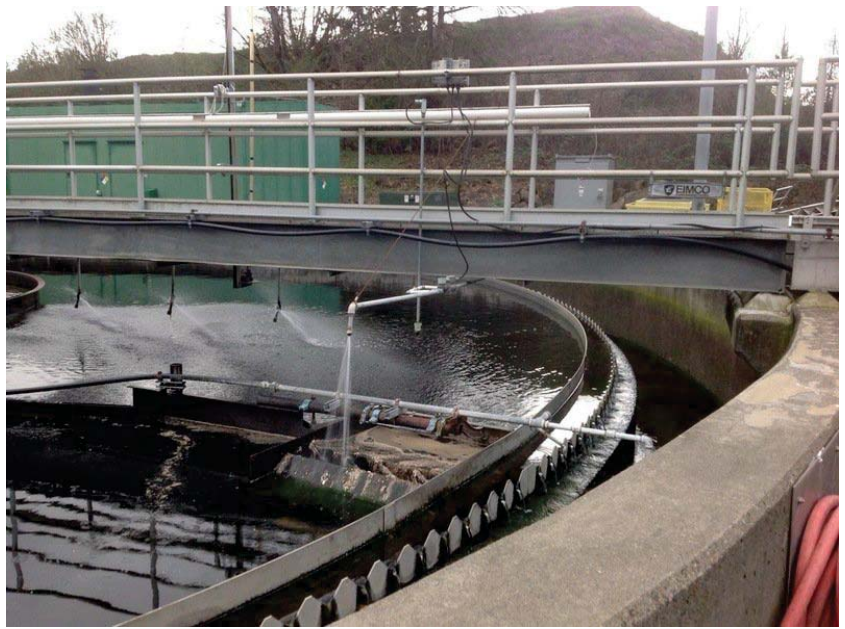
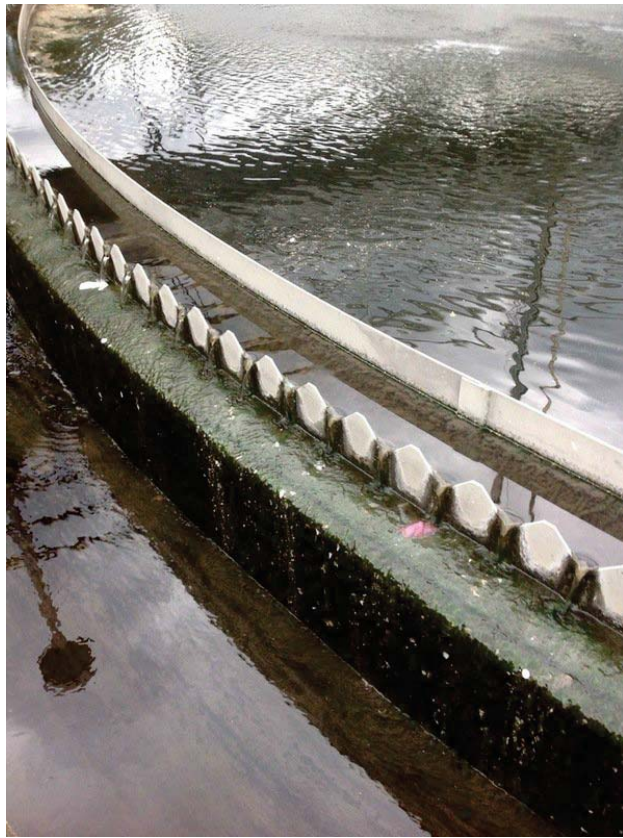
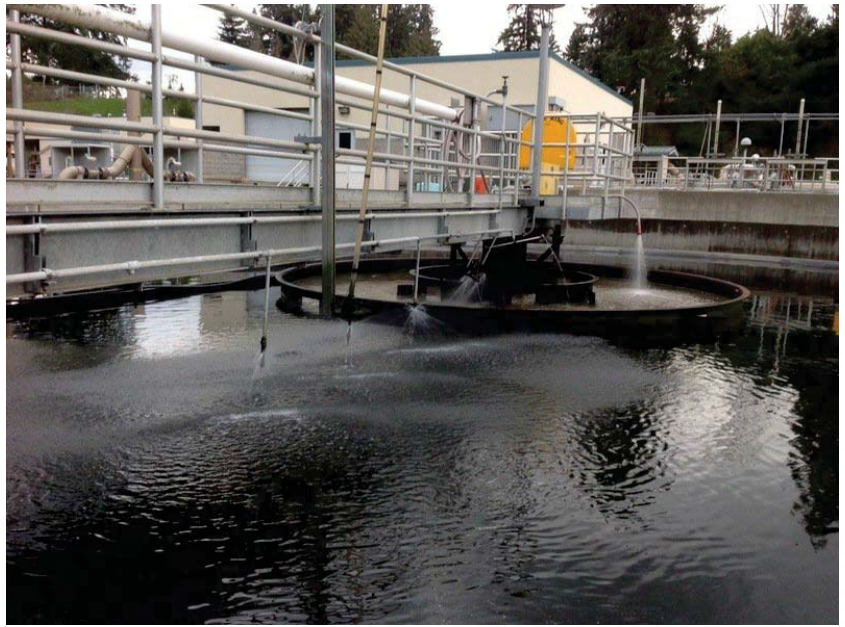
Weir Washer not working

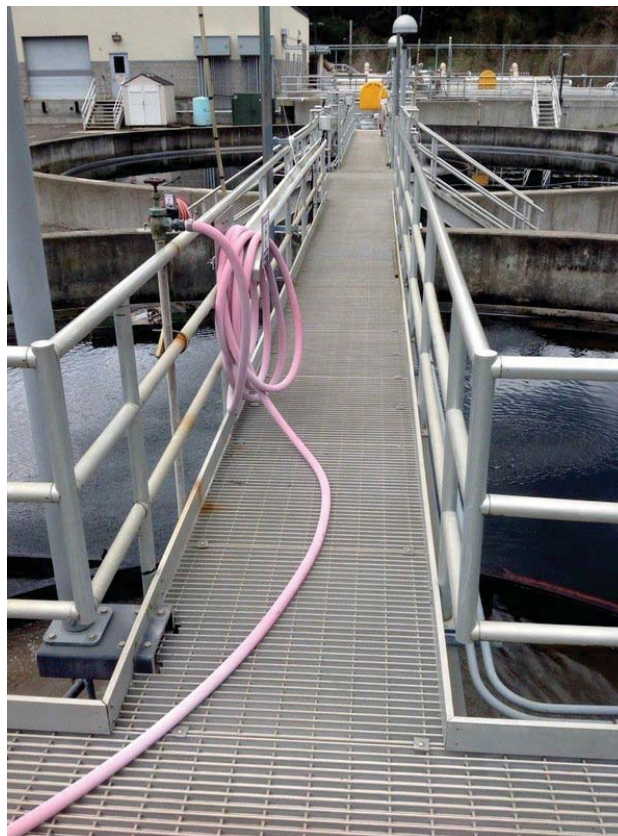
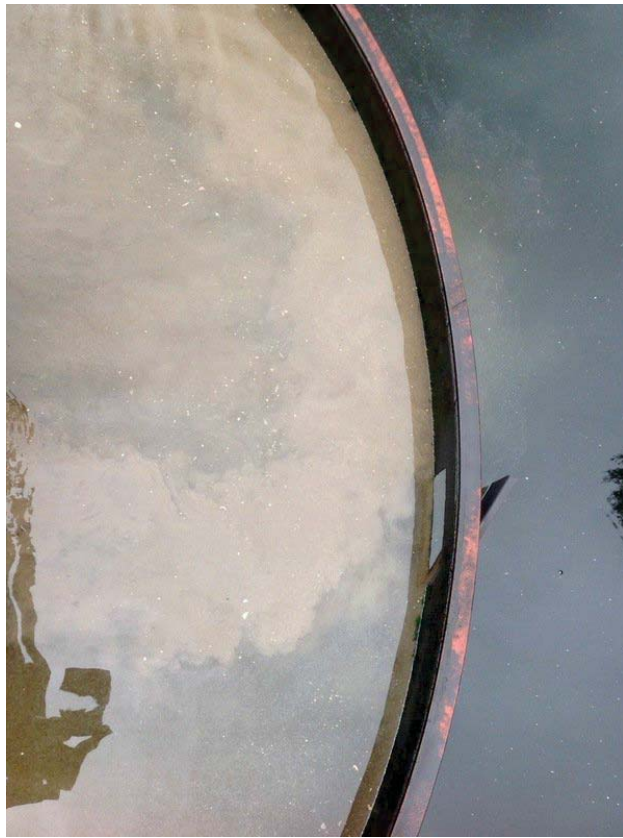
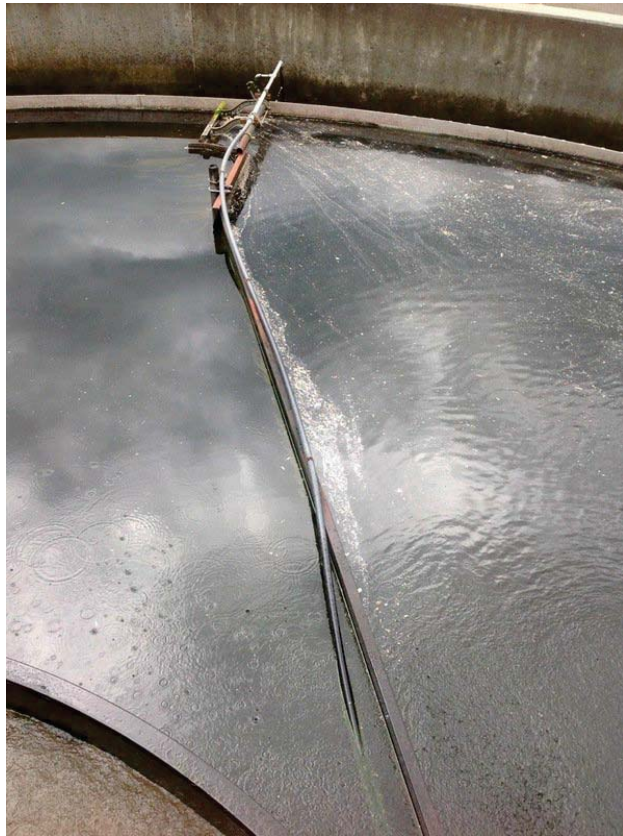
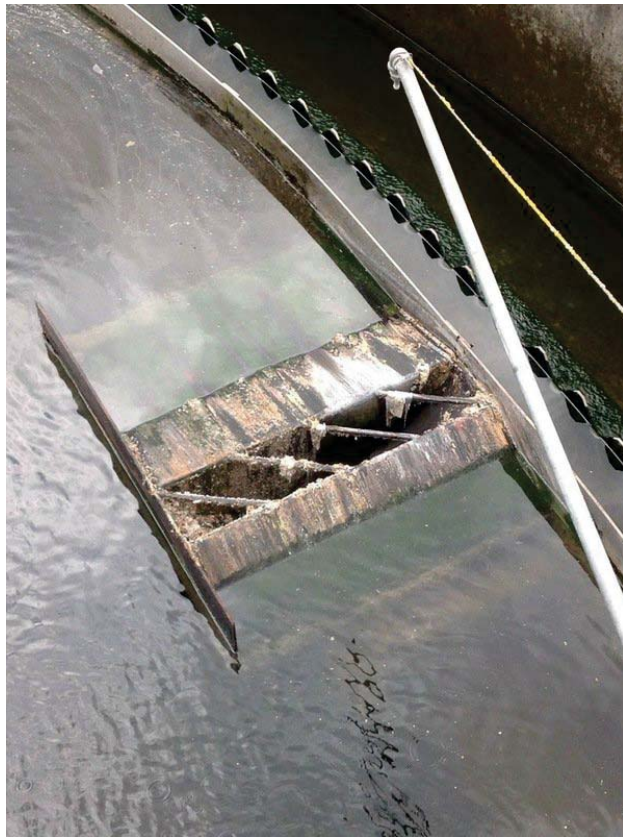
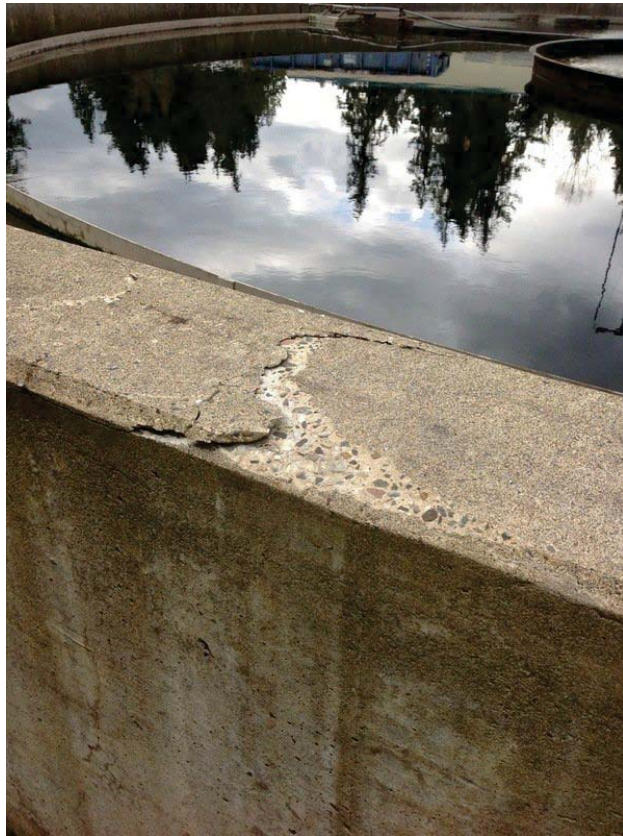
Field Observations	Spalling
Condition Score	3 - Visible Degradation
Performance Score	1 - Component Functioning as Intended
Recommendation	Schedule corrective action work order near term
Field Observations/Comments	Spalling on upper wall by uv area One of the weir washers is not working

Concret damage

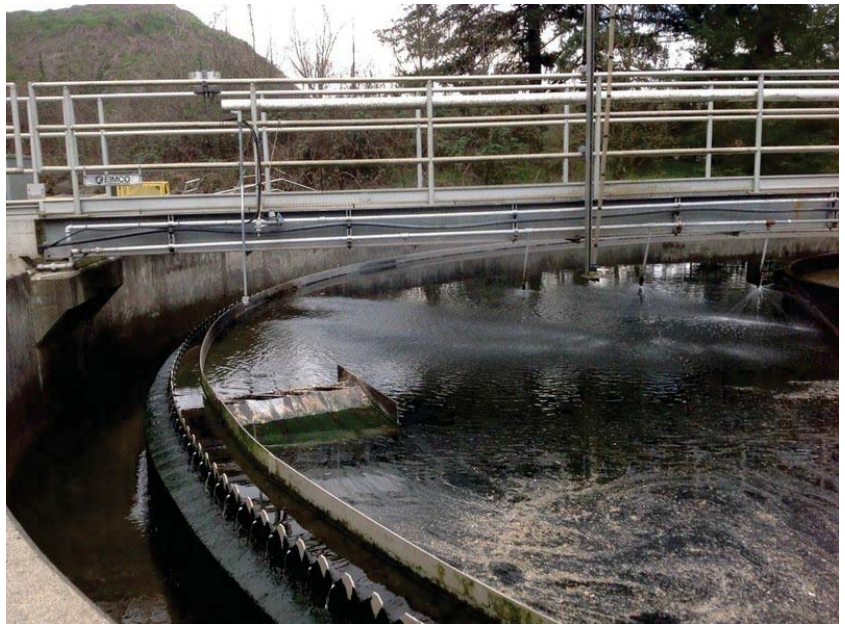
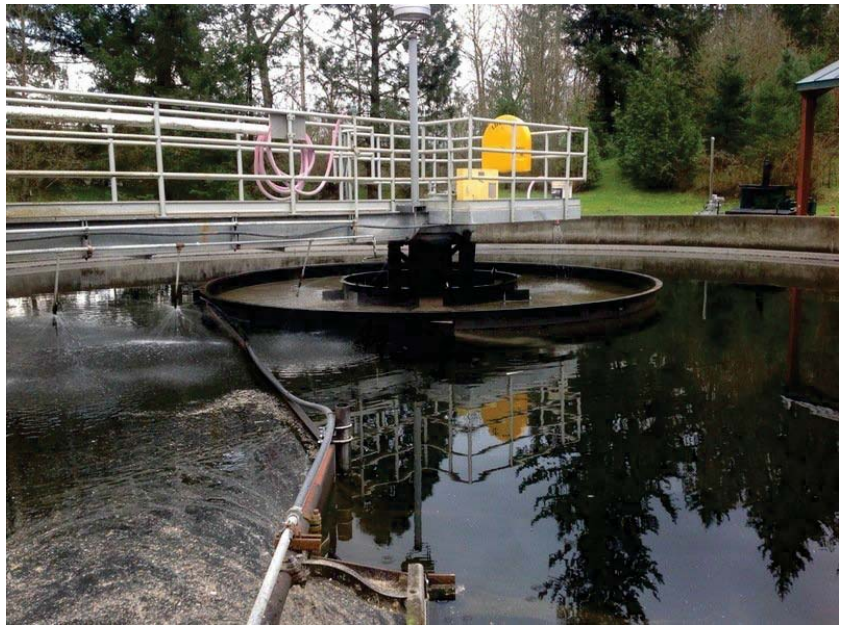
Weir washer not working

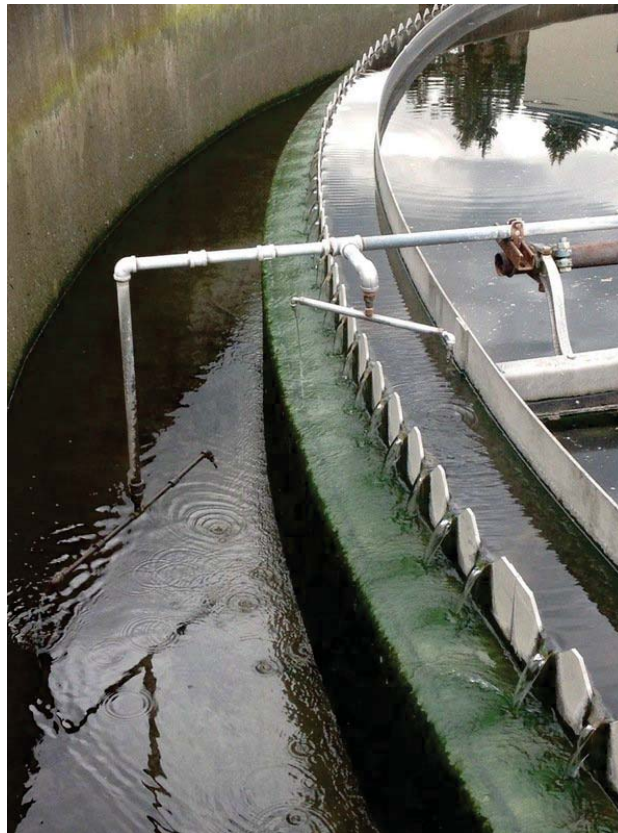
Secondary Treatment	Sec Clarifier #1 Weir Washer, SC-50-1-3
Station ID	SC-50-1-3
Asset Description	Sec Clarifier #1 Weir Washer
What type of Asset?	Mechanical
Condition Score	3 - Visible Degradation
Performance Score	4 - In Service, but Function is Highly Impaired
Recommendation	Schedule corrective action work order near term
Field Observations/Comments	Washer not working

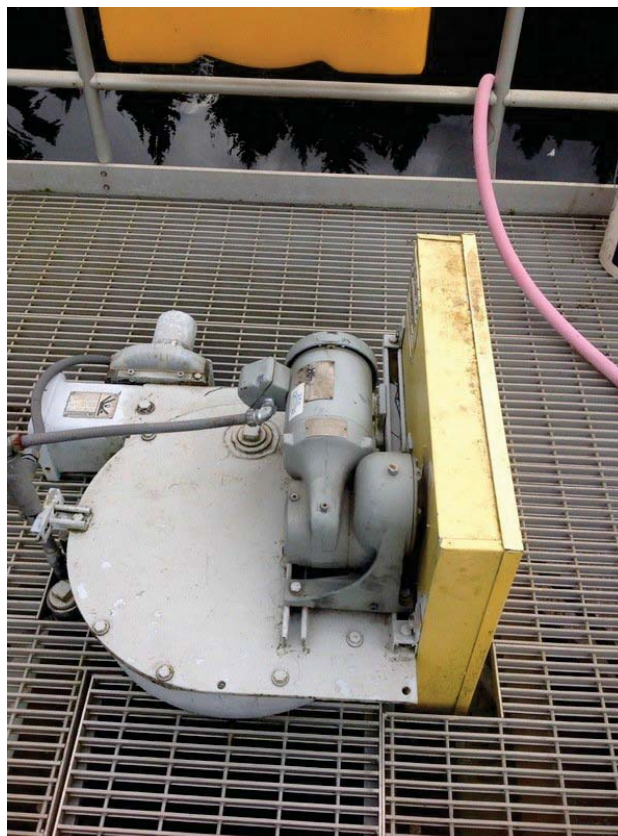
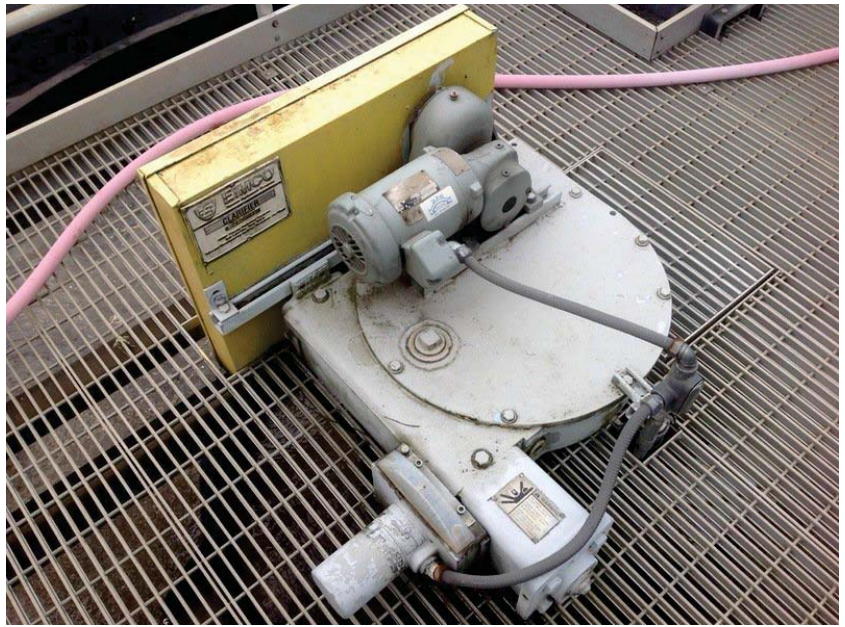
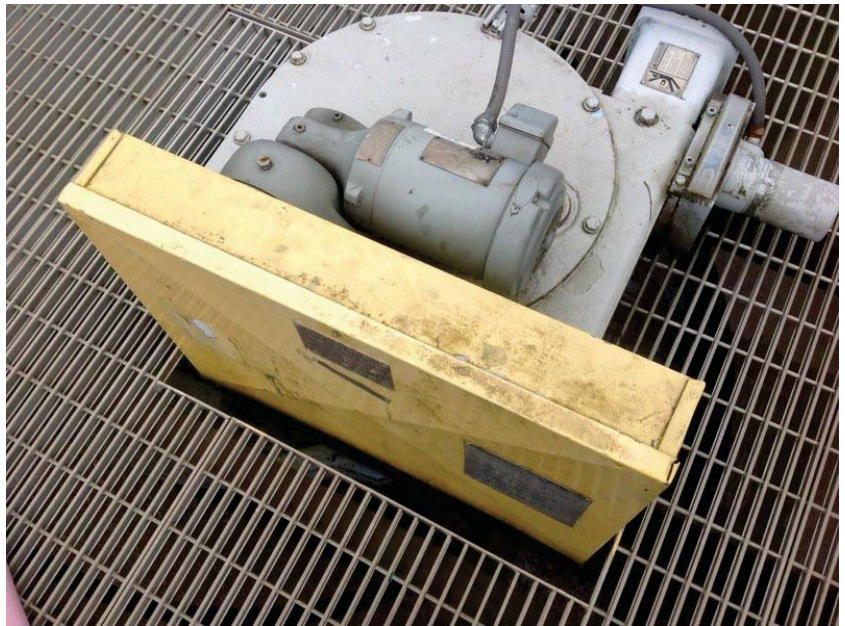
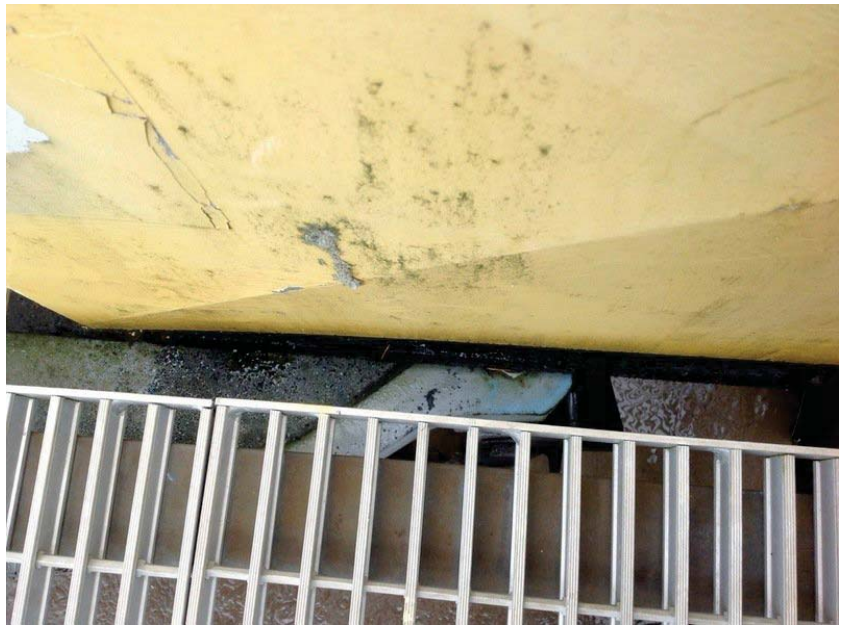
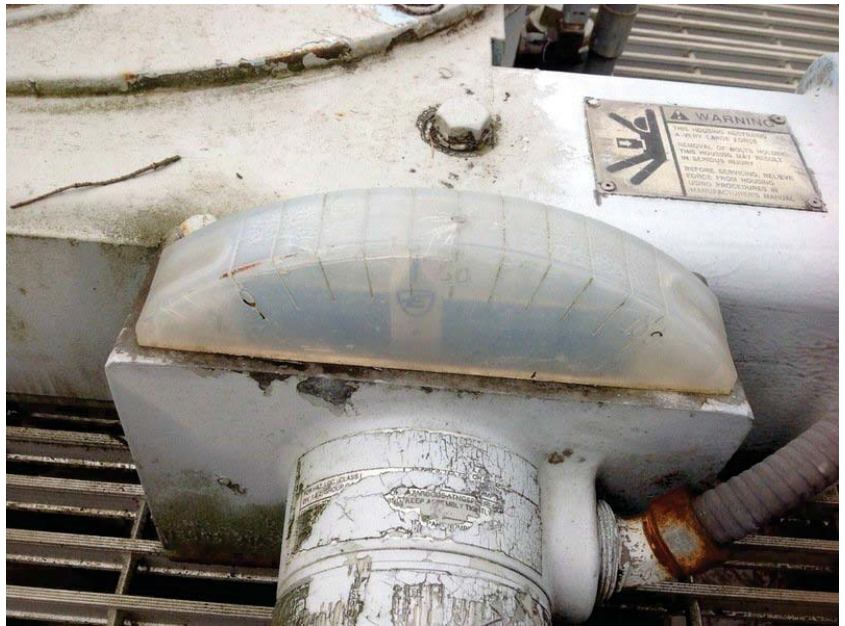
Secondary Treatment	Secondary Clarifier, #2 Mechan, SC-M-50-1-2
Station ID	SC-M-50-1-2
Asset Description	Secondary Clarifier, #2 Mechan
What type of Asset?	Mechanical
Condition Score	2 - Slight Visible Degradation
Performance Score	1 - Component Functioning as Intended
Recommendation	Schedule corrective action work order near term
Field Observations/Comments	Middle gearbox appears to be leaking oil into the process Torque meter at 40

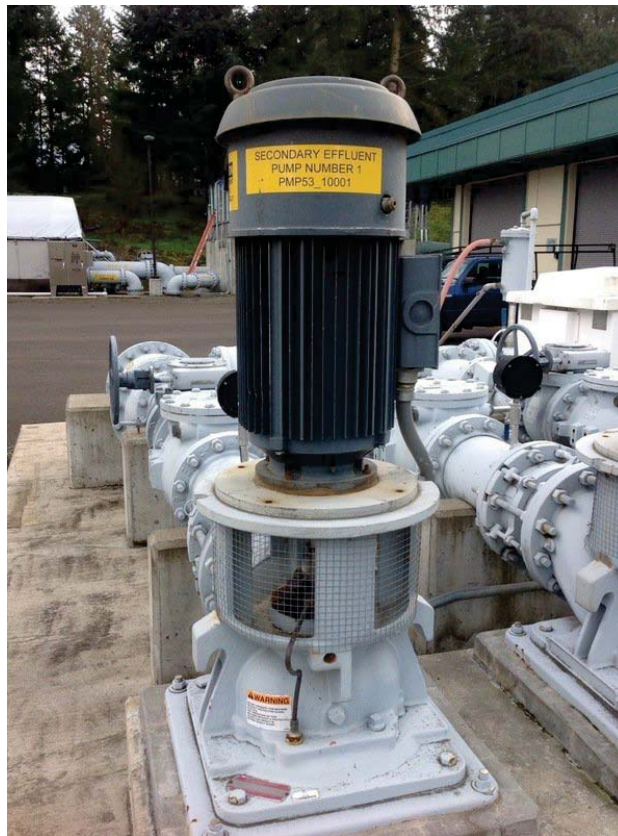
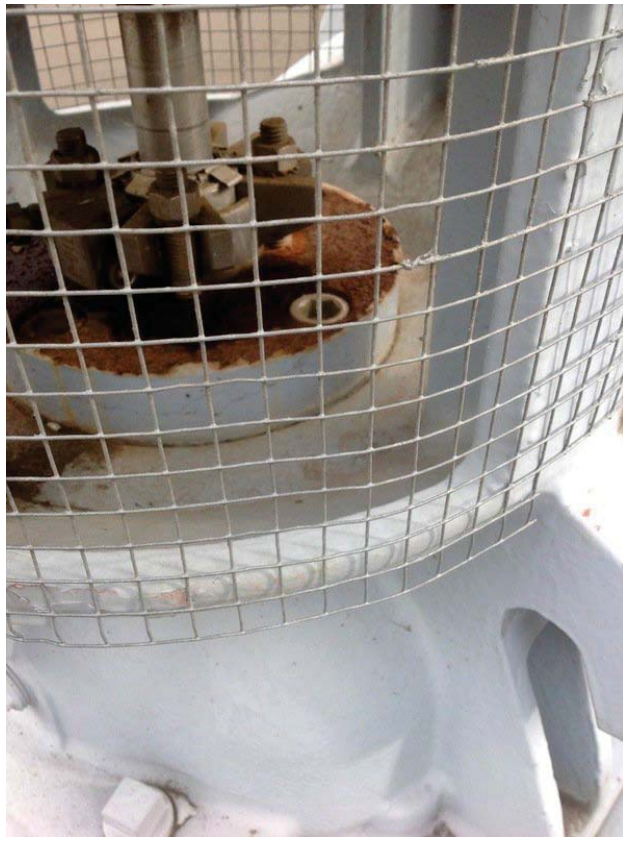
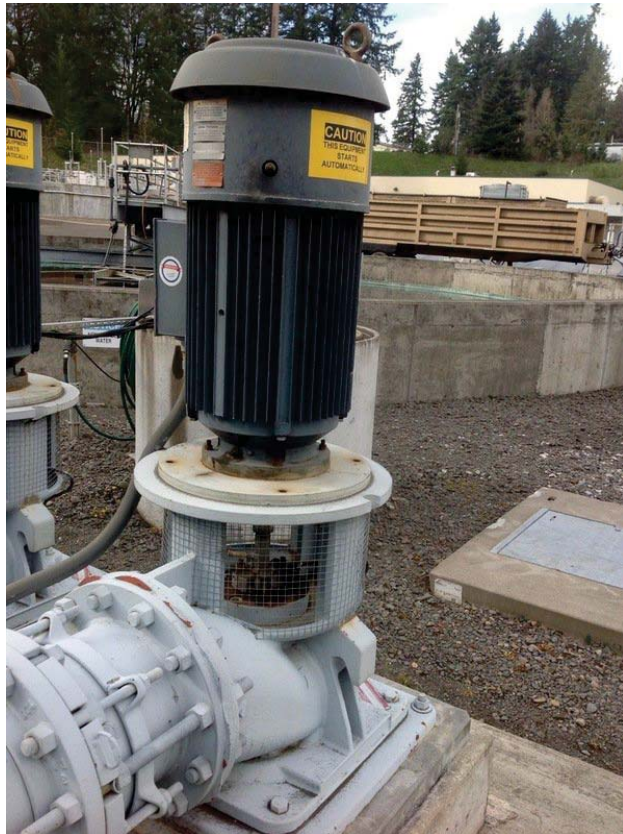
Secondary Treatment	Secondary Effluent Pump #1, PMP53-10001
Station ID	PMP53-10001
What type of Asset?	Pumps and Motors
Condition Score	2 - Slight Visible Degradation
Performance Score	1 - Component Functioning as Intended
Recommendation	No immediate action required
Field Observations/Comments	Not in Operation

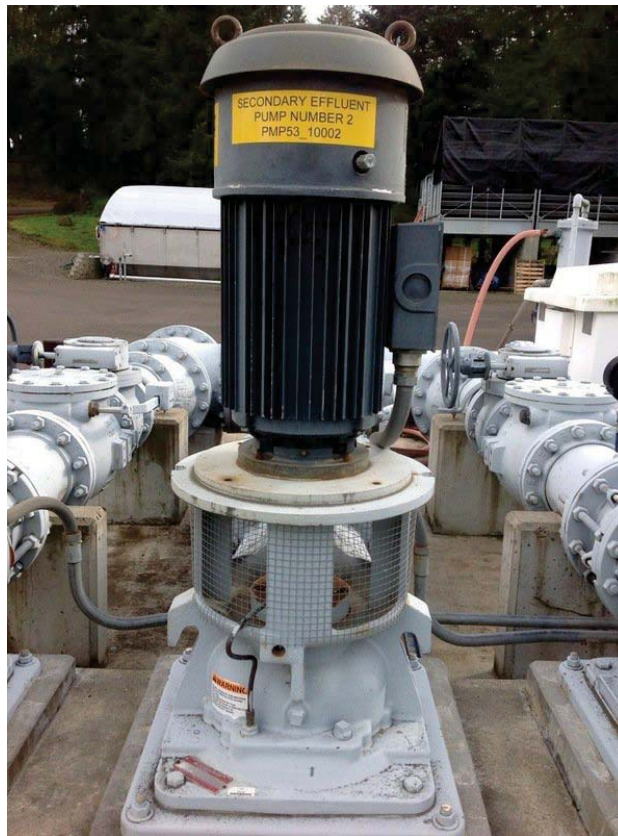
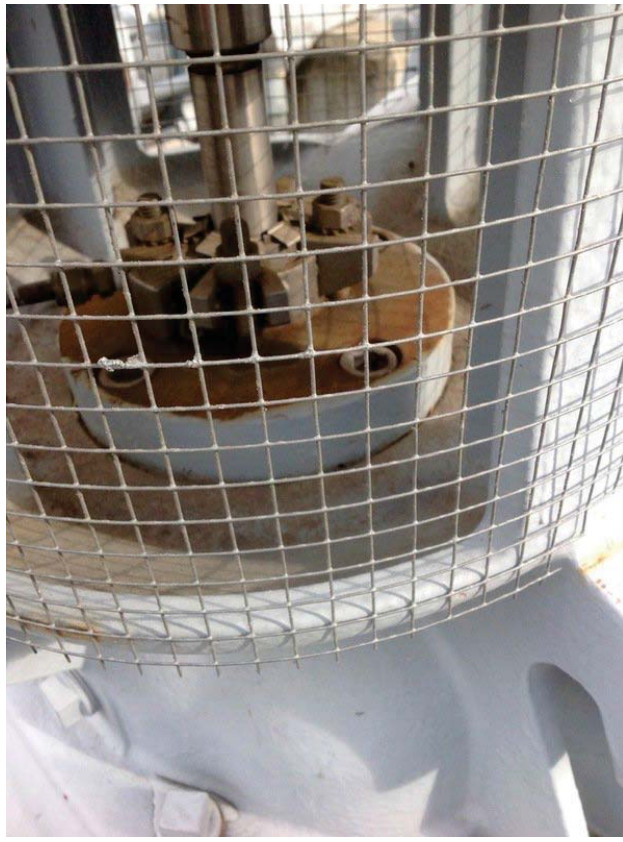
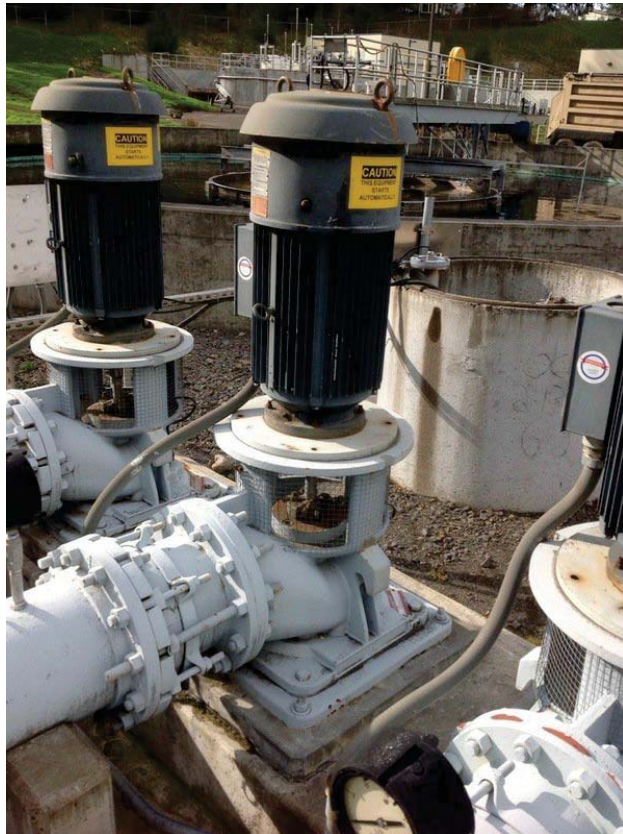
Secondary Treatment	Secondary Effluent Pump #2, PMP53-10002
Station ID	PMP53-10002
What type of Asset?	Pumps and Motors
Condition Score	2 - Slight Visible Degradation
Performance Score	1 - Component Functioning as Intended
Recommendation	No immediate action required
Field Observations/Comments	No Operating

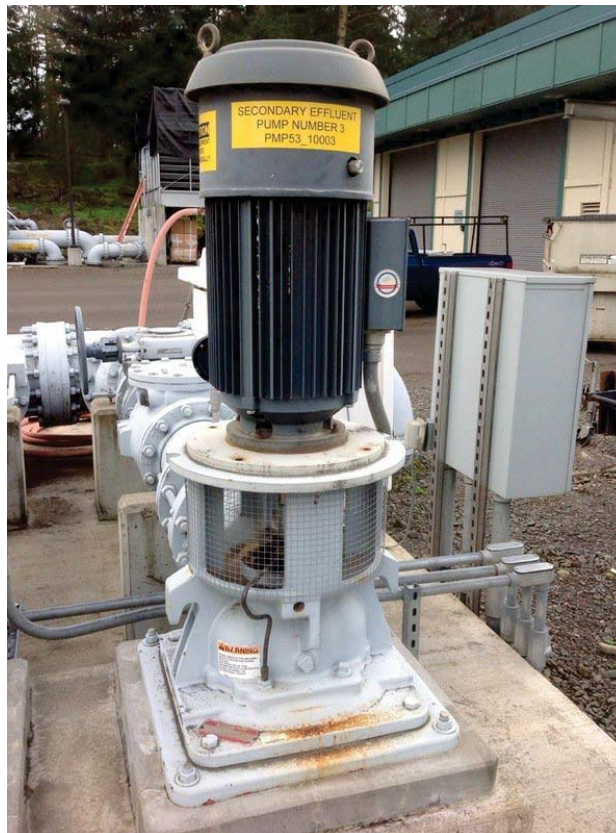
Secondary Treatment	Secondary Effluent Pump #3, PMP53-10003
Station ID	PMP53-10003
What type of Asset?	Pumps and Motors
Condition Score	2 - Slight Visible Degradation
Performance Score	1 - Component Functioning as Intended
Recommendation	No immediate action required
Field Observations/Comments	Not in operation

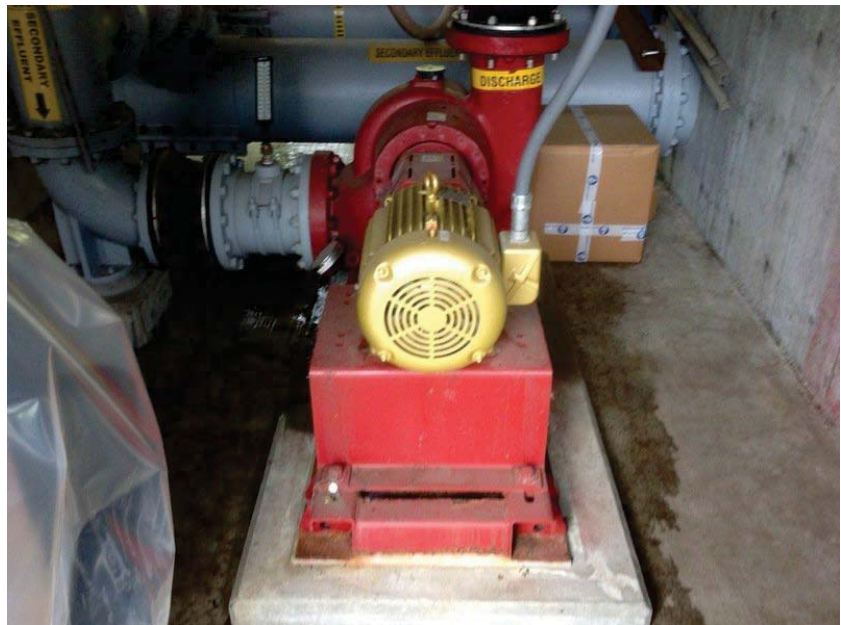
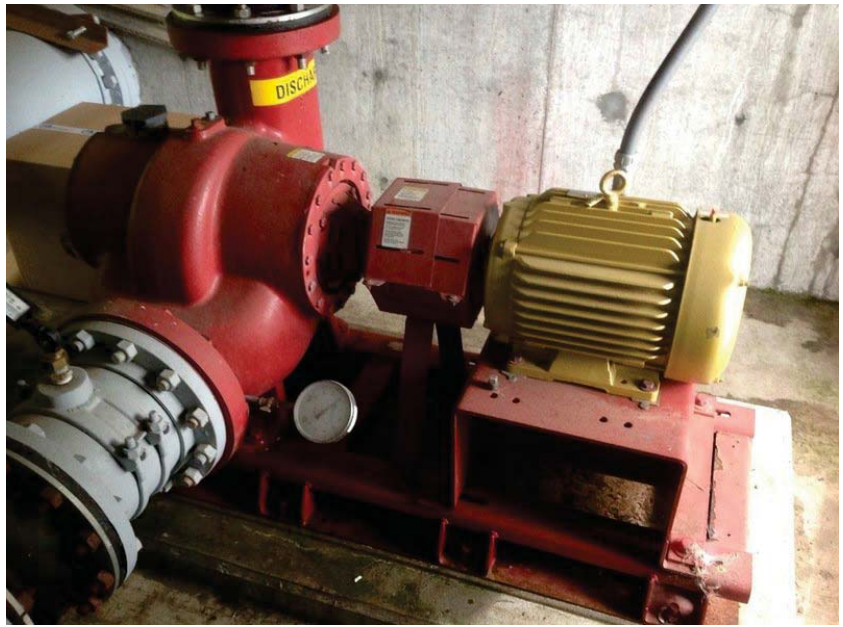
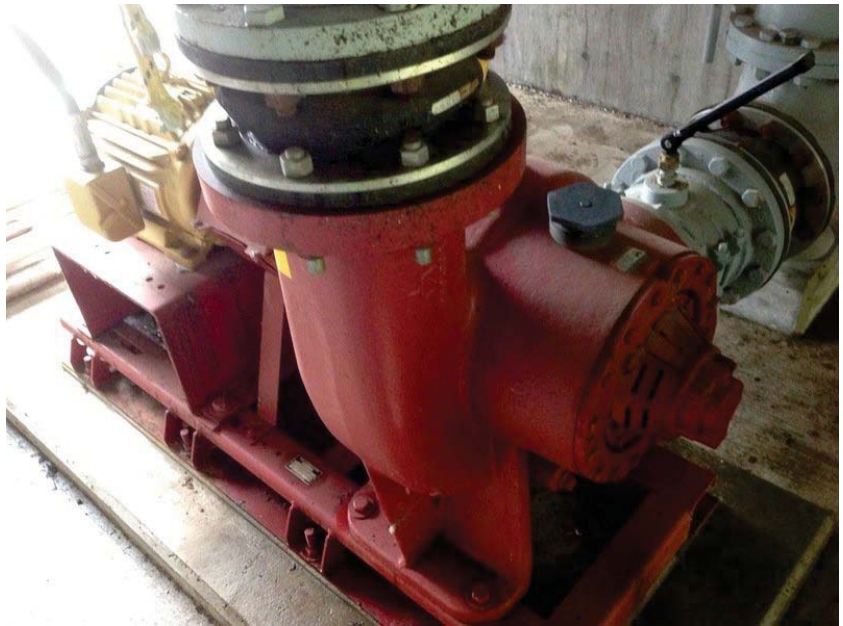
Effluent Cooling	Cooling Tower Pump #1, PMP55-10501
Station ID	PMP55-10501
What type of Asset?	Pumps and Motors
Condition Score	2 - Slight Visible Degradation
Performance Score	1 - Component Functioning as Intended
Recommendation	No immediate action required
Field Observations/Comments	Pump drained for winter

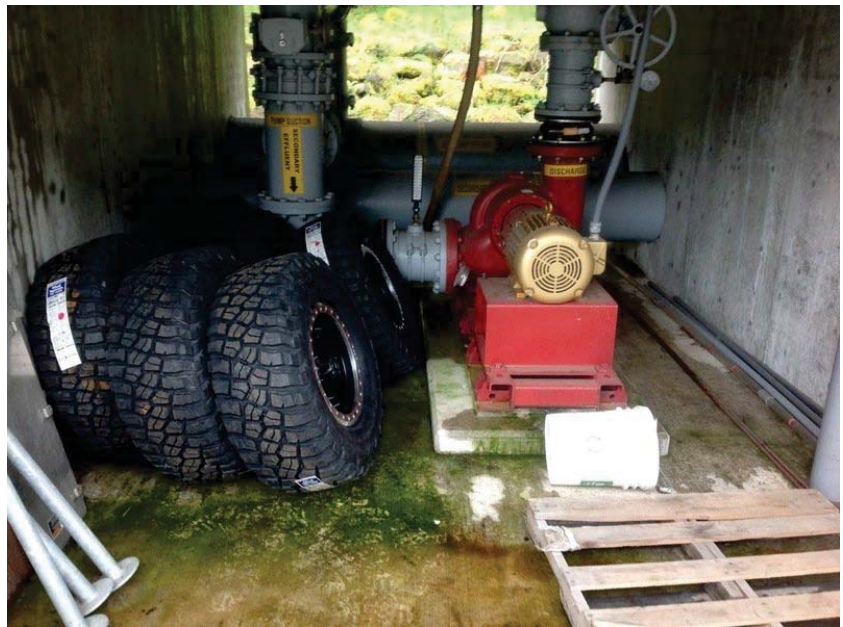
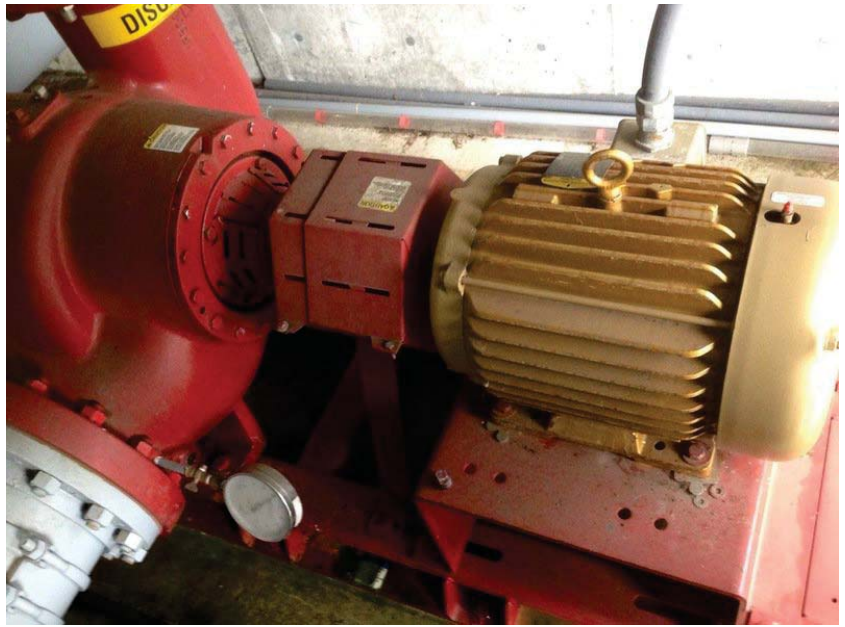
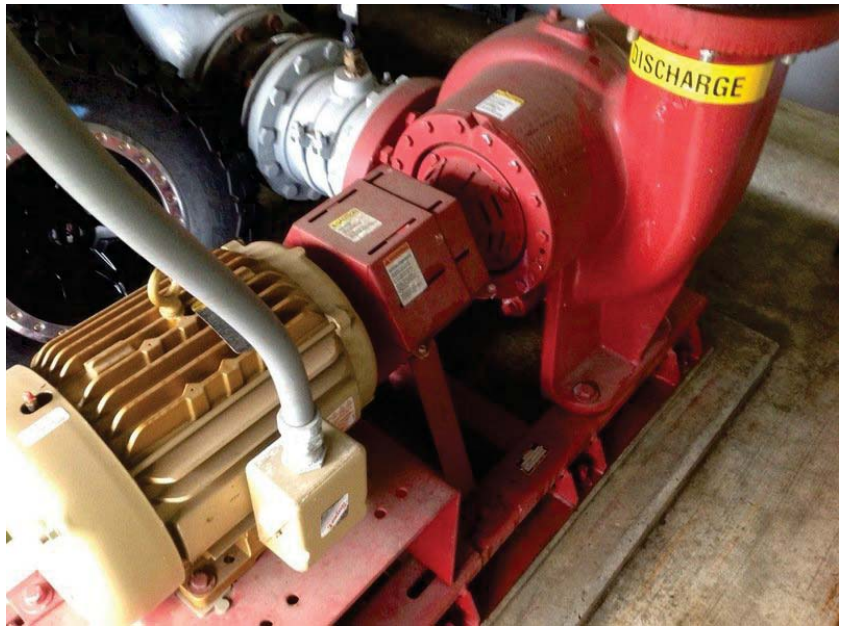
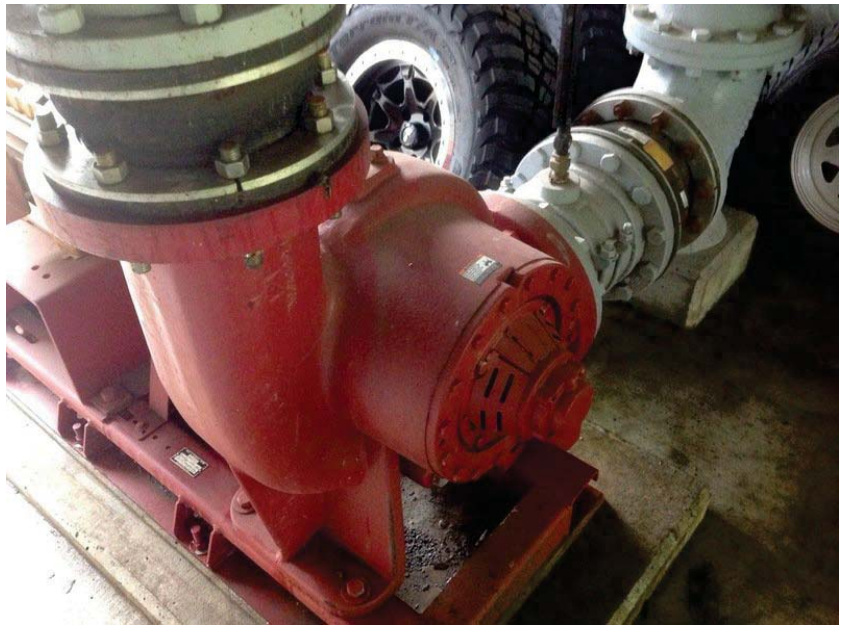
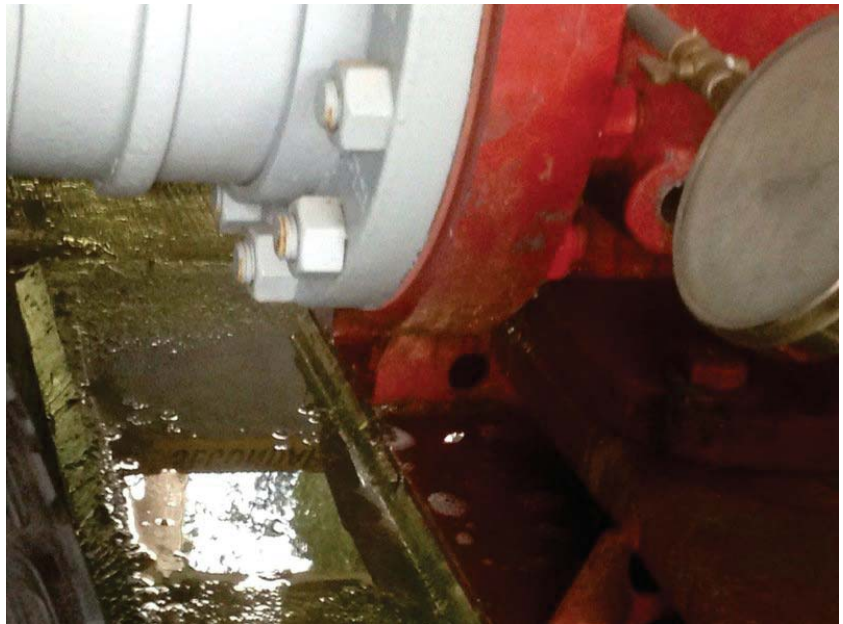
Effluent Cooling	Cooling Tower Pump #2, PMP55-10502
Station ID	PMP55-10502
What type of Asset?	Pumps and Motors
Condition Score	2 - Slight Visible Degradation
Performance Score	1 - Component Functioning as Intended
Recommendation	No immediate action required
Field Observations/Comments	Pump drained for the winter

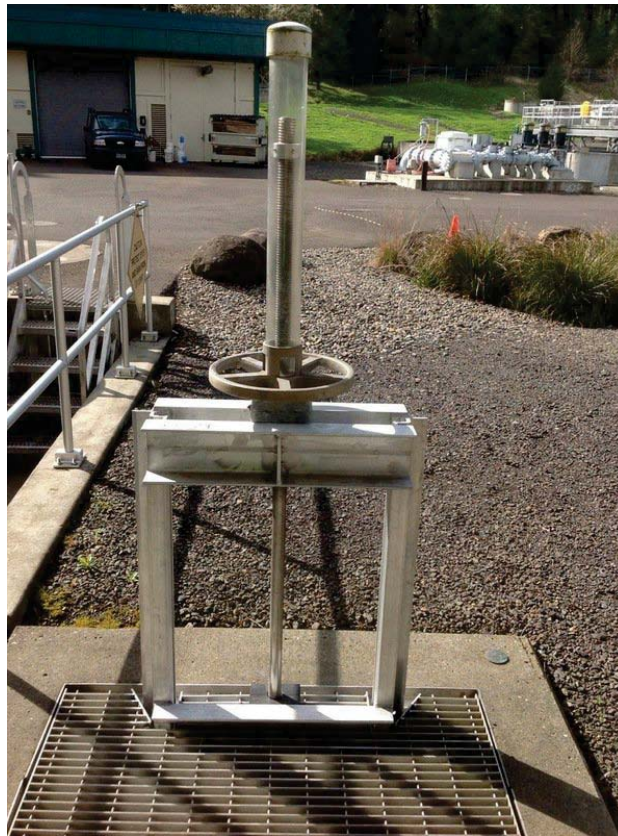
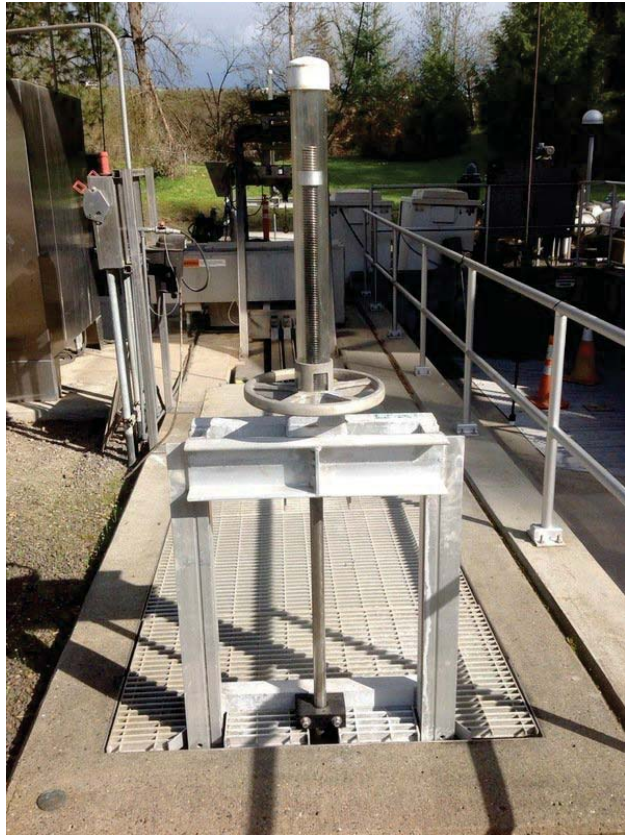
Field Observations	Good condition
Condition Score	2 - Slight Visible Degradation
Performance Score	1 - Component Functioning as Intended
Recommendation	No immediate action required

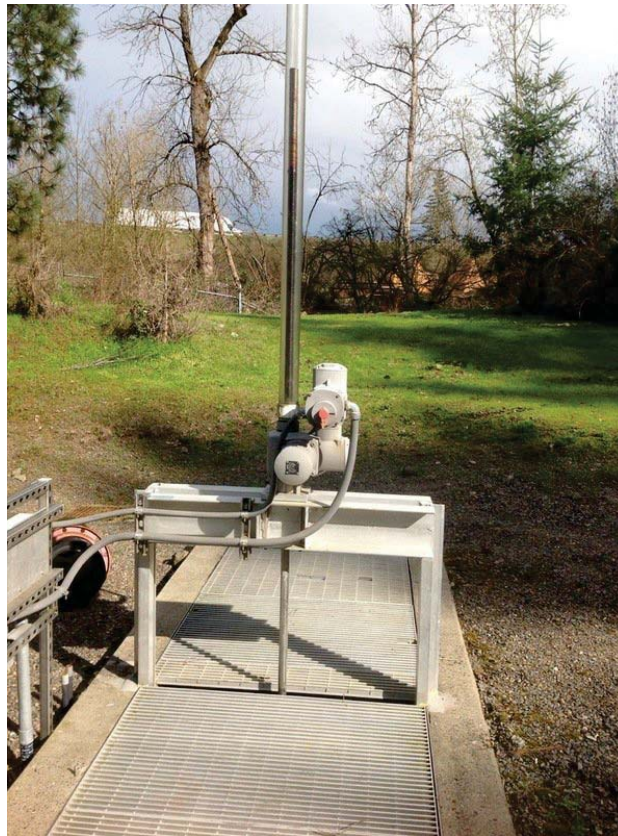
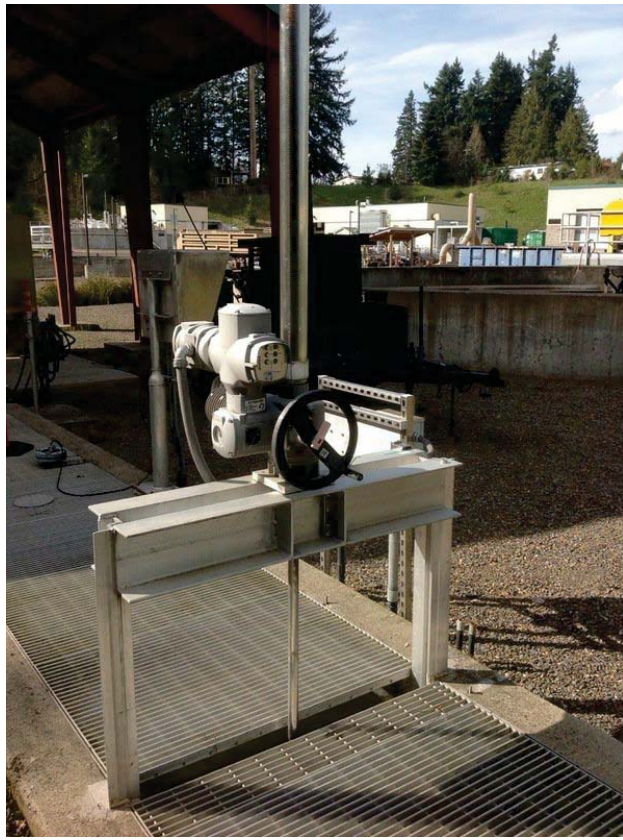
Field Observations	Good condition
Condition Score	2 - Slight Visible Degradation
Performance Score	1 - Component Functioning as Intended
Recommendation	No immediate action required
