# City of Wilsonville Triennial Inspection Report

Wilsonville WWTP and  
Wastewater Lift Stations:

Project Title: On-Call Civil Engineering and Related Services,  
Triennial Inspection of the Wilsonville WWTP and Nine Lift Stations

Subject: 2019 Triennial Inspection of the Wilsonville WWTP  
and Sewage Lift Stations

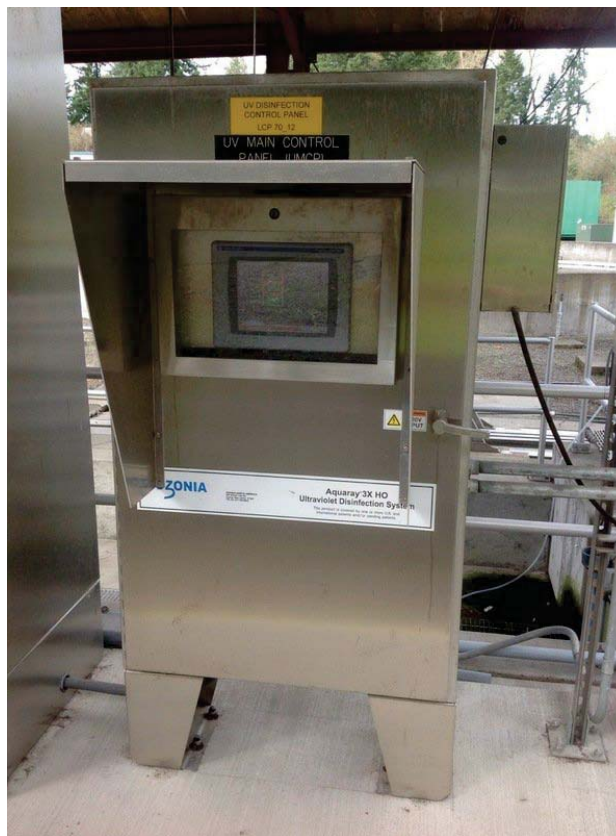
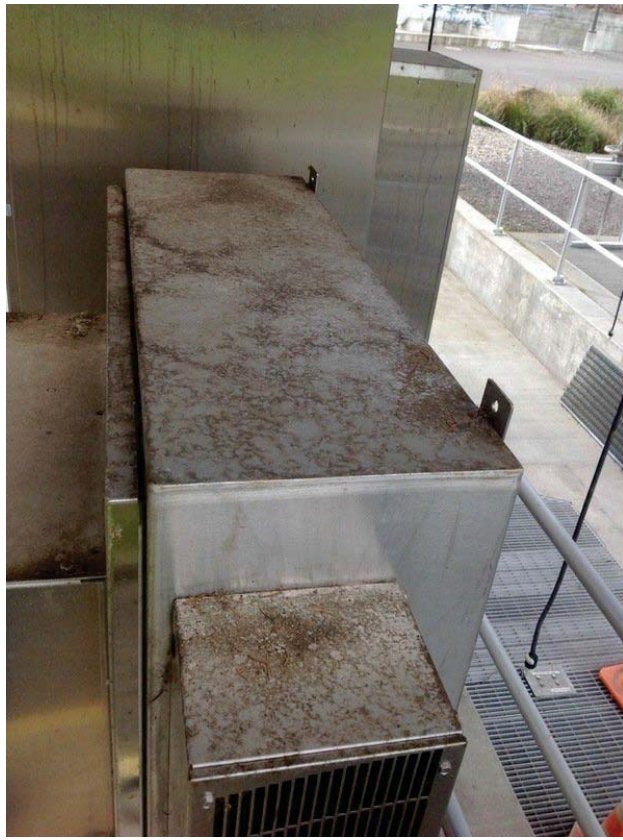
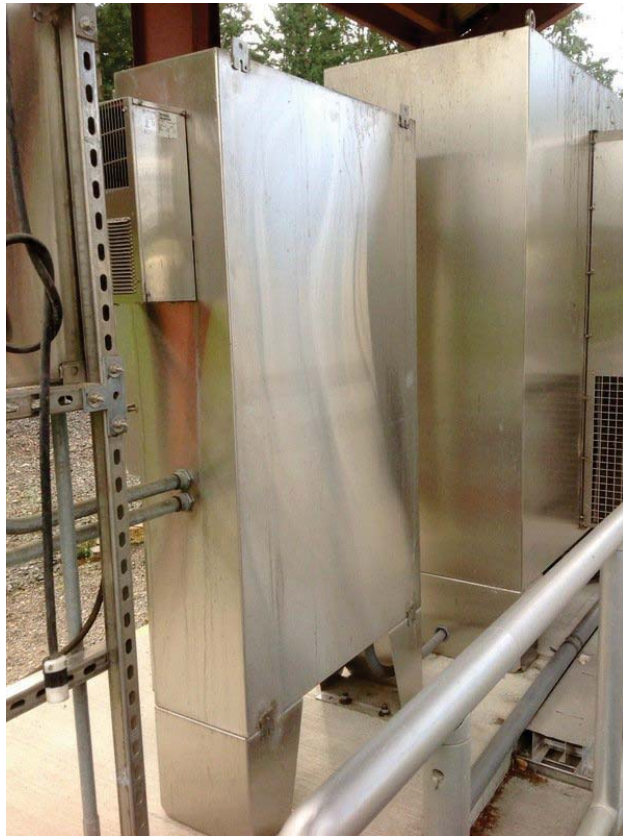
Description	UV Main Control Panel
Condition Score	2 - Slight Visible Degradation
Performance Score	1 - Component Functioning as Intended
Recommendation	No immediate action required

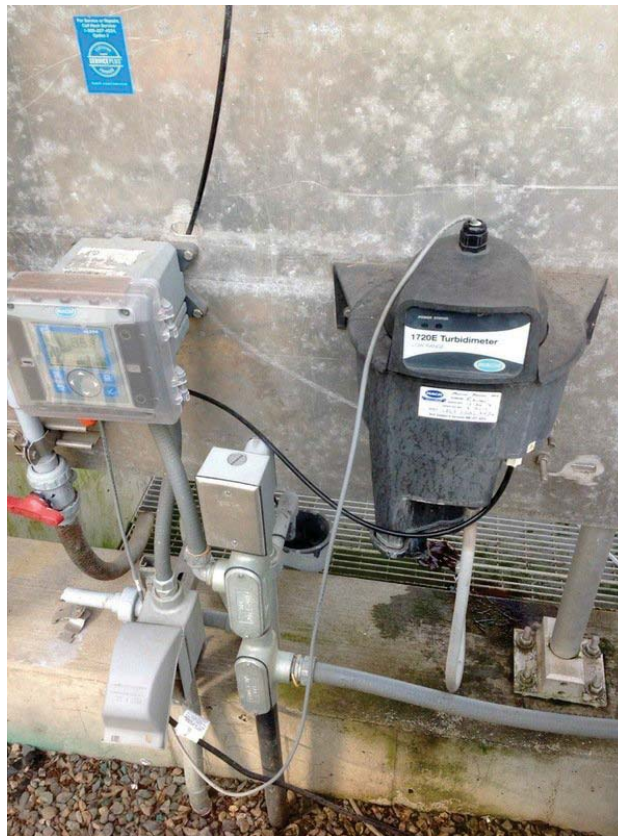
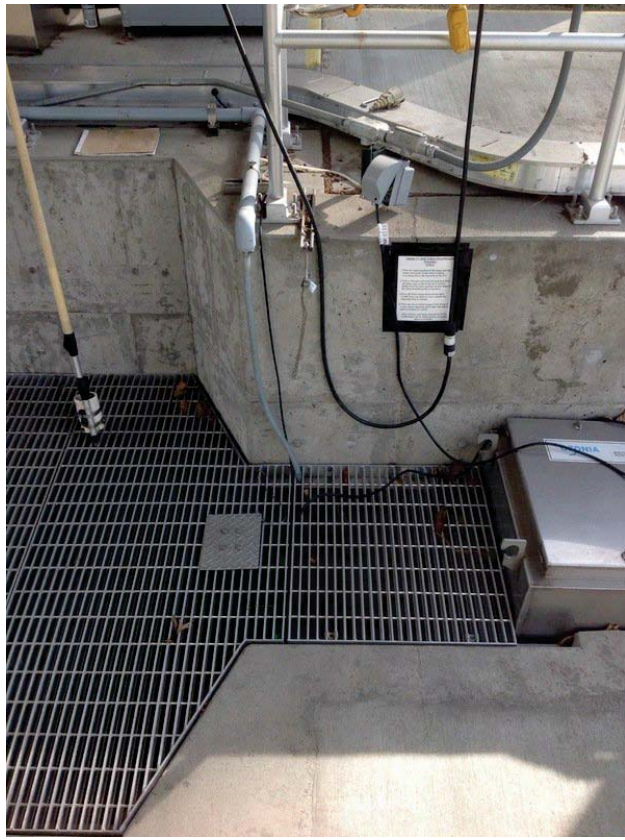
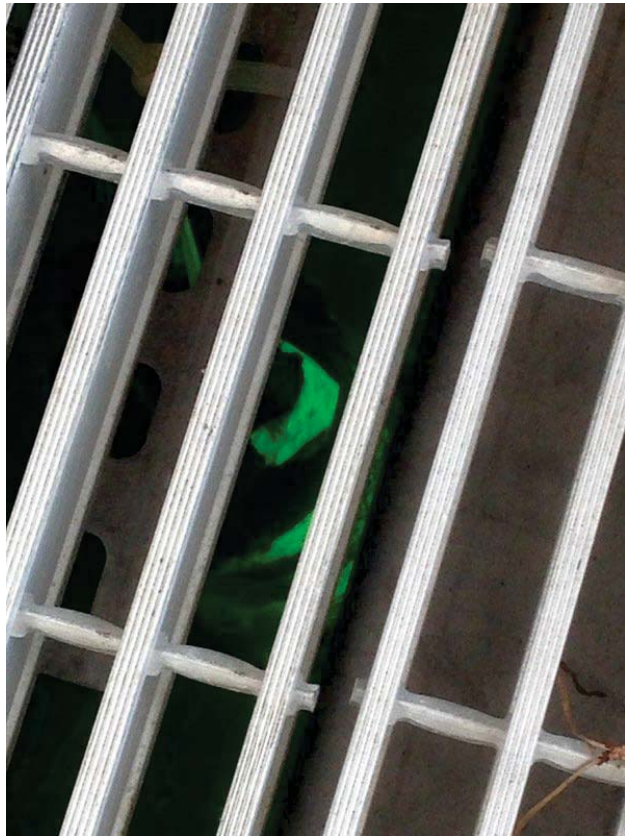
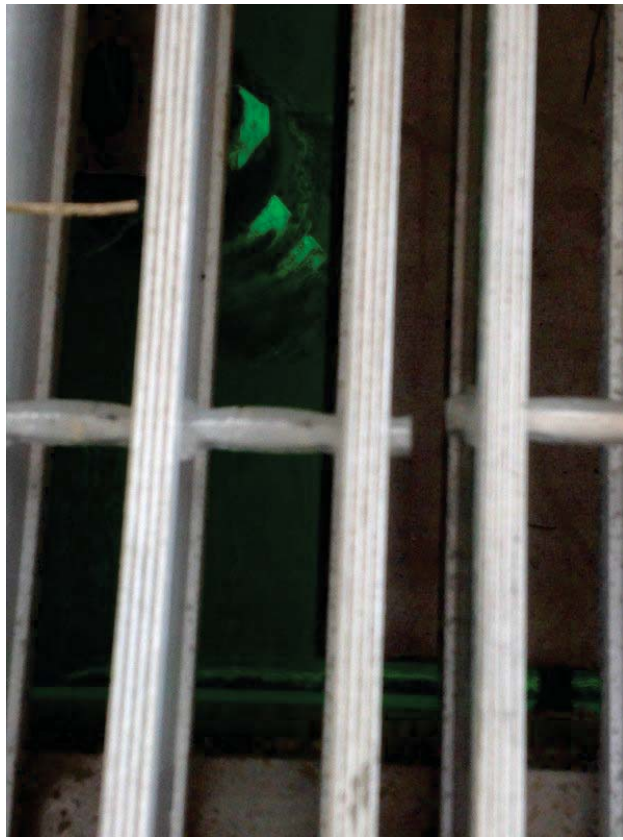
Water Quality	Effluent Turbidity Sample Pump, PMP70-21500
Station ID	PMP70-21500
What type of Asset?	Pumps and Motors
Condition Score	2 - Slight Visible Degradation
Performance Score	1 - Component Functioning as Intended
Recommendation	No immediate action required
Field Observations/Comments	Flow through turbidity meter appears to be good

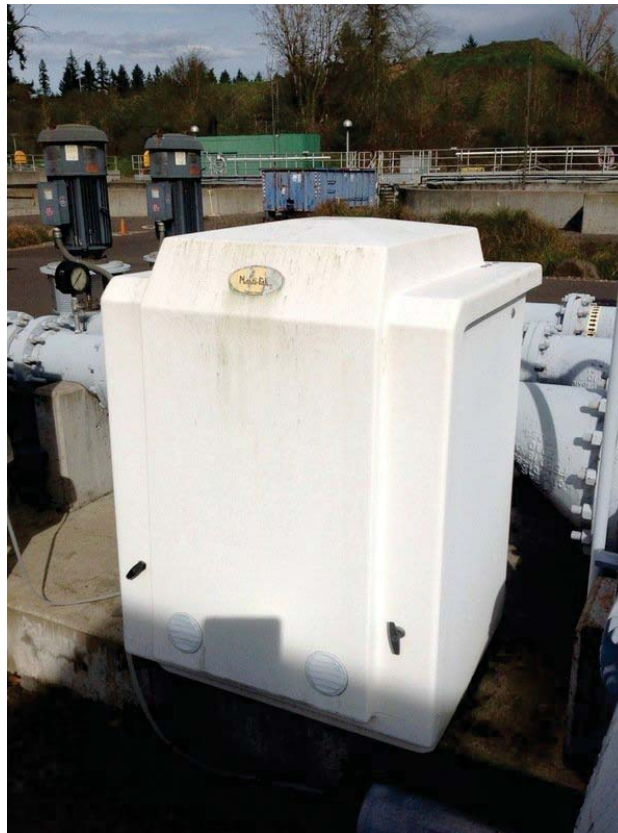
Water Quality	Effluent Composite Sampler #3 (on Secondary), UV-70-S-1-3
Station ID	UV-70-S-1-3
Asset Description	Effluent Composite Sampler #3 (on Secondary)
What type of Asset?	Mechanical
Condition Score	2 - Slight Visible Degradation
Performance Score	1 - Component Functioning as Intended
Recommendation	No immediate action required
Field Observations/Comments	Vent fans not plugged in

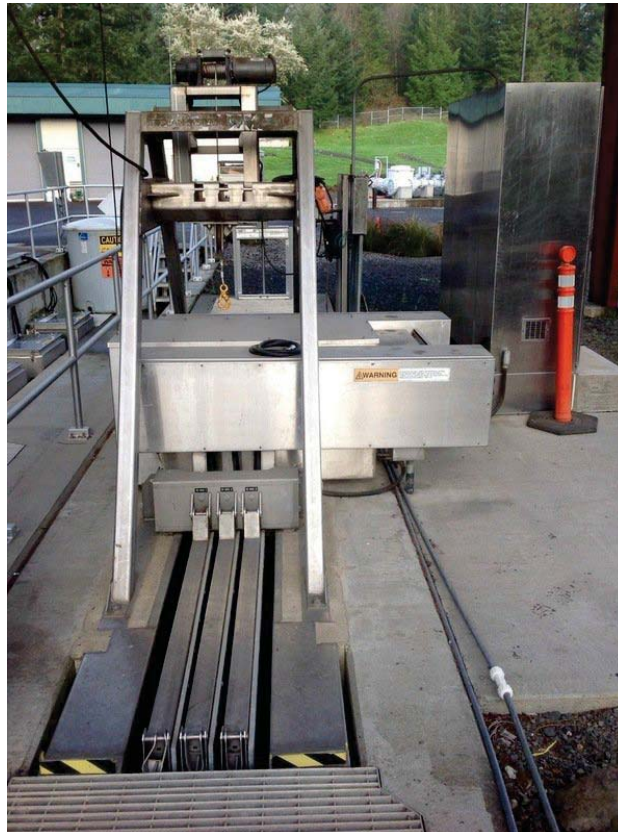
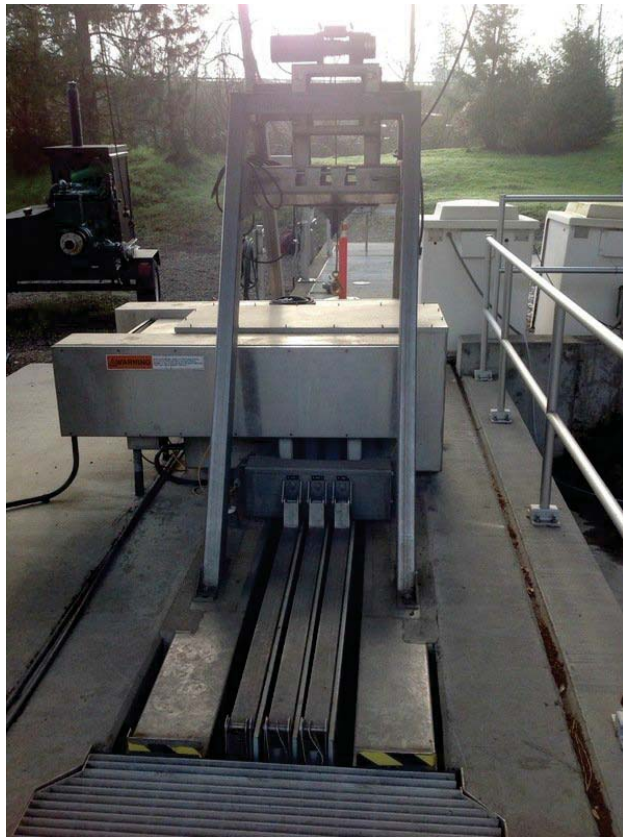
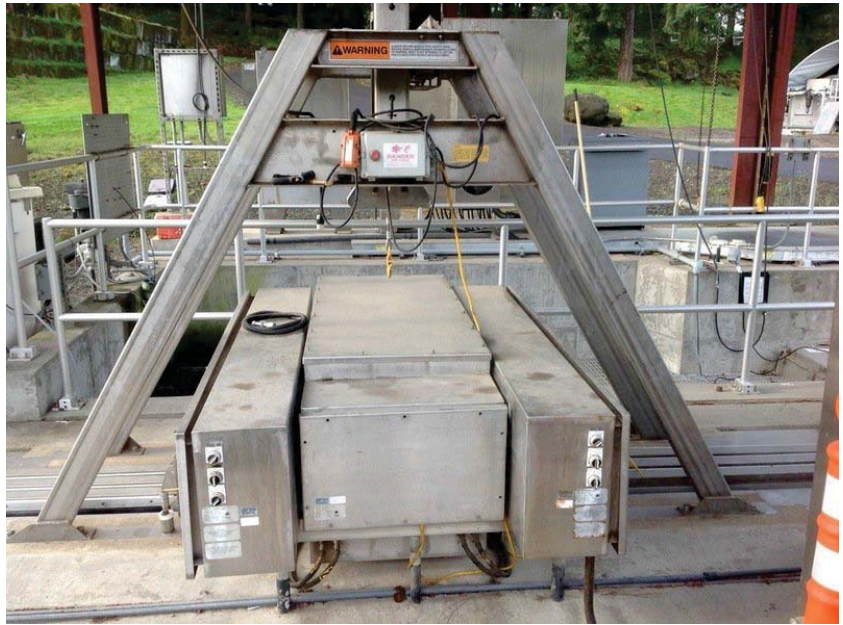
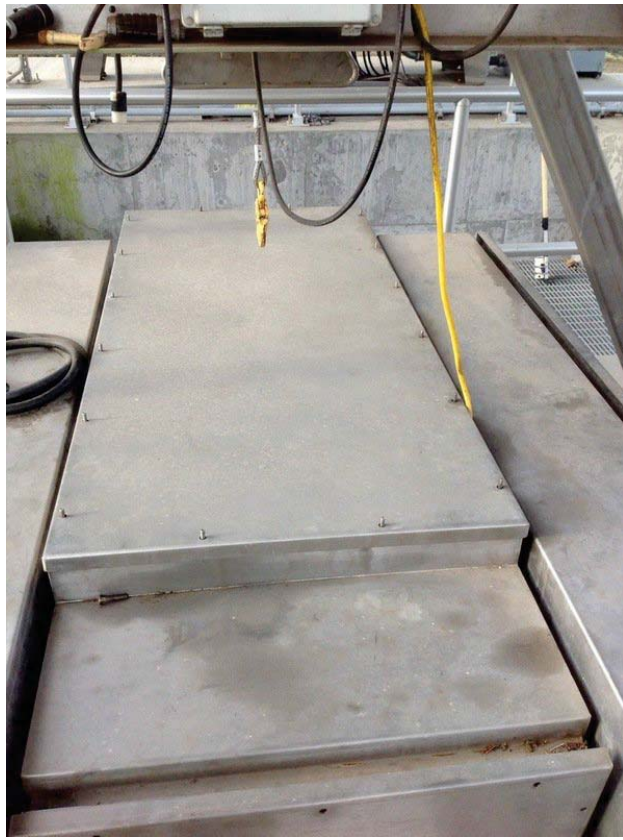
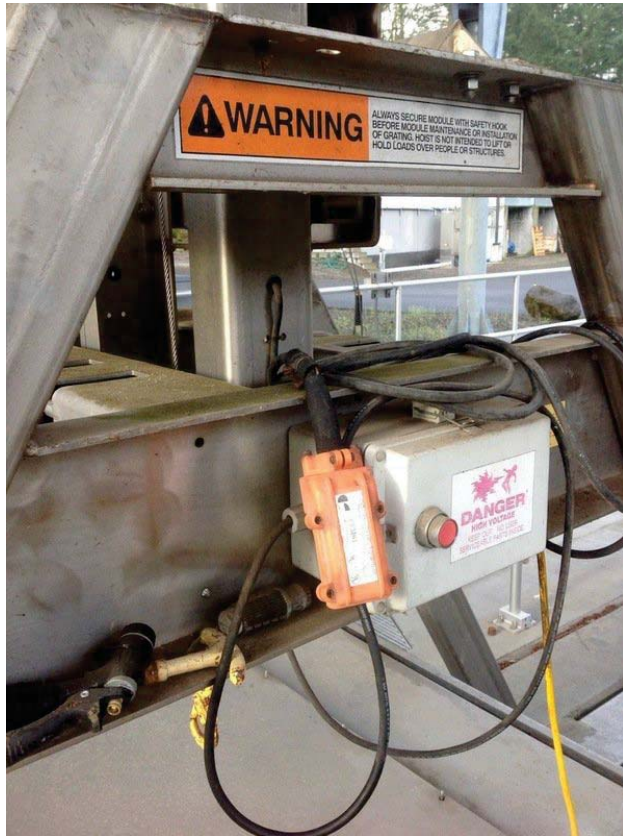
Disinfection	Trojan UV 4000 UV System, UV-M-70
Station ID	UV-M-70
Asset Description	Trojan UV 4000 UV System
What type of Asset?	Mechanical
Condition Score	3 - Visible Degradation
Performance Score	2 - In Service, but higher than Expected O&M
Recommendation	Initiate more detailed inspection
Field Observations/Comments	Not operating Appears to have been out of service for a long time Appears it would take quite some time to put it back in operation

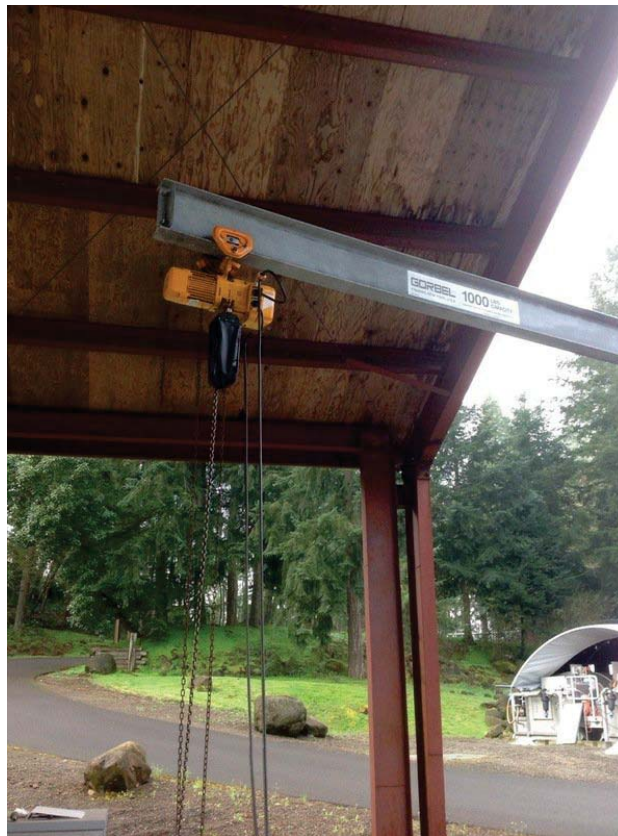
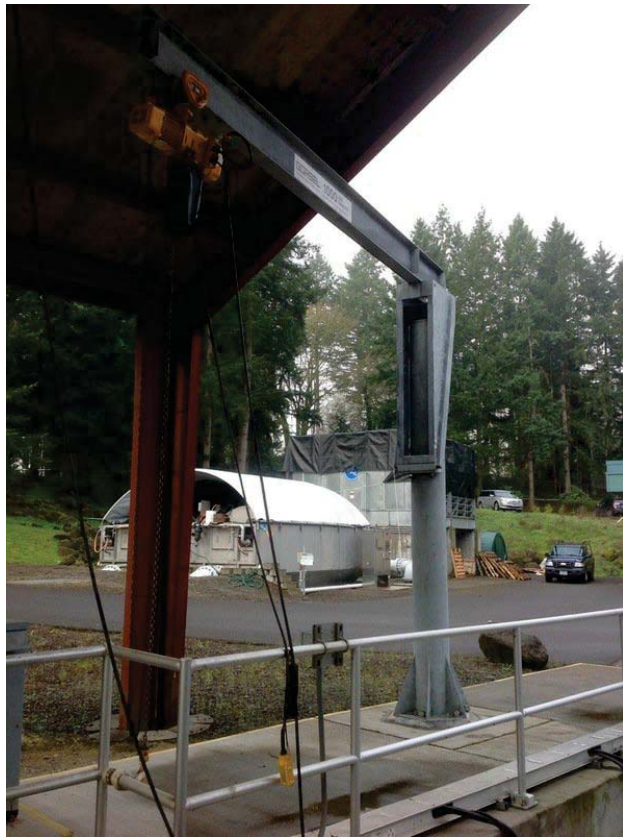
Disinfection	UV Module Winch Motor, UV-M-70-5
Station ID	UV-M-70-5
Asset Description	UV Module Winch Motor
What type of Asset?	Mechanical
Condition Score	1 - Excellent
Performance Score	1 - Component Functioning as Intended
Recommendation	No immediate action required

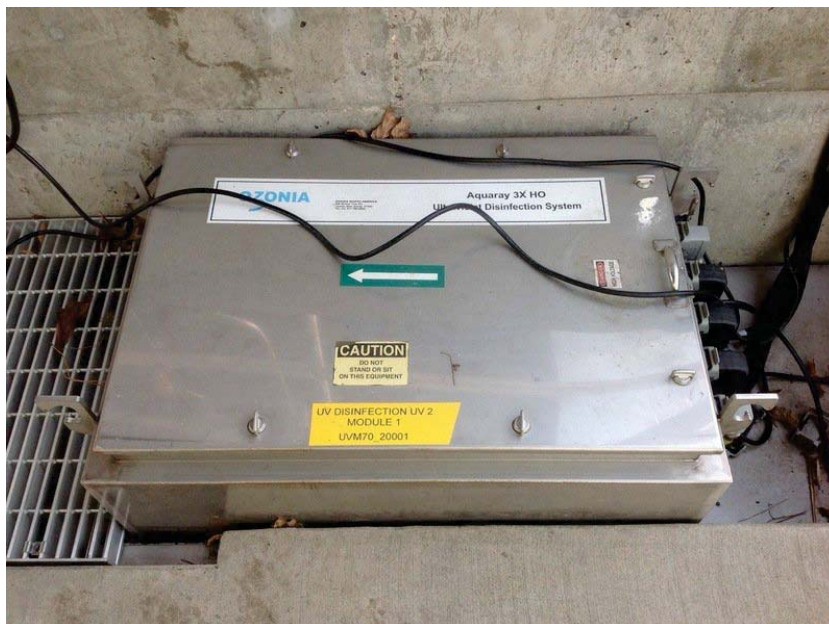
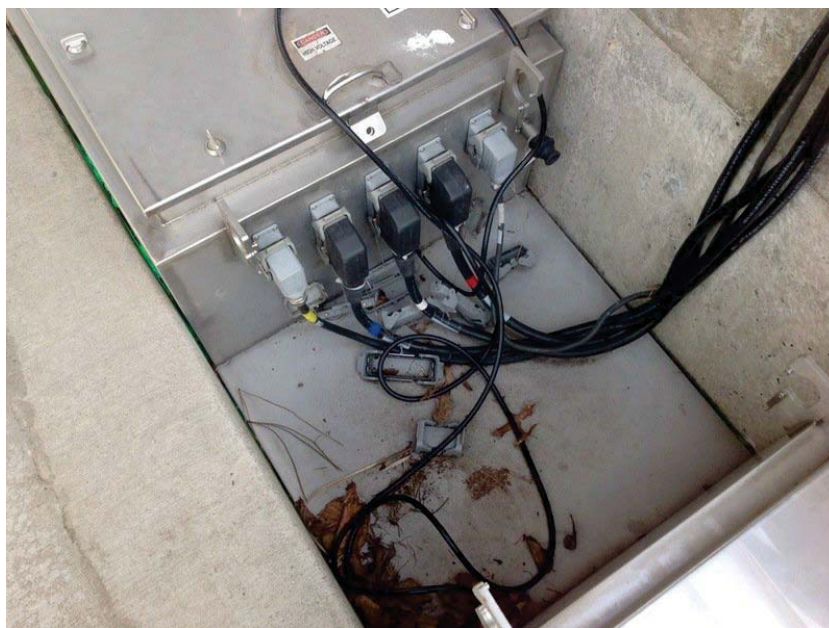
Disinfection	UV Module #1 Ozonia, UVM70-20001
Station ID	UVM70-20001
Asset Description	UV Module #1 Ozonia
What type of Asset?	Electrical
Condition Score	1 - Excellent
Performance Score	1 - Component Functioning as Intended
Recommendation	No immediate action required

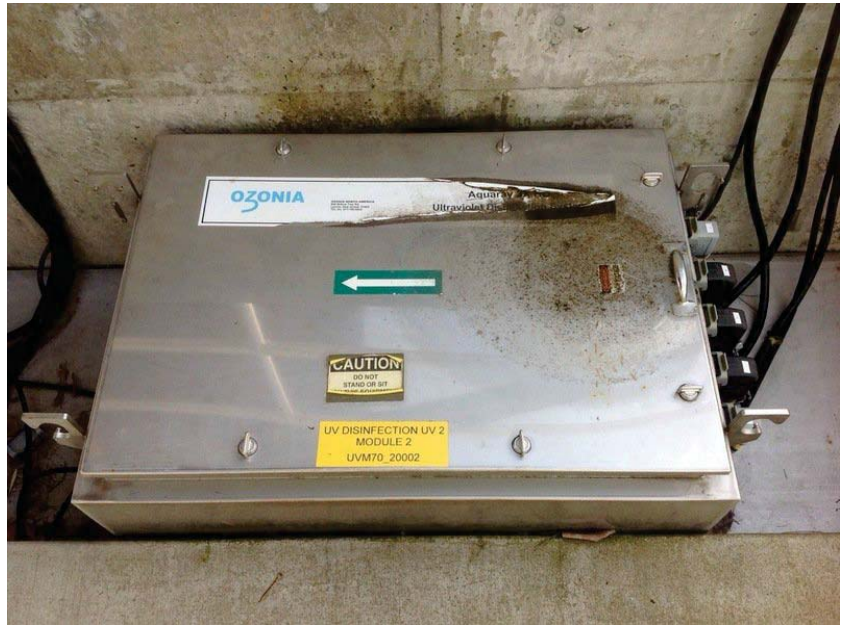
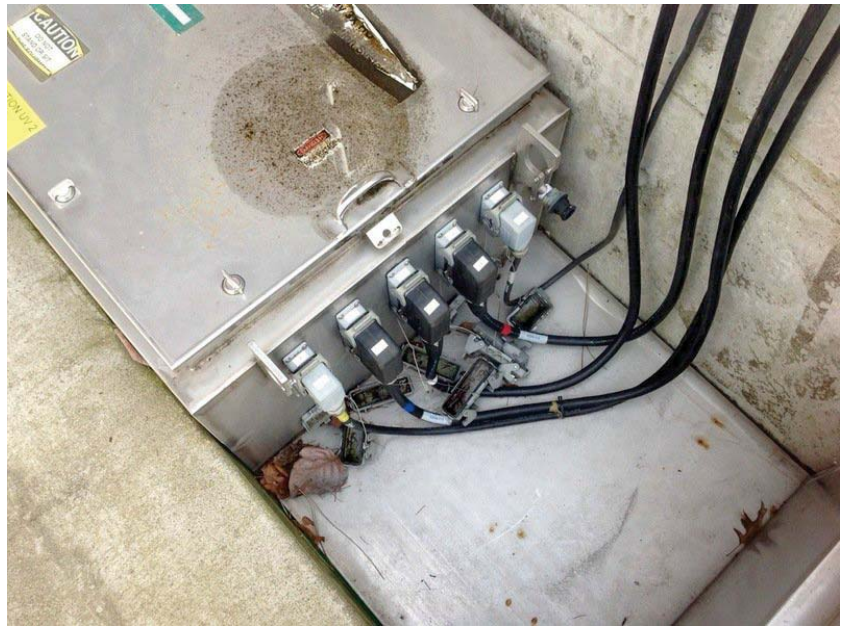
Disinfection	UV Module #2 Ozonia, UVM70-20002
Station ID	UVM70-20002
Asset Description	UV Module #2 Ozonia
What type of Asset?	Electrical
Condition Score	2 - Slight Visible Degradation
Performance Score	1 - Component Functioning as Intended
Recommendation	No immediate action required

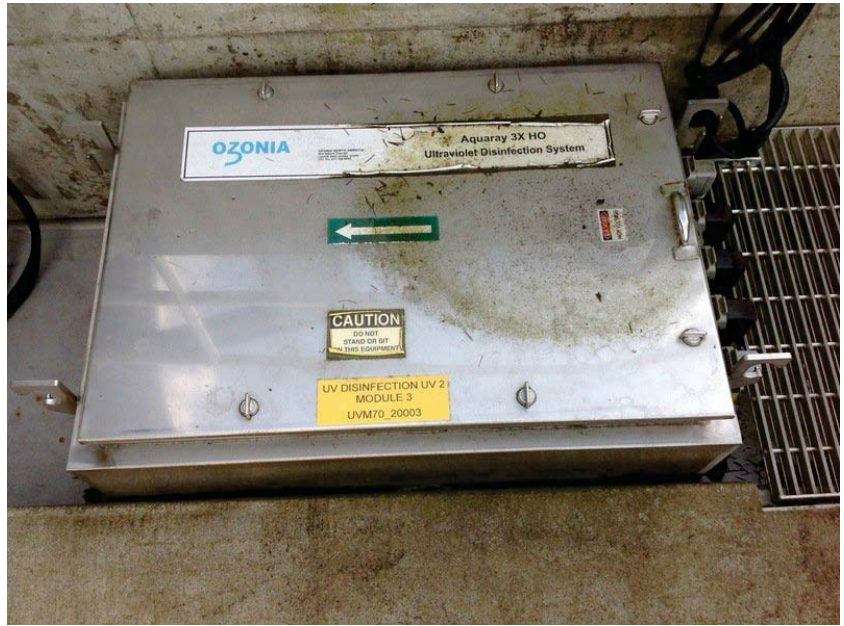
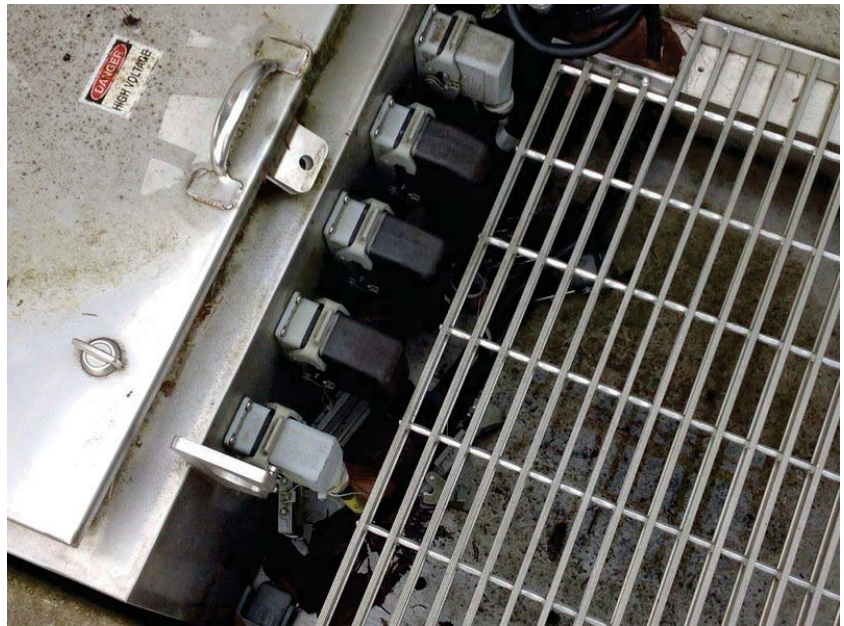
Disinfection	UV Module #3 Ozonia, UVM70-20003
Station ID	UVM70-20003
Asset Description	UV Module #3 Ozonia
What type of Asset?	Mechanical
Condition Score	2 - Slight Visible Degradation
Performance Score	1 - Component Functioning as Intended
Recommendation	No immediate action required

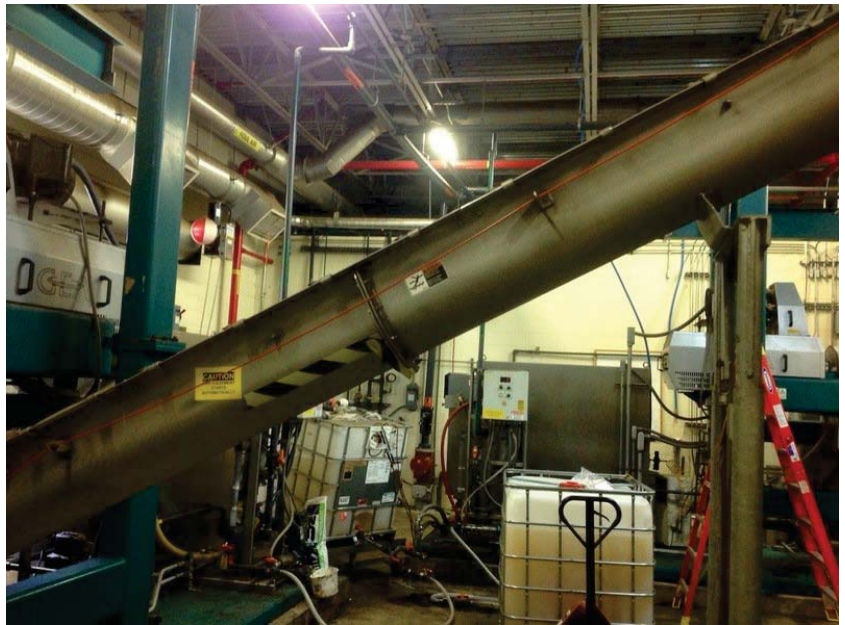
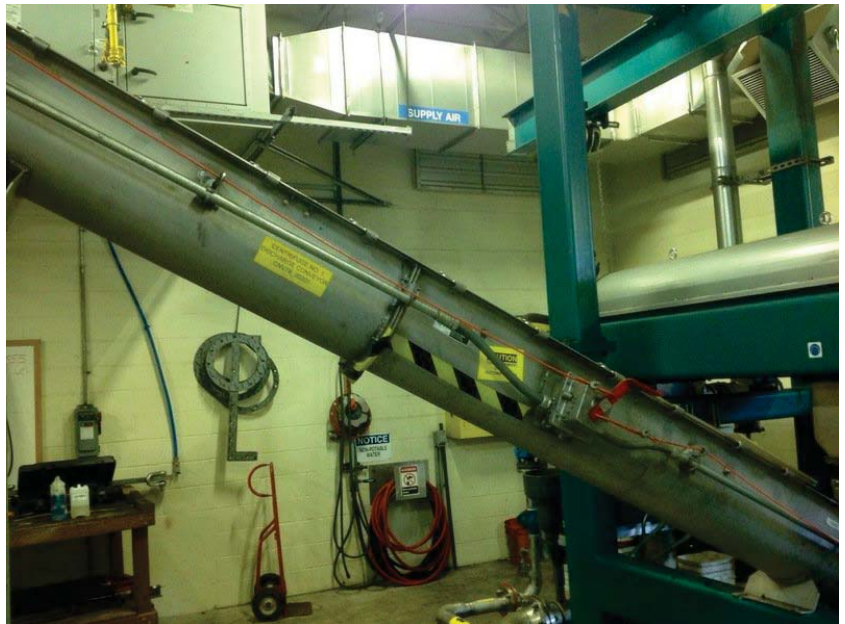
Field Observations	Leaking
Condition Score	2 - Slight Visible Degradation
Performance Score	1 - Component Functioning as Intended
Recommendation	No immediate action required
Field Observations/Comments	Not in operation Liner looks to be in good shape

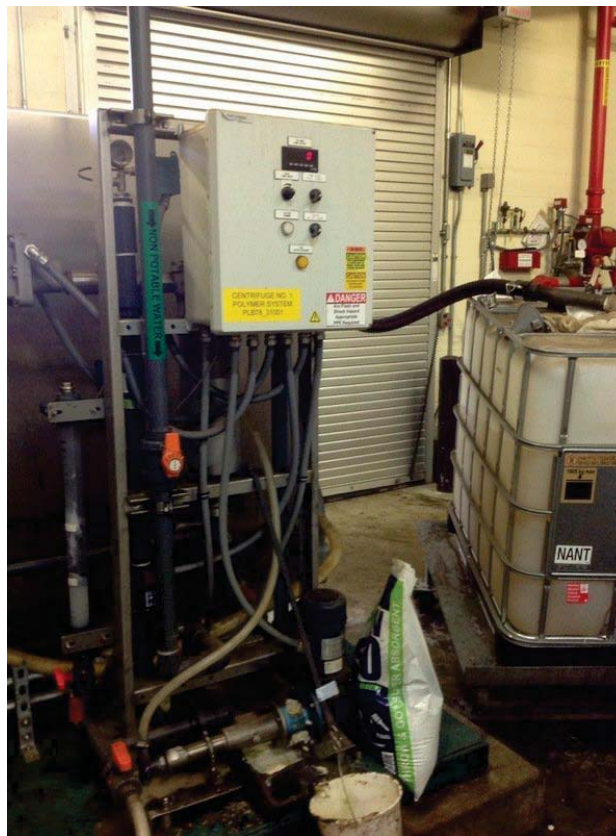
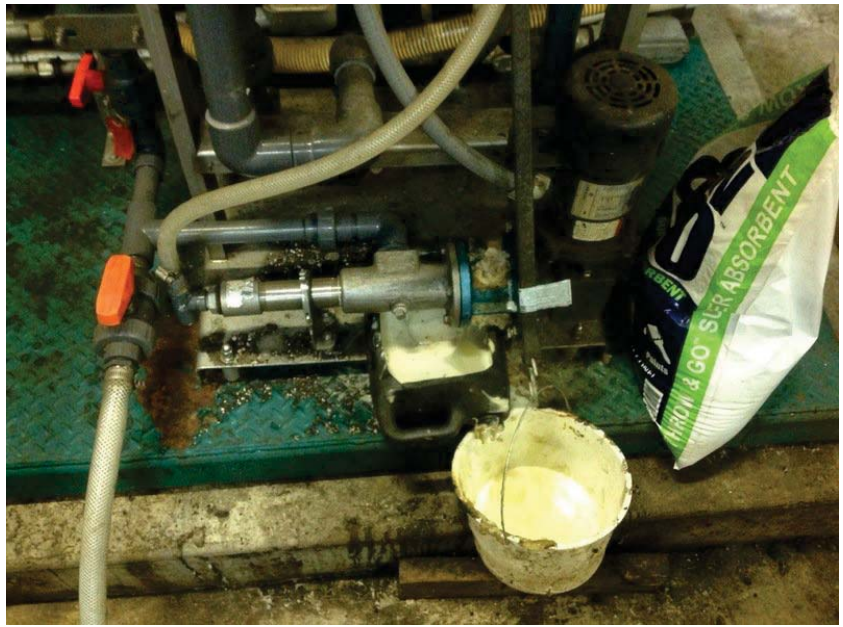
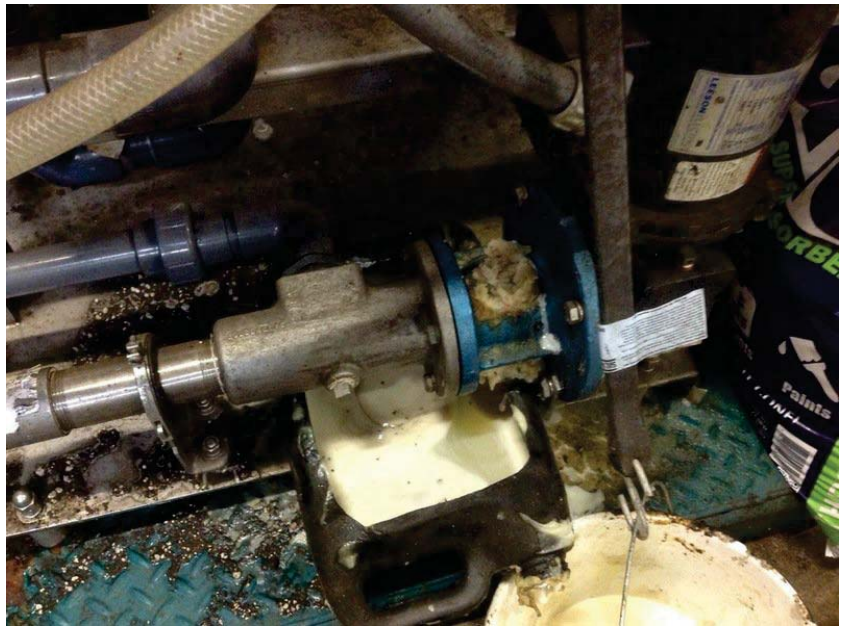
Field Observations	Leaking
Condition Score	2 - Slight Visible Degradation
Performance Score	2 - In Service, but higher than Expected O&M
Recommendation	Schedule corrective action work order near term
Field Observations/Comments	Polymer leaking from packing

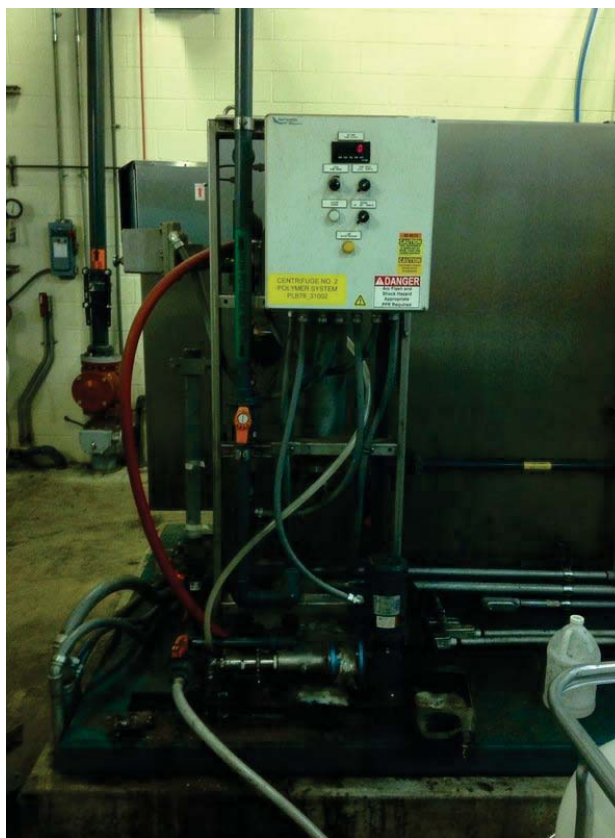
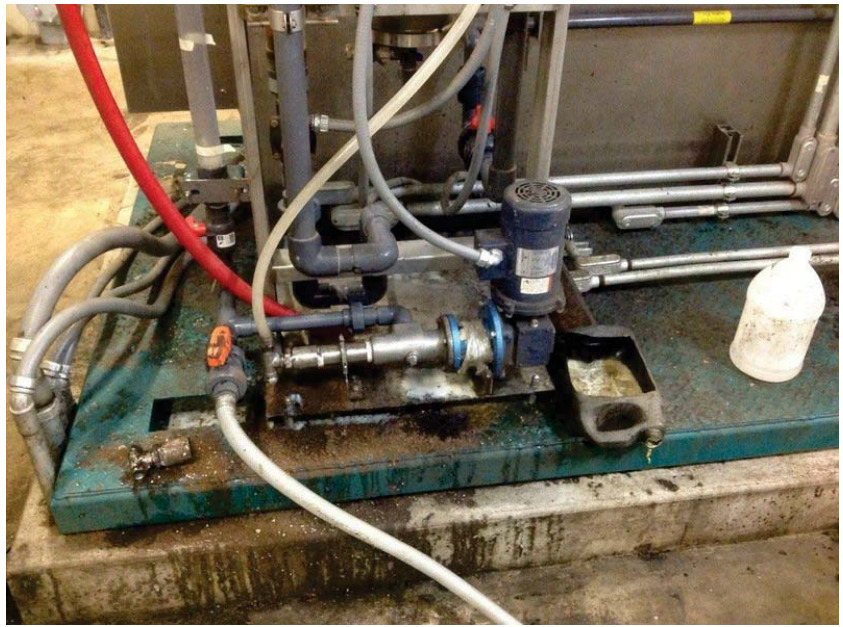
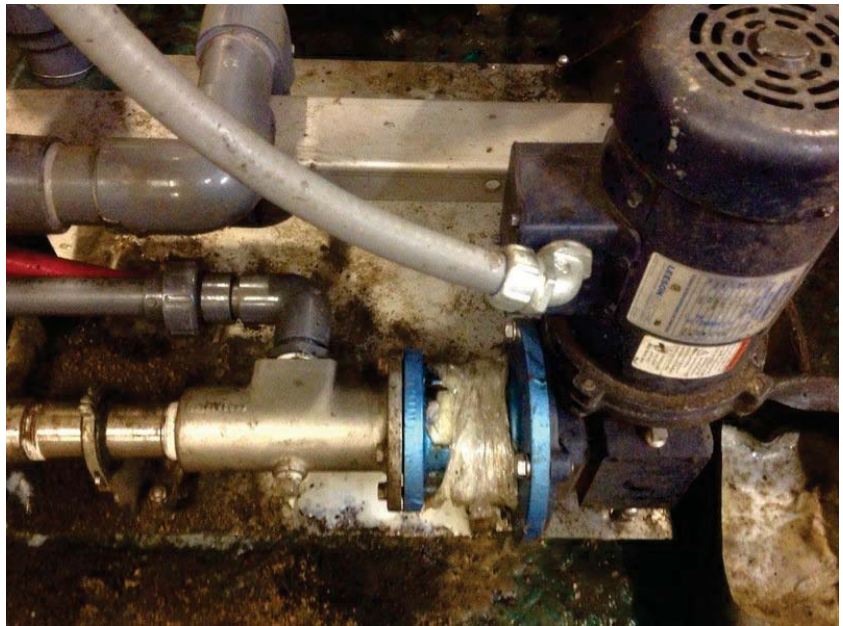
Field Observations	Leaking
Condition Score	2 - Slight Visible Degradation
Performance Score	2 - In Service, but higher than Expected O&M
Recommendation	Schedule corrective action work order near term
Field Observations/Comments	Polymer leaking from packing

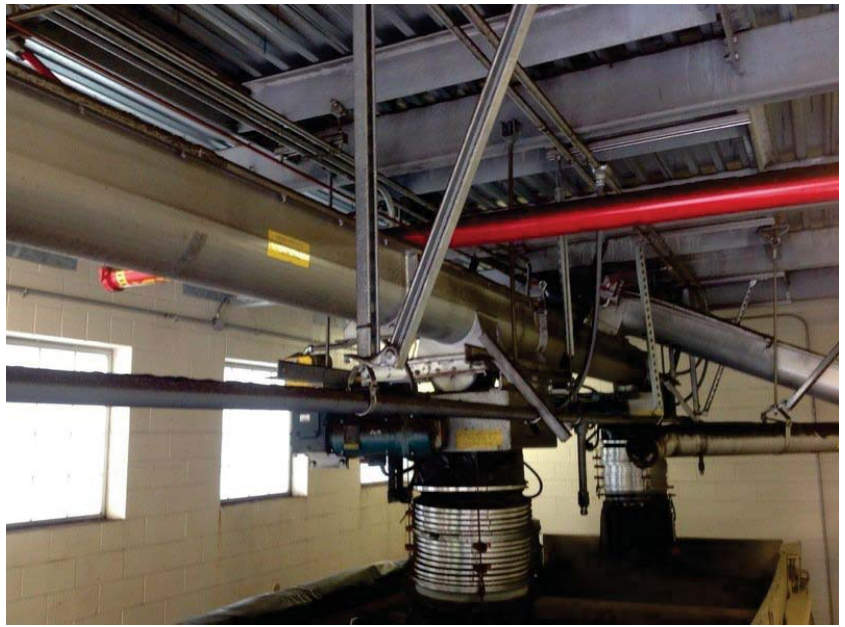
Created	2019-03-27 00:10:49 UTC by Tony Van Haverbeke
Updated	2019-05-28 21:33:44 UTC by Simon Watson
Location	0.0, 0.0
Date	2019-03-28
Time	14:15
Area or Function	Solids Drying
Station ID	CNV78-10100
Asset Description	Load Out Distribution Conveyor
What type of Asset?	Mechanical
Condition Score	2 - Slight Visible Degradation
Performance Score	1 - Component Functioning as Intended
Recommendation	No immediate action required
Field Observations/Comments	Visually appears to be in good order A lot of dry product in the room

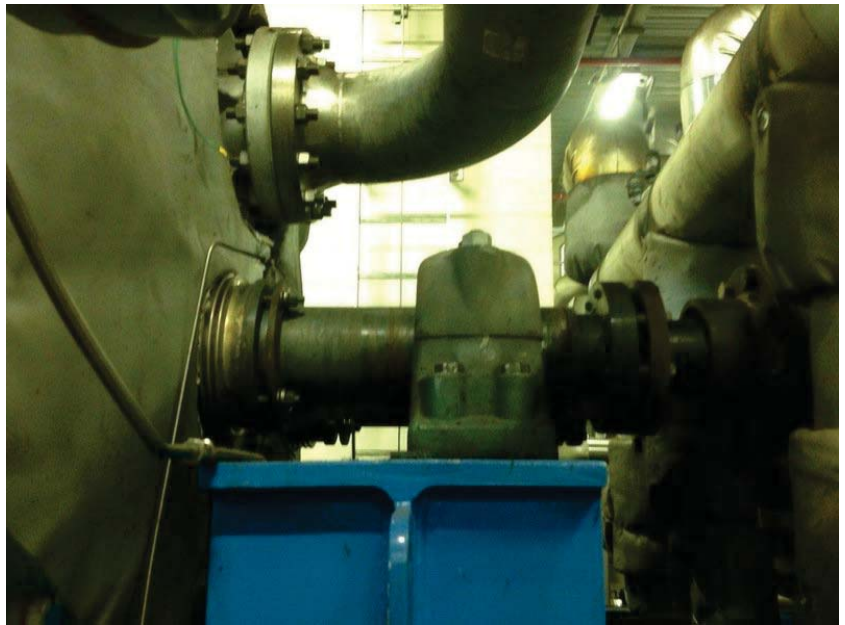
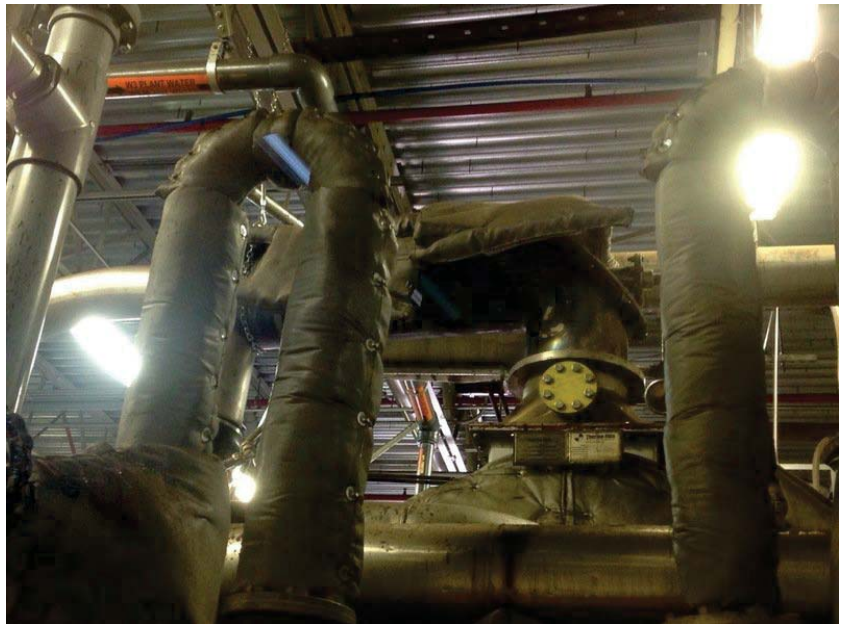
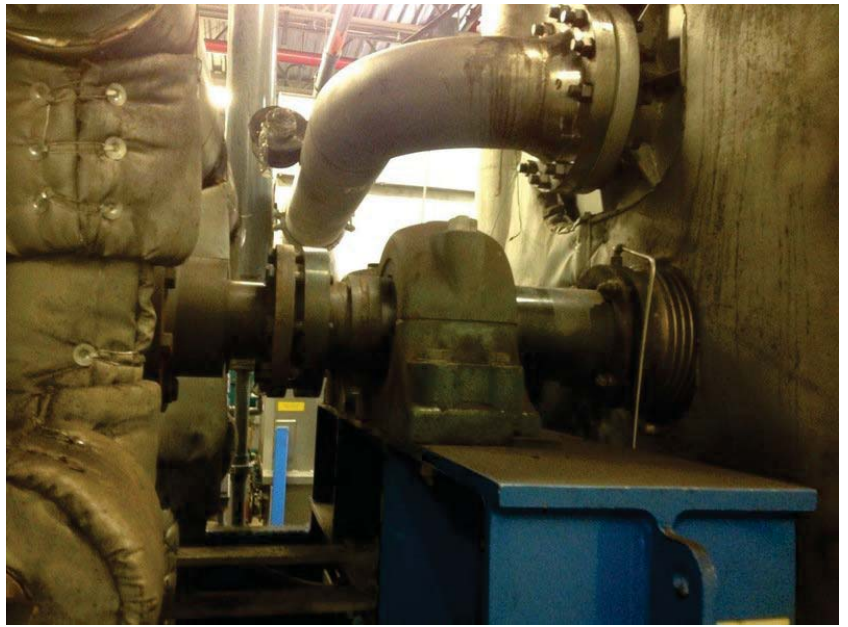
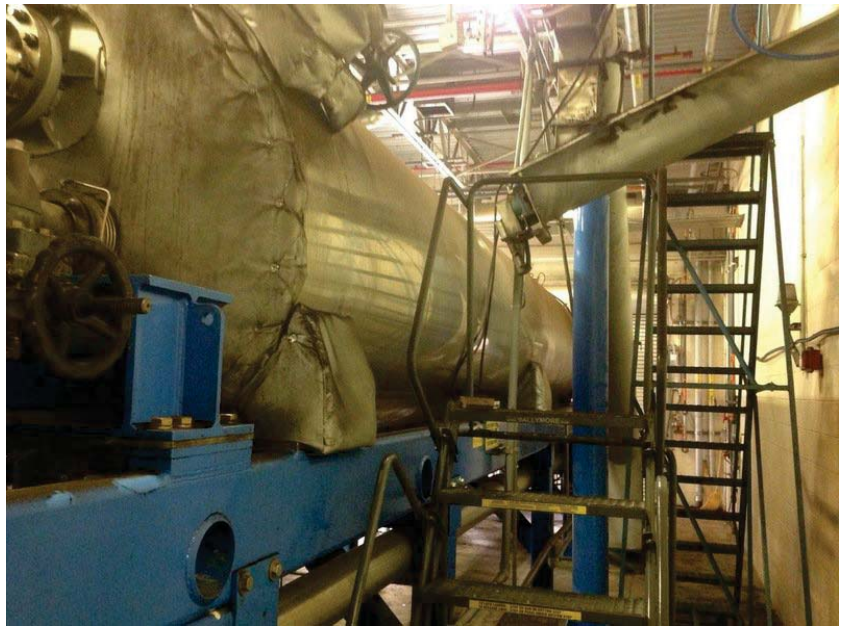
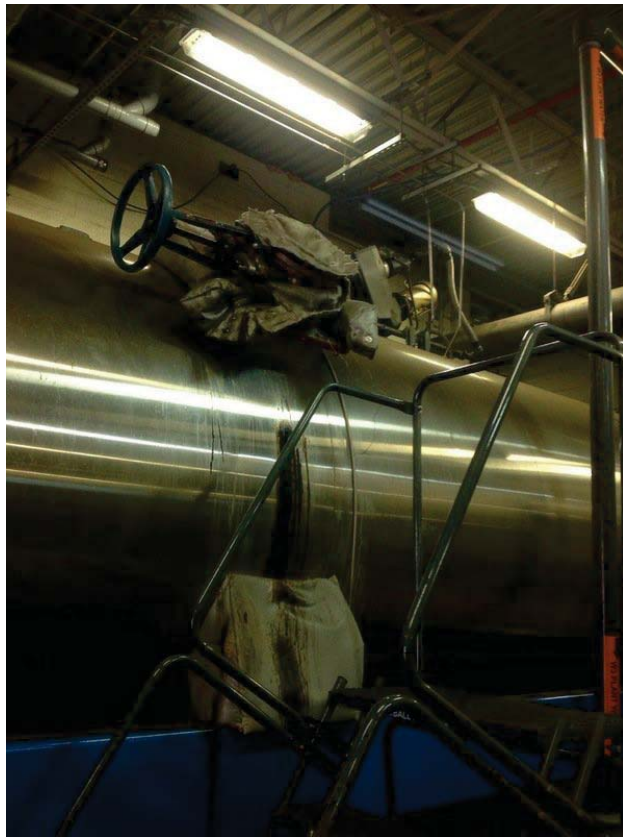
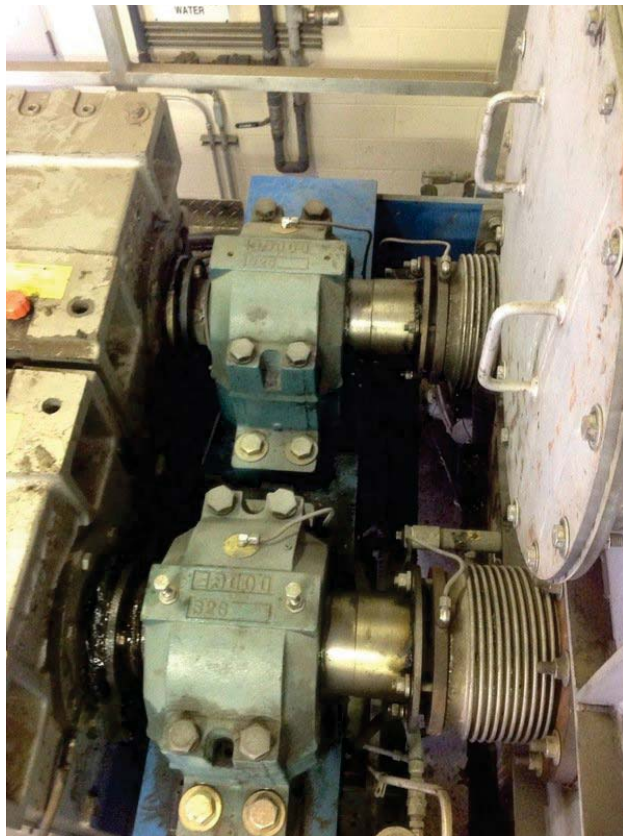
Field Observations	Leaking
Condition Score	2 - Slight Visible Degradation
Performance Score	1 - Component Functioning as Intended
Recommendation	No immediate action required
Field Observations/Comments	Some excessive grease around the drive shafts Side valve leaking

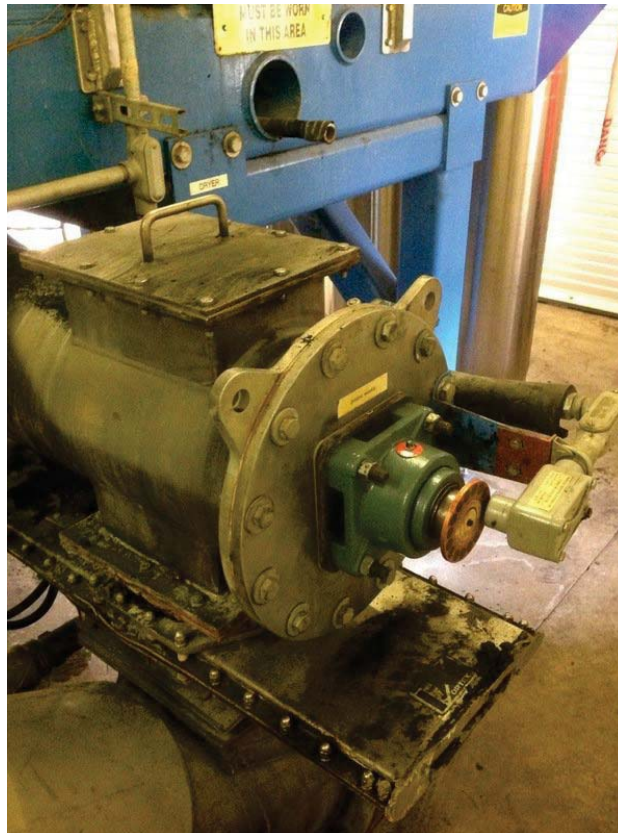
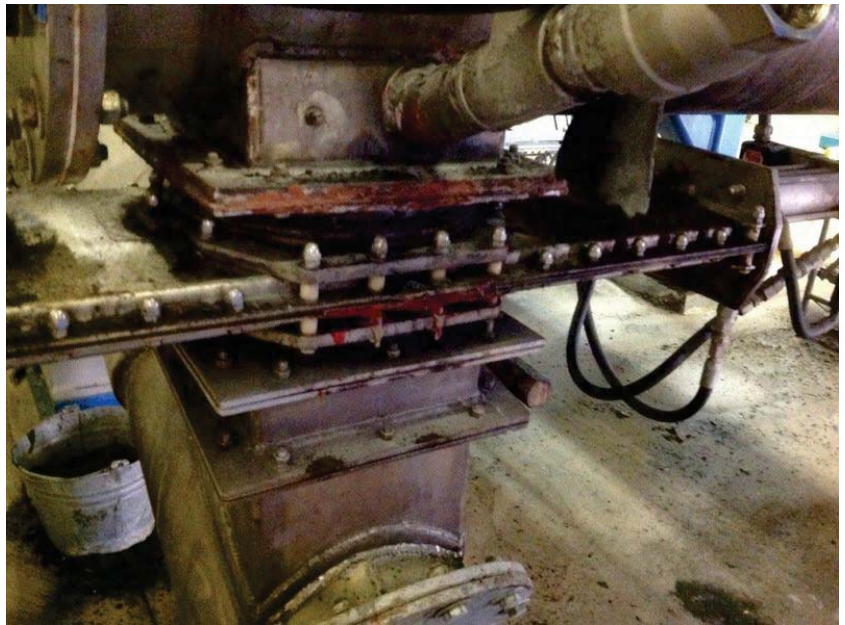
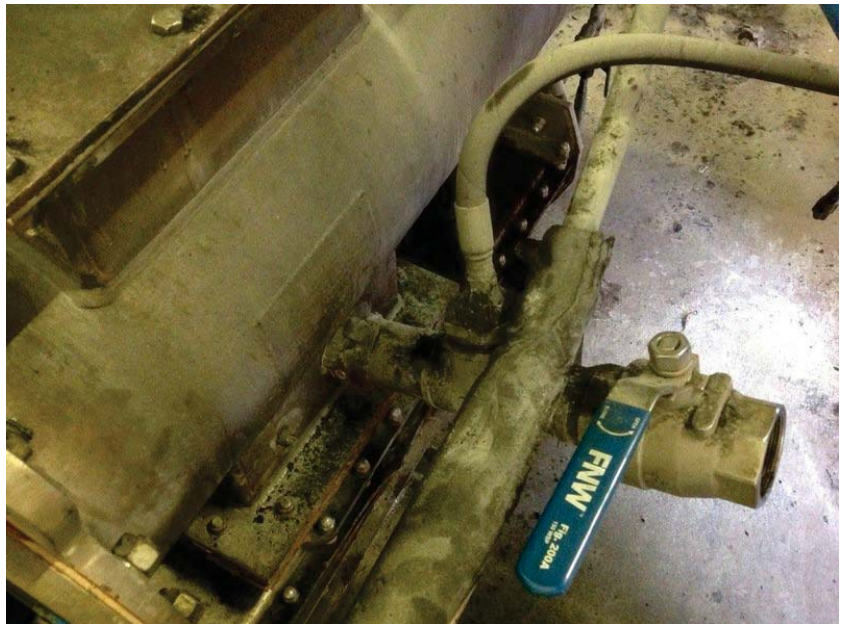
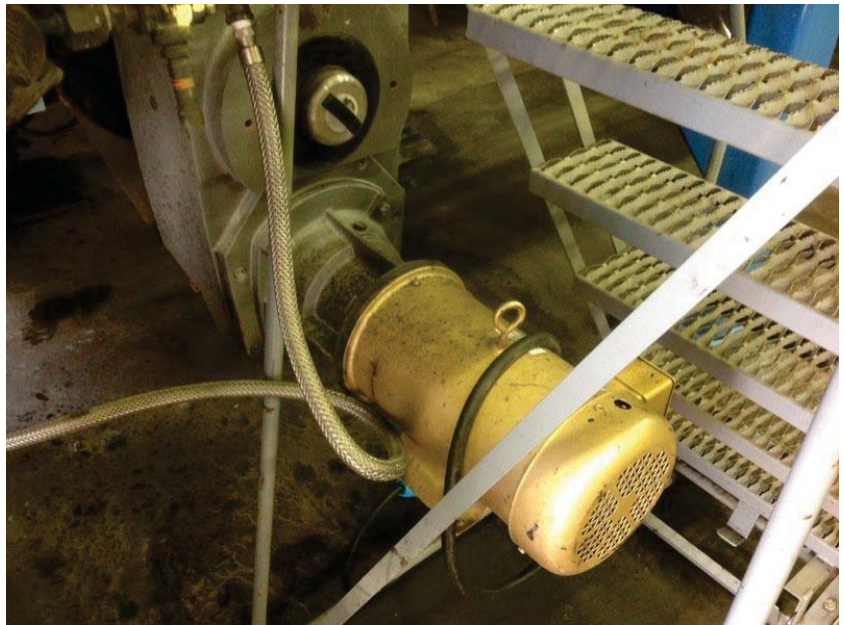
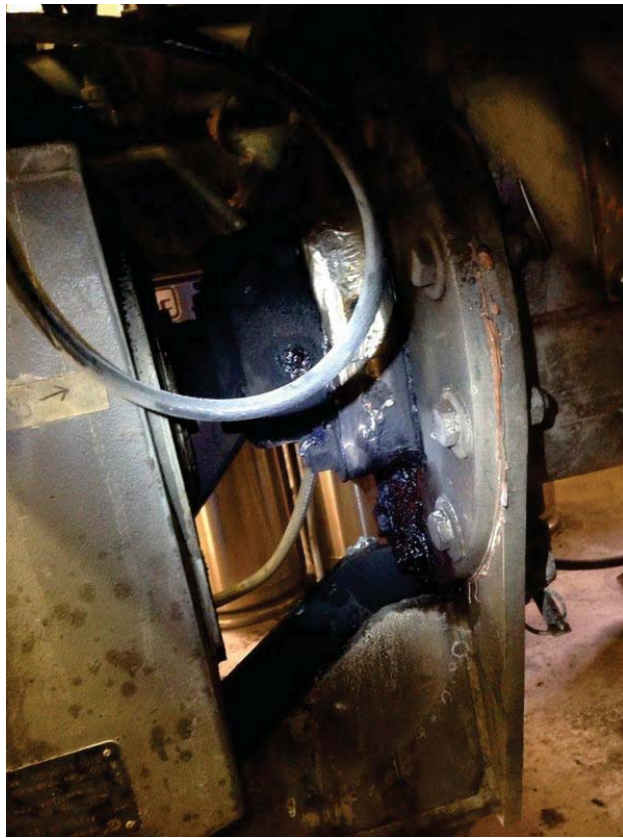
Solids Drying	Dryer Discharge Conveyor, CNV78-20800
Station ID	CNV78-20800
Asset Description	Dryer Discharge Conveyor
What type of Asset?	Mechanical
Condition Score	2 - Slight Visible Degradation
Performance Score	2 - In Service, but higher than Expected O&M
Recommendation	No immediate action required
Field Observations/Comments	Appears that the conveyor has experienced some fires
