# City of Wilsonville Triennial Inspection Report

Wilsonville WWTP and  
Wastewater Lift Stations:

Project Title: On-Call Civil Engineering and Related Services,  
Triennial Inspection of the Wilsonville WWTP and Nine Lift Stations

Subject: 2019 Triennial Inspection of the Wilsonville WWTP  
and Sewage Lift Stations

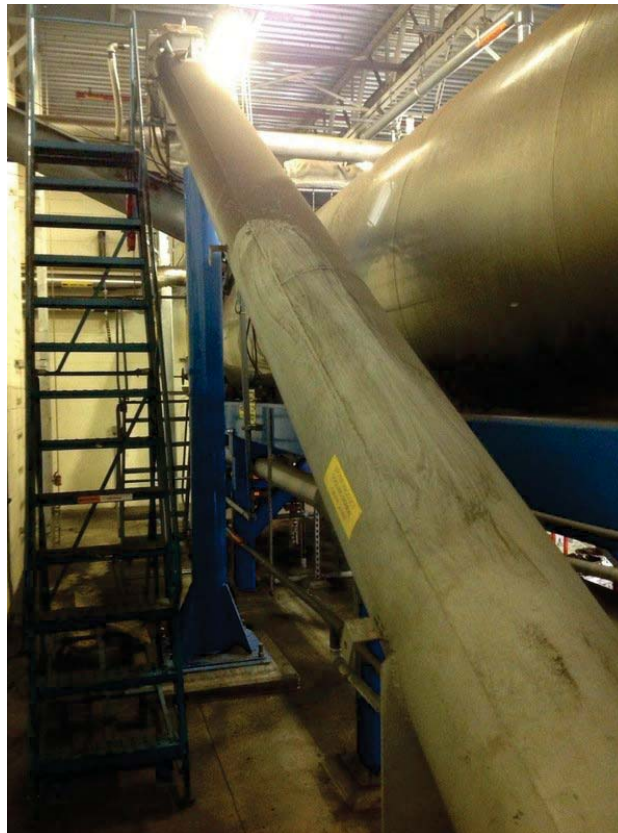
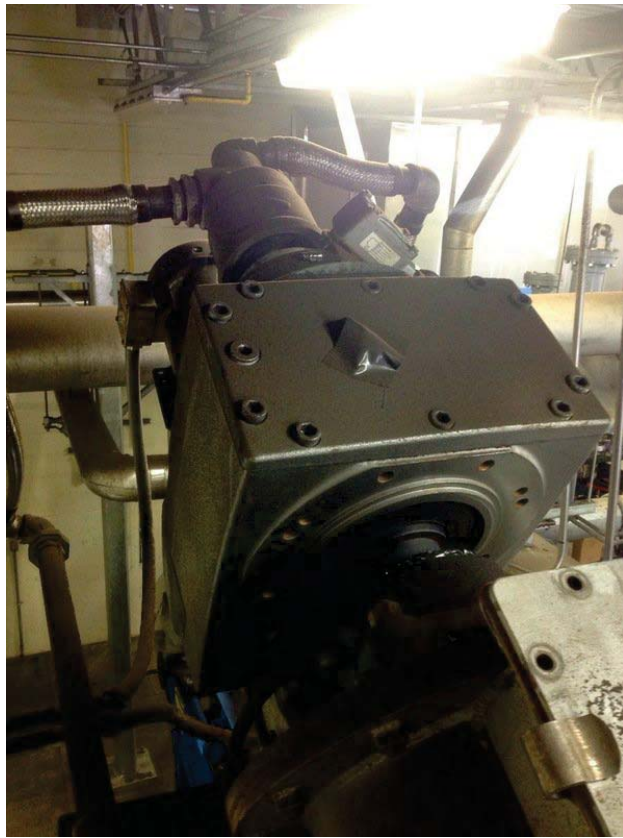
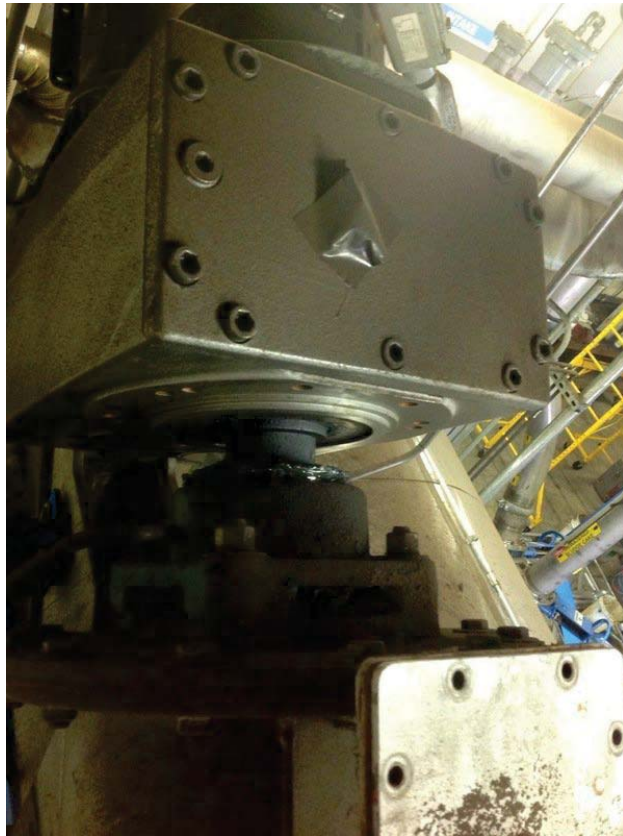
Solids Drying	Dry Product Cooling Conveyor, CNV78-20900
Station ID	CNV78-20900
Asset Description	Dry Product Cooling Conveyor
What type of Asset?	Mechanical
Condition Score	2 - Slight Visible Degradation
Performance Score	1 - Component Functioning as Intended
Recommendation	No immediate action required
Field Observations/Comments	Grease on drive shaft

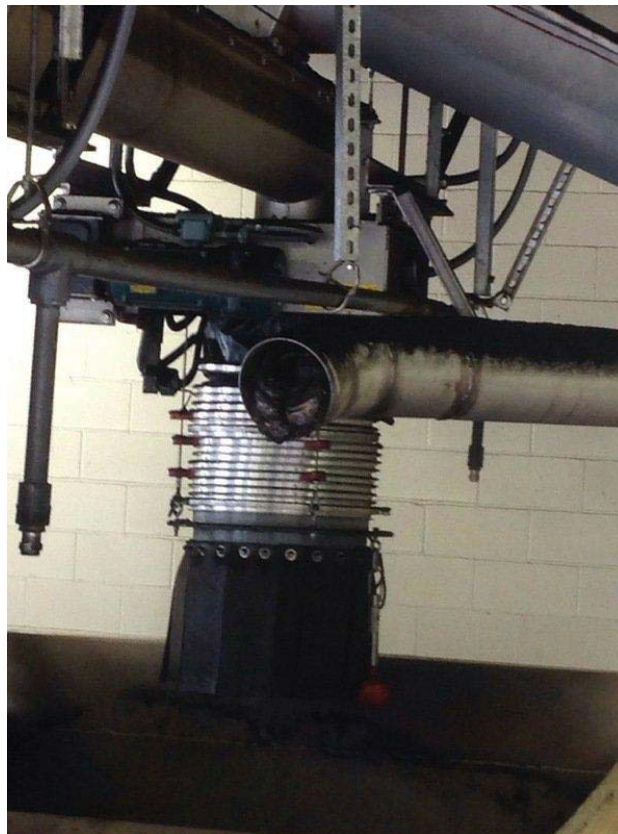
Solids Drying	Retractable Loadout Chute #1, CTE78-10201
Station ID	CTE78-10201
Asset Description	Retractable Loadout Chute #1
What type of Asset?	Mechanical
Condition Score	2 - Slight Visible Degradation
Performance Score	1 - Component Functioning as Intended
Recommendation	Initiate more detailed inspection
Field Observations/Comments	Does not appear to be used Fully retracted with an empty bin

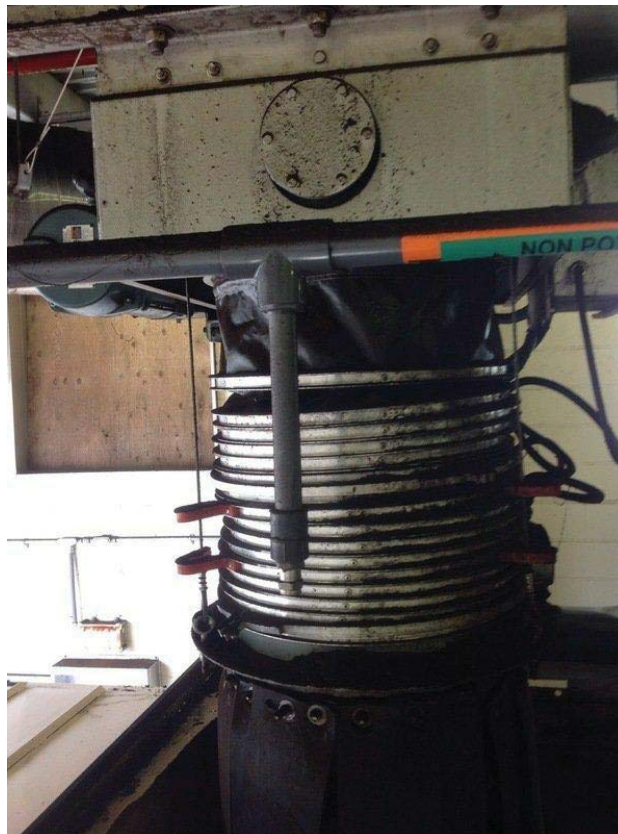
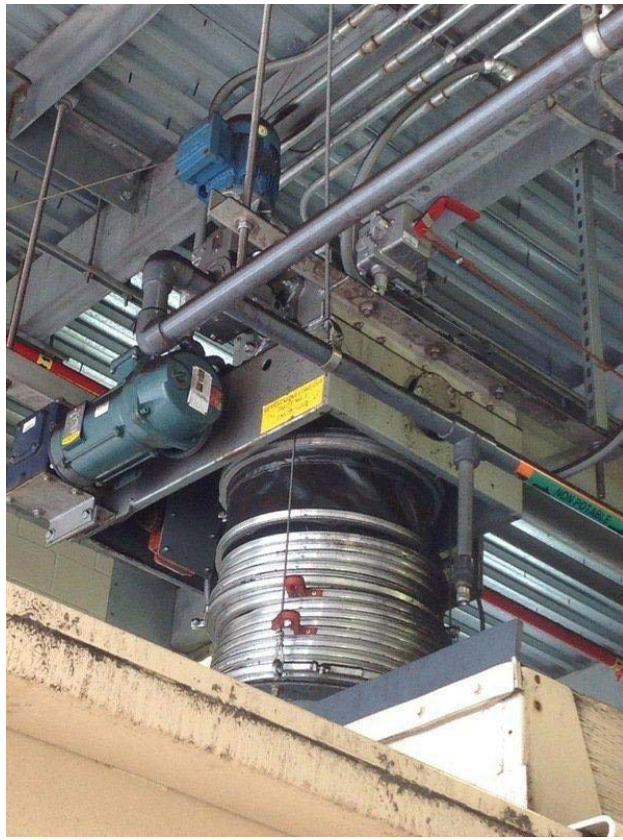
Solids Drying	Retractable Loadout Chute #3, CTE78-10203
Station ID	CTE78-10203
Asset Description	Retractable Loadout Chute #3
What type of Asset?	Mechanical
Condition Score	2 - Slight Visible Degradation
Performance Score	1 - Component Functioning as Intended
Recommendation	No immediate action required
Field Observations/Comments	Does not appear to be used Fully retracted with an empty trailer and dry product coming out of chute

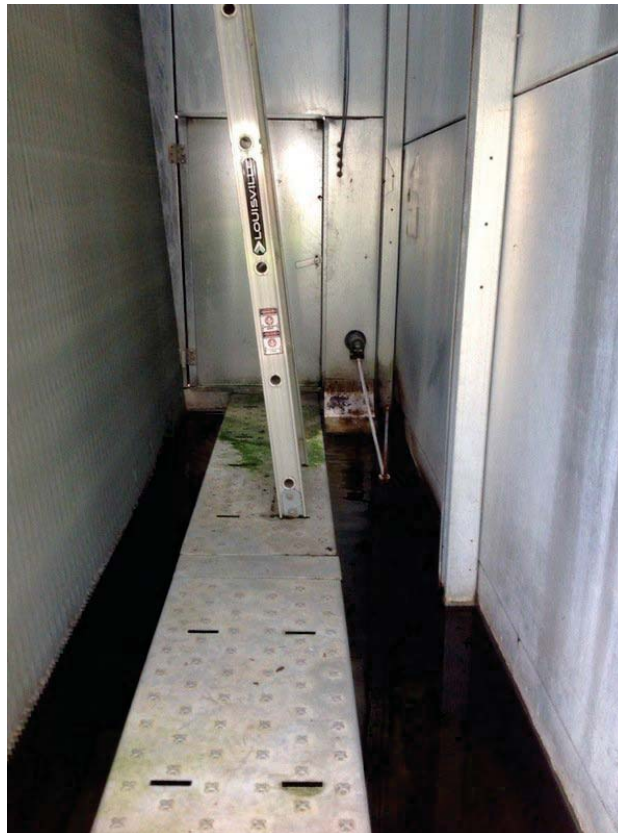
Field Observations	Leaking
Condition Score	2 - Slight Visible Degradation
Performance Score	1 - Component Functioning as Intended
Recommendation	Schedule corrective action work order near term
Field Observations/Comments	Unit not operating Over all condition looks good Water reservoir auto fill valve appears to be running constantly

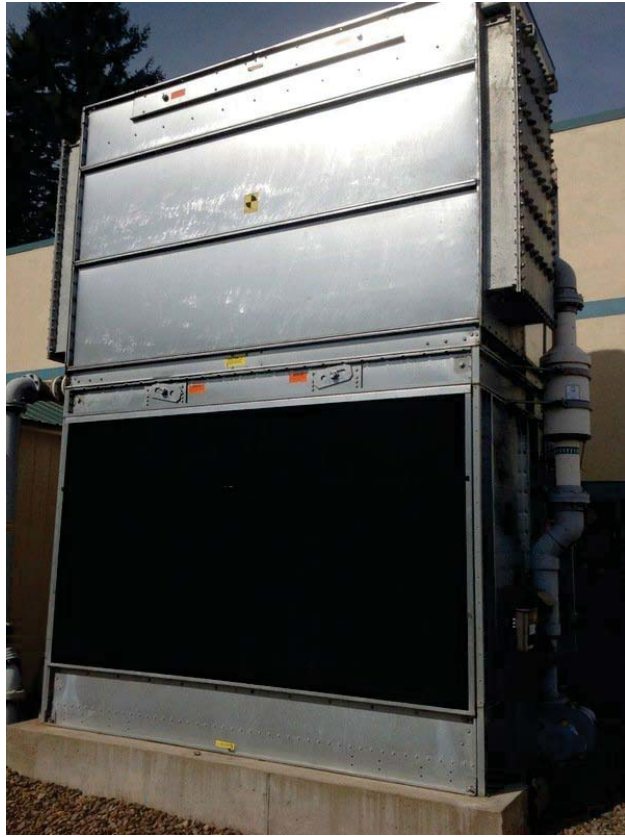
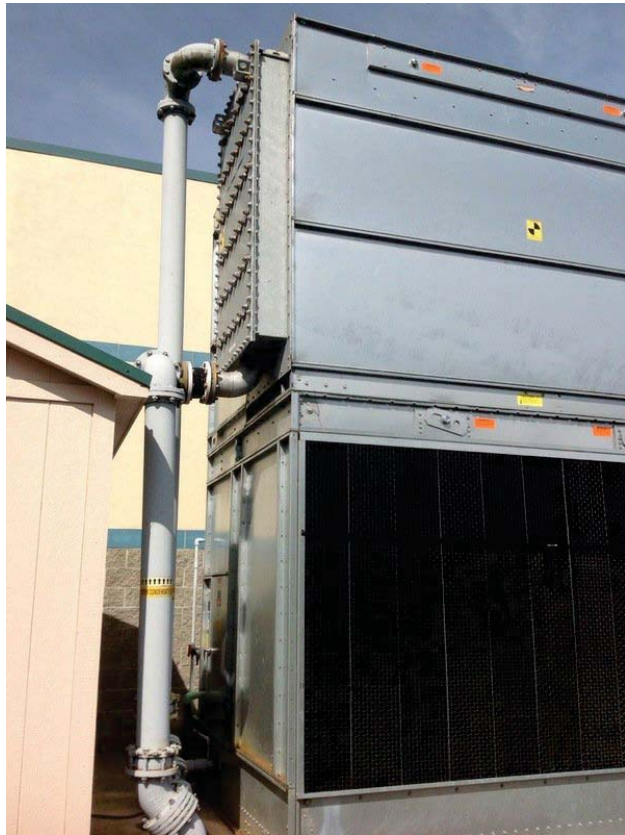
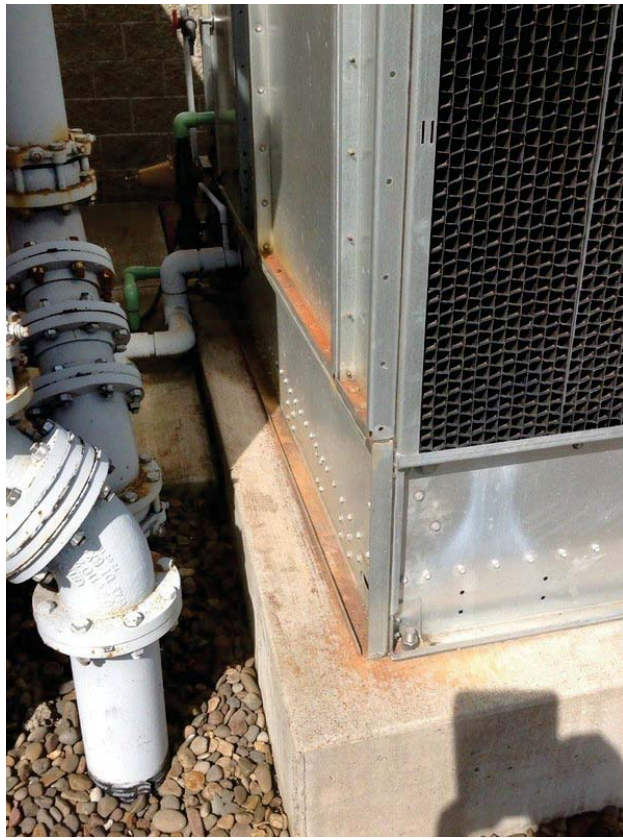
Auto fill valve

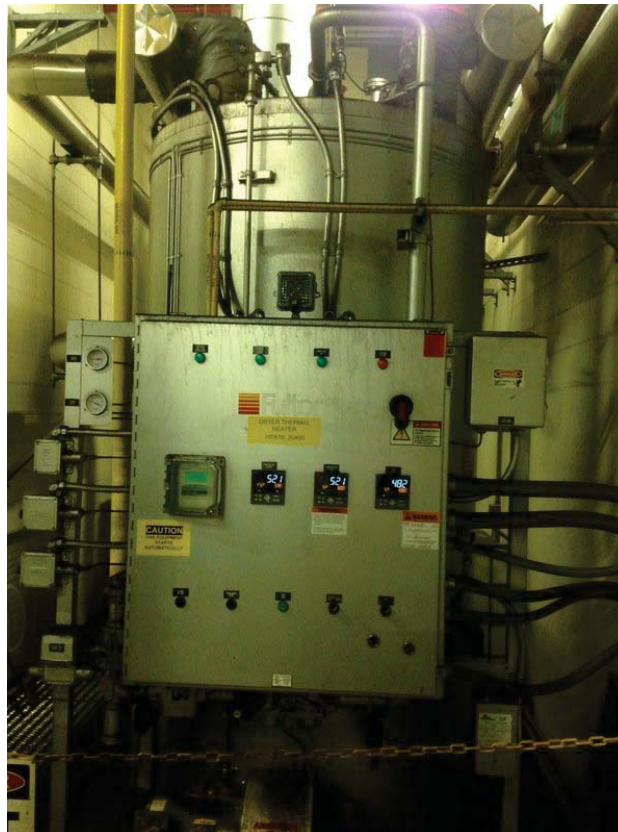
Created	2019-03-28 21:28:08 UTC by Simon Watson
Updated	2019-05-28 21:31:11 UTC by Simon Watson
Location	45.2947139506, -122.770791654
Date	2019-03-28
Time	14:28
Area or Function	Solids Drying
Station ID	HTR78_20400
Asset Description	Dryer Thermal Heater
What type of Asset?	Mechanical
Condition Score	2 - Slight Visible Degradation
Performance Score	1 - Component Functioning as Intended
Recommendation	No immediate action required
Field Observations/Comments	Operating no visible leaks

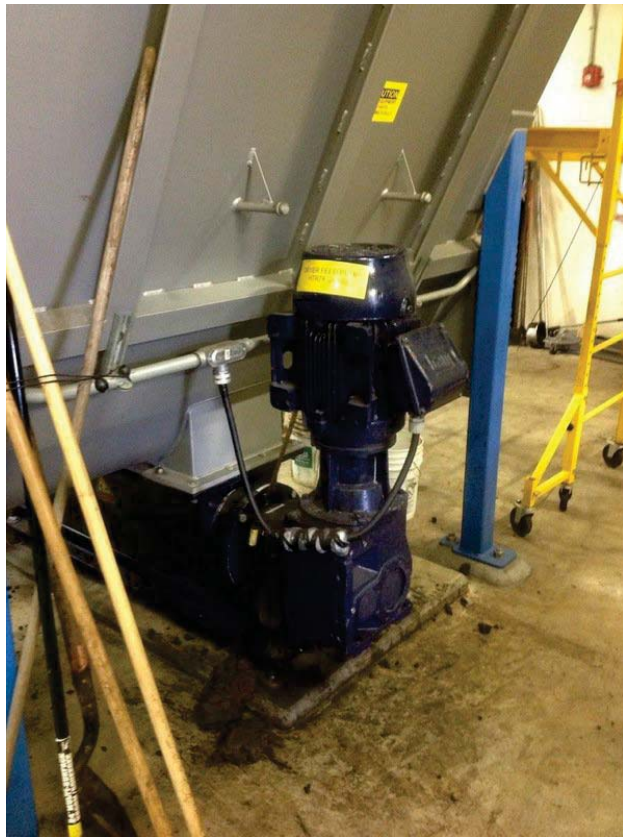
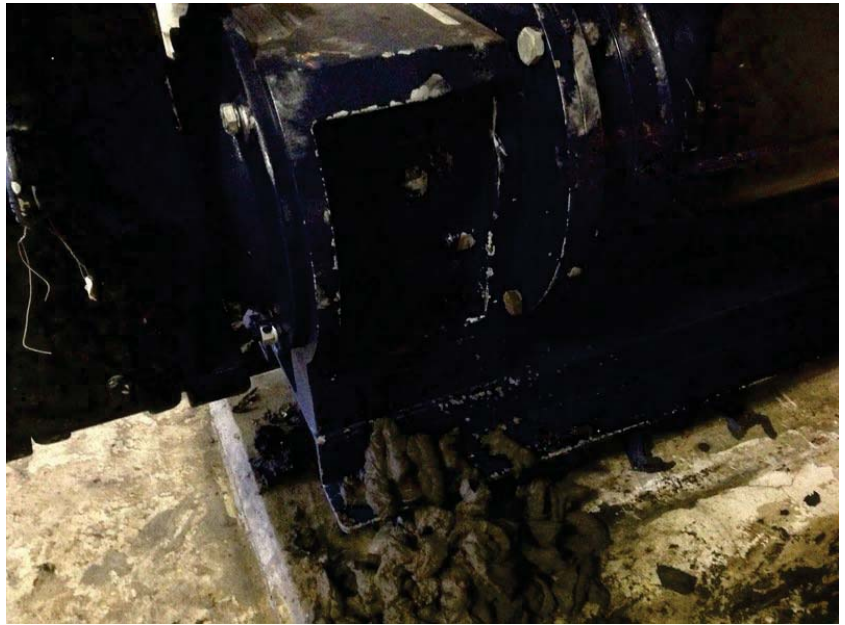
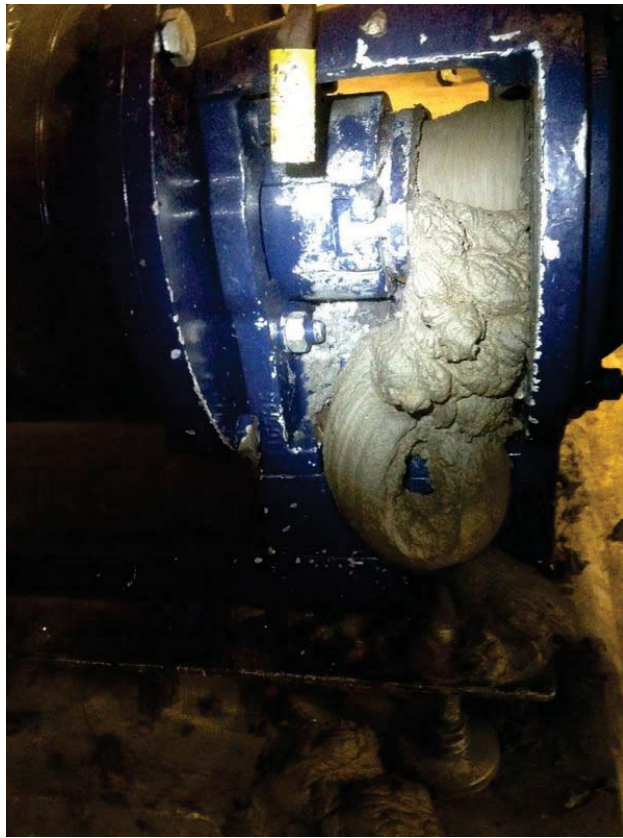
Field Observations	Leaking
Condition Score	2 - Slight Visible Degradation
Performance Score	1 - Component Functioning as Intended
Recommendation	Schedule corrective action work order near term
Field Observations/Comments	Sludge leaking from packing

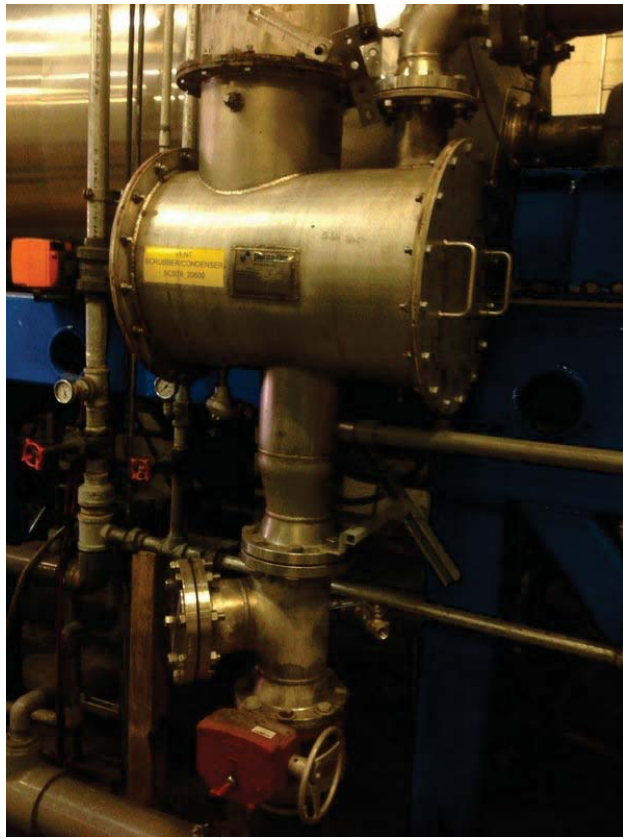
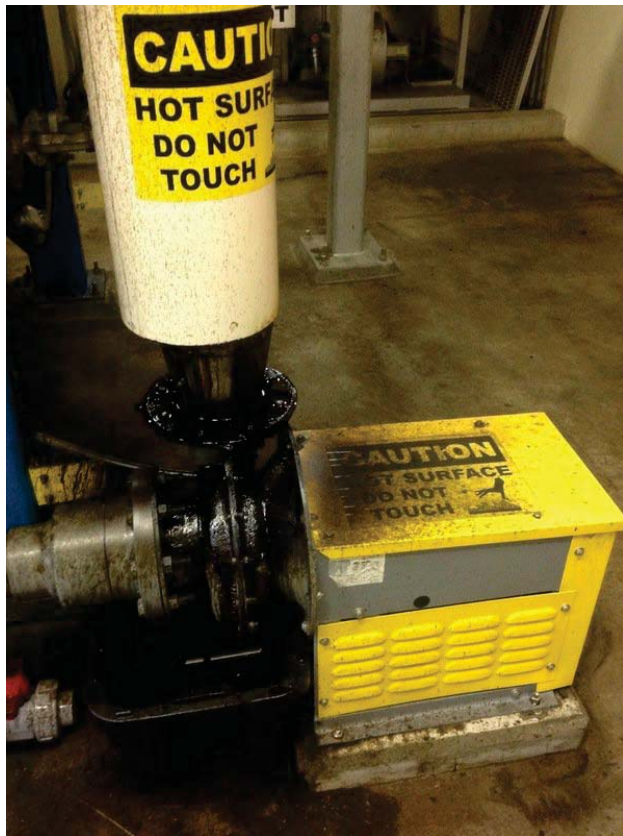
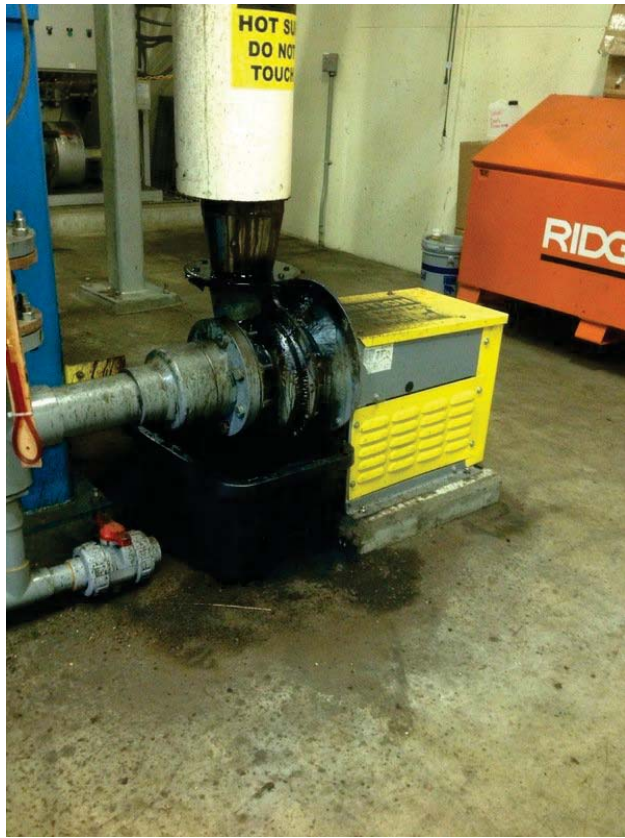
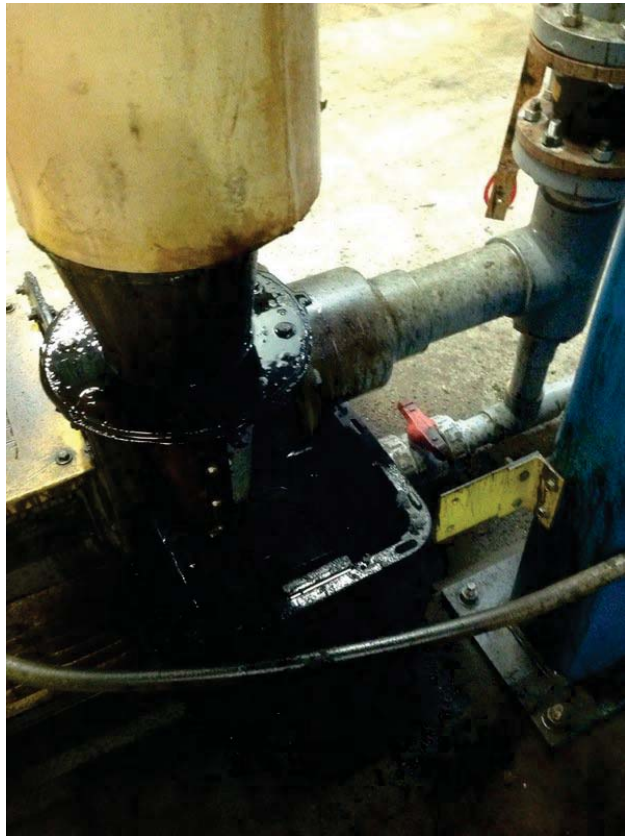
Field Observations	Leaking
Condition Score	3 - Visible Degradation
Performance Score	2 - In Service, but higher than Expected O&M
Recommendation	Schedule corrective action work order near term
Field Observations/Comments	Scrubber fan has excessive oil leaking out

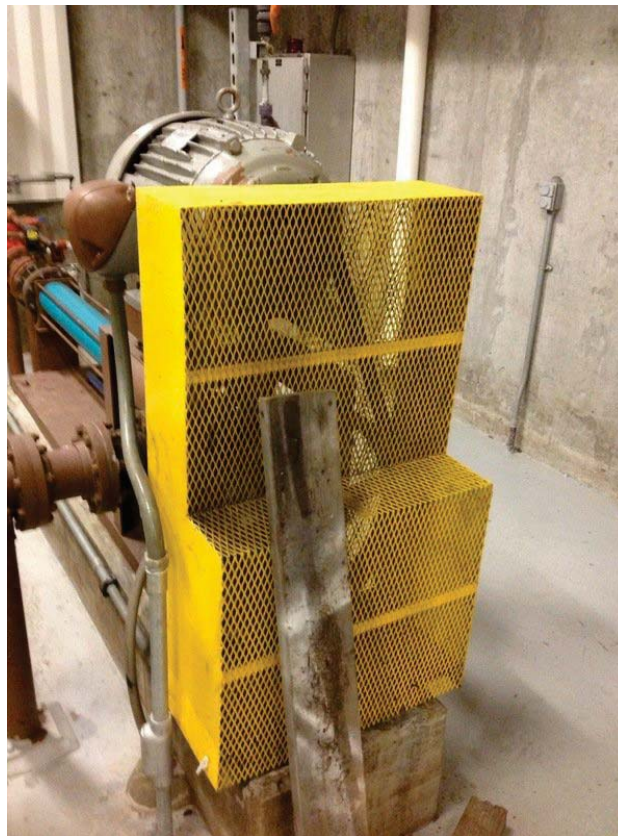
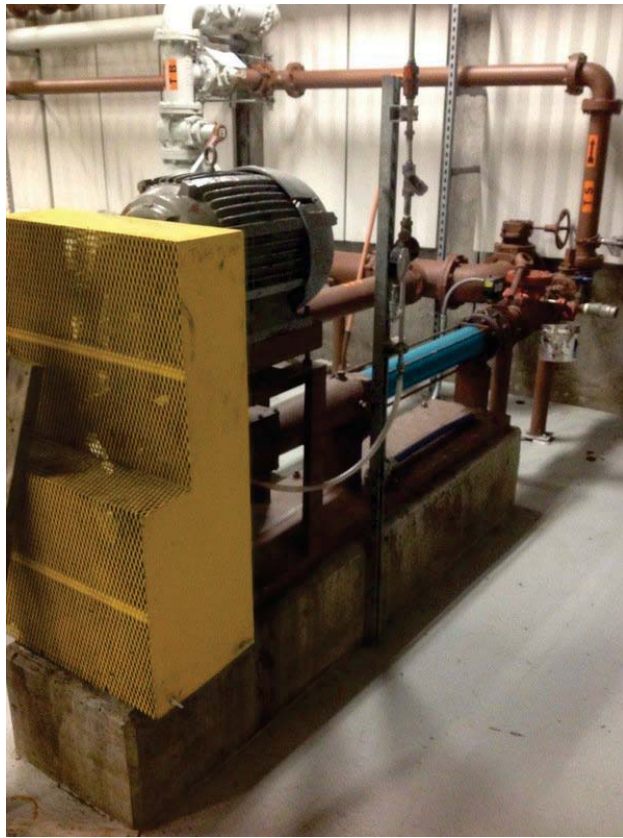
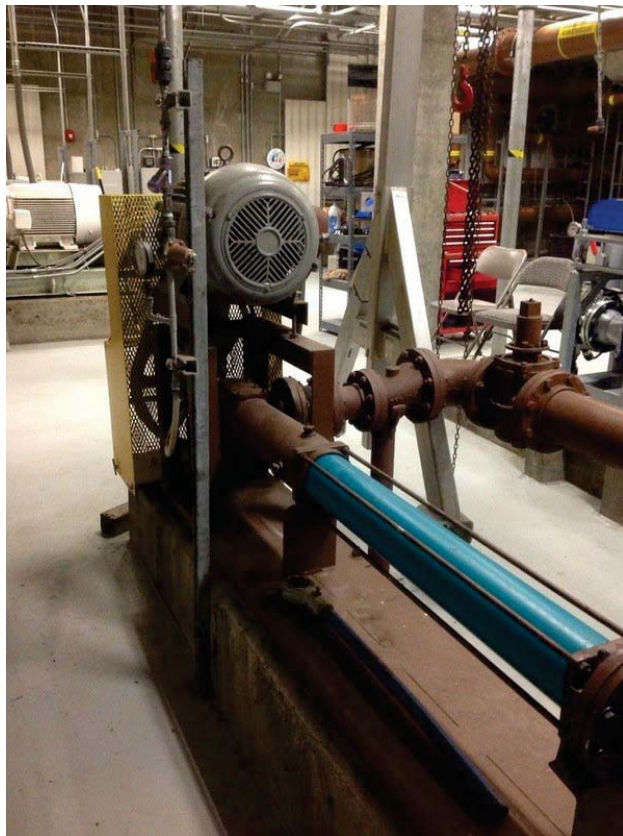
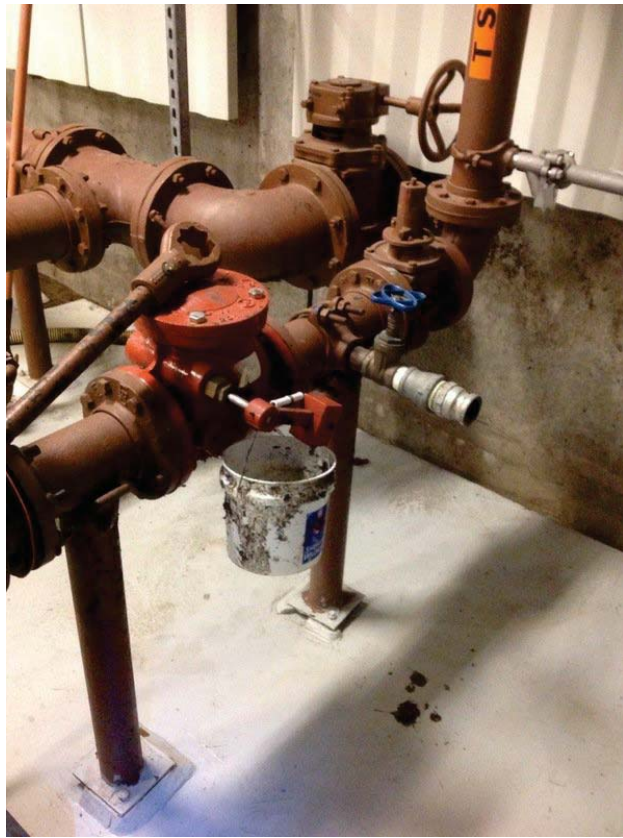
Solids Dewatering	Thickened Biosolids Pump, PGB-P-80-6
Station ID	PGB-P-80-6
What type of Asset?	Pumps and Motors
Condition Score	2 - Slight Visible Degradation
Performance Score	1 - Component Functioning as Intended
Recommendation	No immediate action required
Field Observations/Comments	Check valve may have a leak

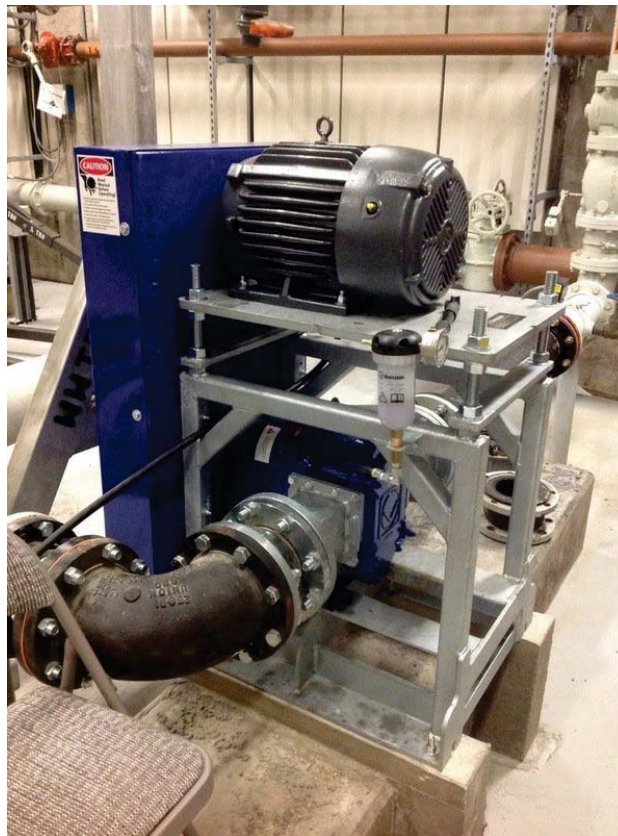
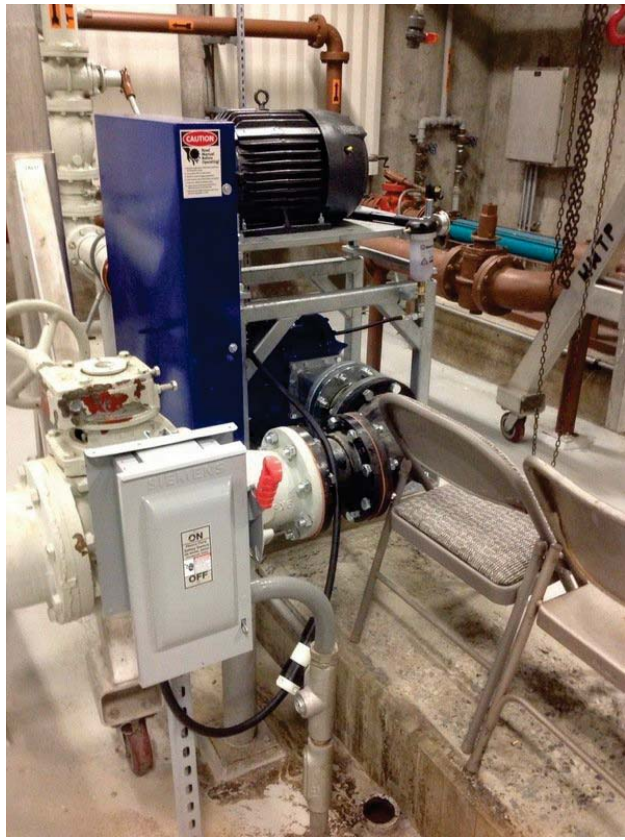
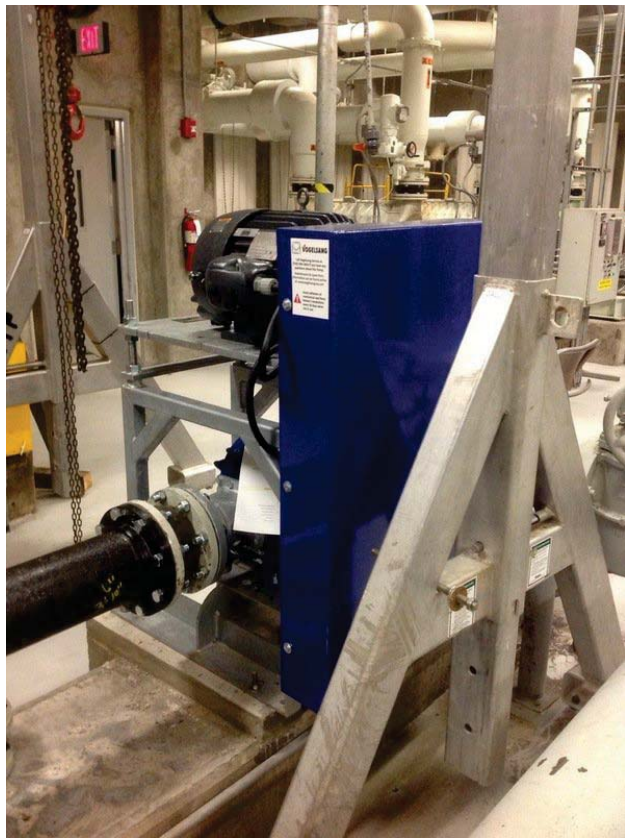
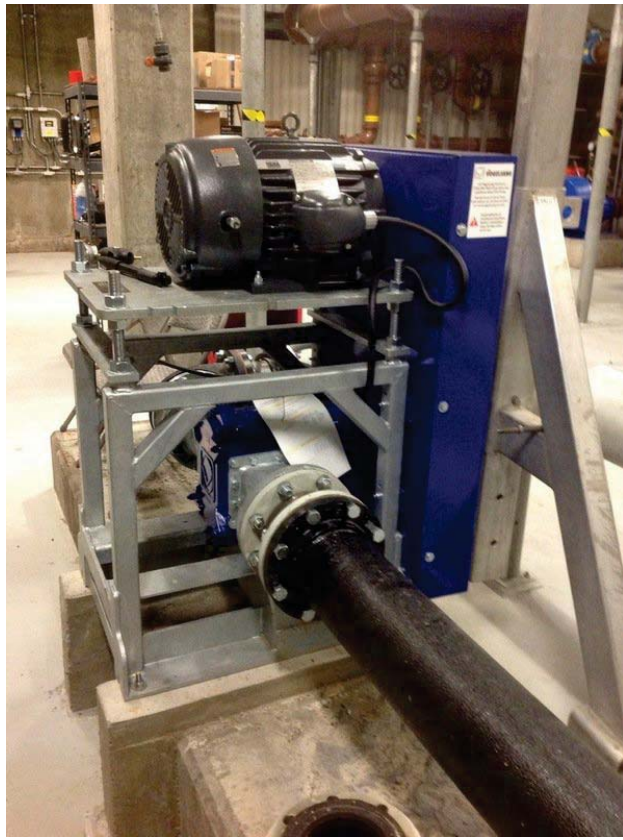
Solids Dewatering	Vogelsang TWAS Rotary Lobe Pump, PGB-P-80-8
Station ID	PGB-P-80-8
What type of Asset?	Pumps and Motors
Condition Score	1 - Excellent
Performance Score	1 - Component Functioning as Intended
Recommendation	No immediate action required
Field Observations/Comments	Not operating

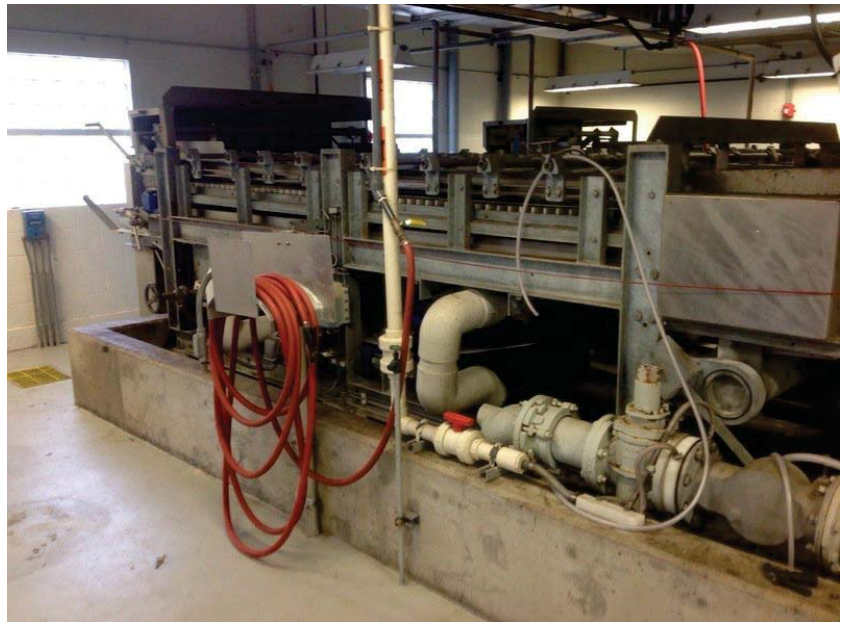
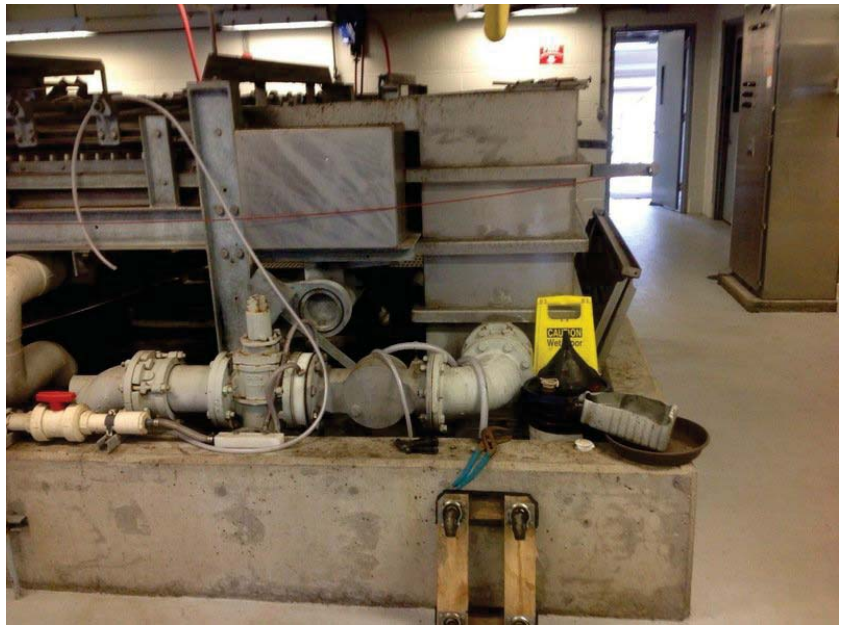
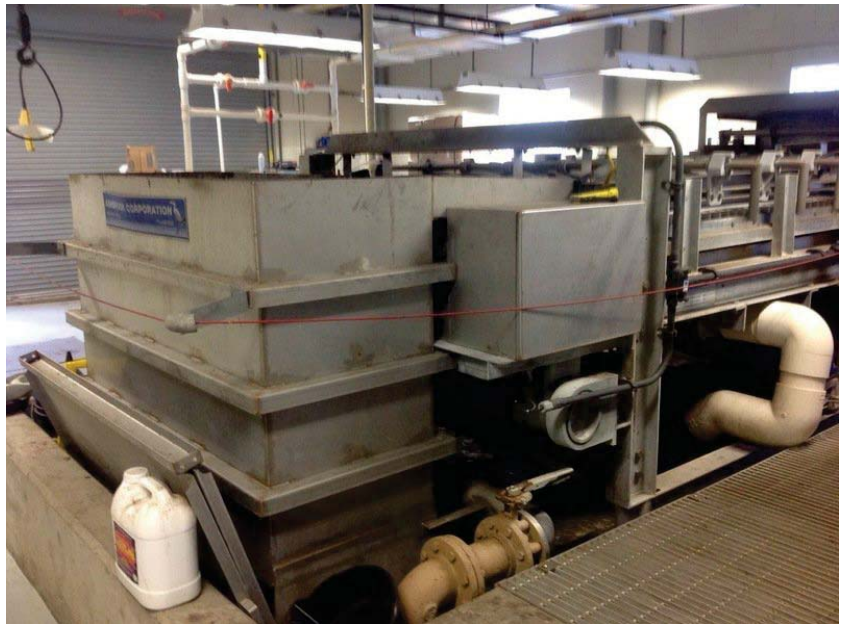
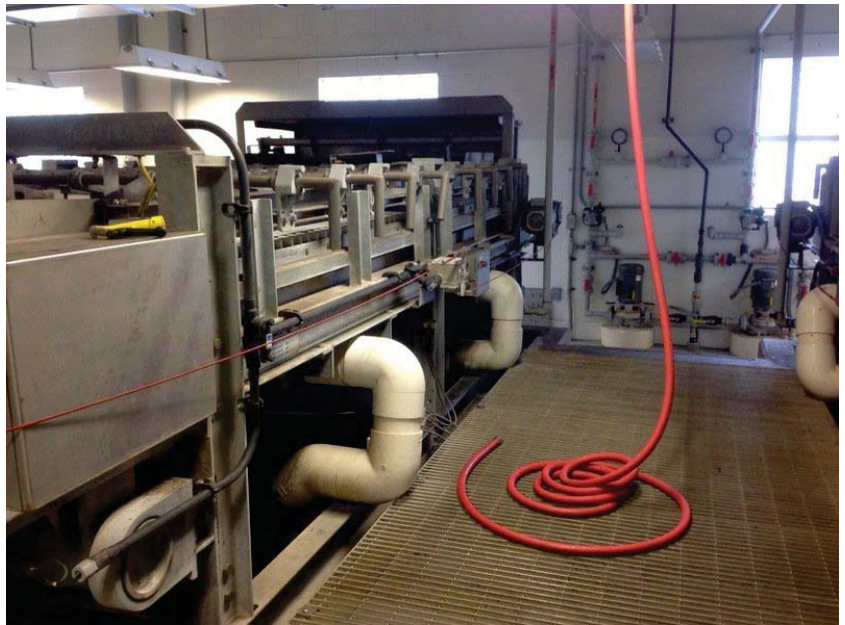
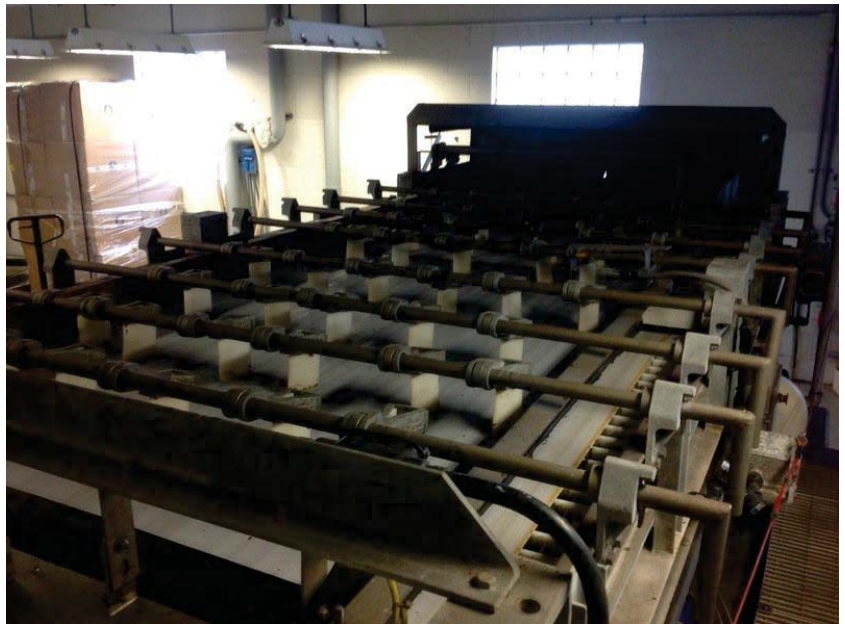
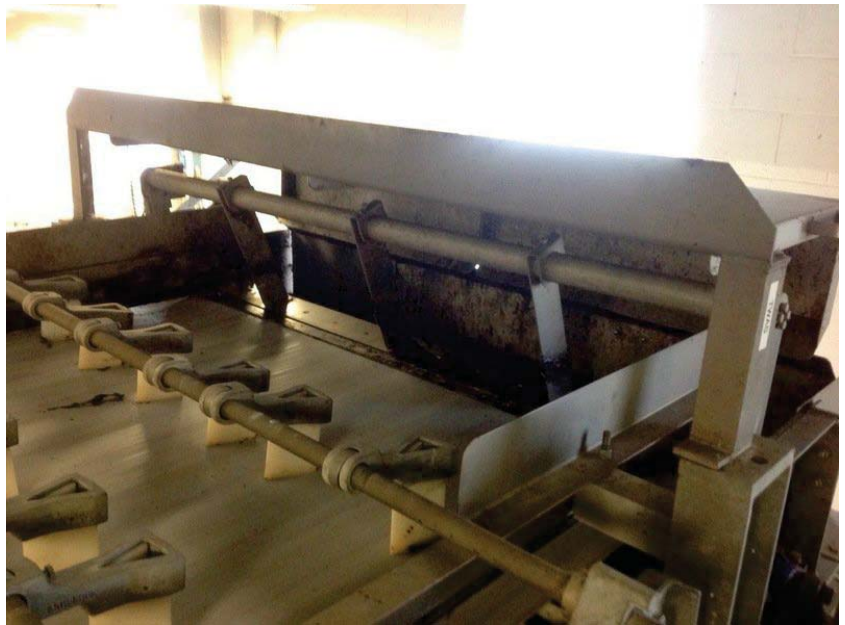
Solids Dewatering	Gravity Belt Thickener #1, PG-M-80-4-1
Station ID	PG-M-80-4-1
Asset Description	Gravity Belt Thickener #1
What type of Asset?	Mechanical
Condition Score	2 - Slight Visible Degradation
Performance Score	1 - Component Functioning as Intended
Recommendation	No immediate action required
Field Observations/Comments	Not operating

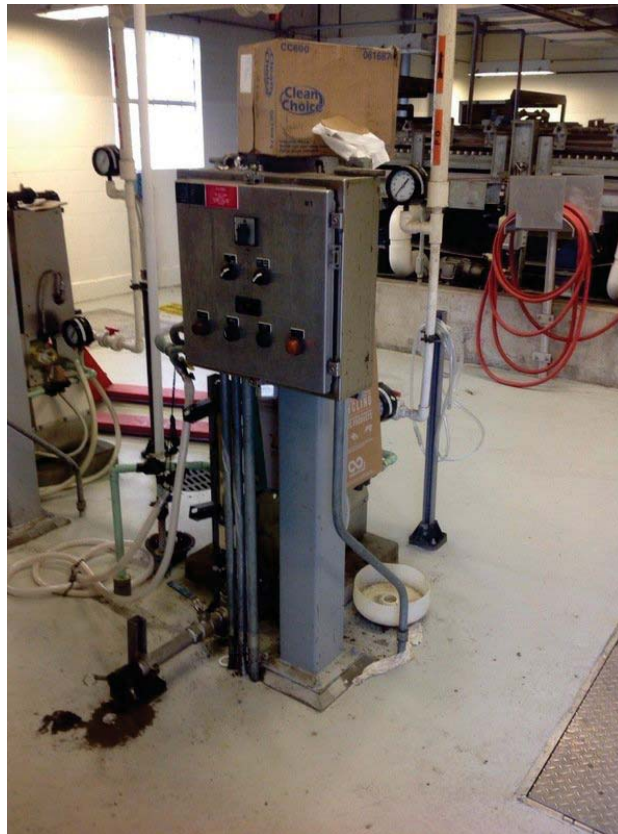
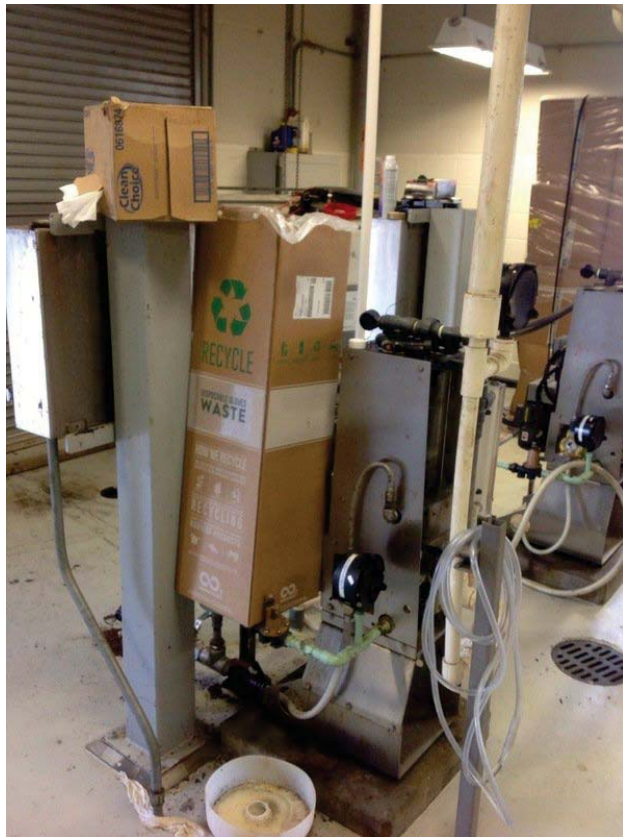
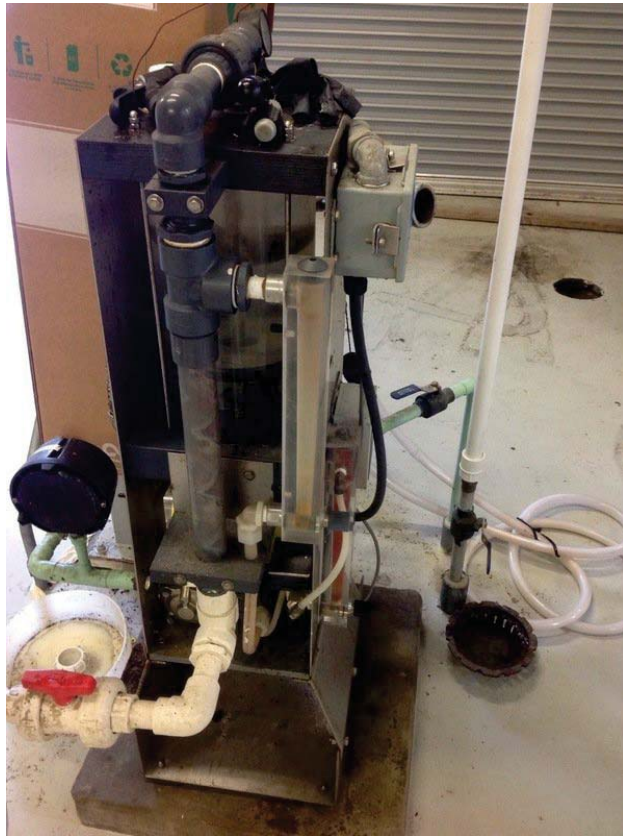
Field Observations	Leaking
Condition Score	2 - Slight Visible Degradation
Performance Score	2 - In Service, but higher than Expected O&M
Recommendation	Schedule corrective action work order near term
Field Observations/Comments	Not operating

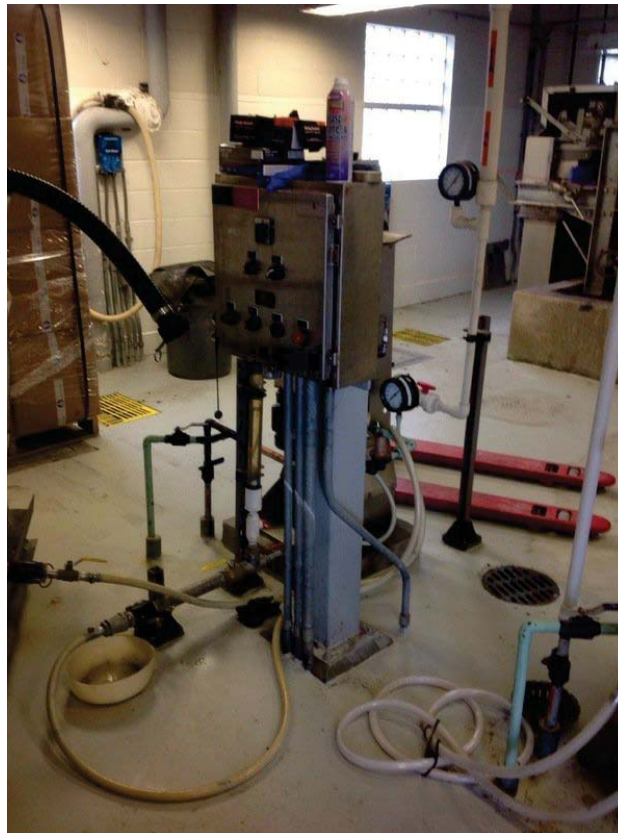
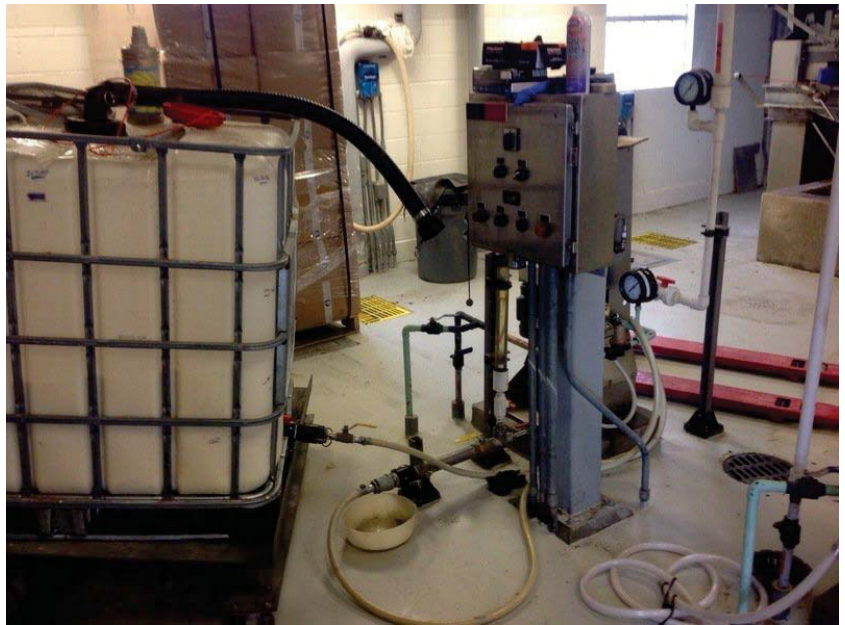
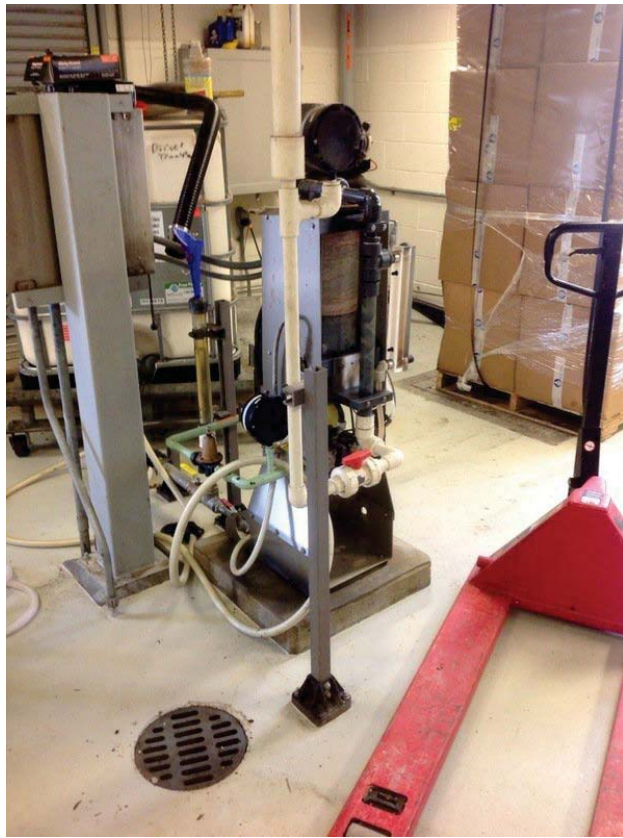
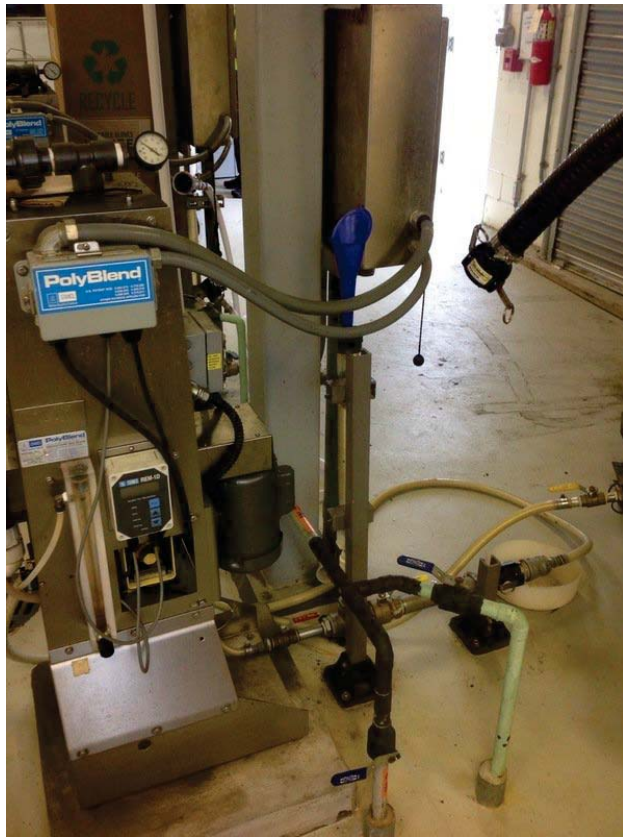
Solids Dewatering	Polymer Injector / Mixer #2, PG-M-81-2
Station ID	PG-M-81-2
Asset Description	Polymer Injector / Mixer #2
What type of Asset?	Mechanical
Condition Score	2 - Slight Visible Degradation
Performance Score	1 - Component Functioning as Intended
Recommendation	No immediate action required
Field Observations/Comments	Not in operation

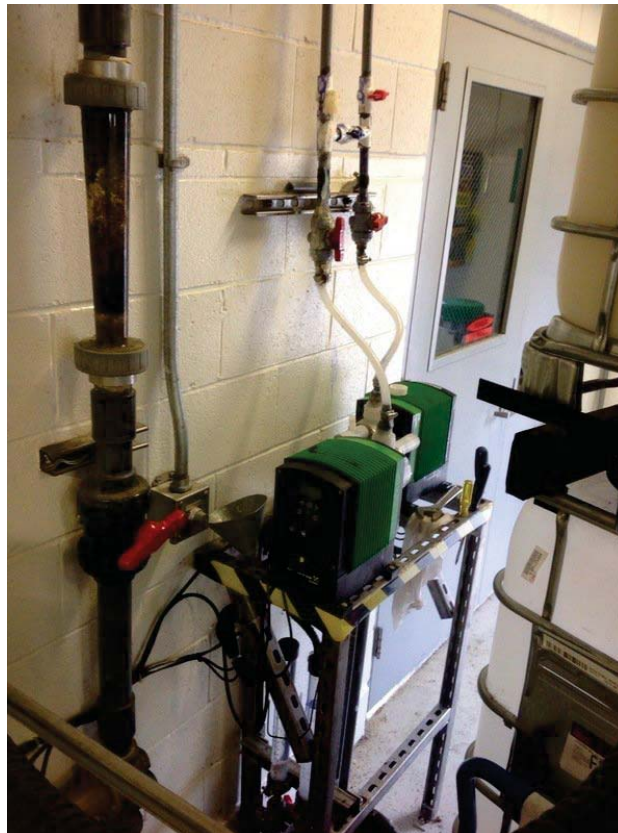
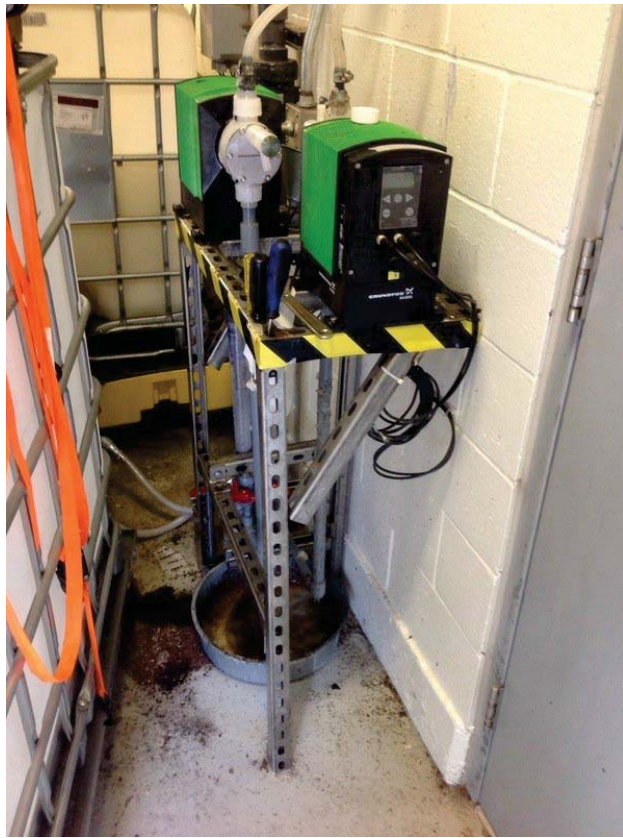
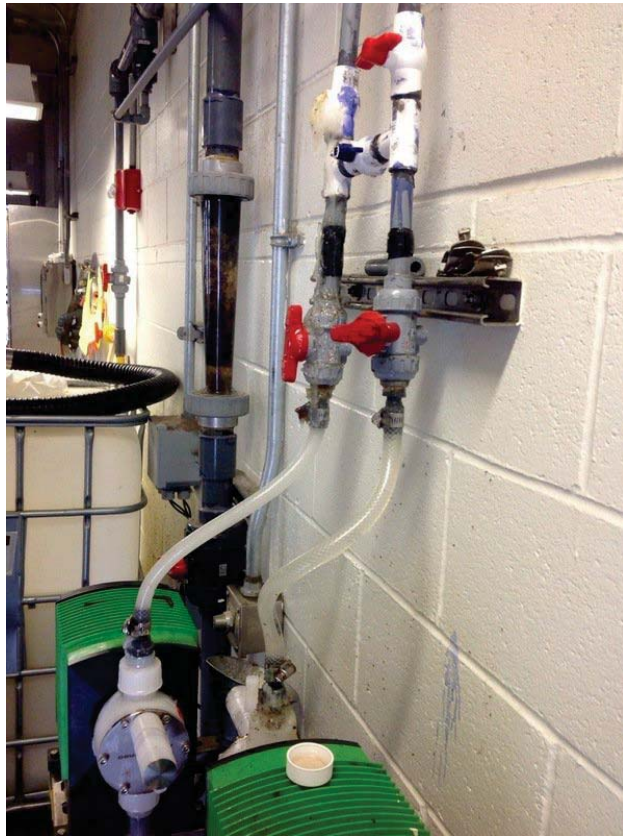
Field Observations	Leaking
Condition Score	2 - Slight Visible Degradation
Performance Score	2 - In Service, but higher than Expected O&M
Recommendation	Schedule corrective action work order near term
Field Observations/Comments	Discharge lines leaking
