# City of Wilsonville Triennial Inspection Report

Wilsonville WWTP and  
Wastewater Lift Stations:

Project Title: On-Call Civil Engineering and Related Services,  
Triennial Inspection of the Wilsonville WWTP and Nine Lift Stations

Subject: 2019 Triennial Inspection of the Wilsonville WWTP  
and Sewage Lift Stations

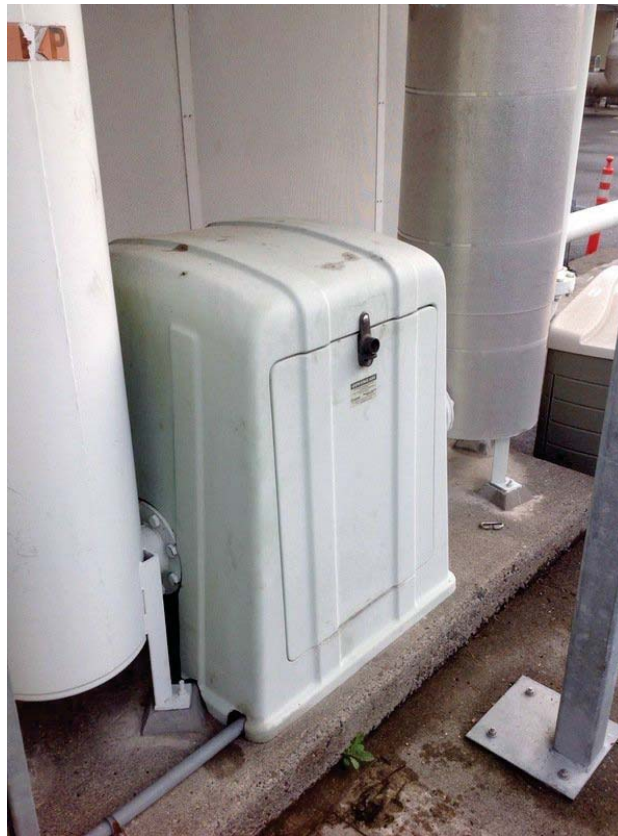
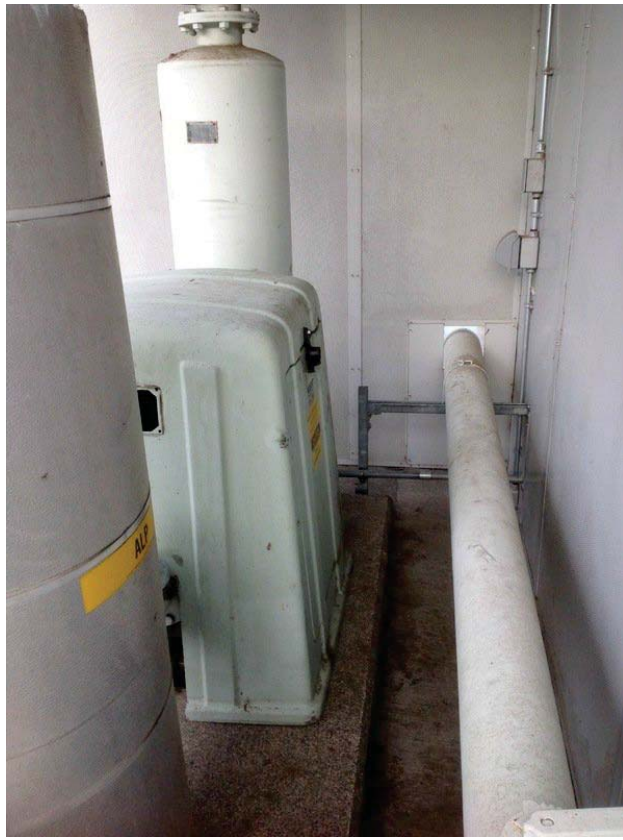
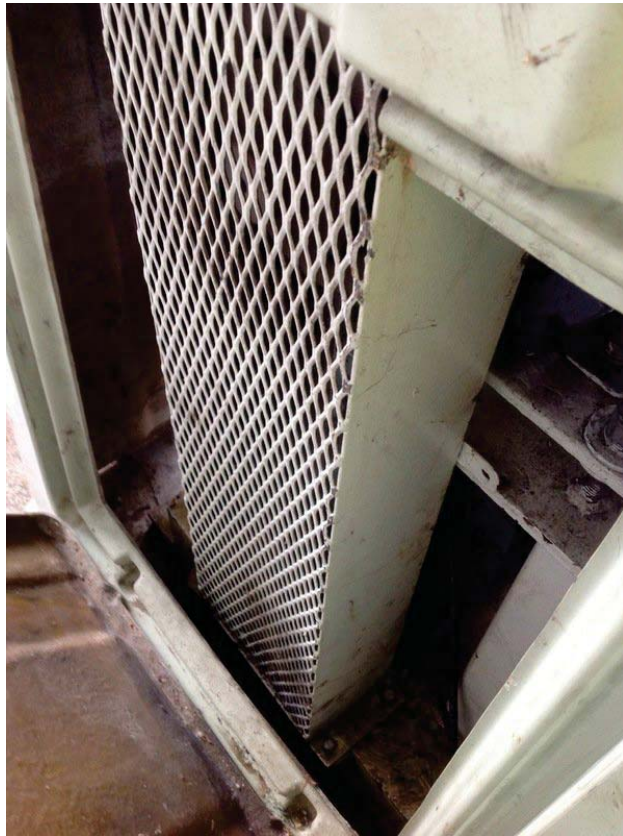
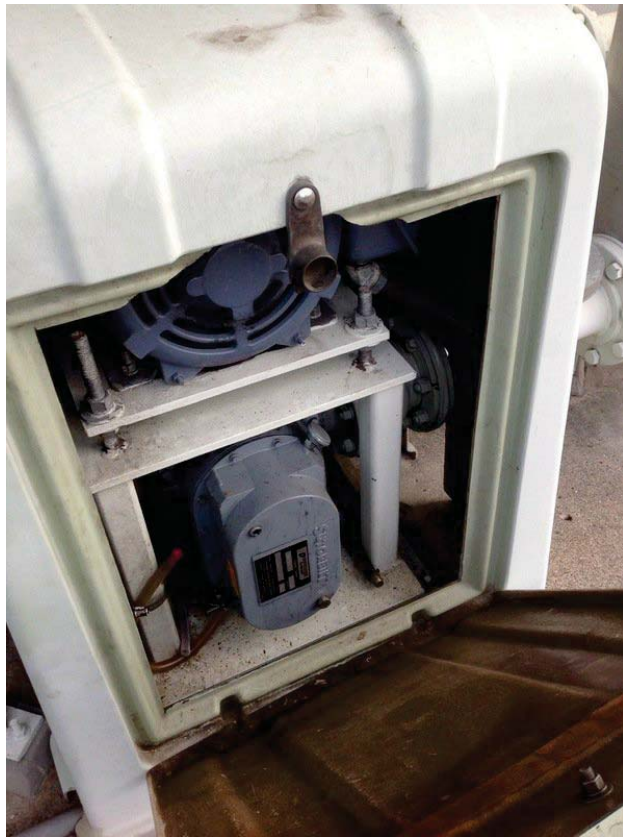
Created	2019-03-27 00:10:47 UTC by Tony Van Haverbeke
Updated	2019-05-28 22:05:21 UTC by Simon Watson
Location	0.0, 0.0
Date	2019-03-29
Time	07:59
Area or Function	Solids Handling
Station ID	BS-M-82-1-1
Asset Description	Biosolids Storage Blower #1
What type of Asset?	Mechanical
Condition Score	2 - Slight Visible Degradation
Performance Score	1 - Component Functioning as Intended
Recommendation	No immediate action required

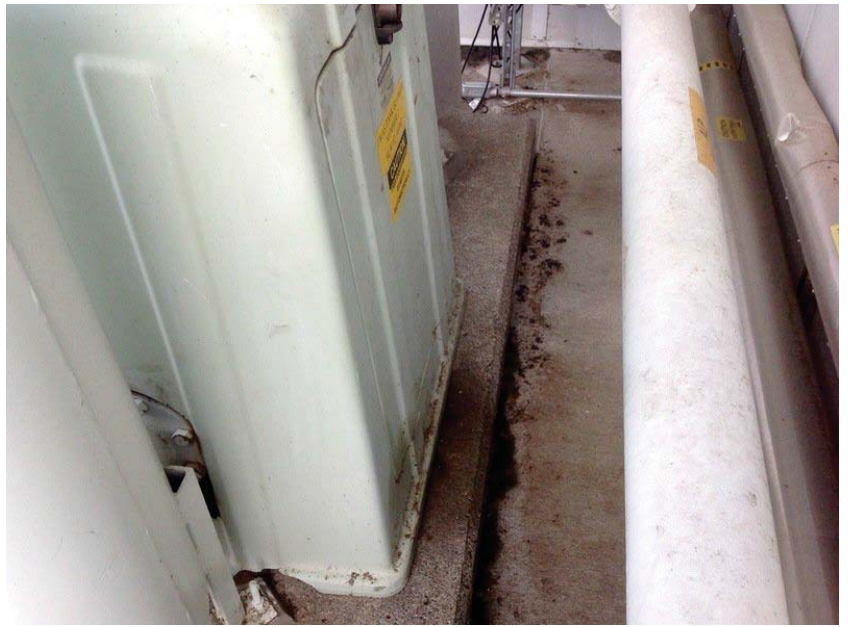
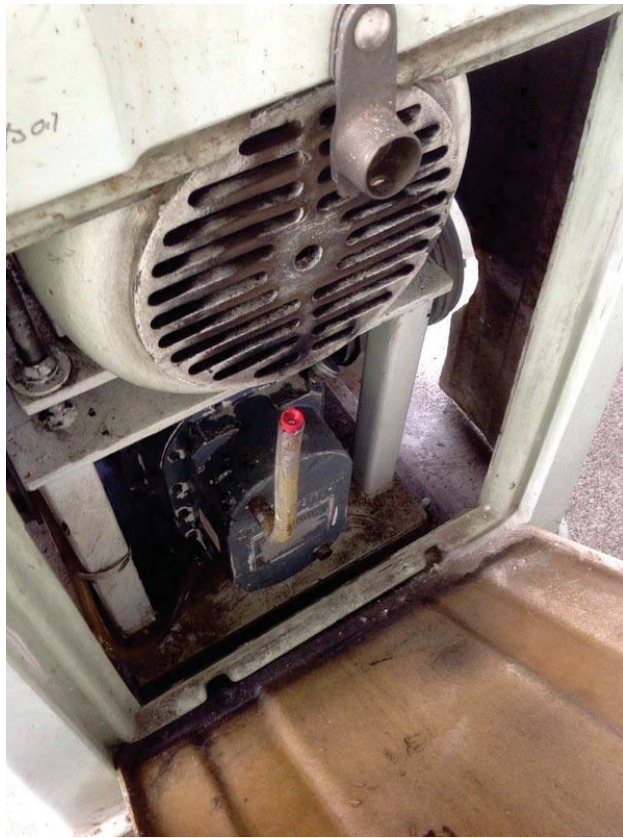
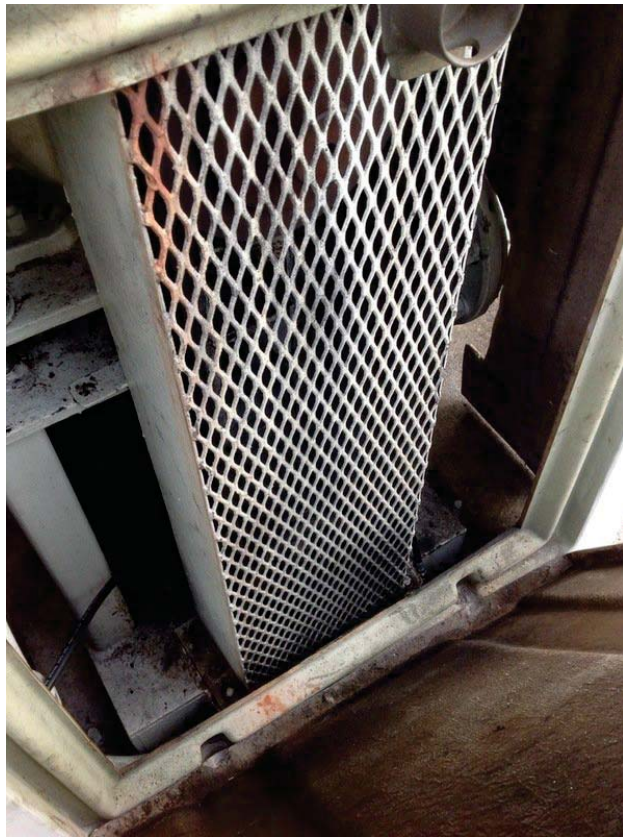
Created	2019-03-27 00:10:48 UTC by Tony Van Haverbeke
Updated	2019-05-28 22:05:53 UTC by Simon Watson
Location	0.0, 0.0
Date	2019-03-29
Time	07:56
Area or Function	Solids Handling
Station ID	BS-M-82-1-2
Asset Description	Biosolids Storage Blower #2
What type of Asset?	Mechanical
Condition Score	2 - Slight Visible Degradation
Performance Score	1 - Component Functioning as Intended
Recommendation	No immediate action required
Field Observations/Comments	Slight oil leak

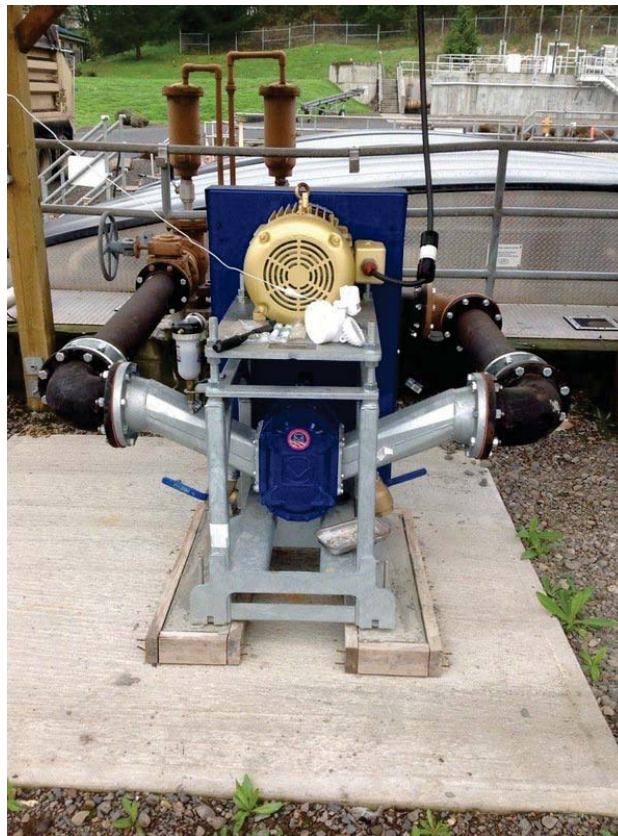
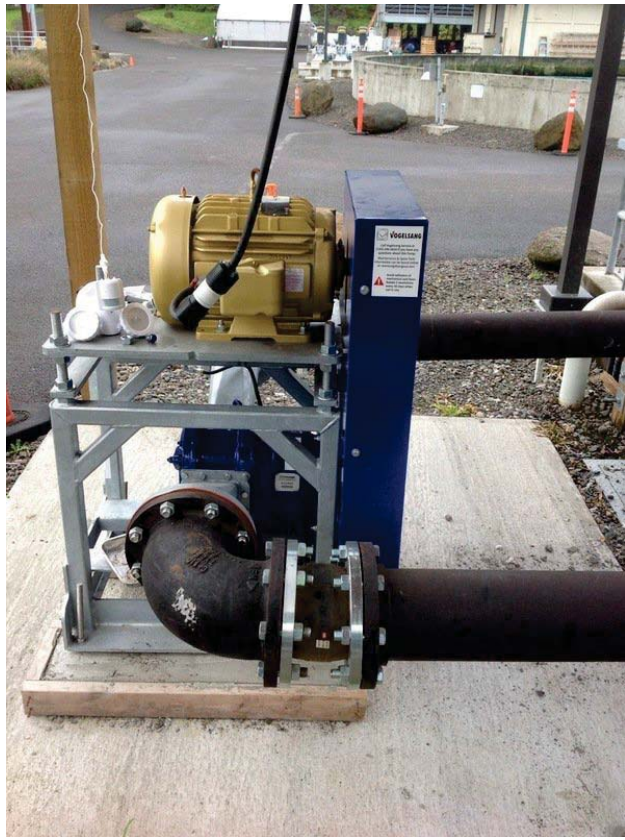
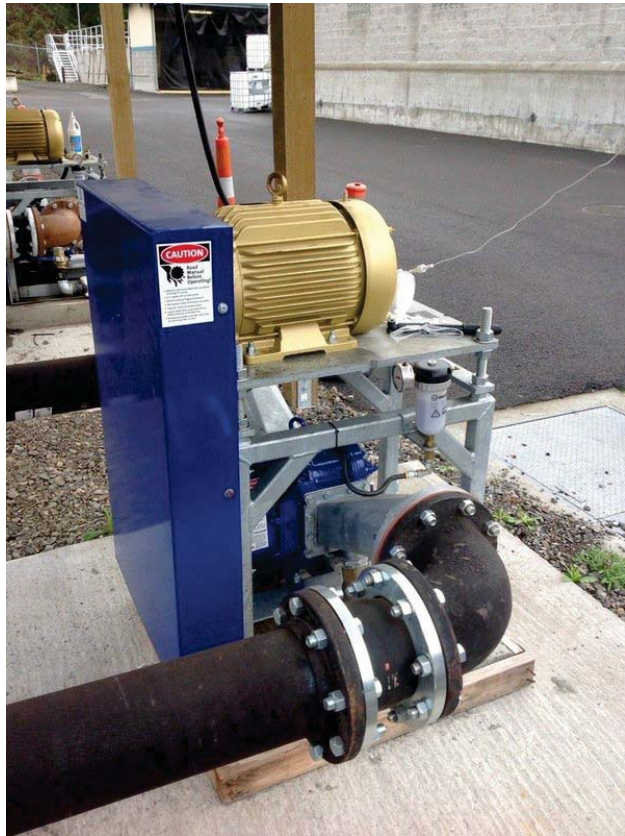
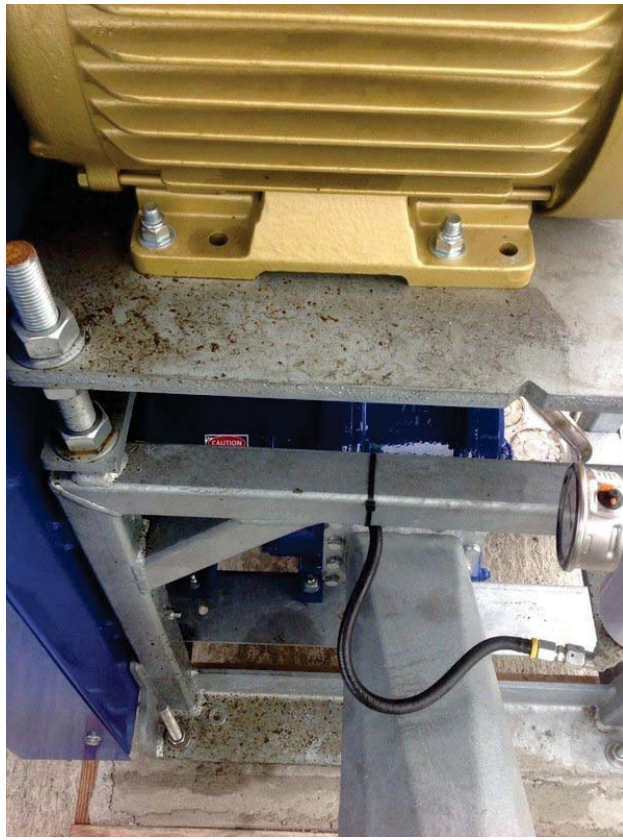
Solids Dewatering	Vogelsang GBT Feed Pump #1, PMP82-10003
Station ID	PMP82-10003
What type of Asset?	Pumps and Motors
Condition Score	1 - Excellent
Performance Score	1 - Component Functioning as Intended
Recommendation	No immediate action required
Field Observations/Comments	Grease or oil from motor area look like residue

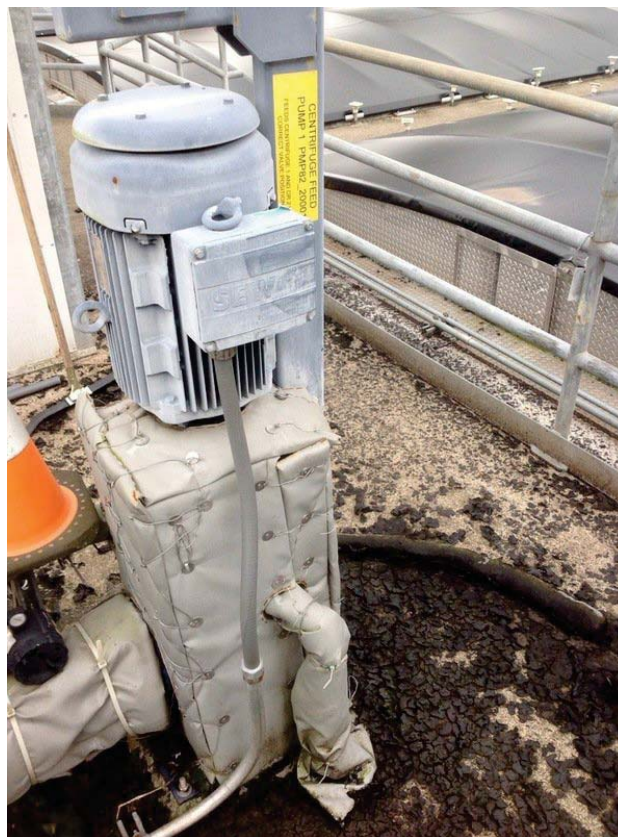
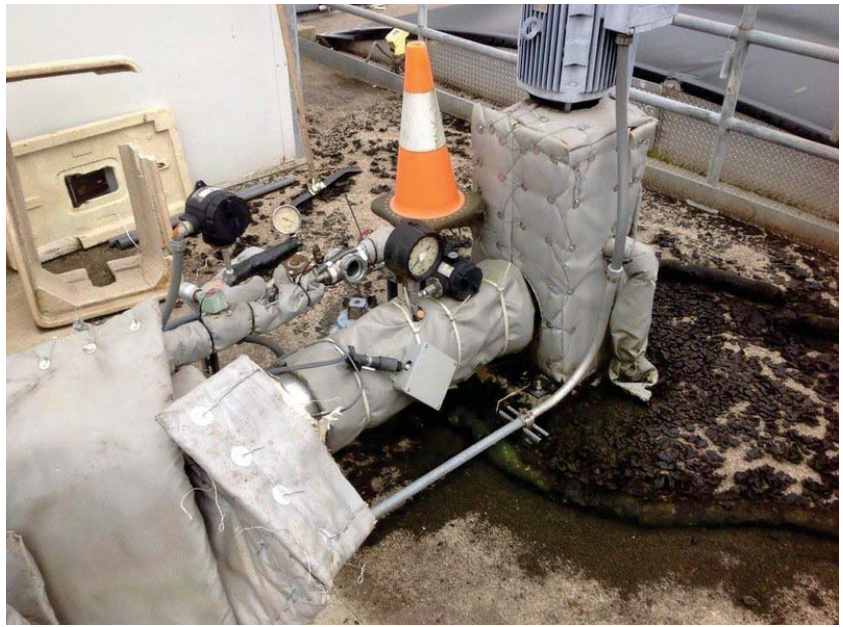
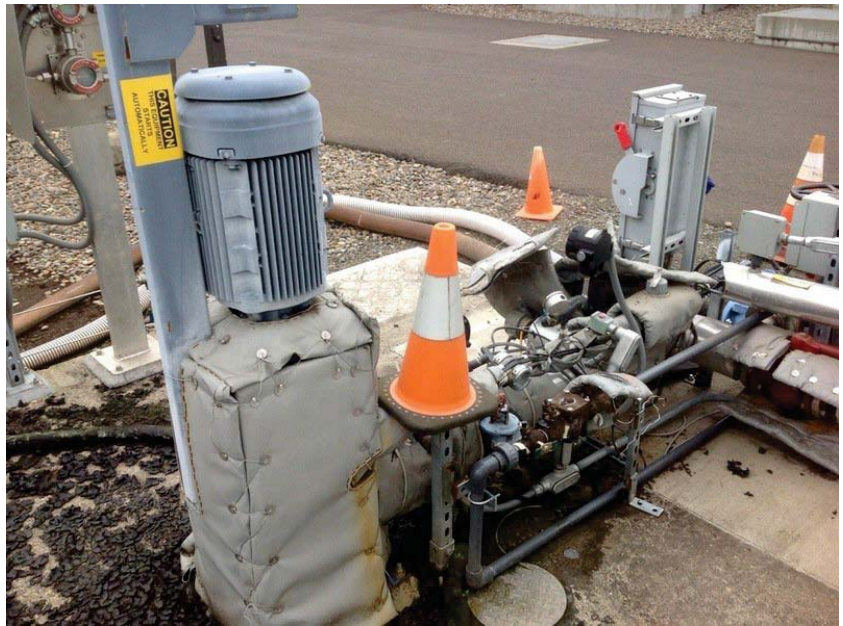
Solids Drying	Centrifuge Feed Pump #1, PMP82-20001
Station ID	PMP82-20001
What type of Asset?	Pumps and Motors
Condition Score	5 - Integrity of Component Severely Compromised
Performance Score	4 - In Service, but Function is Highly Impaired
Recommendation	Immediate corrective action required
Field Observations/Comments	Appears the pump experienced a major process leak. Insulation would have to be removed to determine where the leak is. Backflow device is leaking

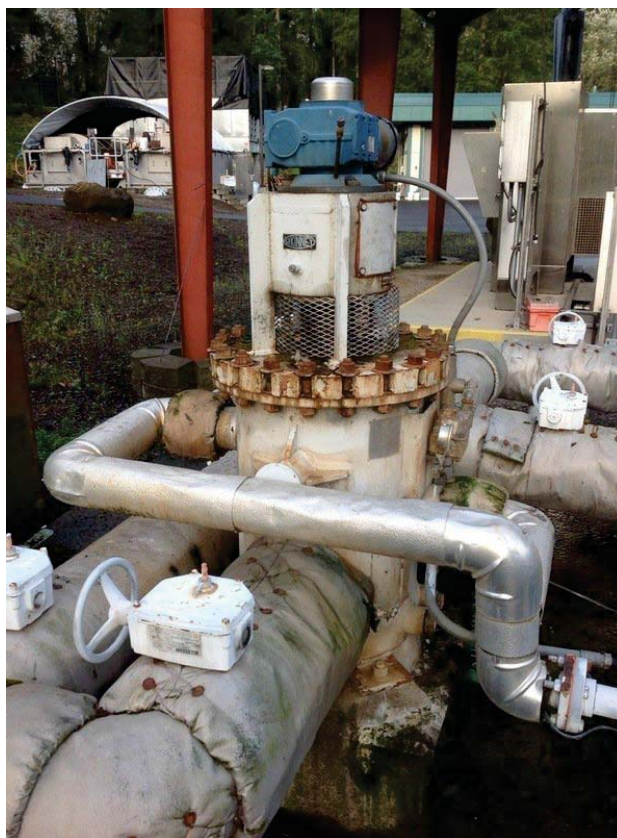
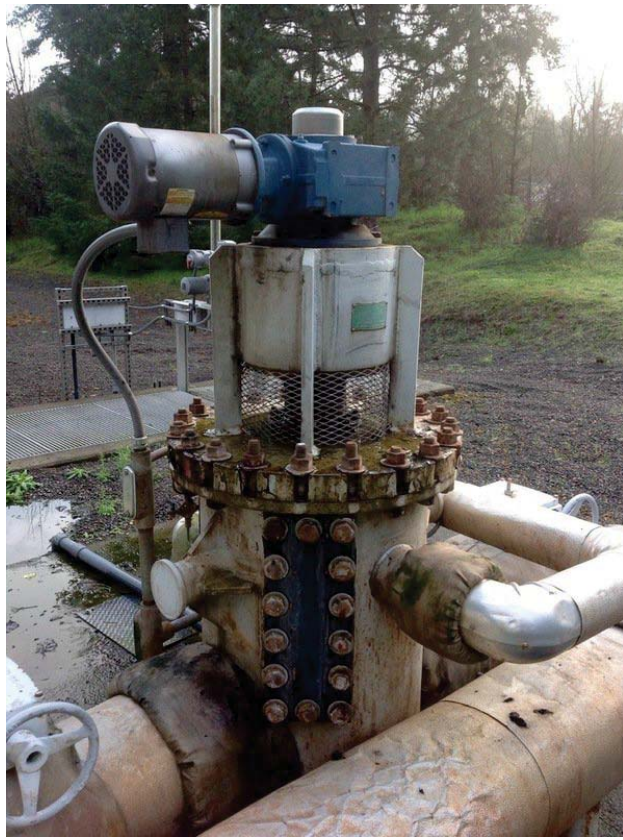
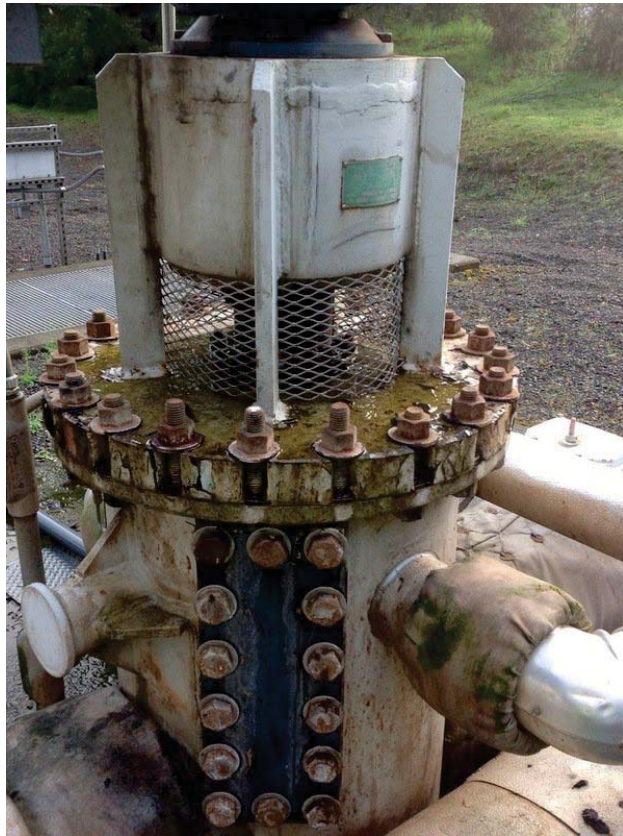
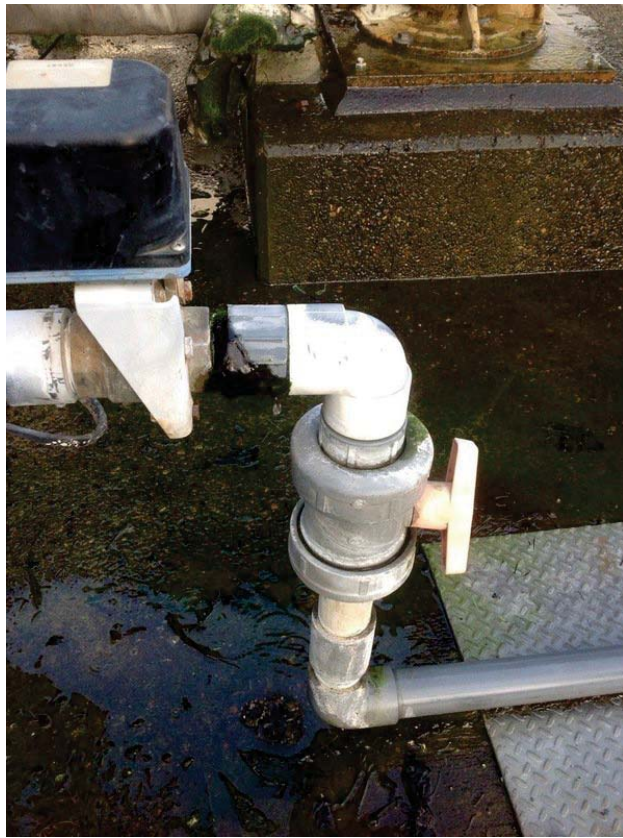
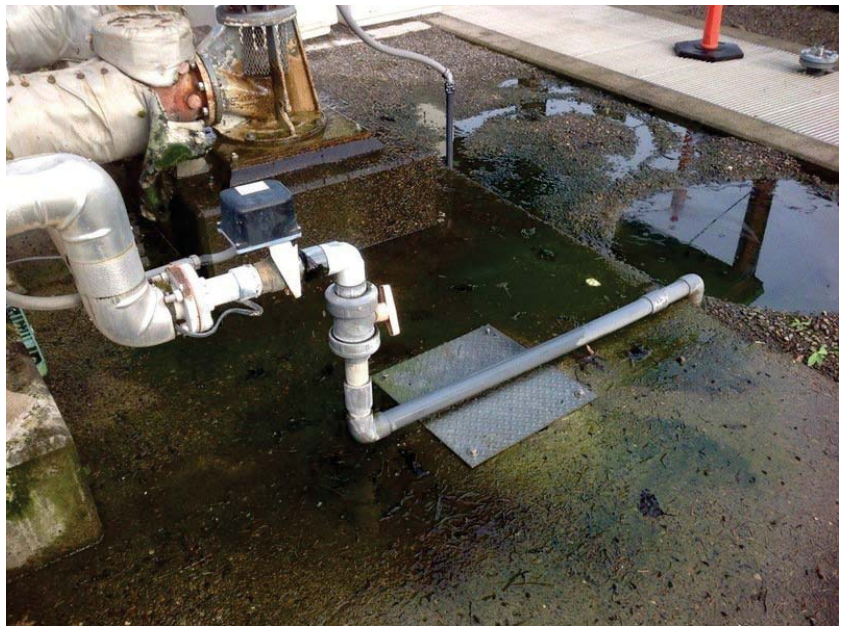
Field Observations	Leaking
Condition Score	3 - Visible Degradation
Performance Score	1 - Component Functioning as Intended
Recommendation	Schedule corrective action work order near term
Field Observations/Comments	Coating system failed Back flush water discharge line leaking

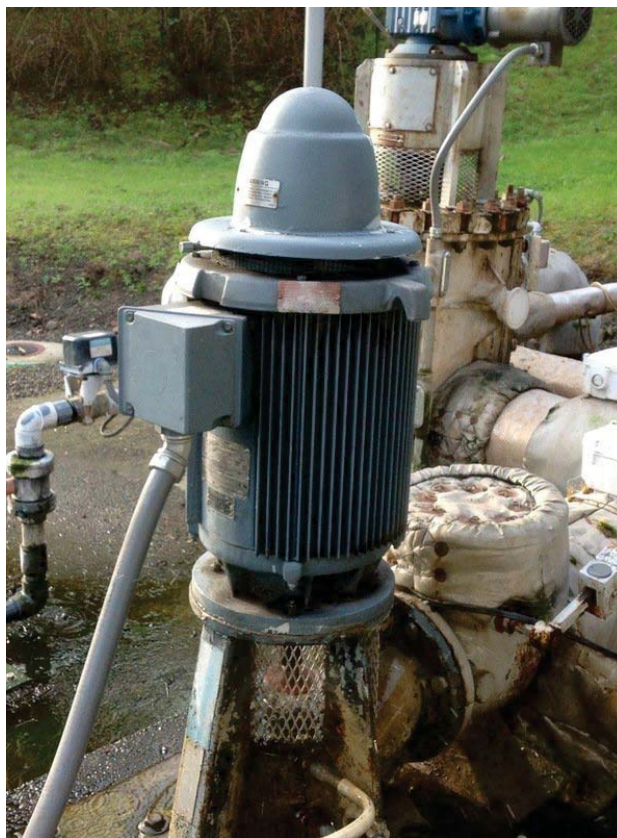
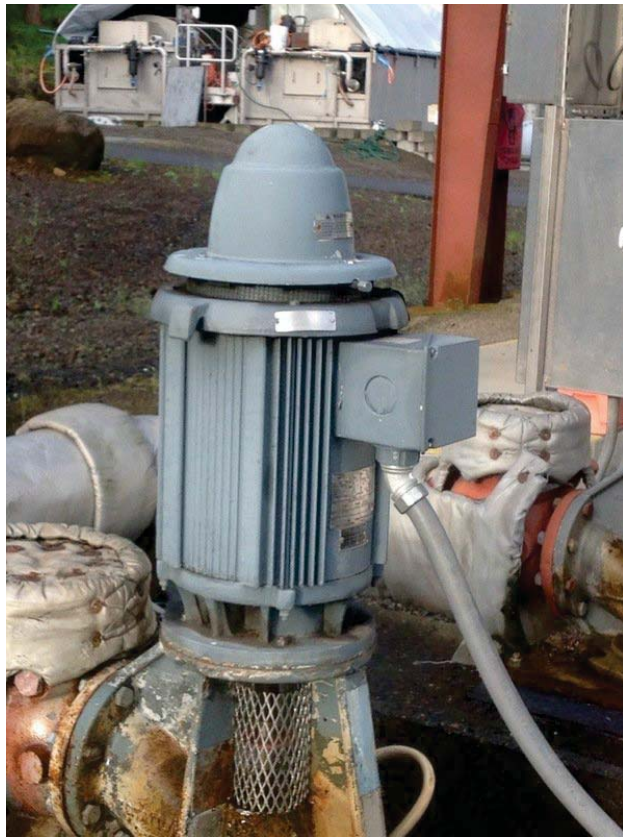
W-3 Water	W-3 Pump #1 Motor, W3-M-90-1-1
Station ID	W3-M-90-1-1
Asset Description	W-3 Pump #1 Motor
What type of Asset?	Mechanical
Condition Score	2 - Slight Visible Degradation
Performance Score	1 - Component Functioning as Intended
Recommendation	No immediate action required

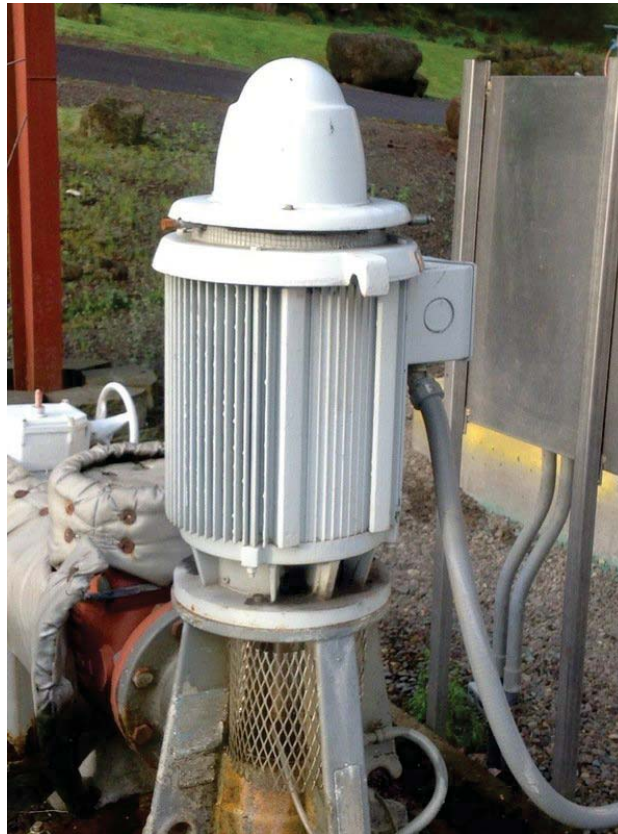
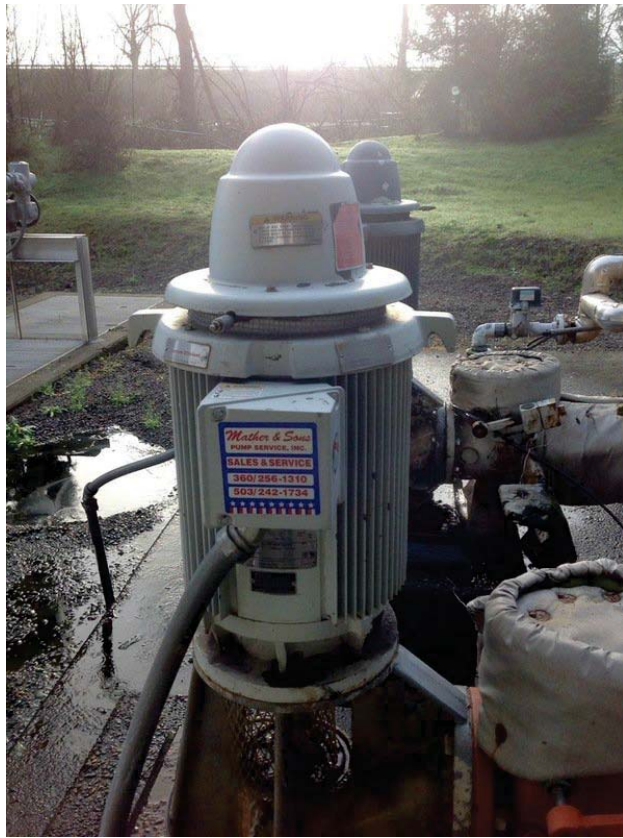
W-3 Water	W-3 Pump #2 Motor, W3-M-90-1-2
Station ID	W3-M-90-1-2
Asset Description	W-3 Pump #2 Motor
What type of Asset?	Mechanical
Condition Score	2 - Slight Visible Degradation
Performance Score	1 - Component Functioning as Intended
Recommendation	No immediate action required

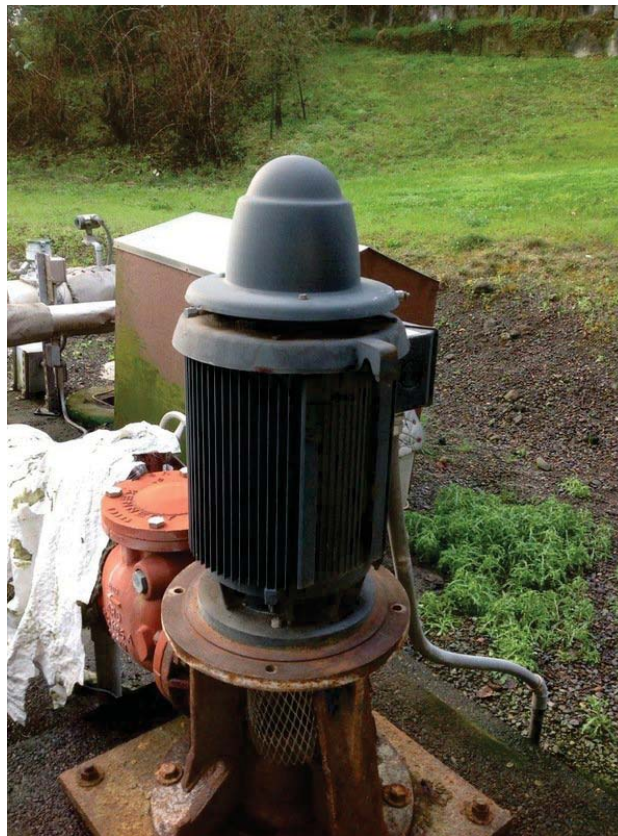
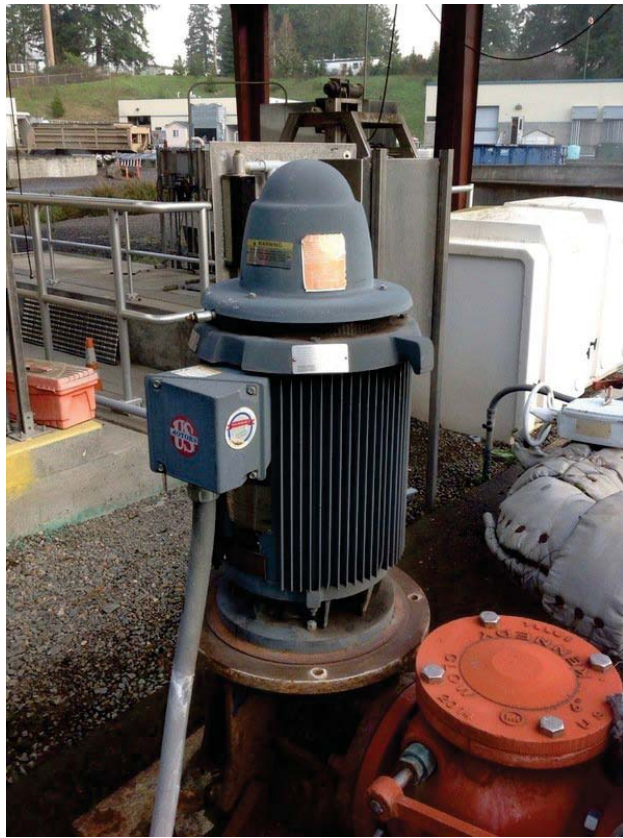
W-3 Water	W-3 Pump #3 Motor, W3-M-90-1-3
Station ID	W3-M-90-1-3
Asset Description	W-3 Pump #3 Motor
What type of Asset?	Mechanical
Condition Score	2 - Slight Visible Degradation
Performance Score	1 - Component Functioning as Intended
Recommendation	No immediate action required

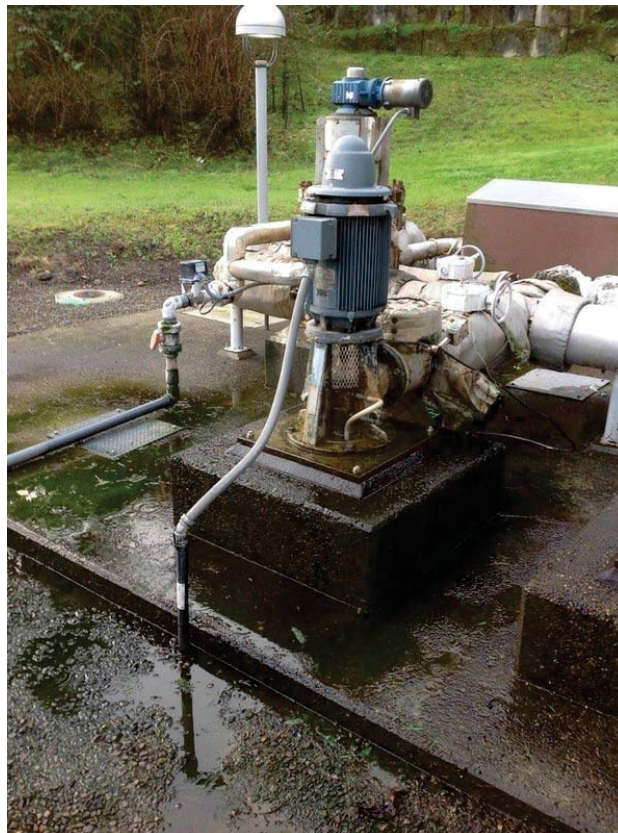
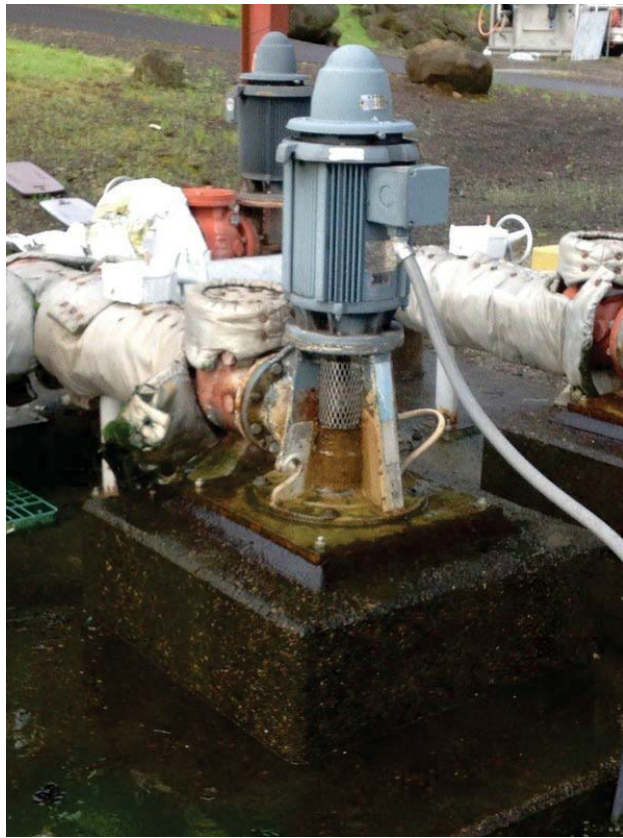
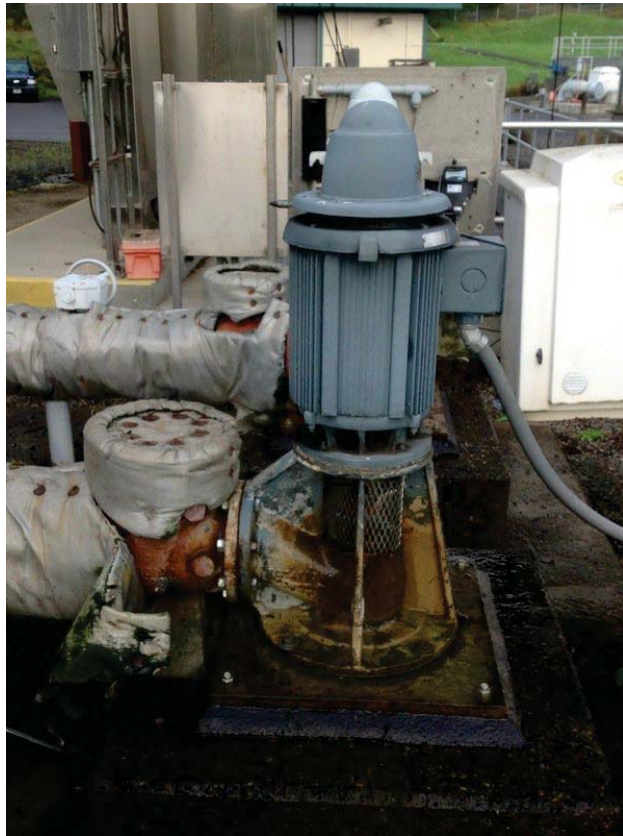
Field Observations	Leaking
Condition Score	3 - Visible Degradation
Performance Score	2 - In Service, but higher than Expected O&M
Recommendation	Schedule corrective action work order near term
Field Observations/Comments	Packing water leaking excessively

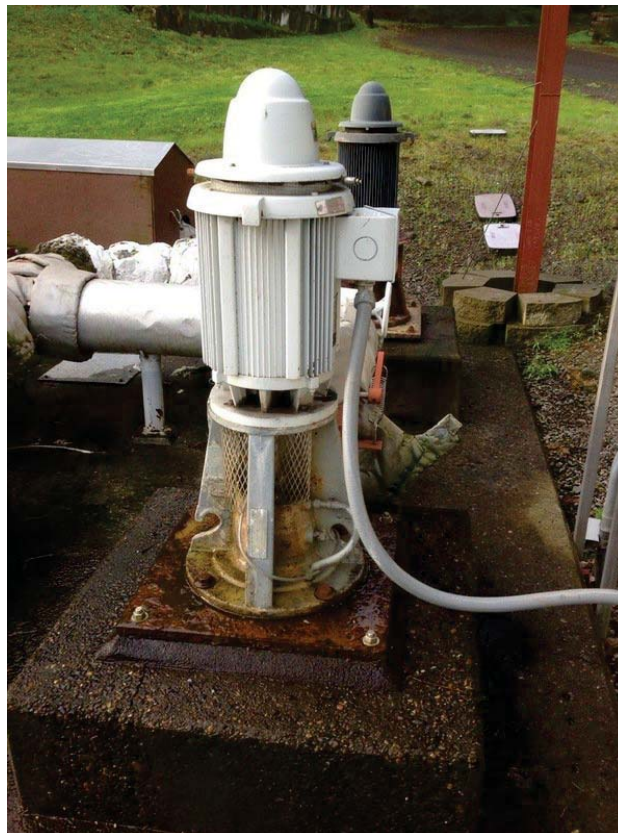
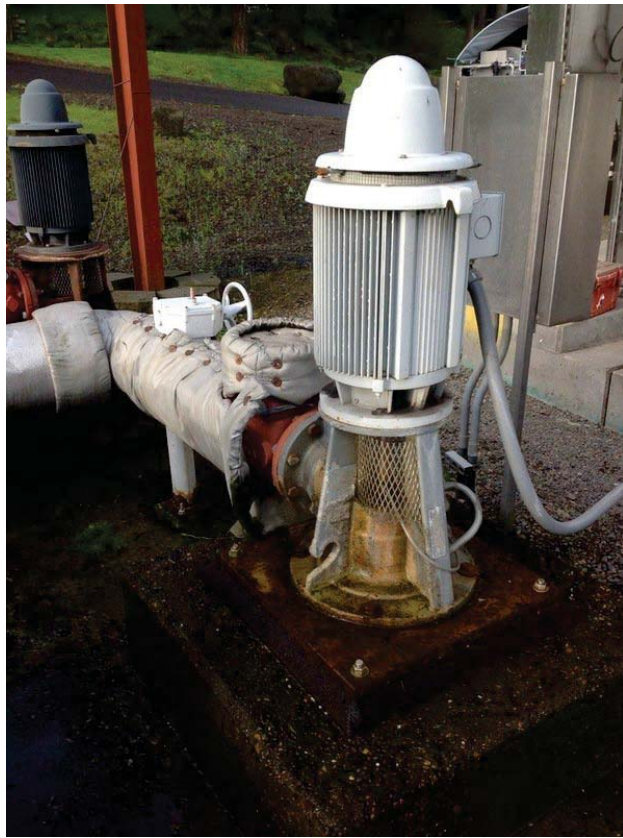
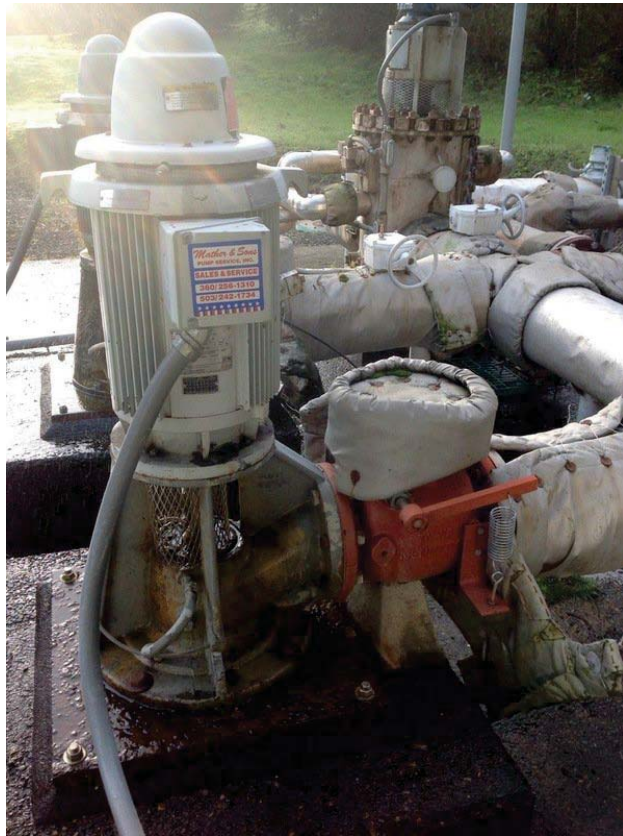
Field Observations	Corrosion
Condition Score	3 - Visible Degradation
Performance Score	2 - In Service, but higher than Expected O&M
Recommendation	Schedule corrective action work order near term
Field Observations/Comments	Coating system failed

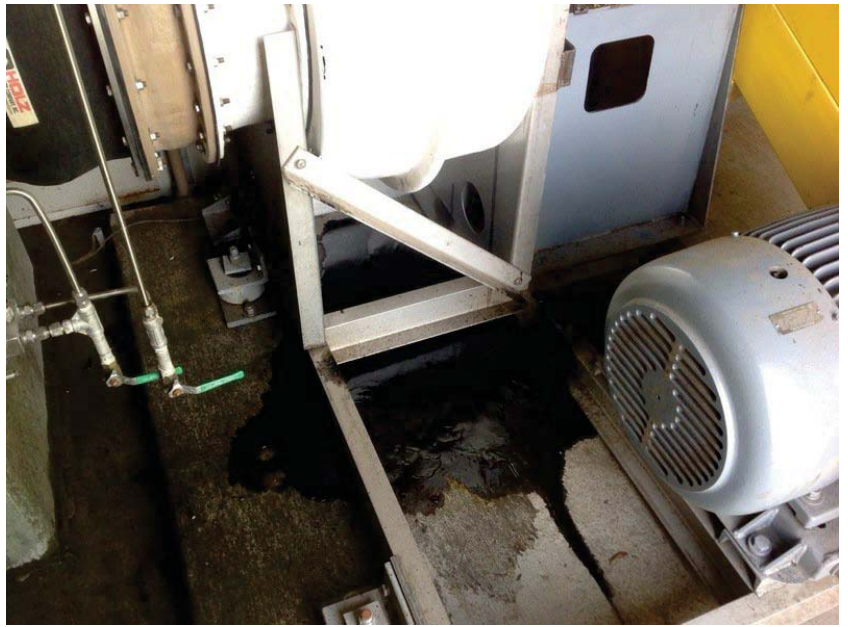
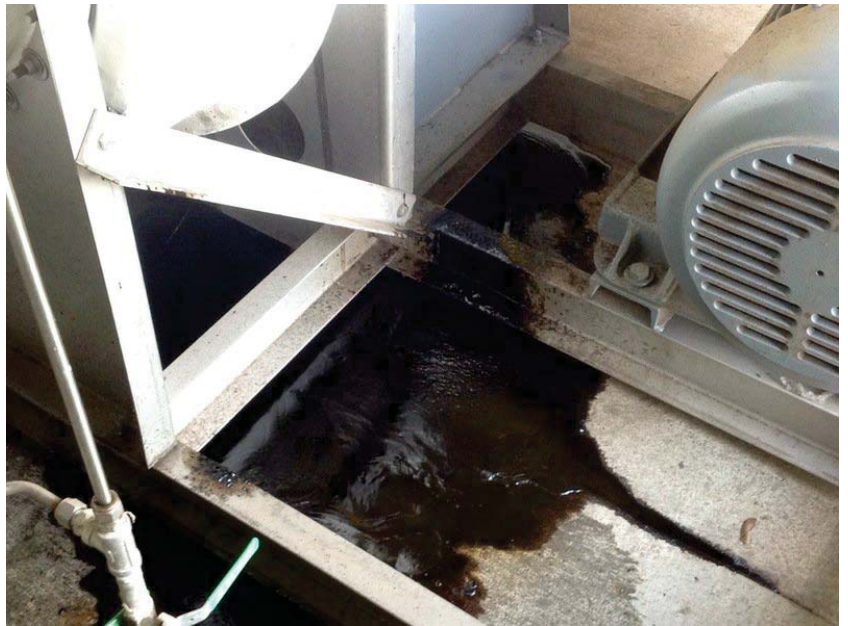
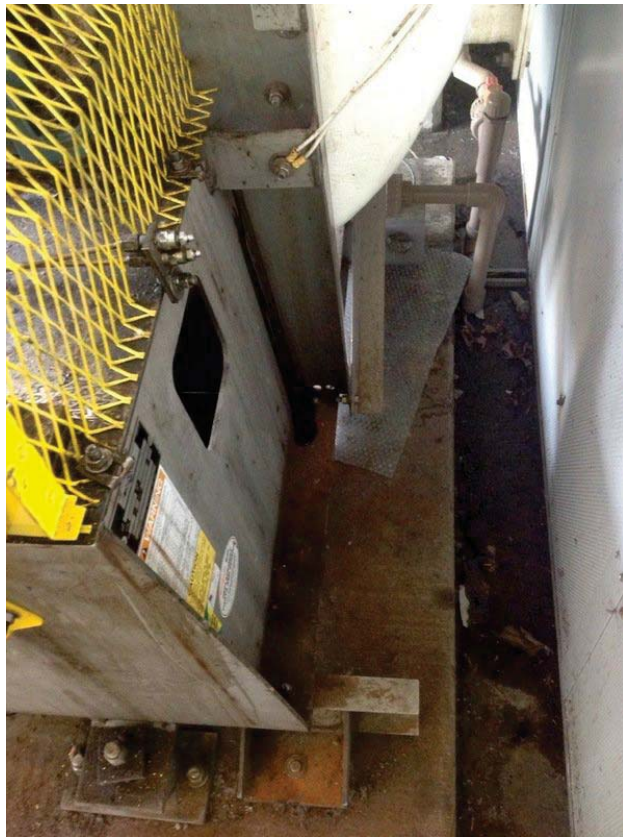
Field Observations	Leaking
Condition Score	2 - Slight Visible Degradation
Performance Score	1 - Component Functioning as Intended
Recommendation	Initiate more detailed inspection
Field Observations/Comments	Unit running smoothly Dripping black tar substance from fan. This comes from the solids dryer.

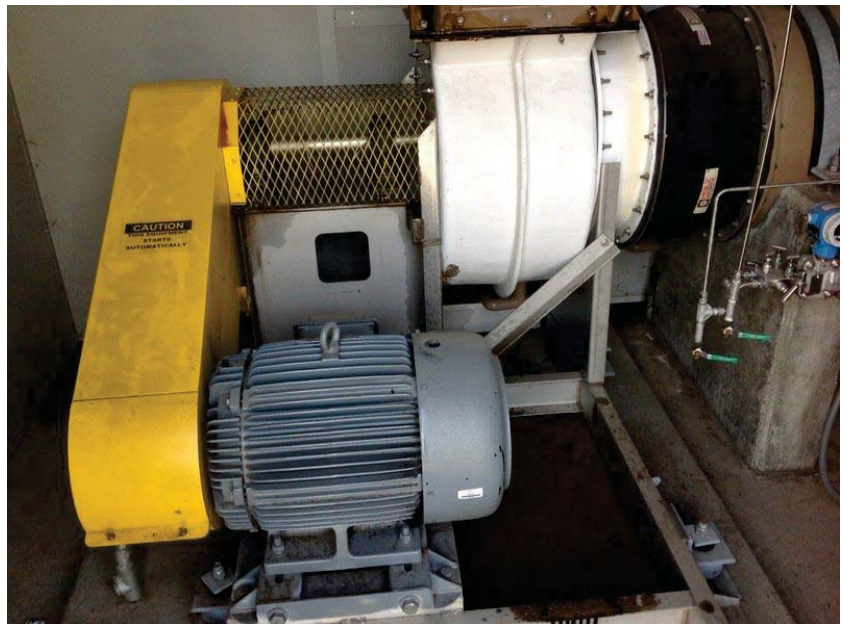
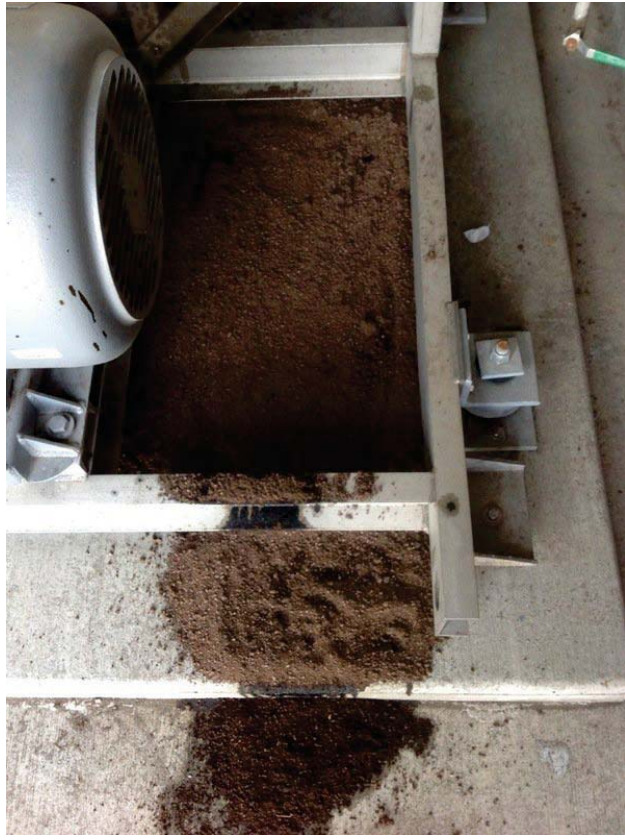
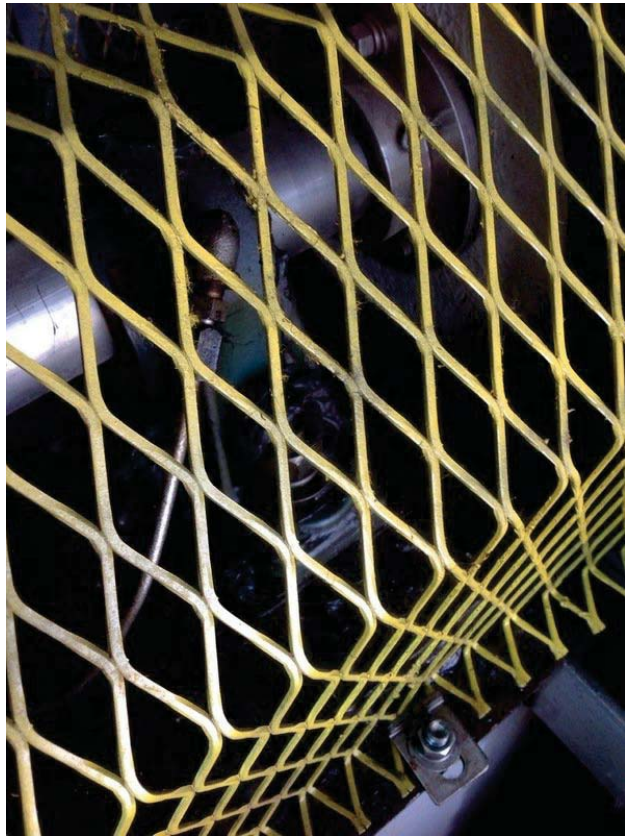
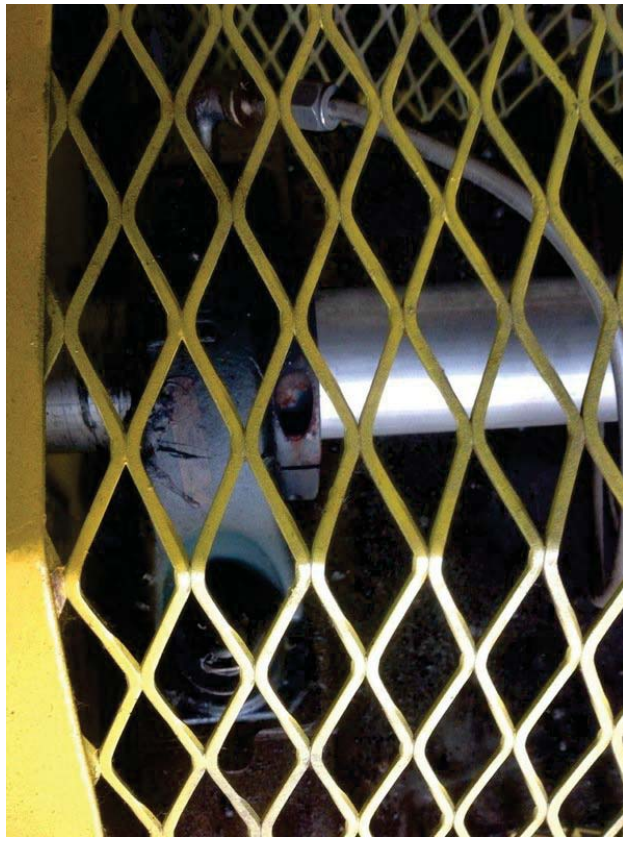
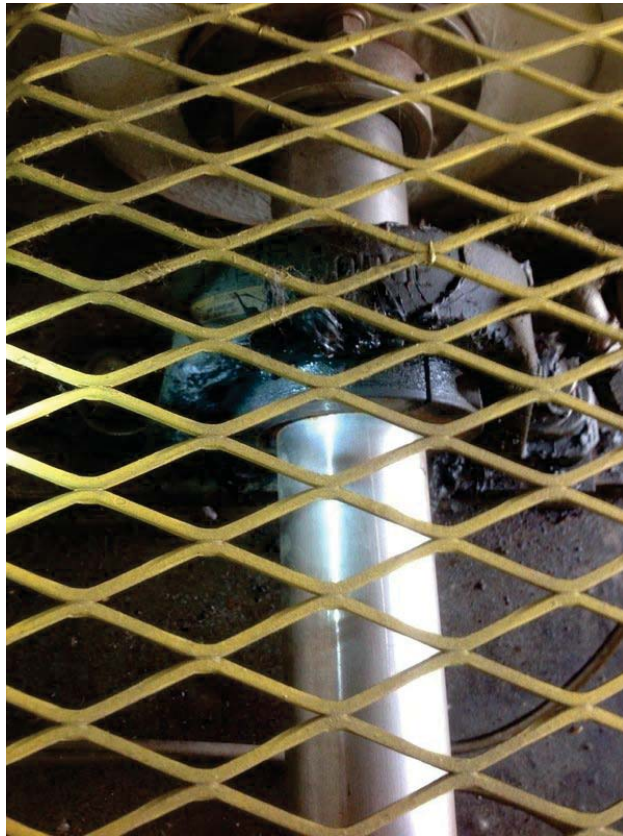
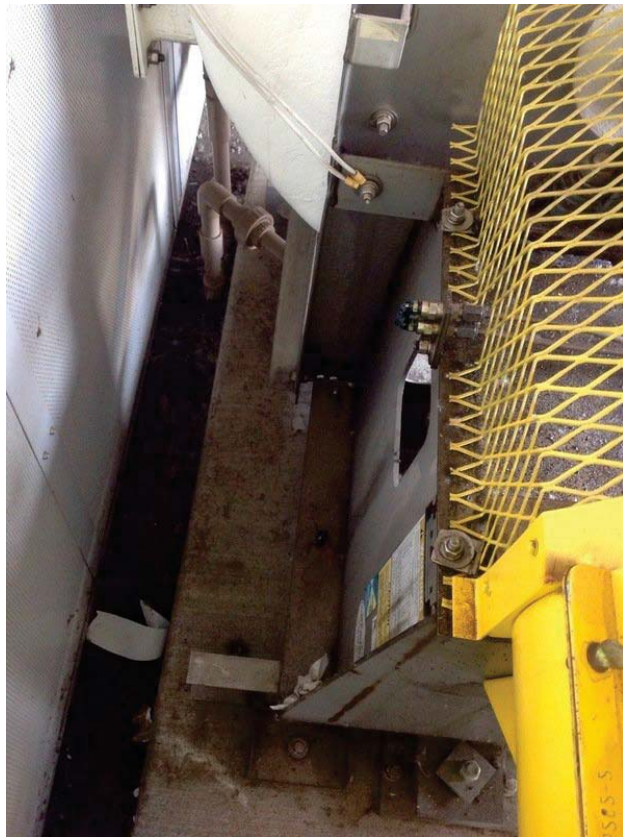
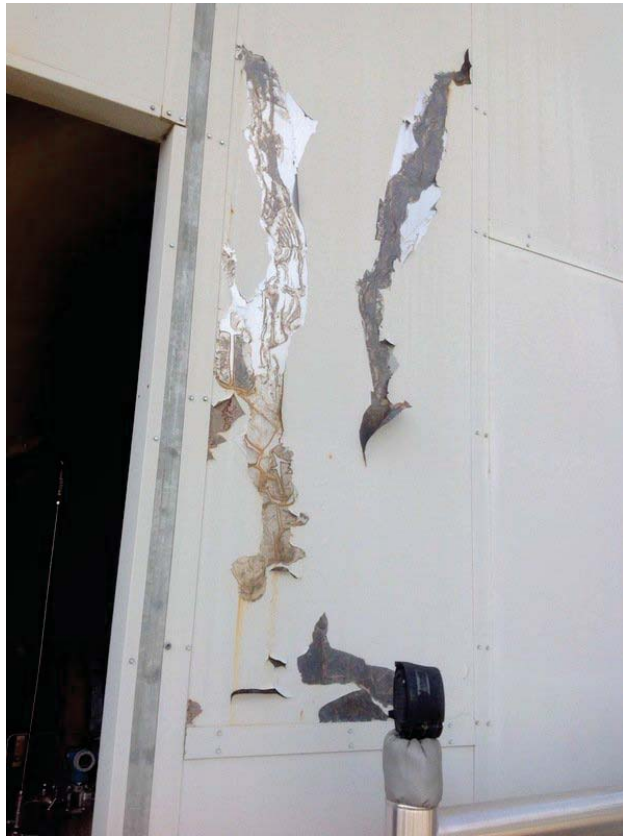
Field Observations	Leaking
Condition Score	2 - Slight Visible Degradation
Performance Score	1 - Component Functioning as Intended
Recommendation	Initiate more detailed inspection
Field Observations/Comments	Unit not in operation Dripping black tar substance from fan. This comes from the solids dryer. Potential over greasing of bearings Coating coming off outside sound proofing surround
