# City of Wilsonville Triennial Inspection Report

Wilsonville WWTP and  
Wastewater Lift Stations:

Project Title: On-Call Civil Engineering and Related Services,  
Triennial Inspection of the Wilsonville WWTP and Nine Lift Stations

Subject: 2019 Triennial Inspection of the Wilsonville WWTP  
and Sewage Lift Stations

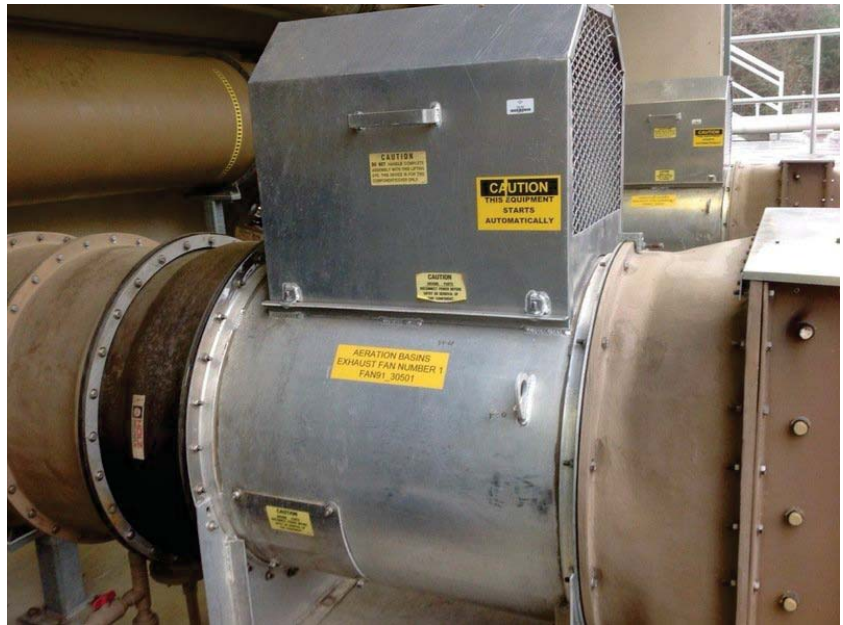
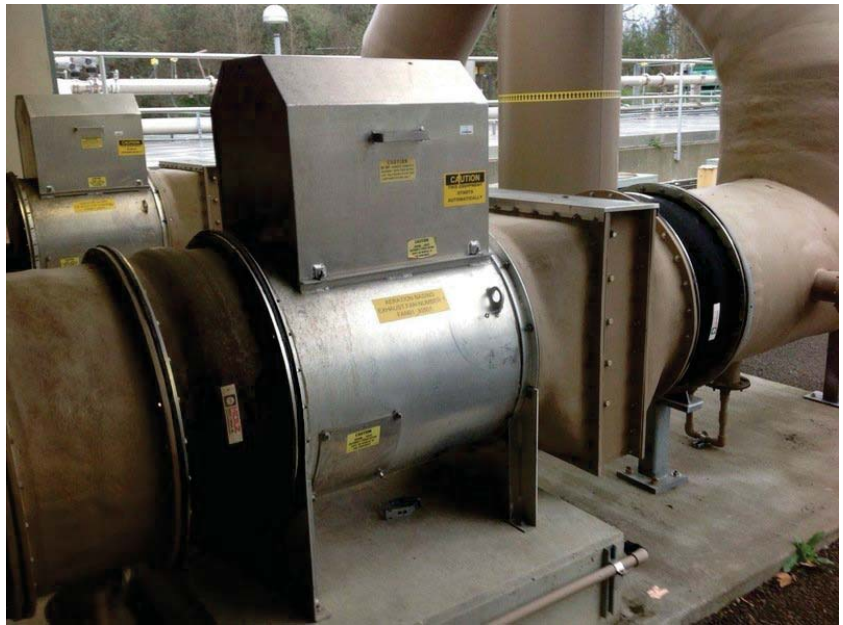
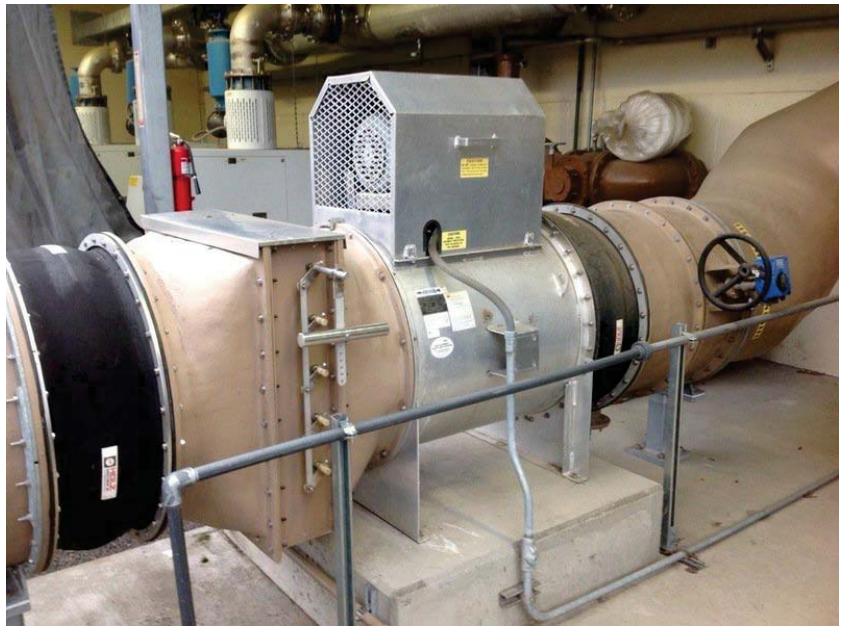
Odor Control	Aeration Basin Ex Fan 30501, FAN91-30501
Station ID	FAN91-30501
Asset Description	Aeration Basin Ex Fan 30501
What type of Asset?	Mechanical
Condition Score	2 - Slight Visible Degradation
Performance Score	1 - Component Functioning as Intended
Recommendation	No immediate action required
Field Observations/Comments	Not in operation

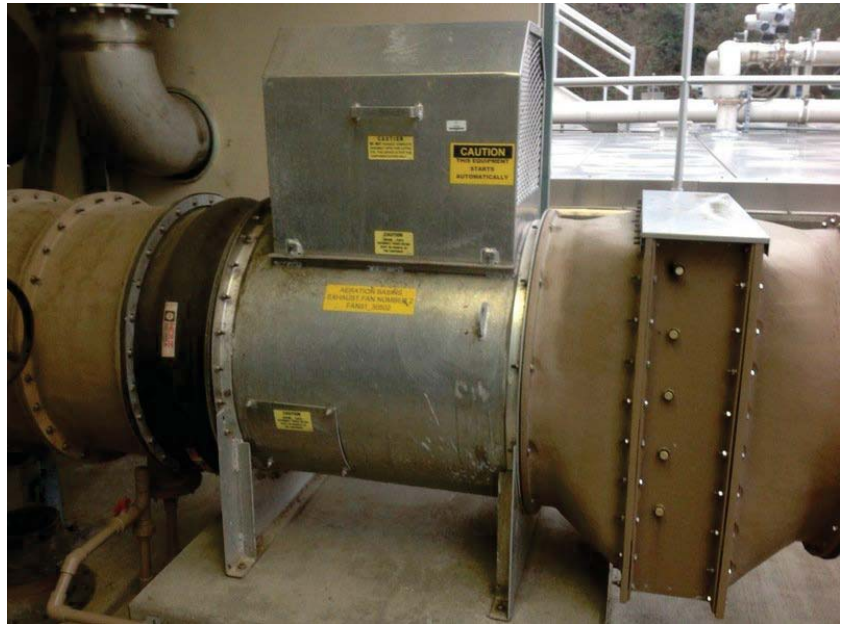
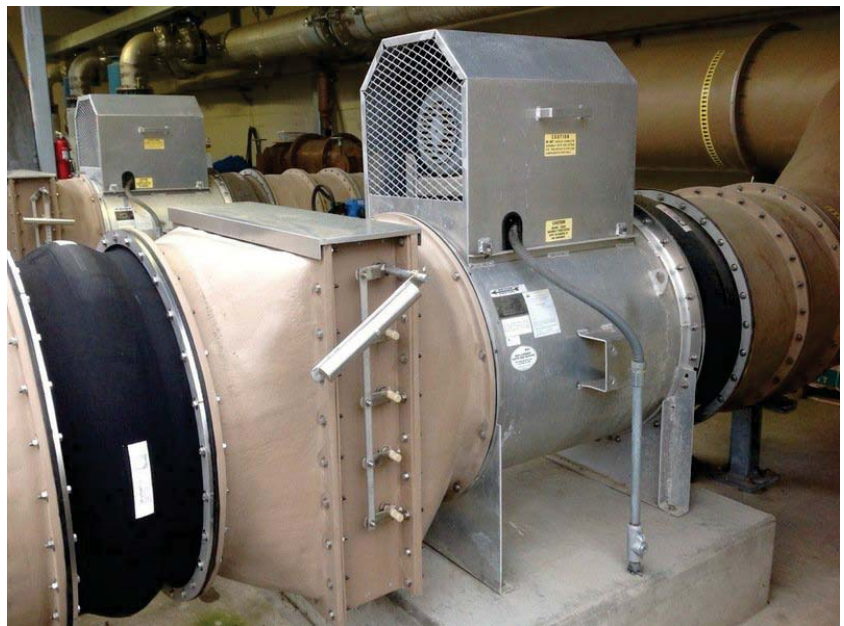
Field Observations	Vibration
Condition Score	2 - Slight Visible Degradation
Performance Score	2 - In Service, but higher than Expected O&M
Recommendation	Schedule corrective action work order near term
Field Observations/Comments	Fan noise and vibrating

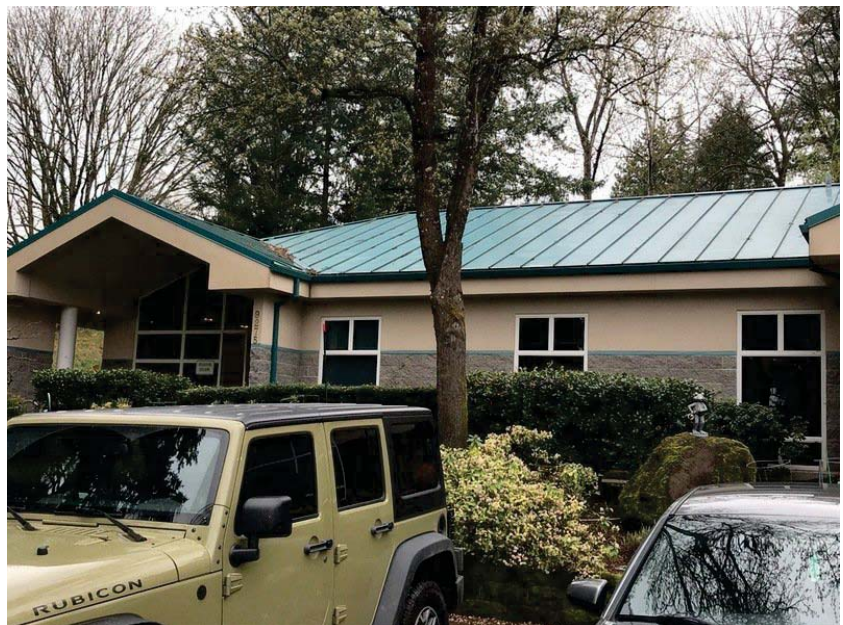
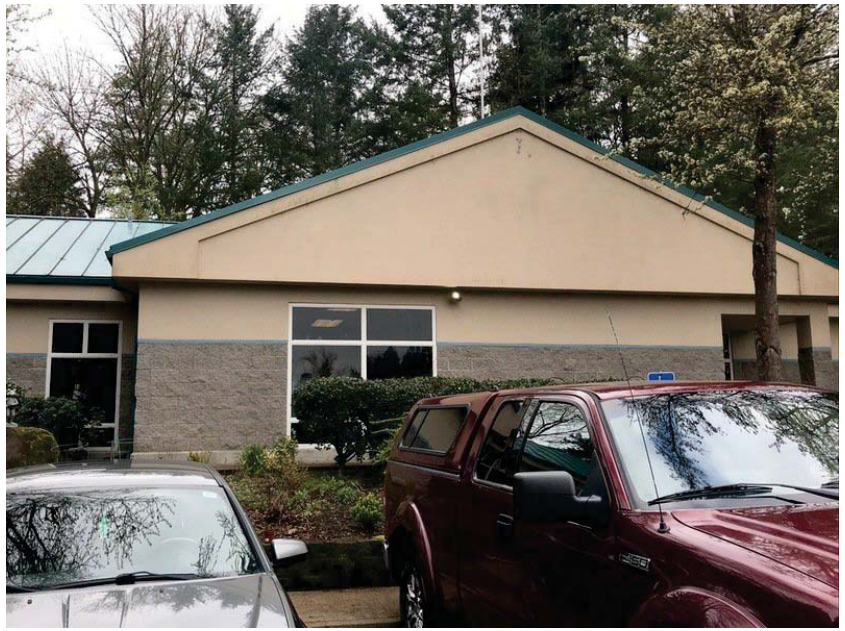
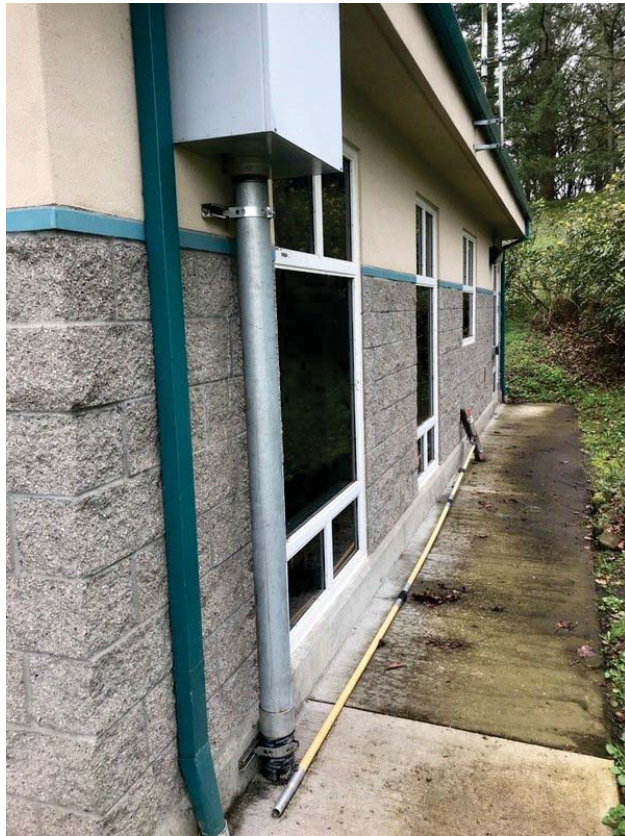
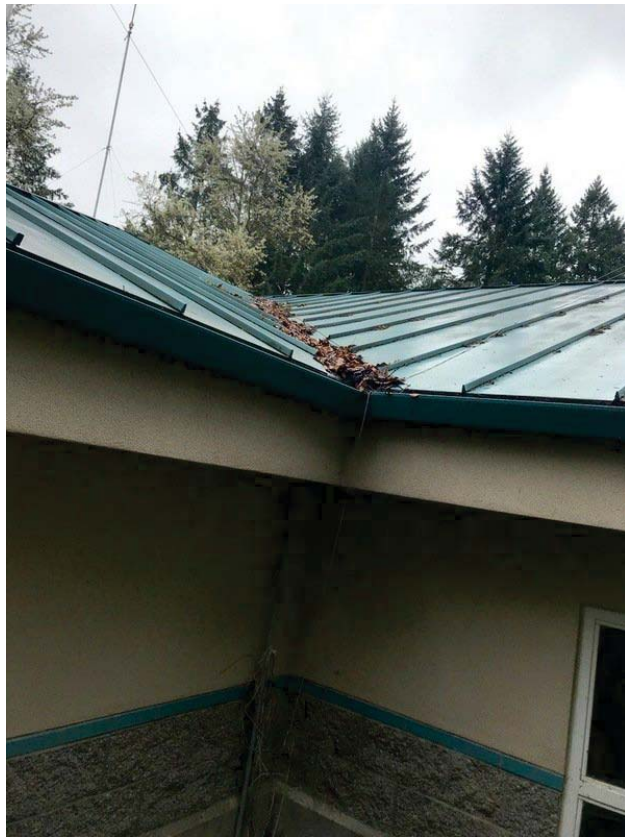
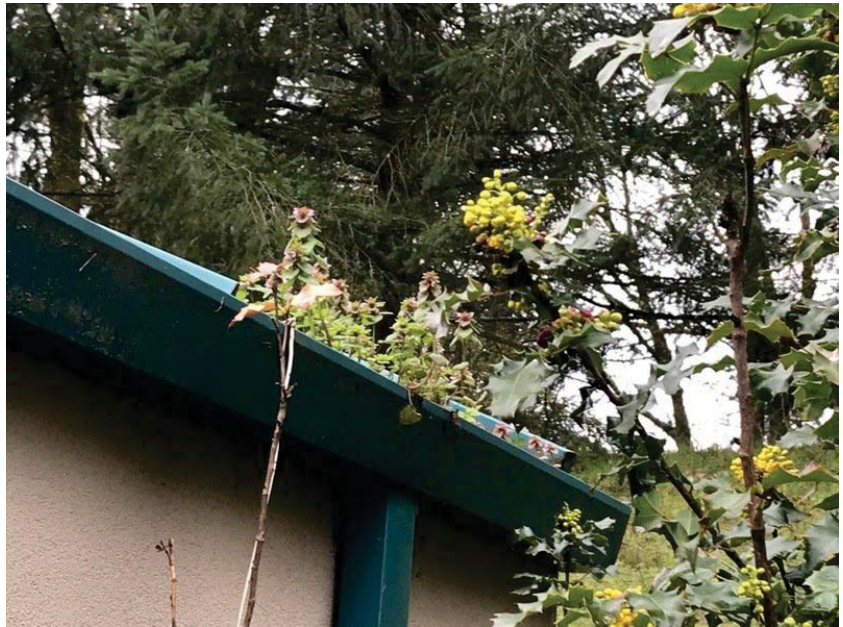
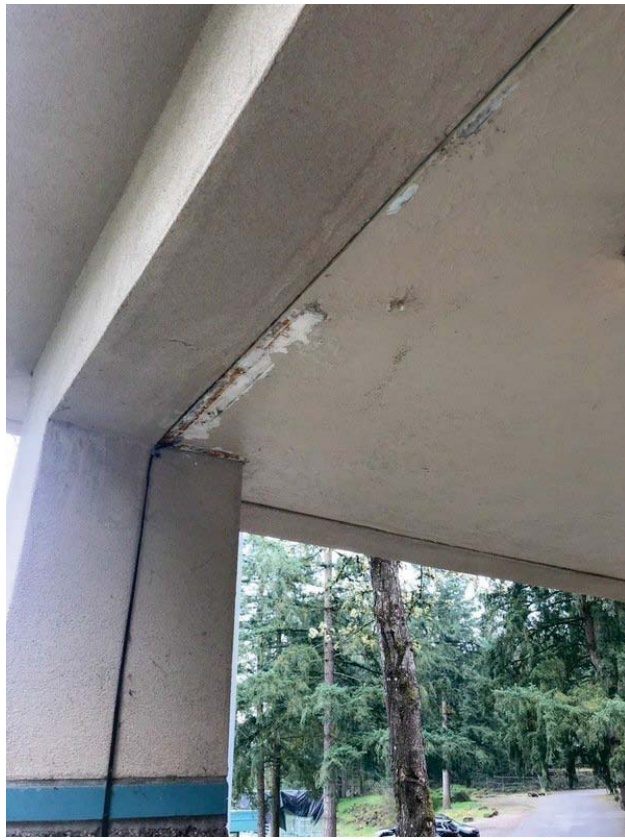
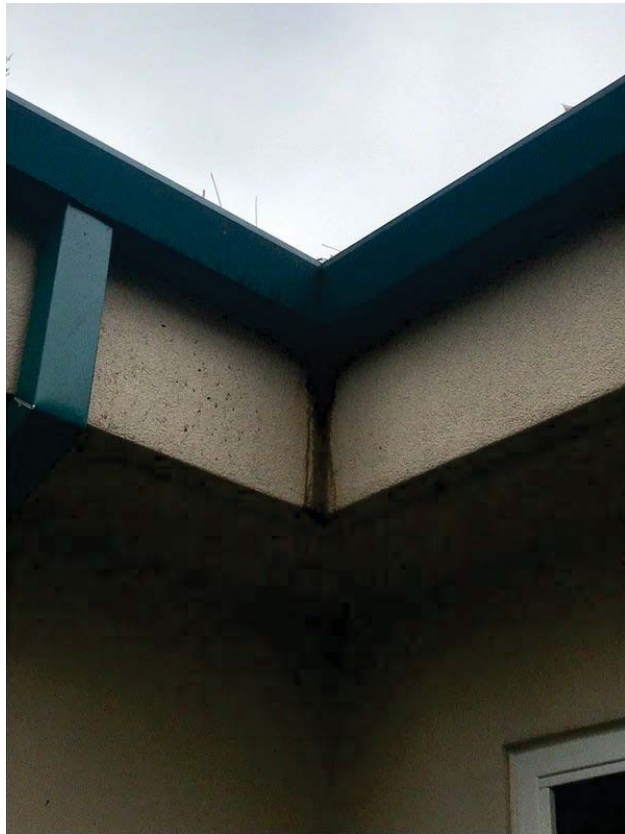
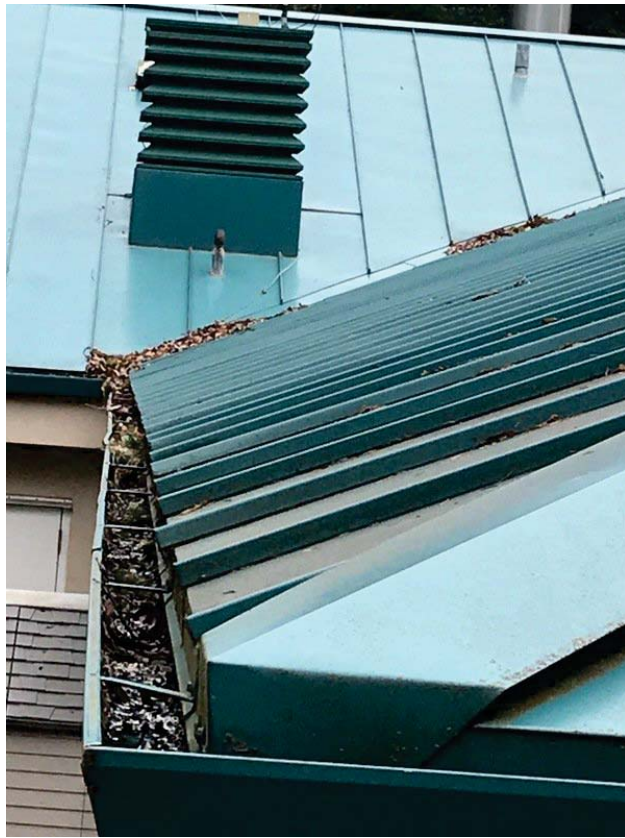
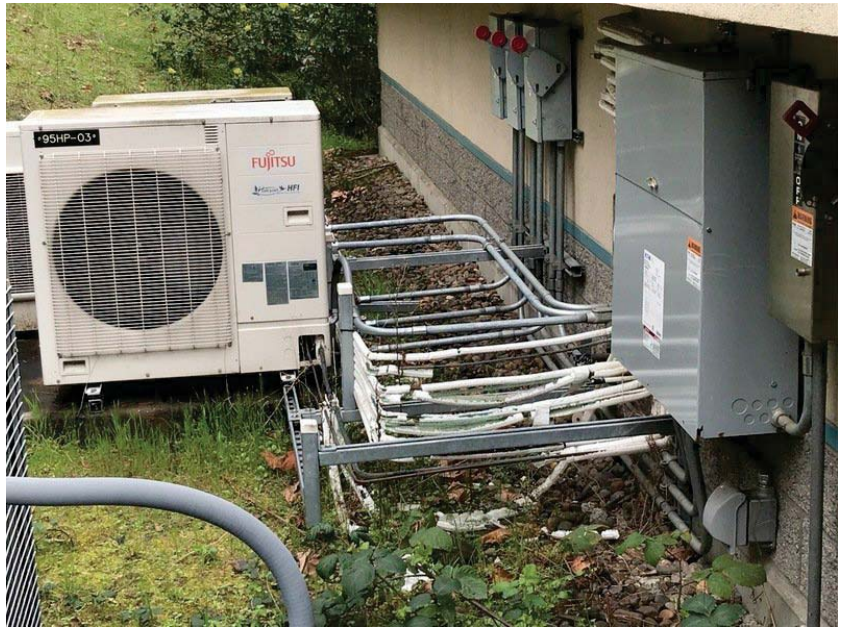
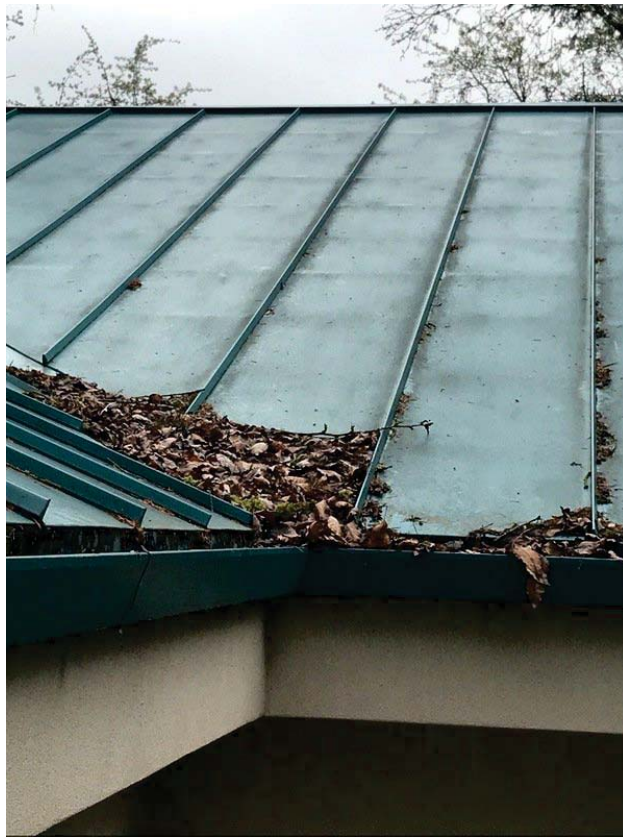
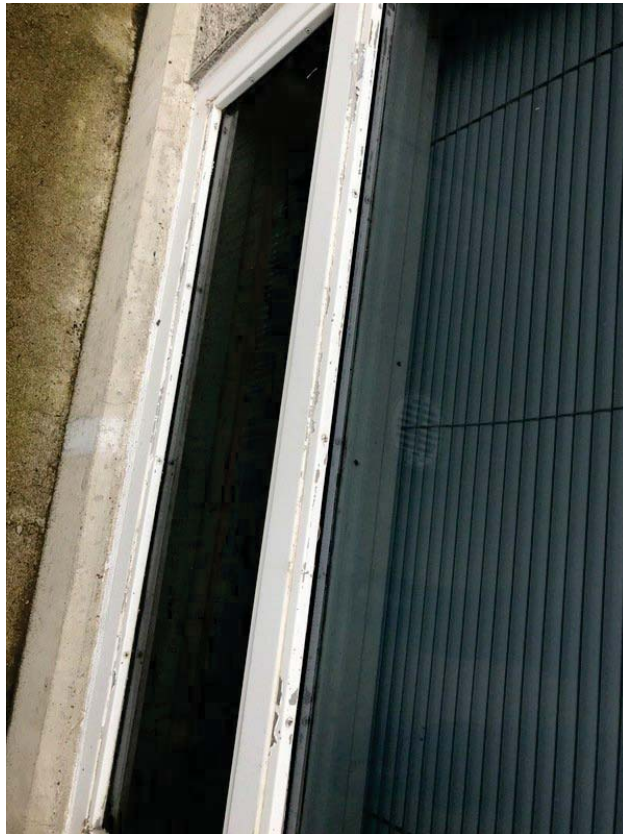
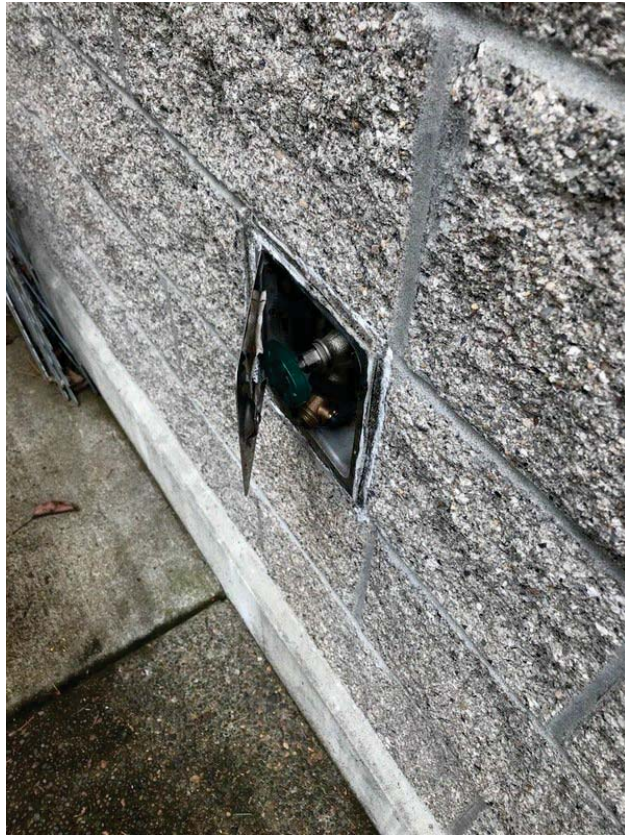
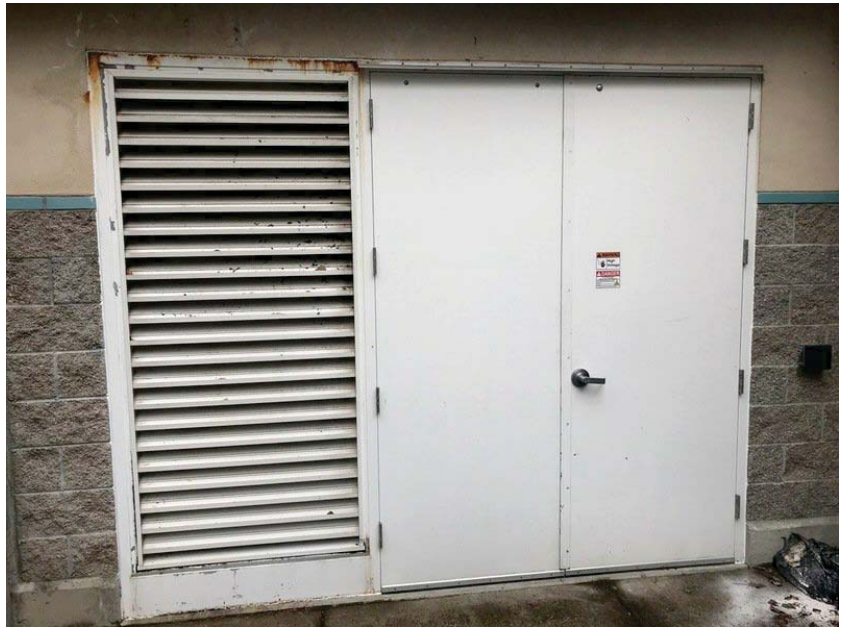
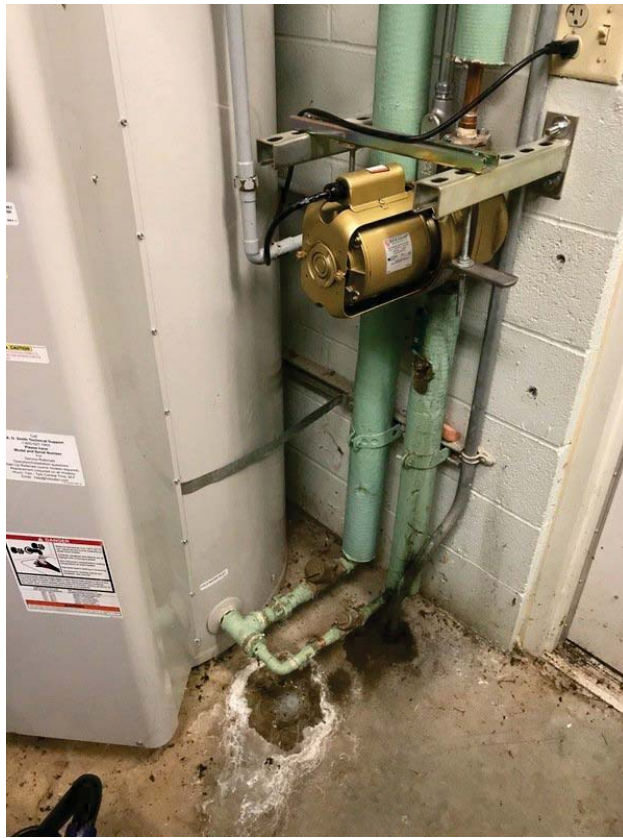
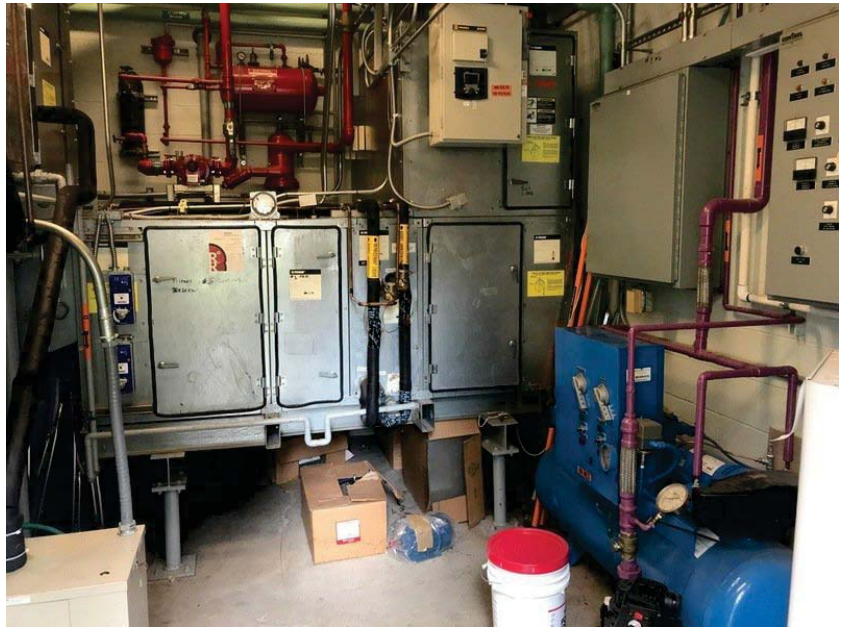
Field Observations	Leaking
Condition Score	3 - Visible Degradation
Performance Score	1 - Component Functioning as Intended
Recommendation	Schedule corrective action work order near term
Field Observations/Comments	Gutters are full and need cleaning out Stucco falling off at secondary front entrance Several floor tiles damaged Stain on lab ceiling not sure if it is HVAC or roof Several pieces of baseboard missing on corners Storage close to electrical panels Several window leaks in break area No backflow device on hose bib in the back of the building

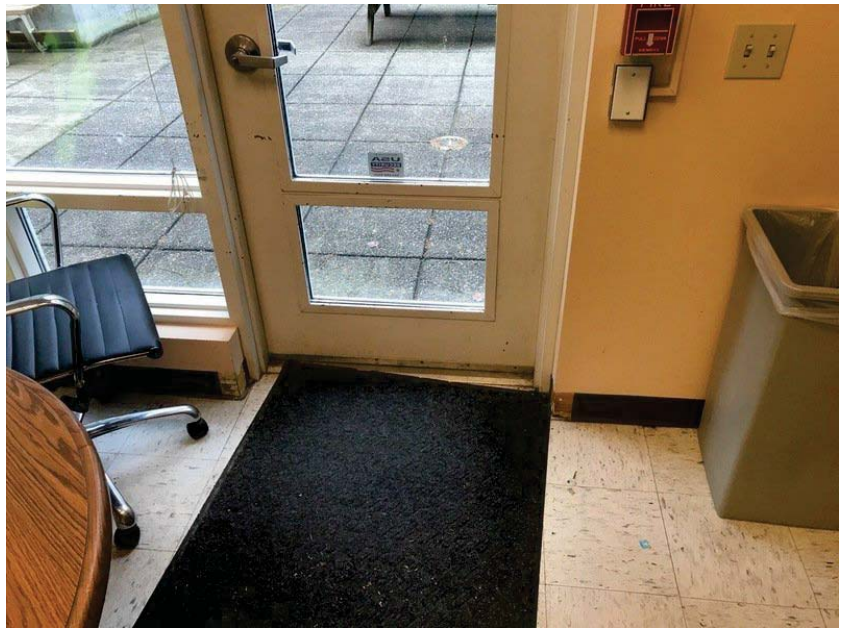
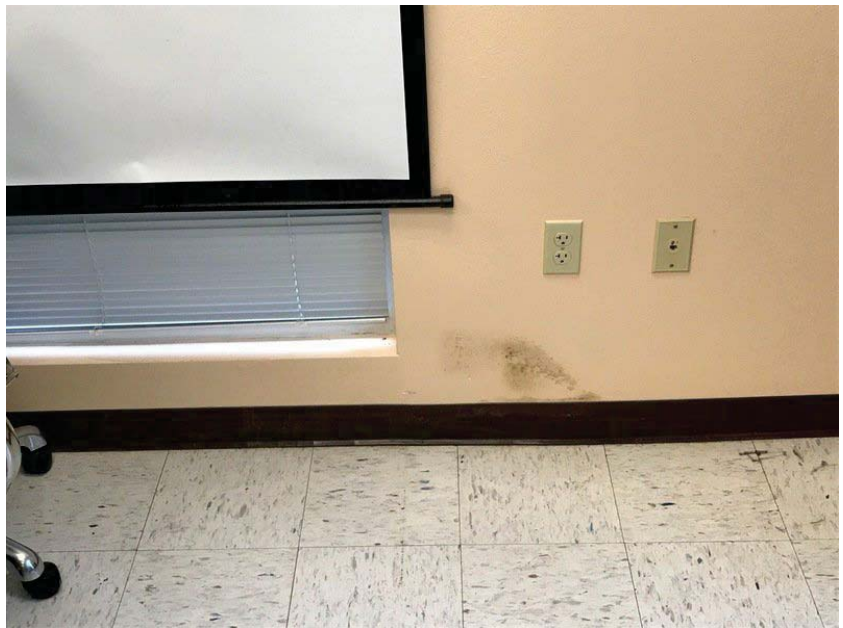
Mold on wall below screen

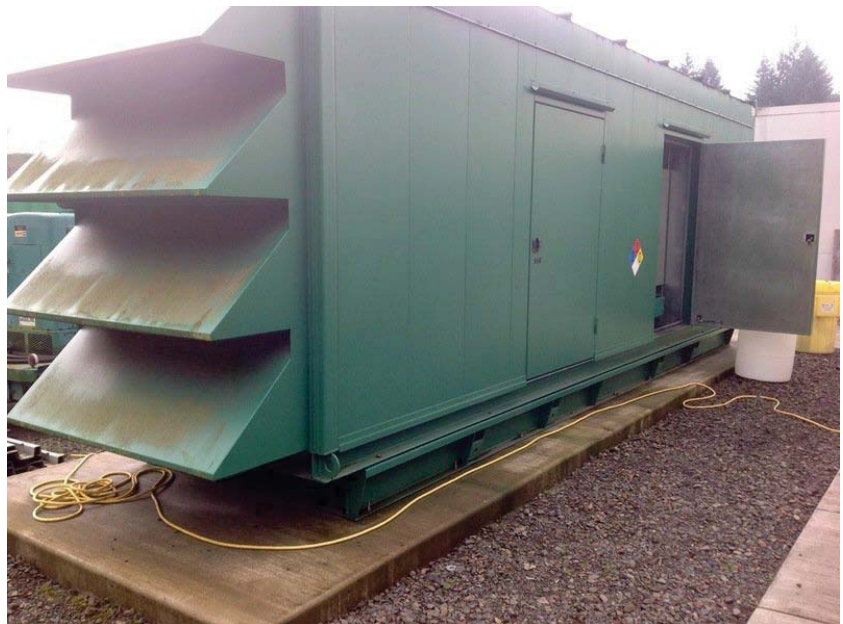
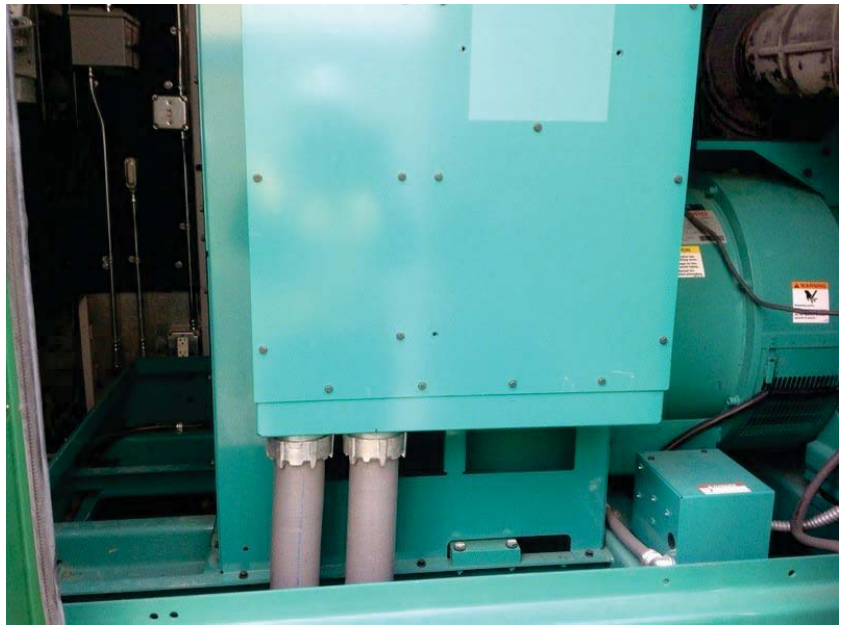
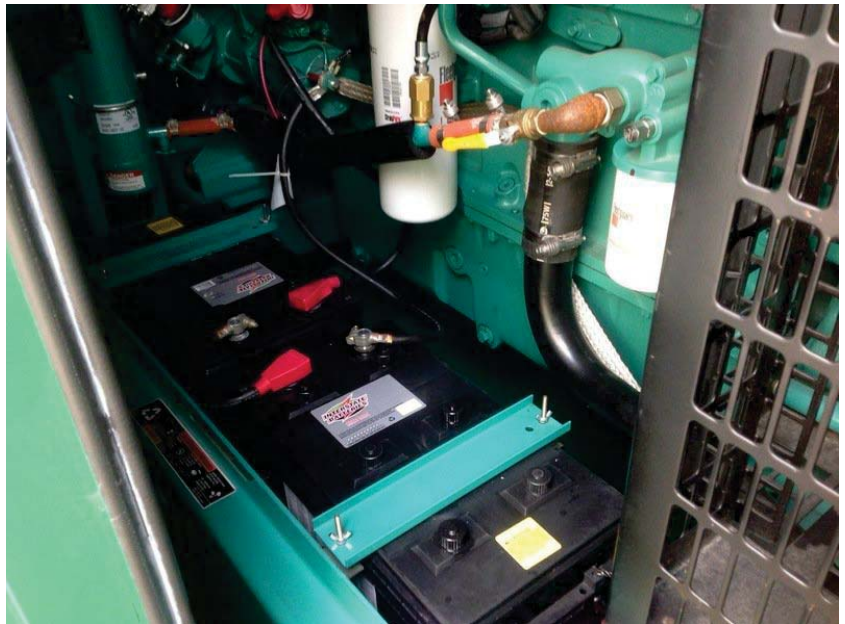
Description	Plant Backup Generator (Large)
Condition Score	1 - Excellent
Performance Score	1 - Component Functioning as Intended
Recommendation	No immediate action required

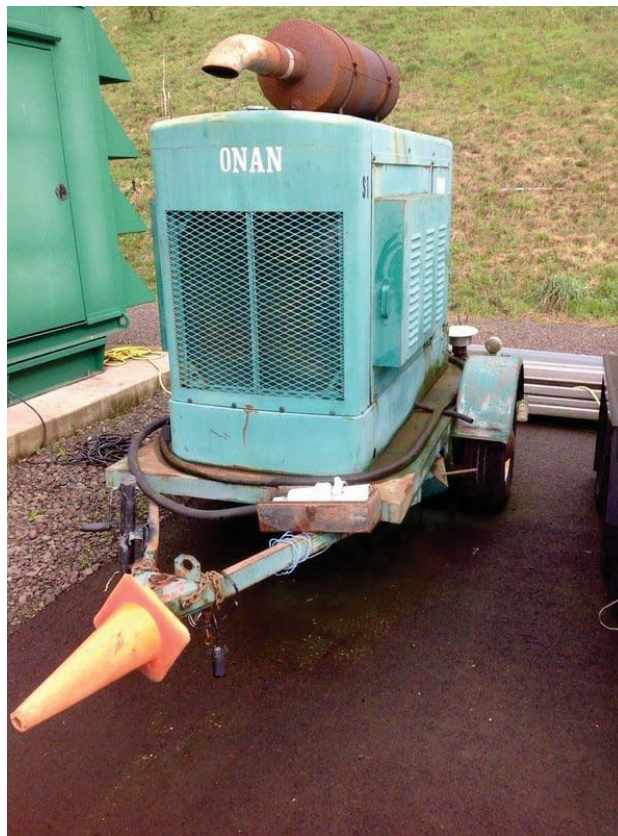
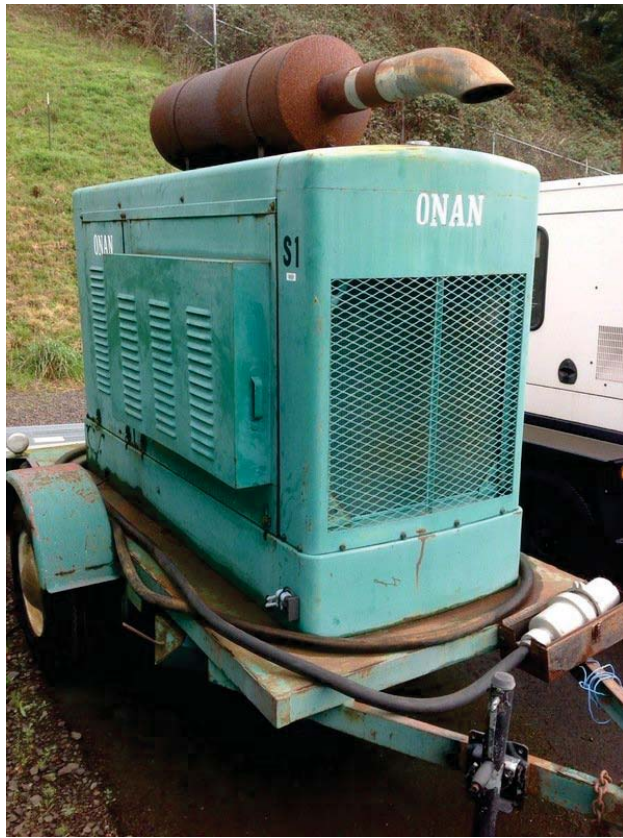
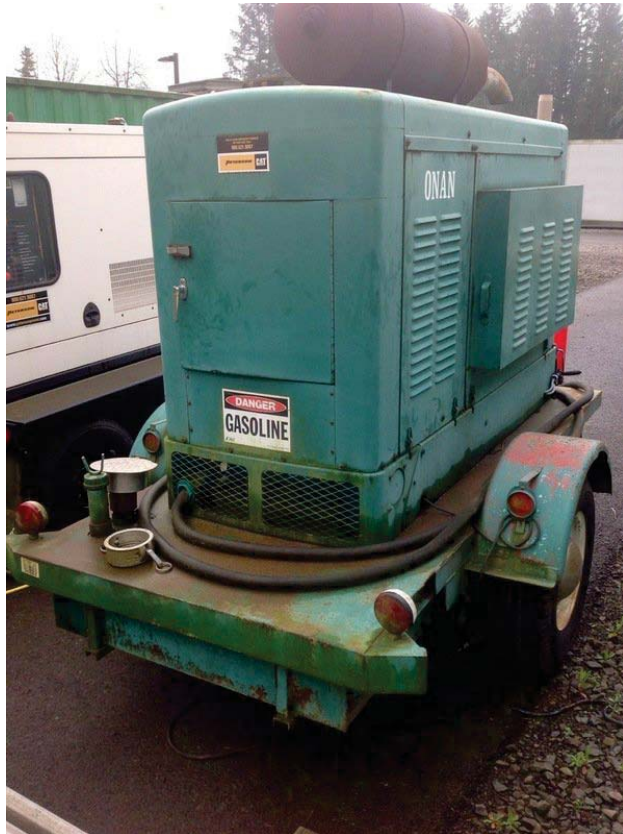
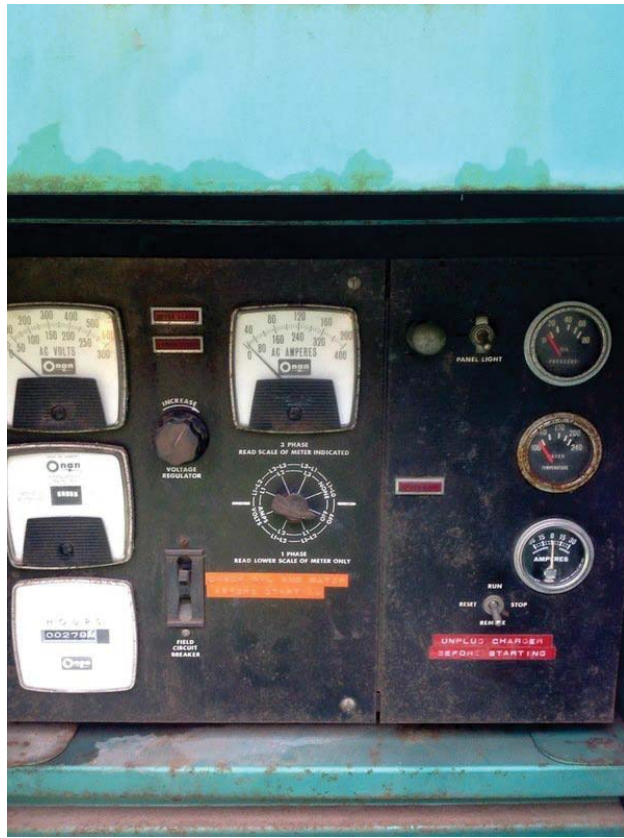
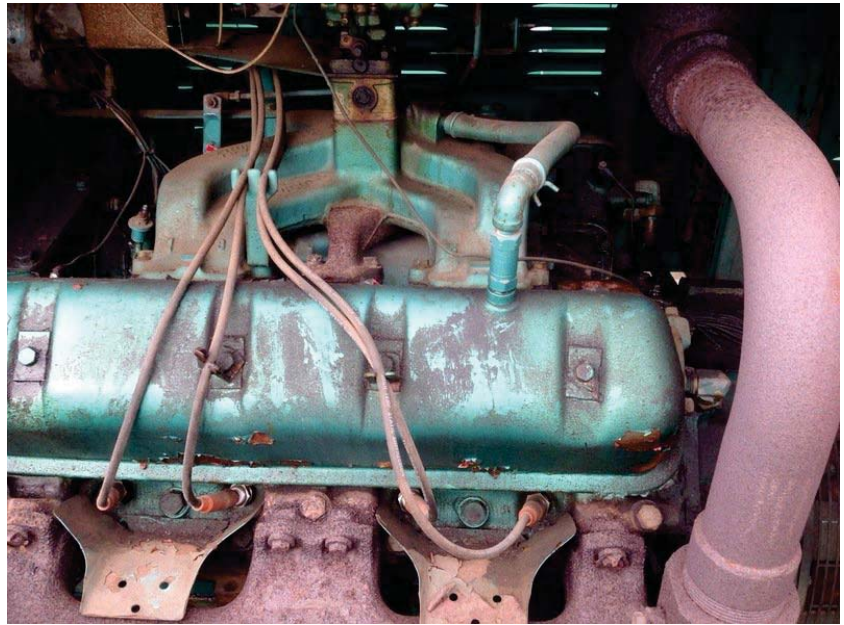
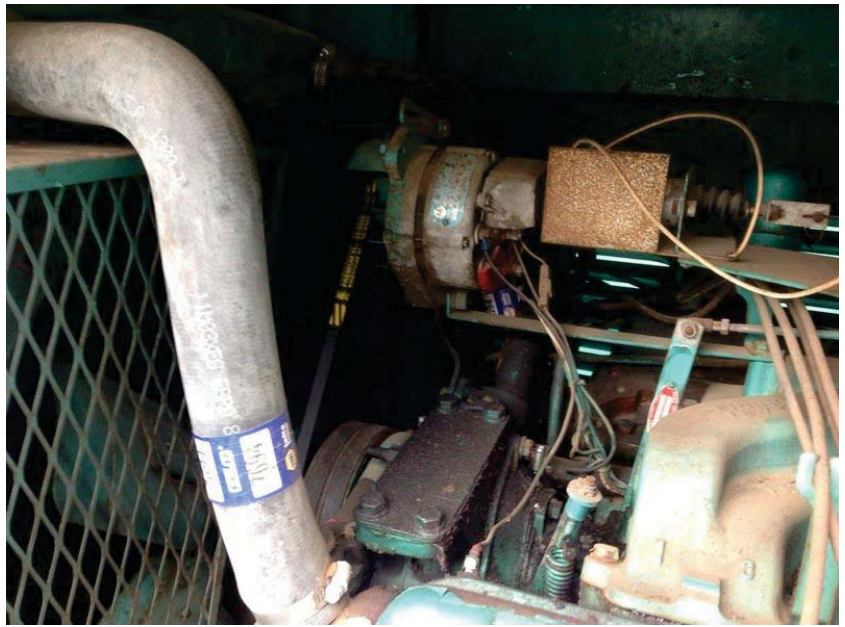
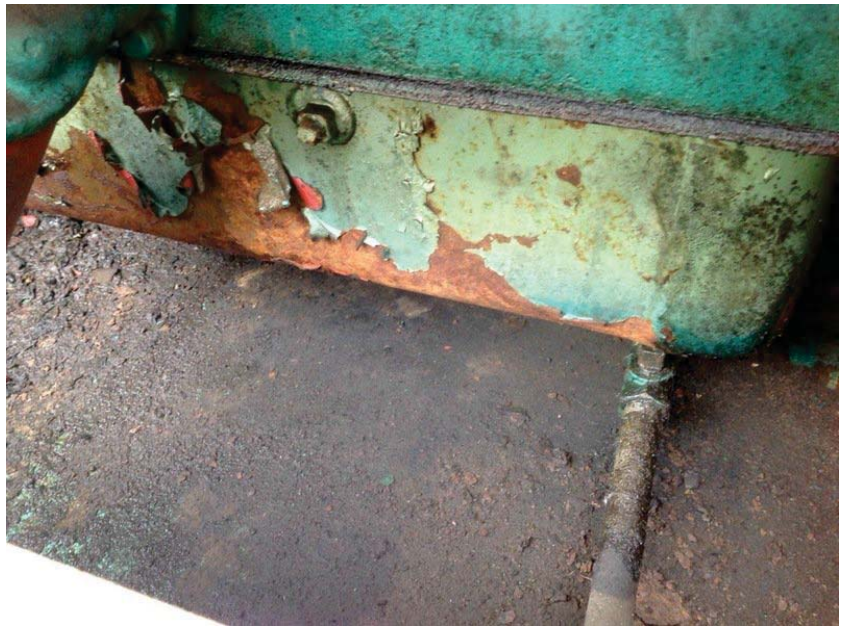
Description	Onan Portable Gas Generator
Field Observations	Corrosion
Condition Score	3 - Visible Degradation
Performance Score	1 - Component Functioning as Intended
Recommendation	Schedule corrective action work order near term
Field Observations/Comments	Coating system failing

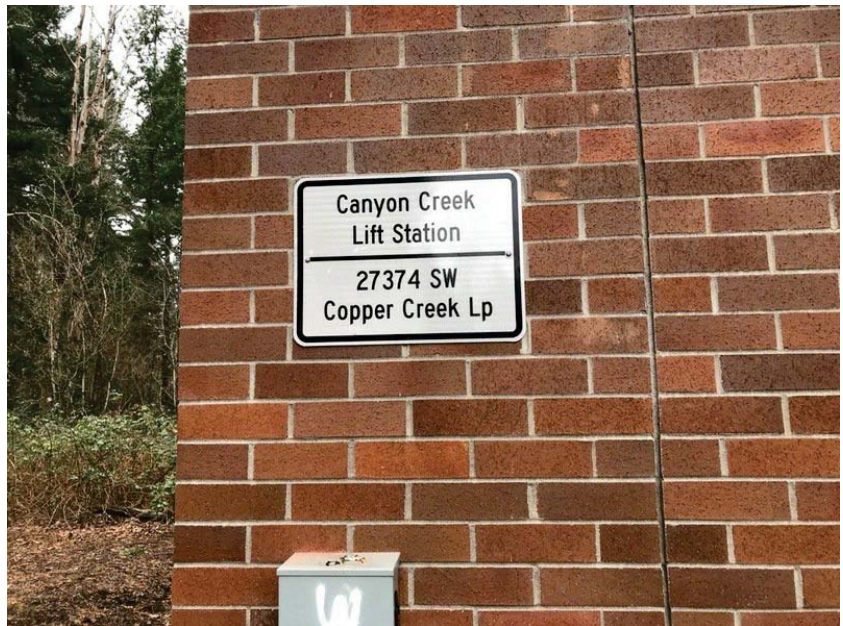
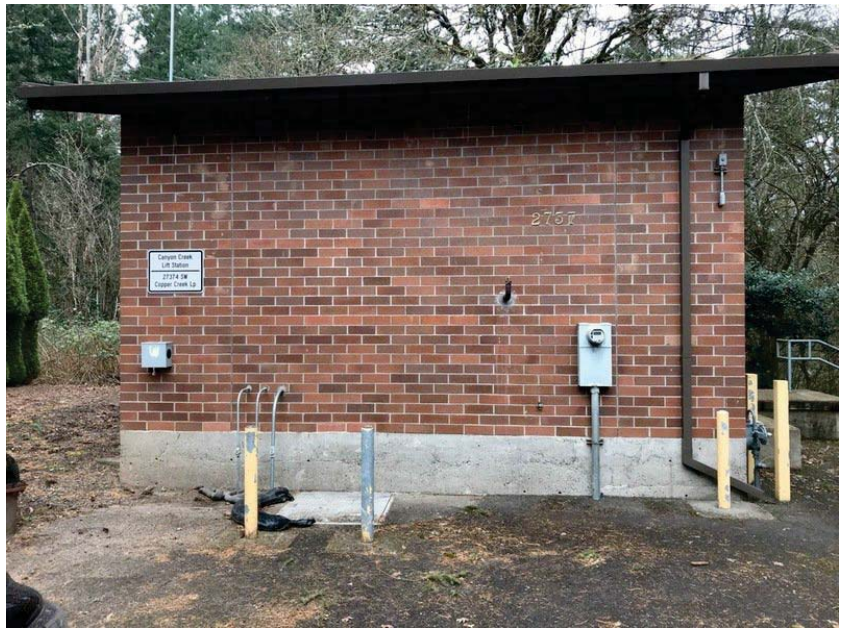
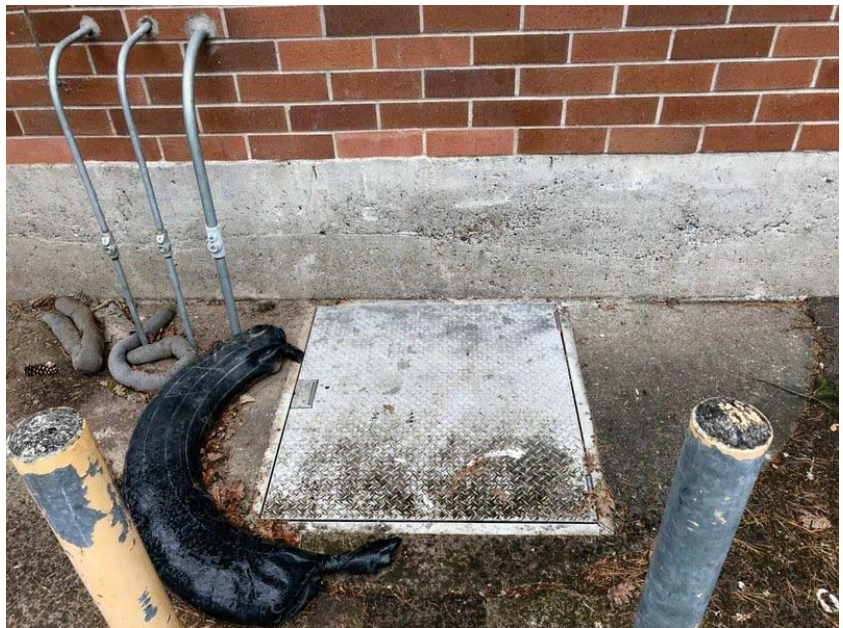
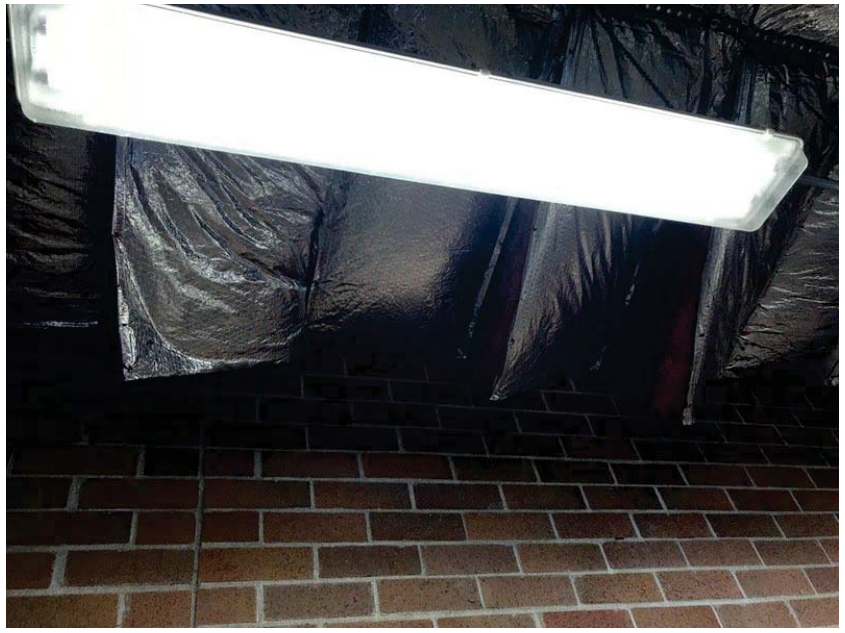
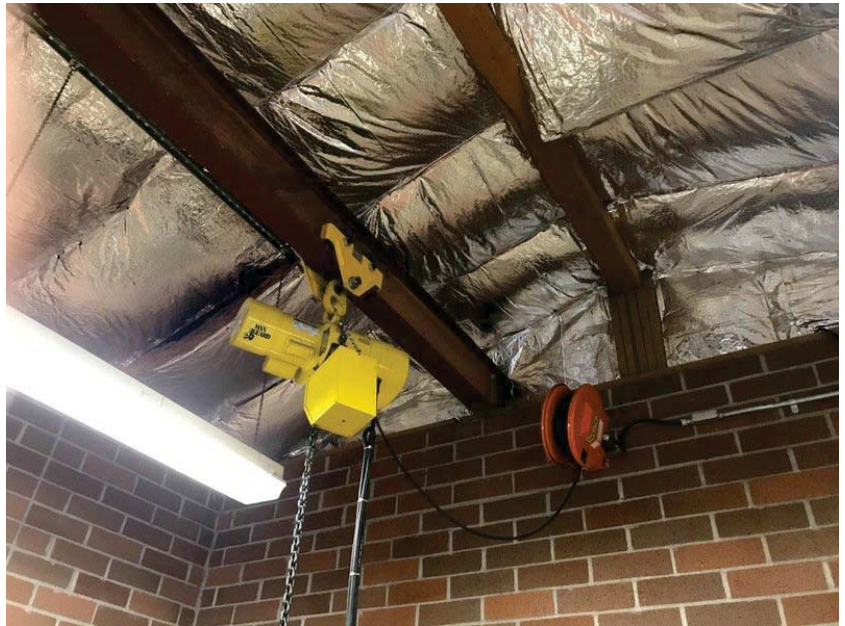
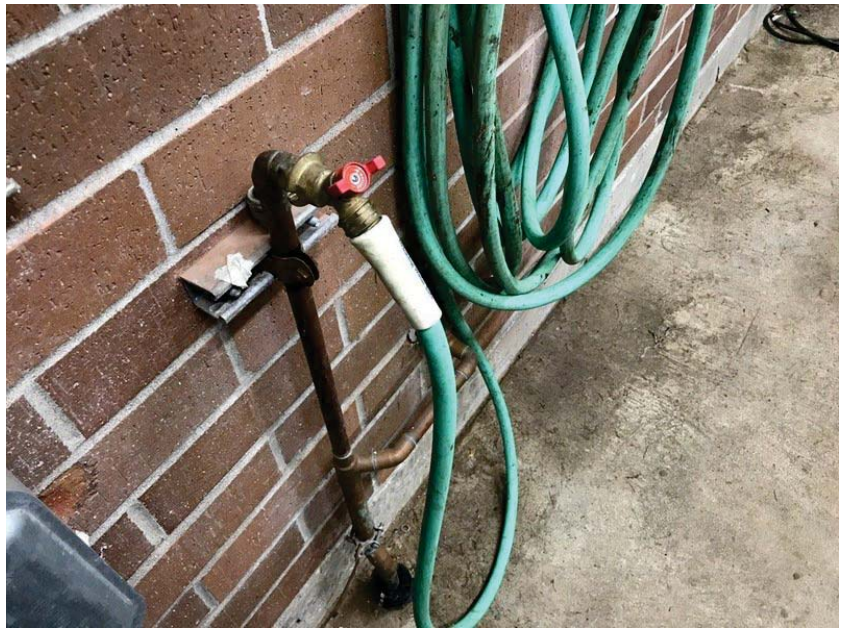
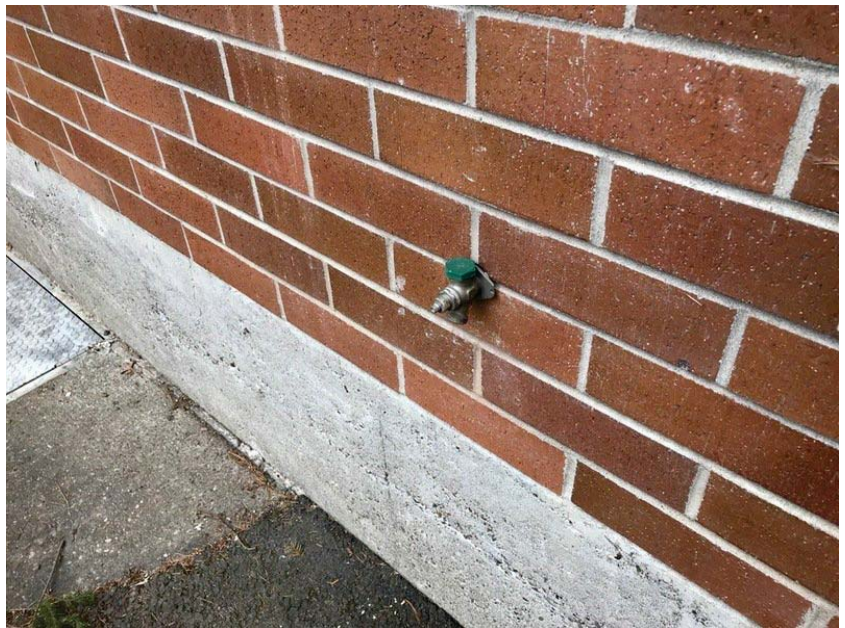
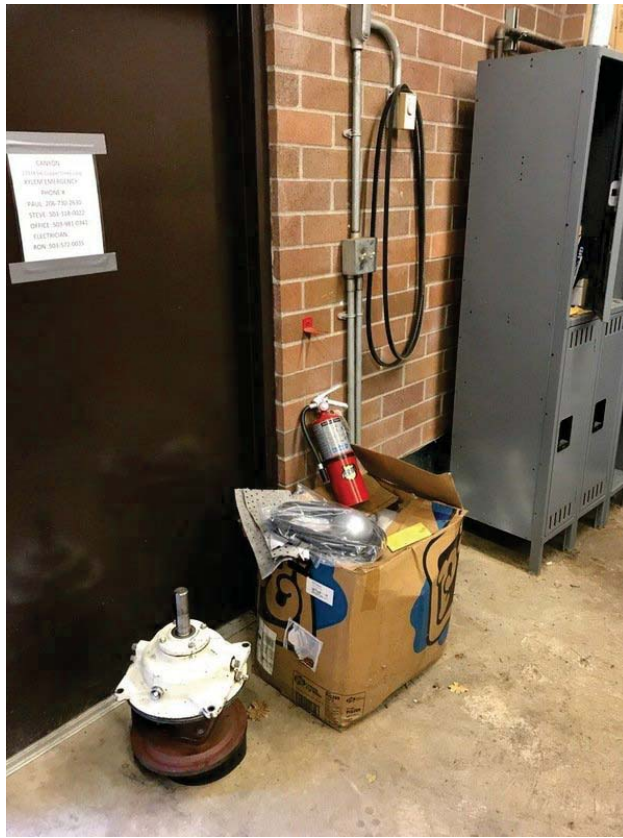
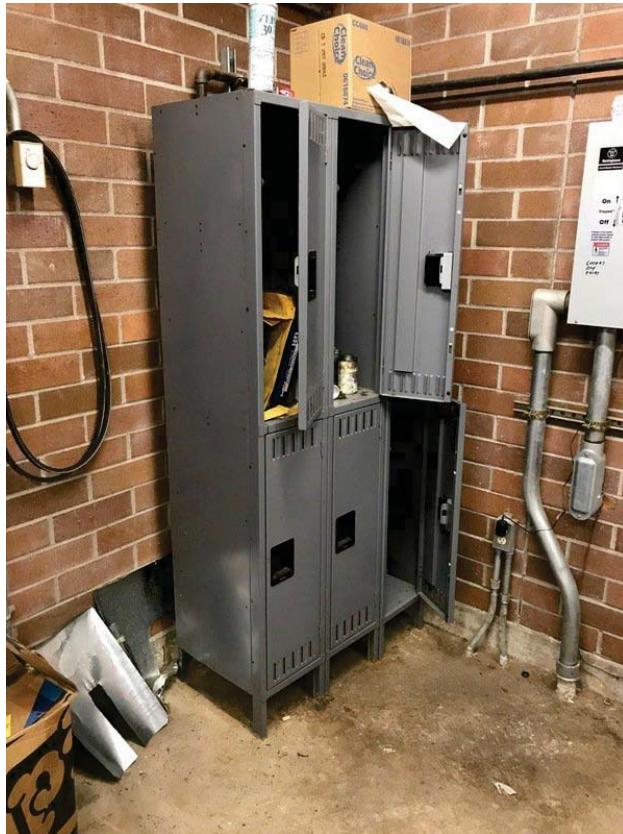
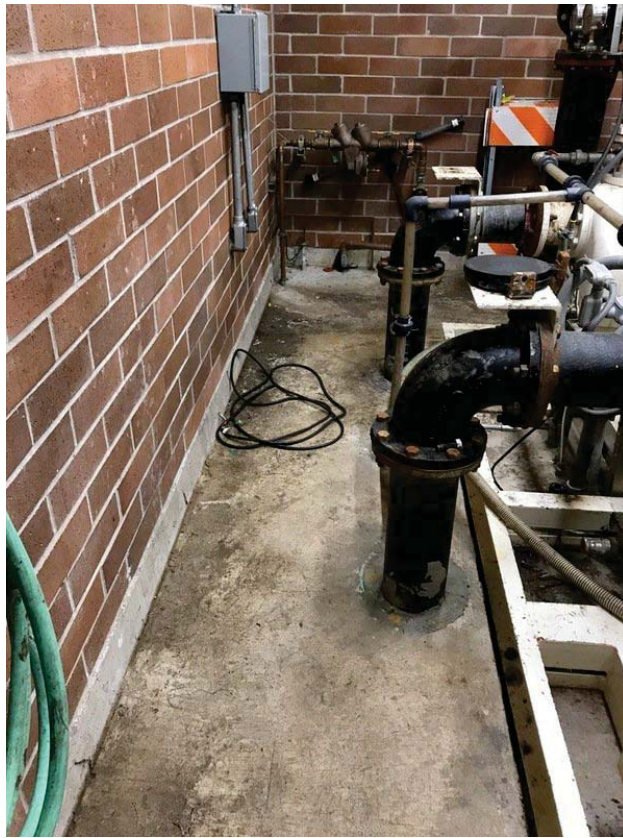
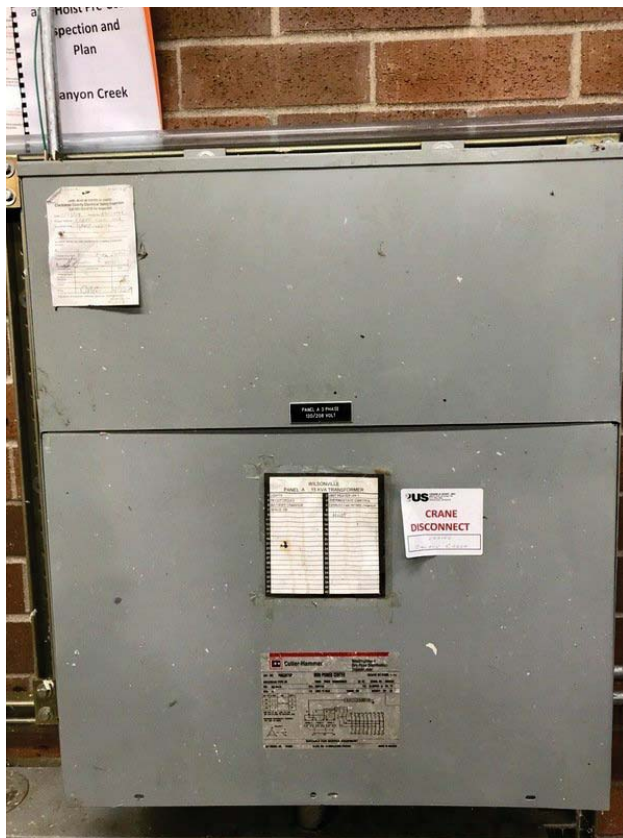
Lift Station	Canyon Creek Lift Station, CANC-LS-07
Station ID	CANC-LS-07
What type of Asset?	Structural
Condition Score	2 - Slight Visible Degradation
Performance Score	1 - Component Functioning as Intended
Recommendation	Schedule corrective action work order near term
Field Observations/Comments	House keeping issues No back flow devices on the hose bibs Roof insulation starting to fall down No confined space sign on wet well 120/208 transformer seems to be hotter than normal. Suggest follow up to verify transformer temperature is in correct operating range

Appears to hitter than normal
