# City of Wilsonville Triennial Inspection Report

Wilsonville WWTP and  
Wastewater Lift Stations:

Project Title: On-Call Civil Engineering and Related Services,  
Triennial Inspection of the Wilsonville WWTP and Nine Lift Stations

Subject: 2019 Triennial Inspection of the Wilsonville WWTP  
and Sewage Lift Stations

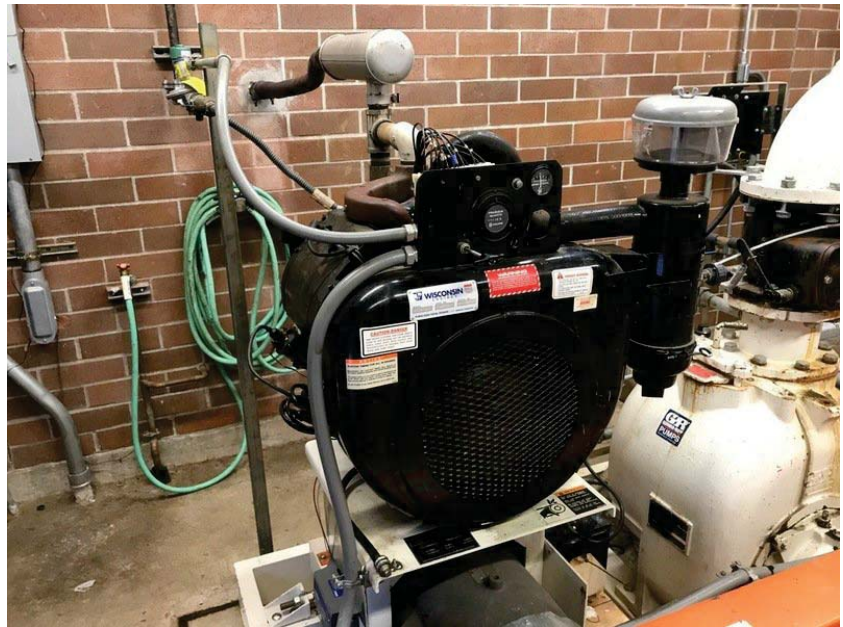
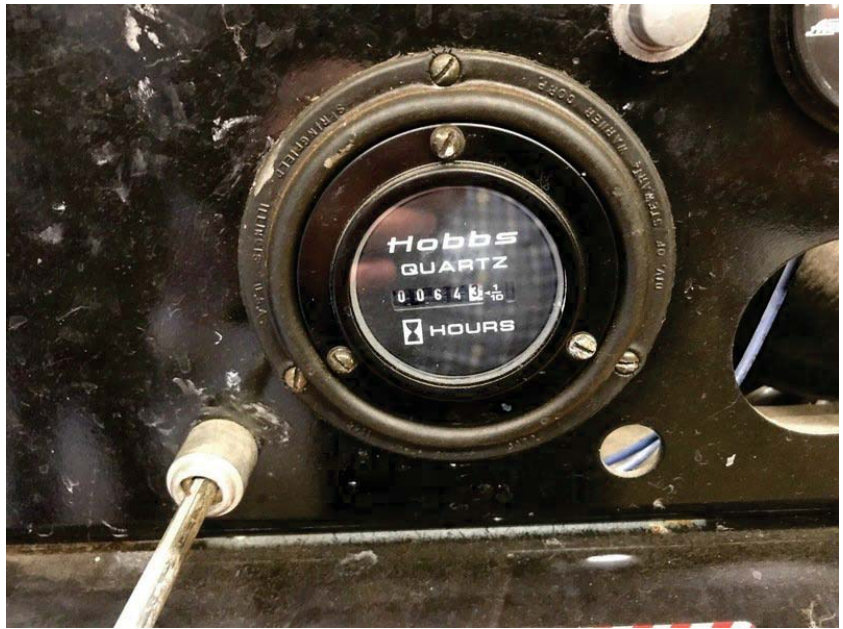
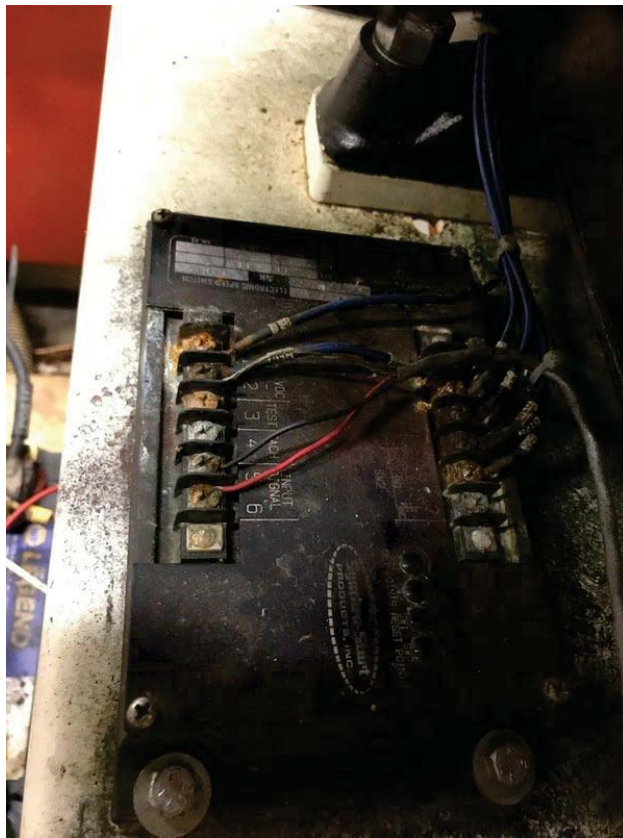
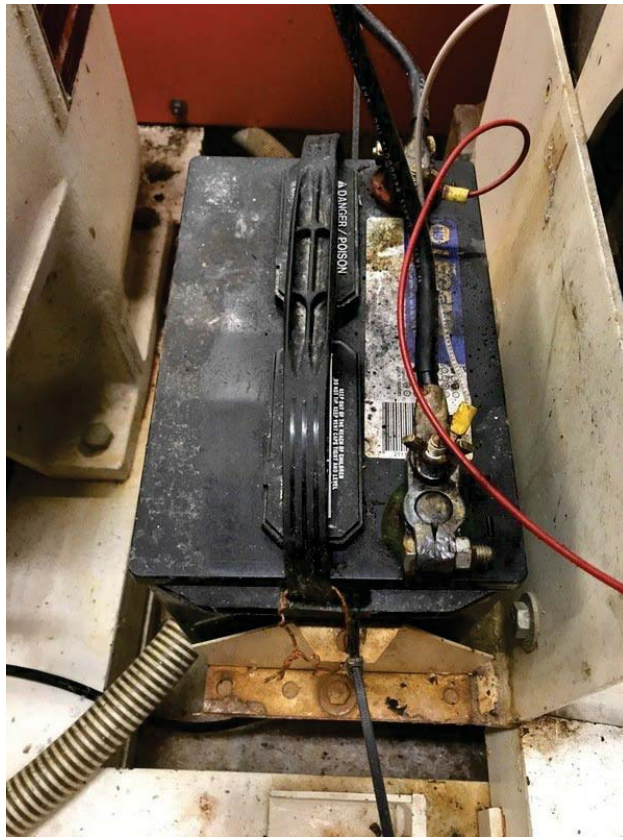
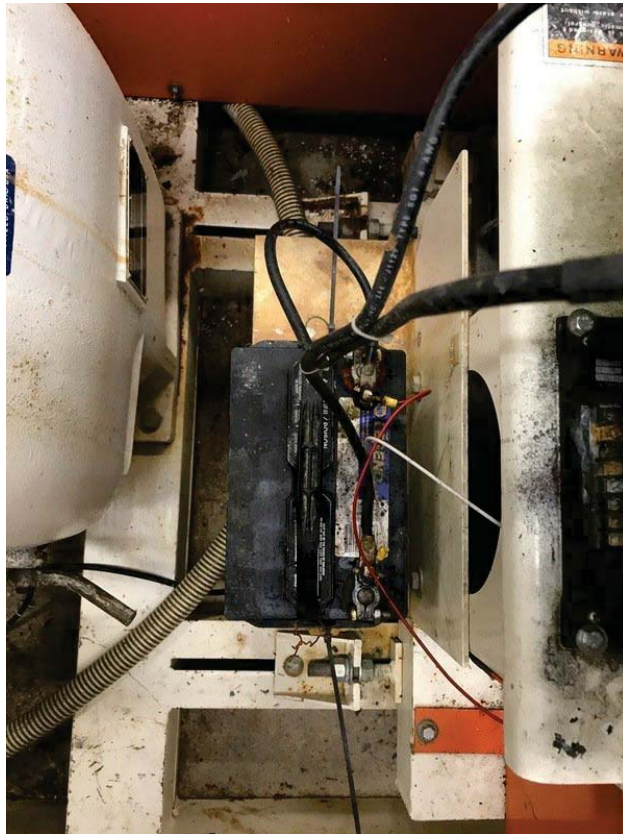
Field Observations	Corrosion
Condition Score	3 - Visible Degradation
Performance Score	1 - Component Functioning as Intended
Recommendation	Schedule corrective action work order near term
Field Observations/Comments	Corroded electrical terminals. Battery held in place with wire ties and bailing wire No cover over battery posts

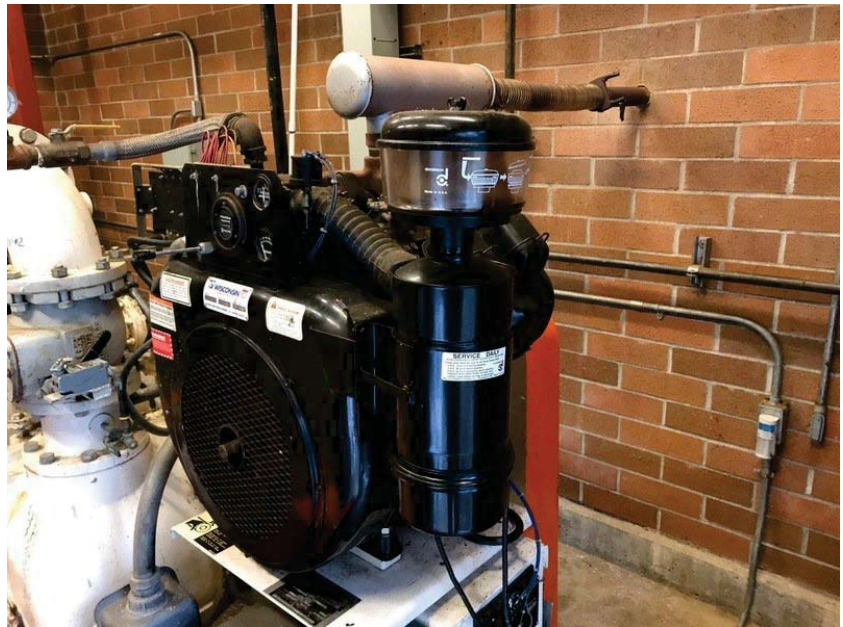
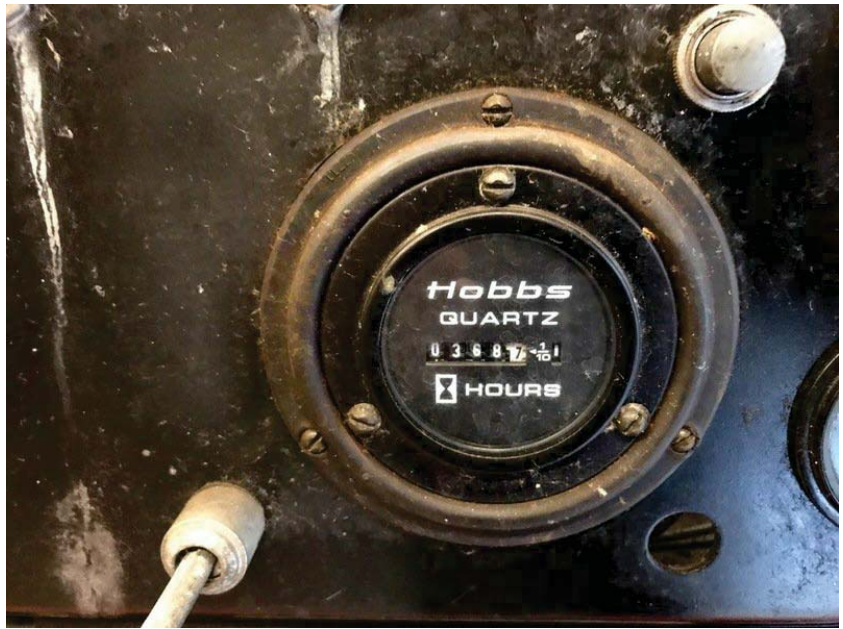
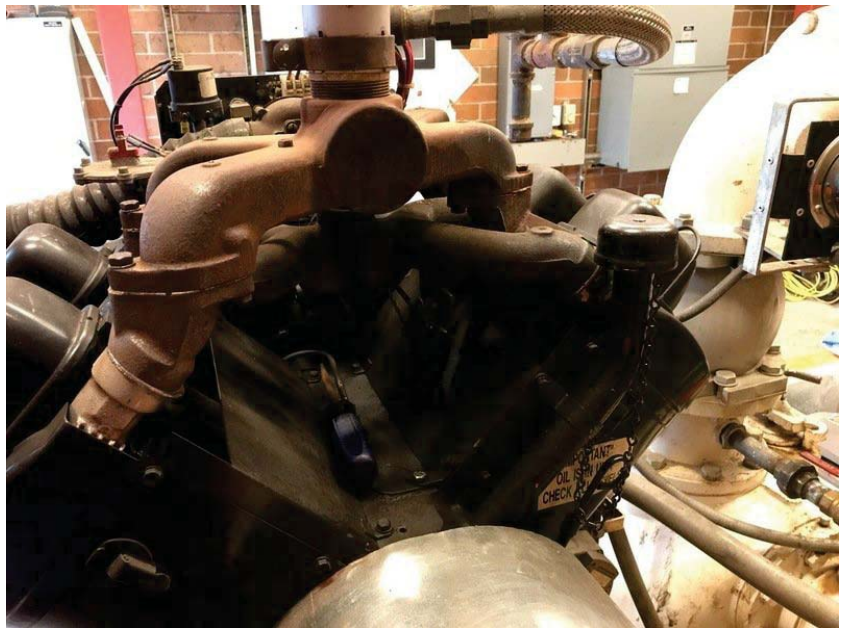
Field Observations	Leaking
Condition Score	2 - Slight Visible Degradation
Performance Score	1 - Component Functioning as Intended
Recommendation	Schedule corrective action work order near term
Field Observations/Comments	Slight oil leak from top of engine Battery has no cover over the posts so it is a hazard Gas line is not supported by the engine so it moves and could cause a hazard

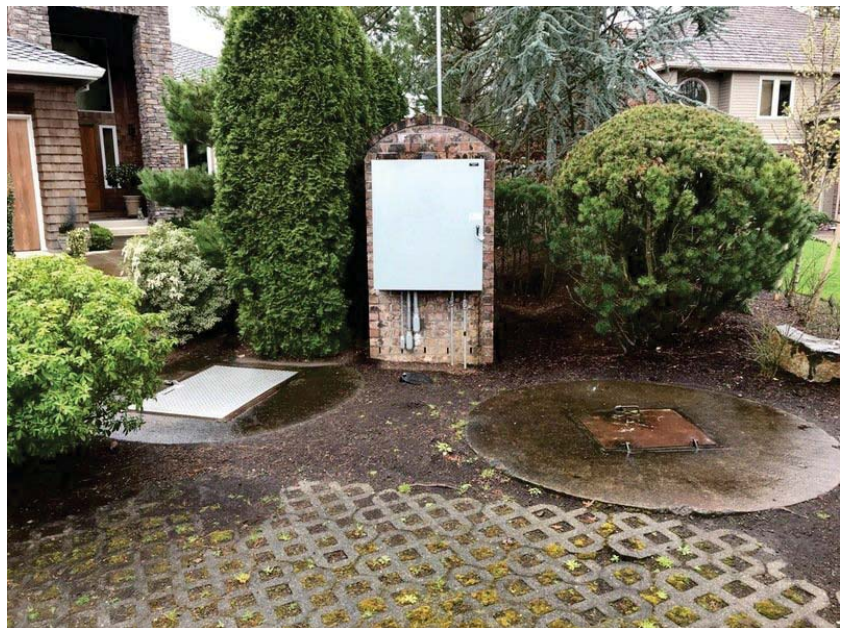
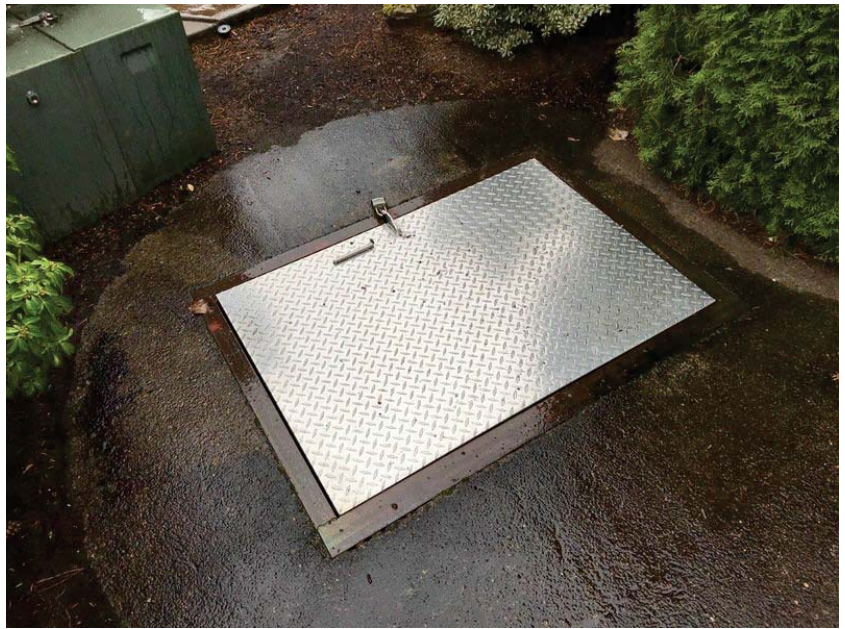
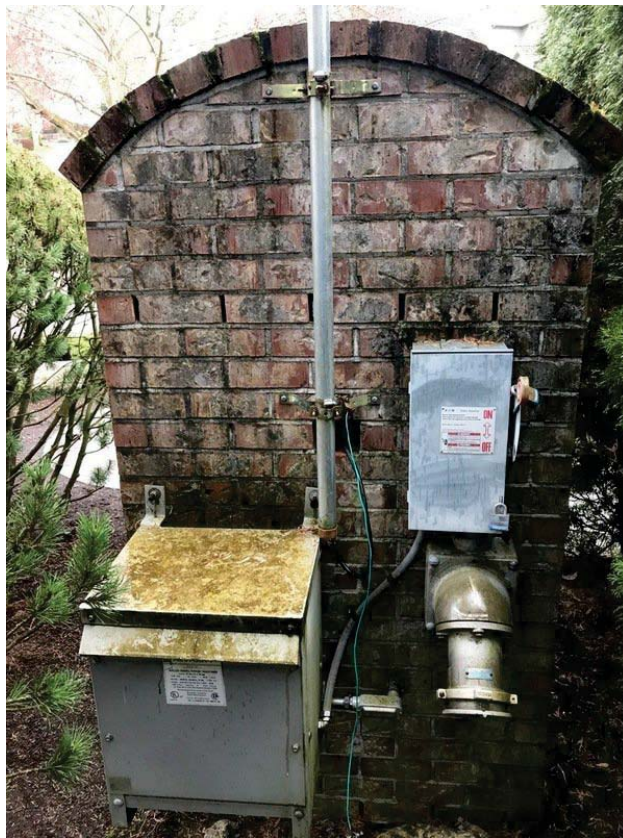
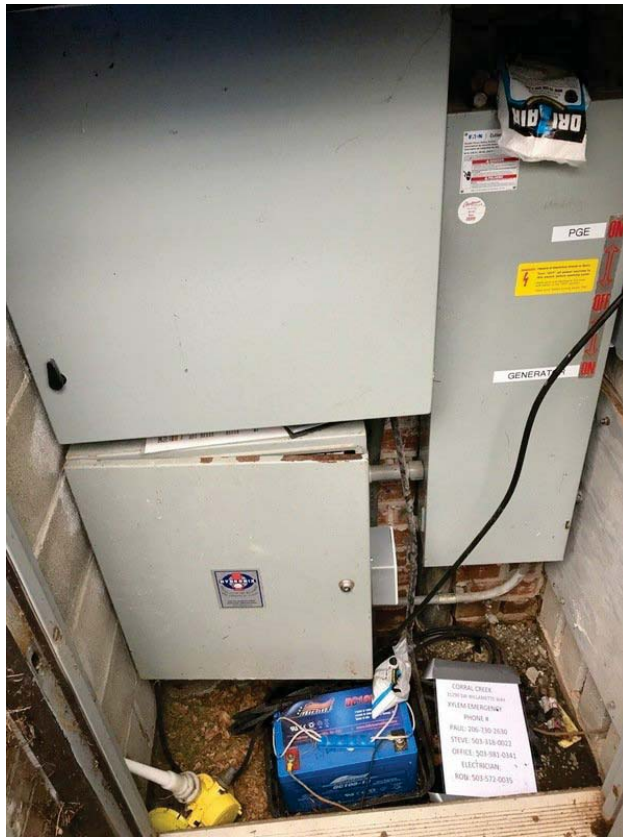
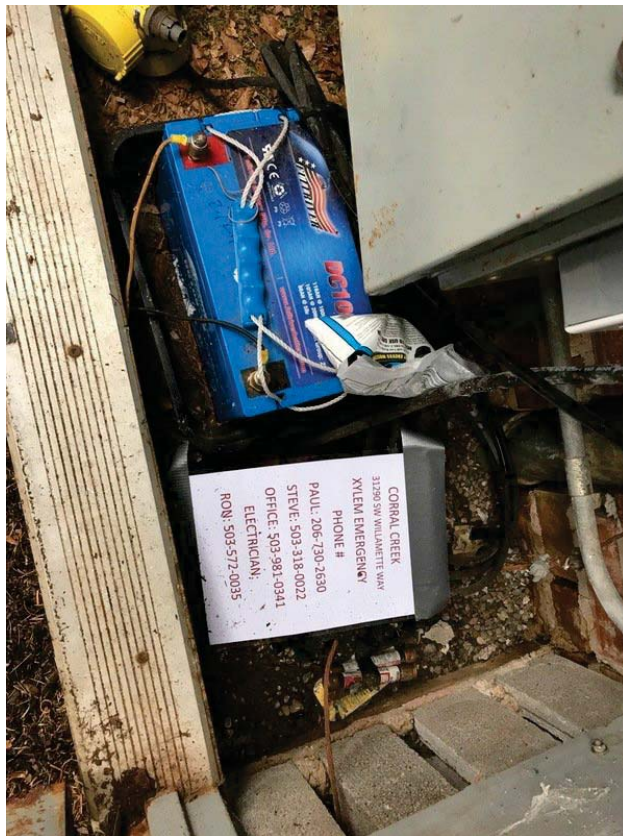
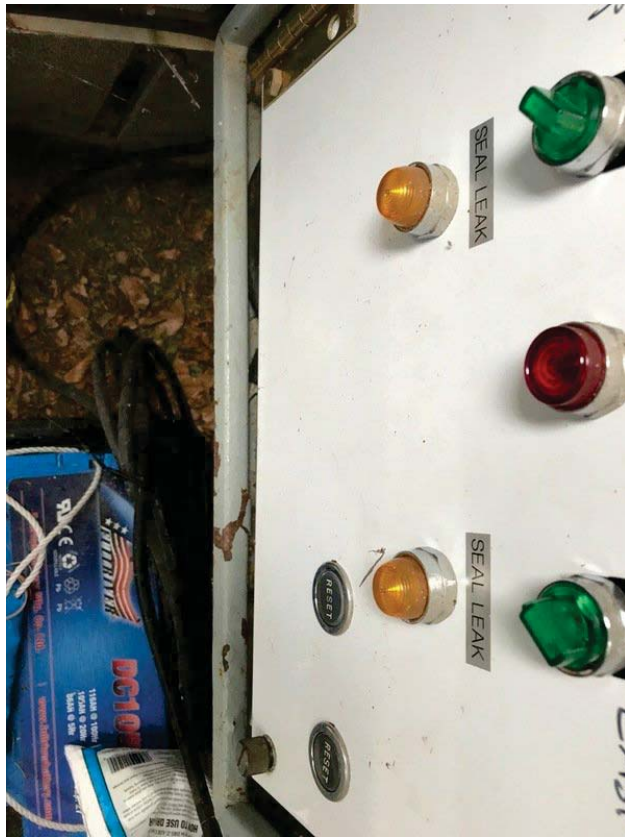
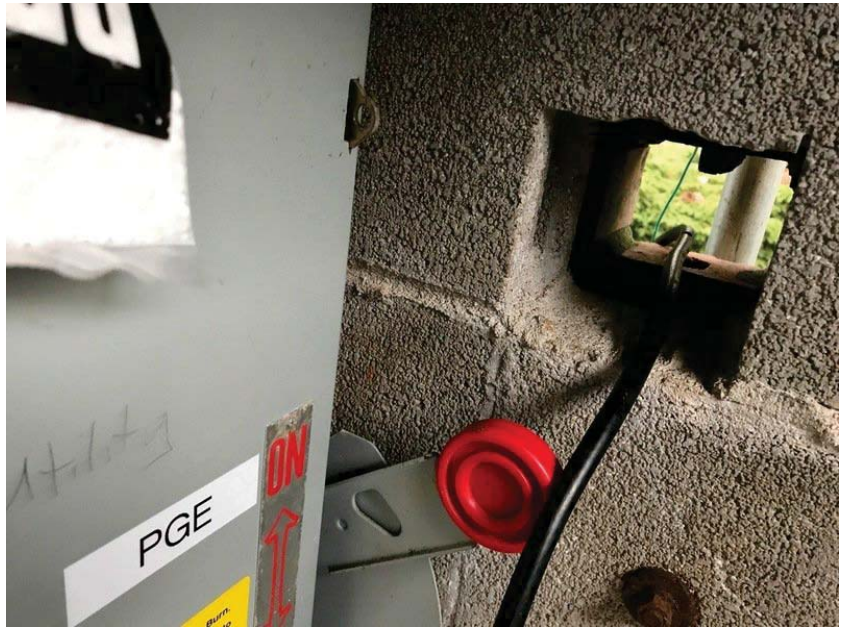
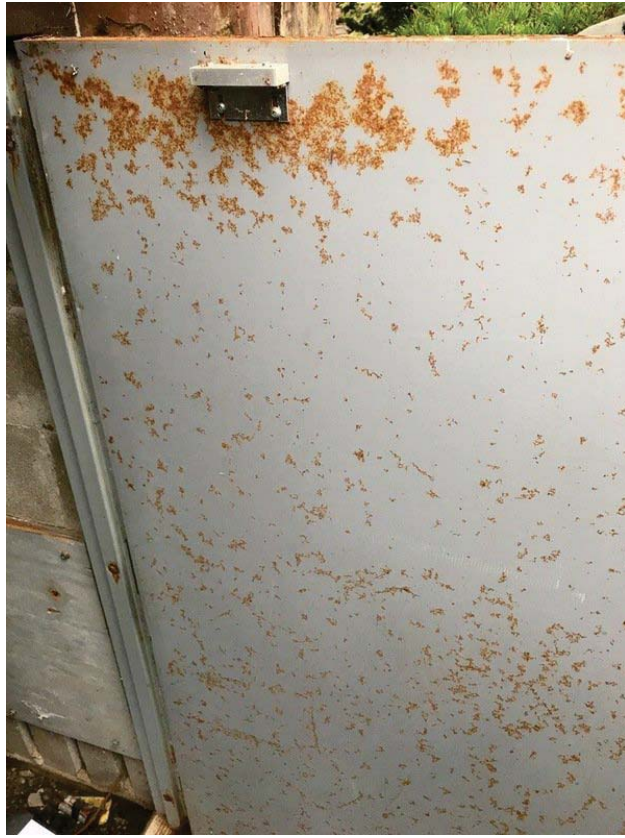
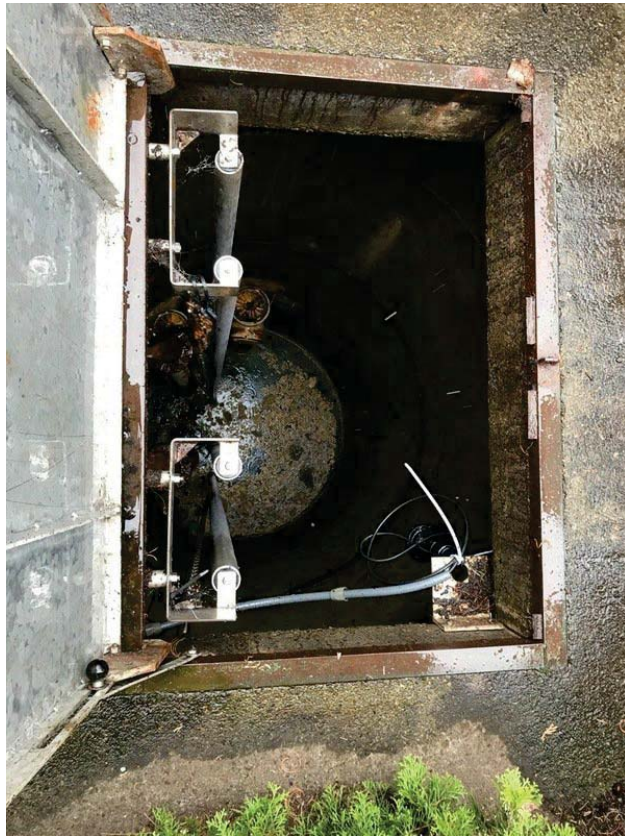
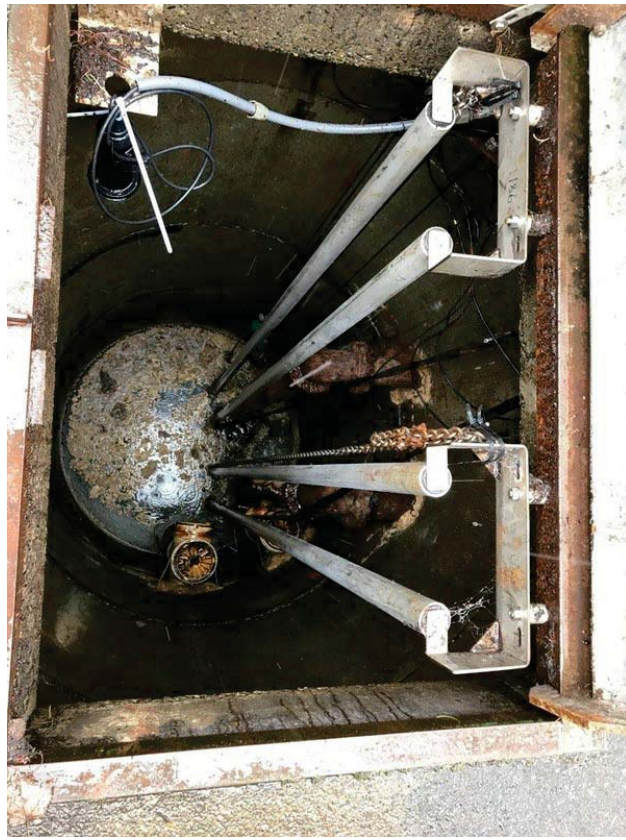
photos

Field Observations	Corrosion
Condition Score	2 - Significant Deterioration
Performance Score	1 - Component Functioning as Intended
Recommendation	Schedule corrective action Work order near term
Field Observations/Comments	Electrical protection on Oet Oel LarRe gone into poOer controNstructure Ogere tge antenna Oire comes tgrouRg. Electrical cover over battery posts Replacement fuses MyinR in dirt Corrosion noted on tge bottom of tge controNpaneN Electrical confined space siRn on OetOel Wumps did not run OgilN onsite

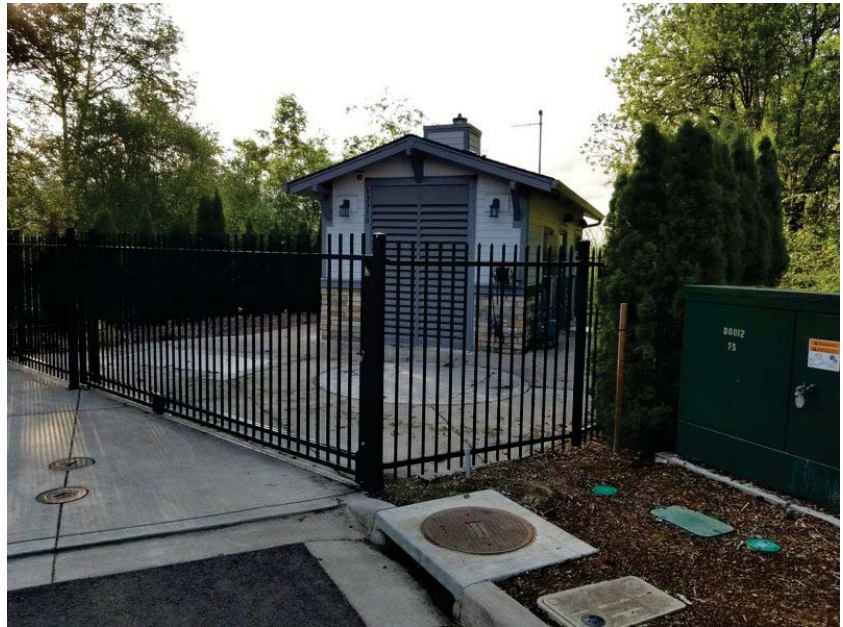
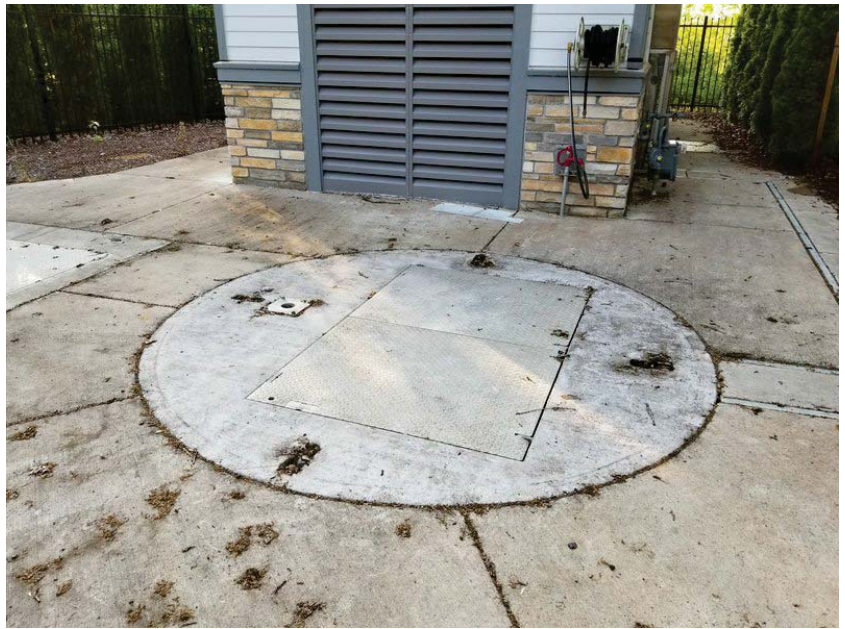
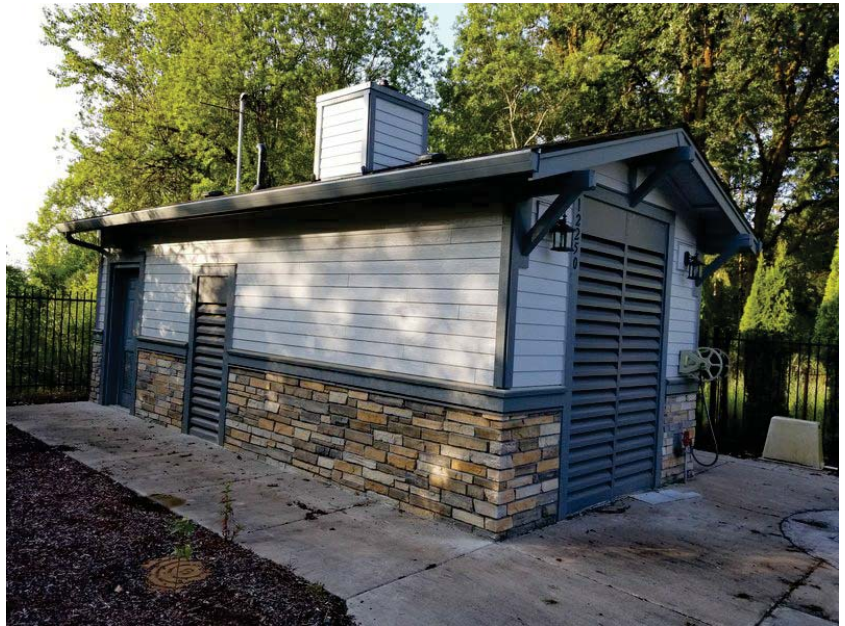
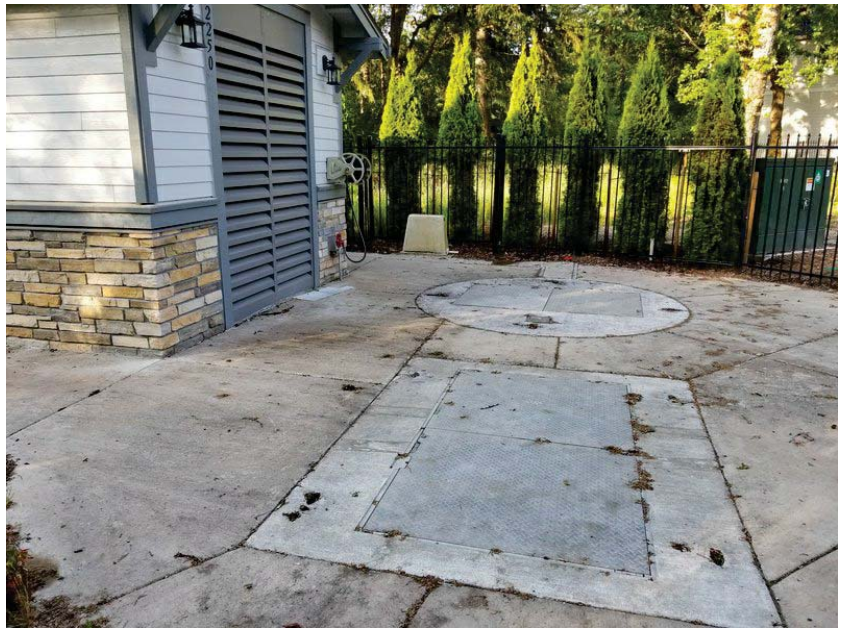
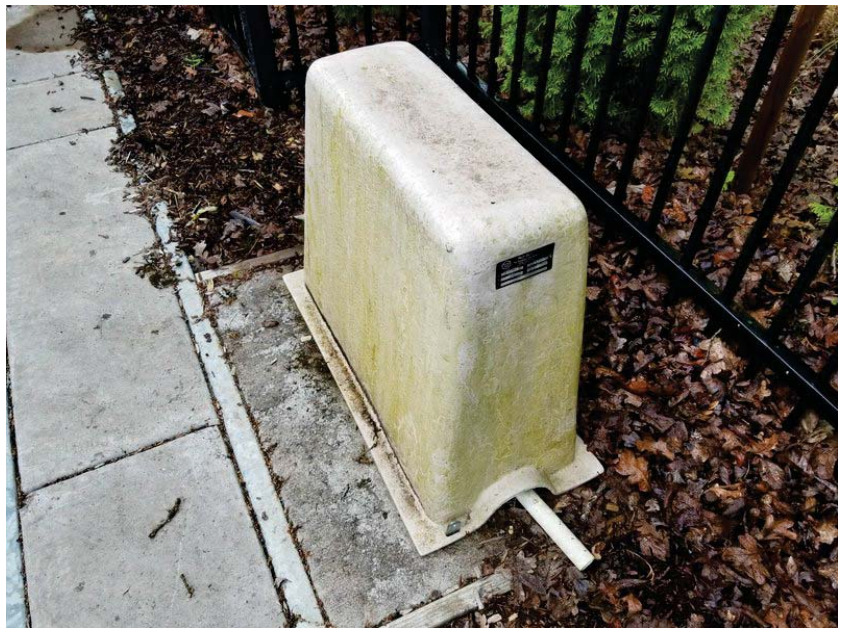
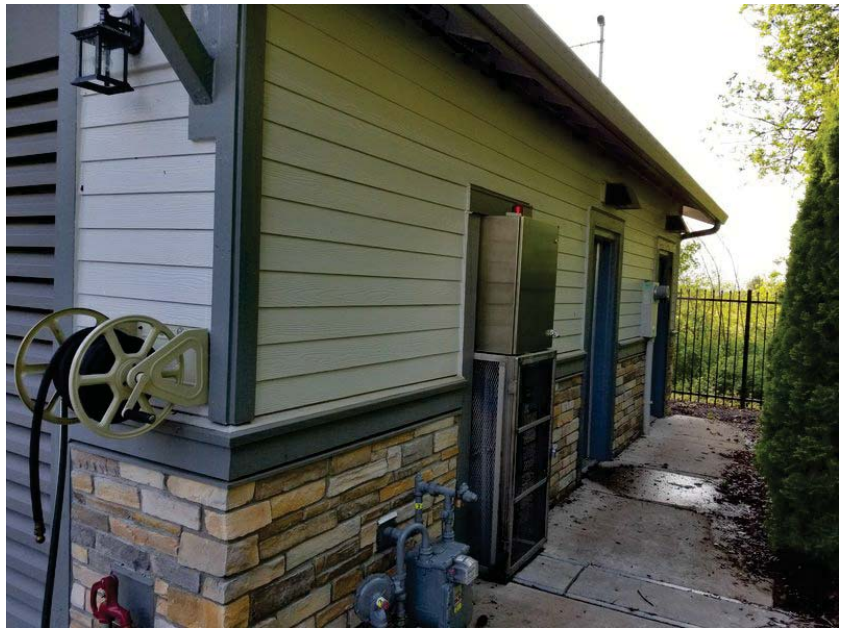
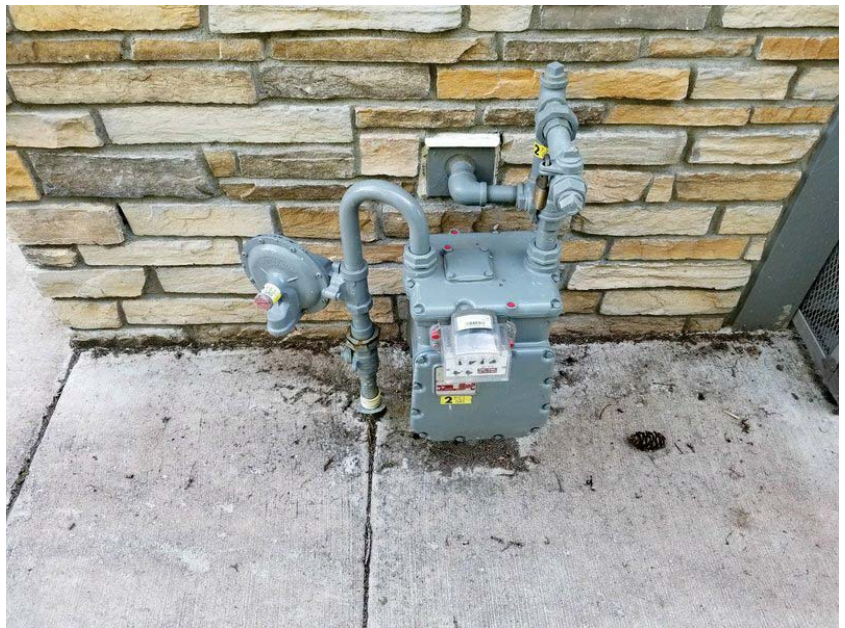
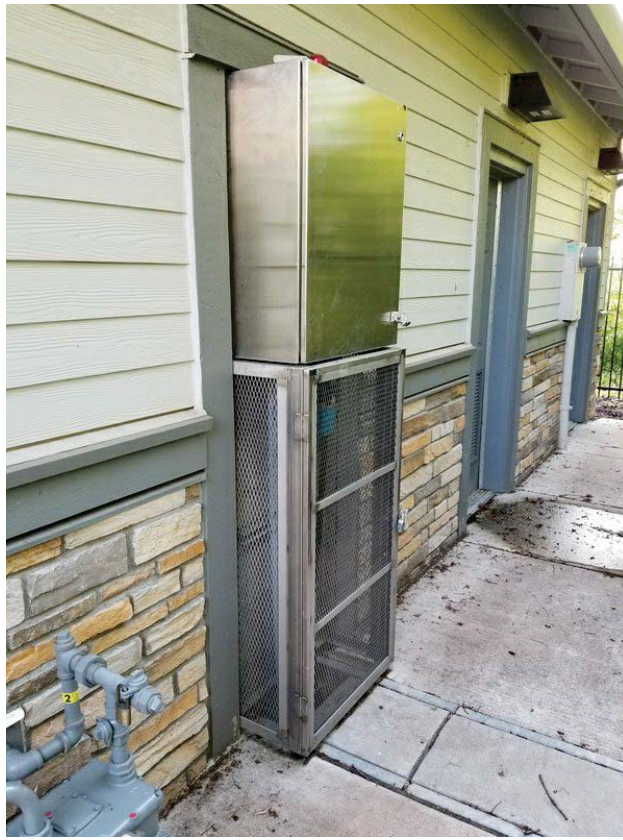
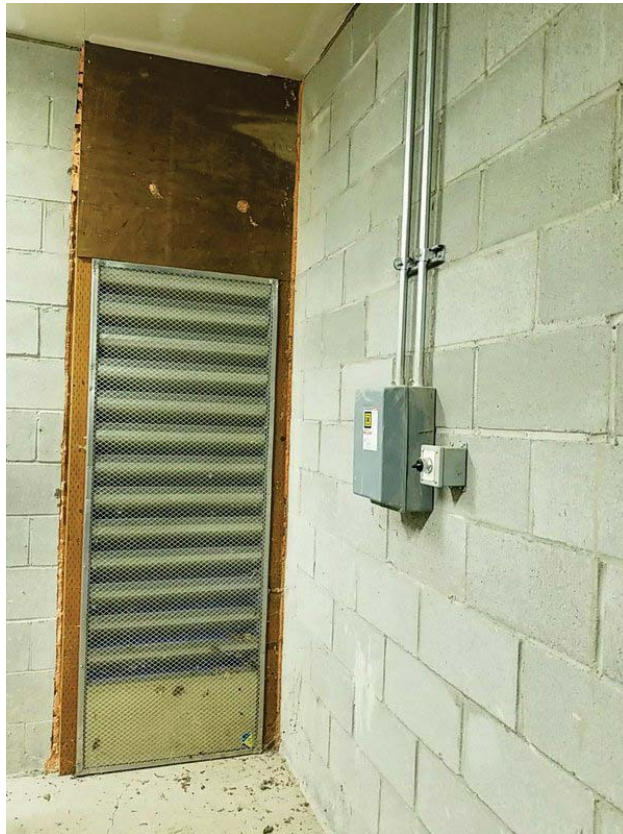
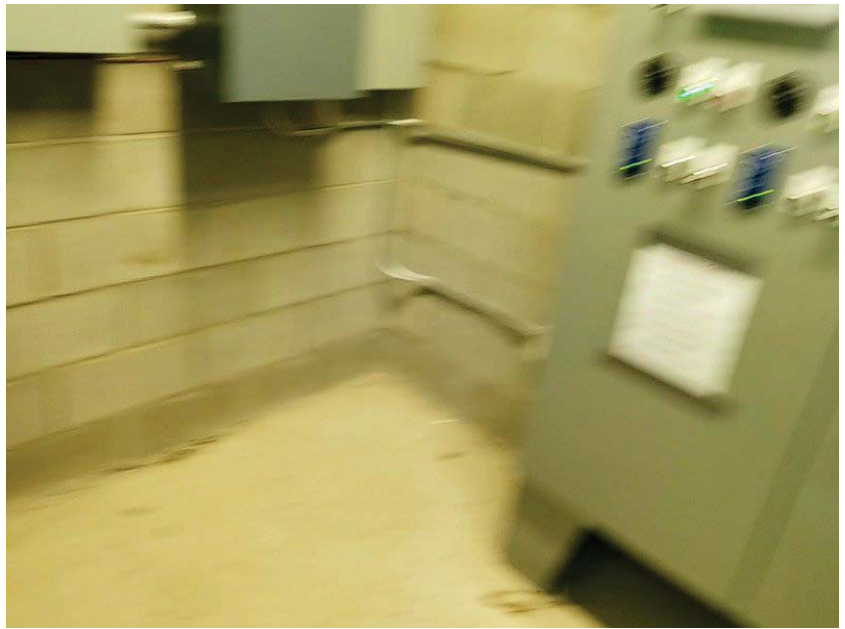
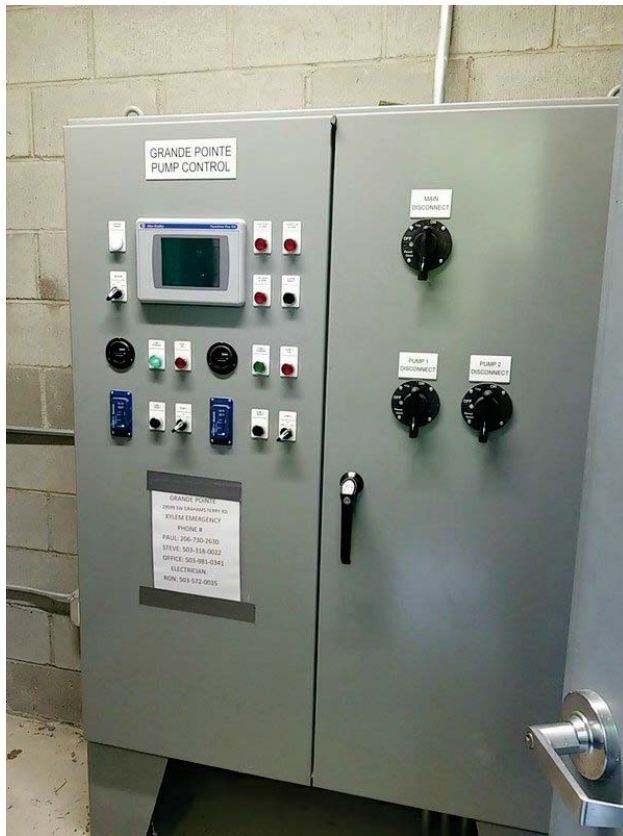
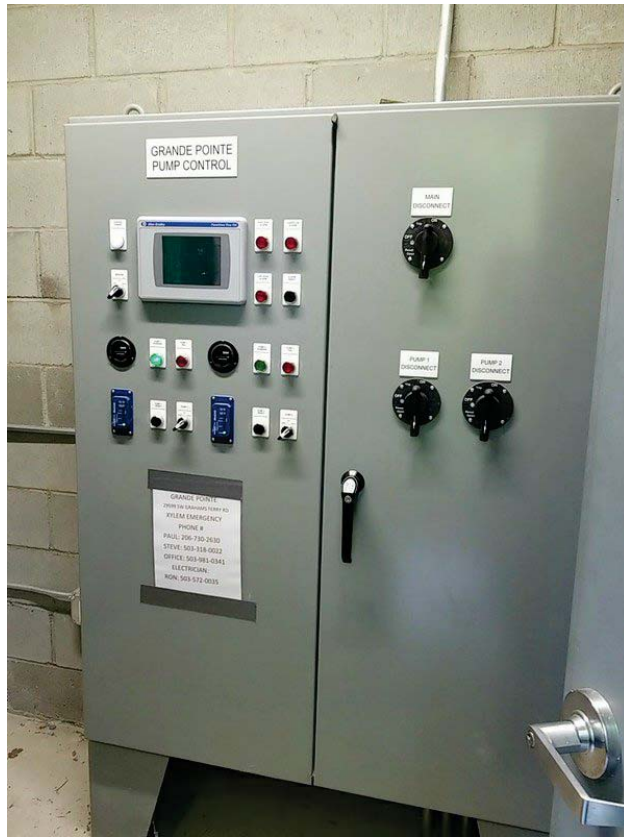
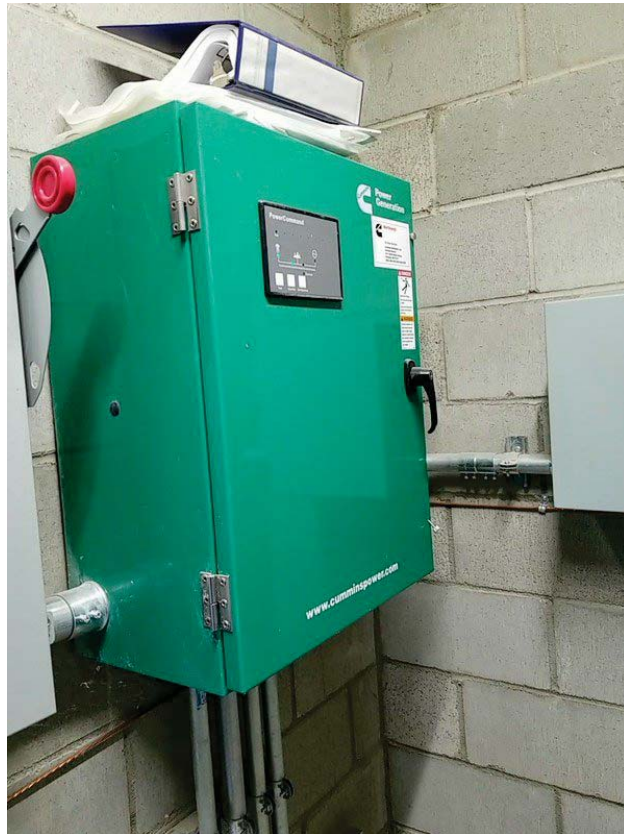
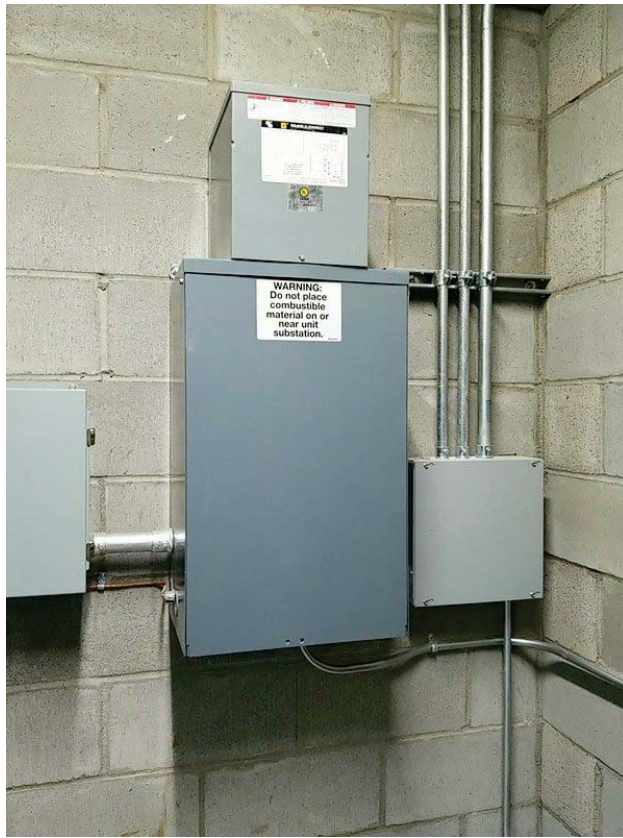
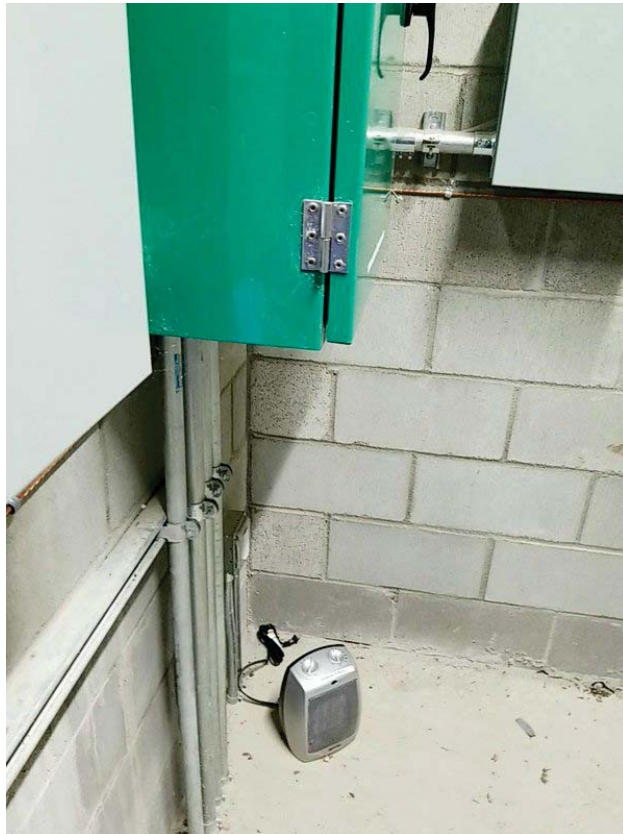
Photos

Lift Station	Grande Pointe LS
Station ID	GRANDEPOINTE-LS-09
Asset Description	Grande Pointe LS
What type of Asset?	Structural
Condition Score	1 - Excellent
Performance Score	1 - Component Functioning as Intended
Recommendation	No immediate action required

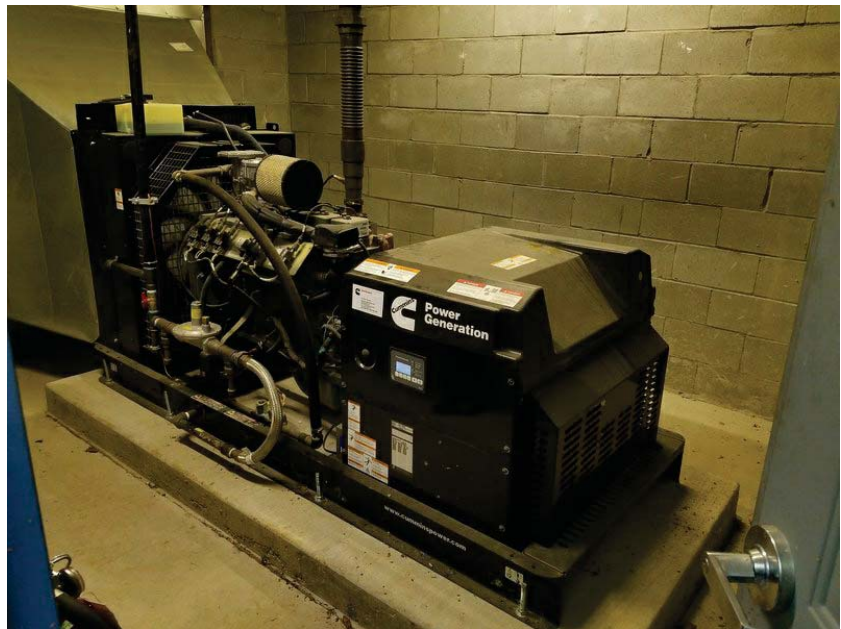
Lift Station	Grande Pointe LS
Station ID	GRANDEPOINTE-LS-09-AUX
Asset Description	Auxiliary Engine
What type of Asset?	Mechanical
Condition Score	1 - Excellent
Performance Score	1 - Component Functioning as Intended
Recommendation	No immediate action required

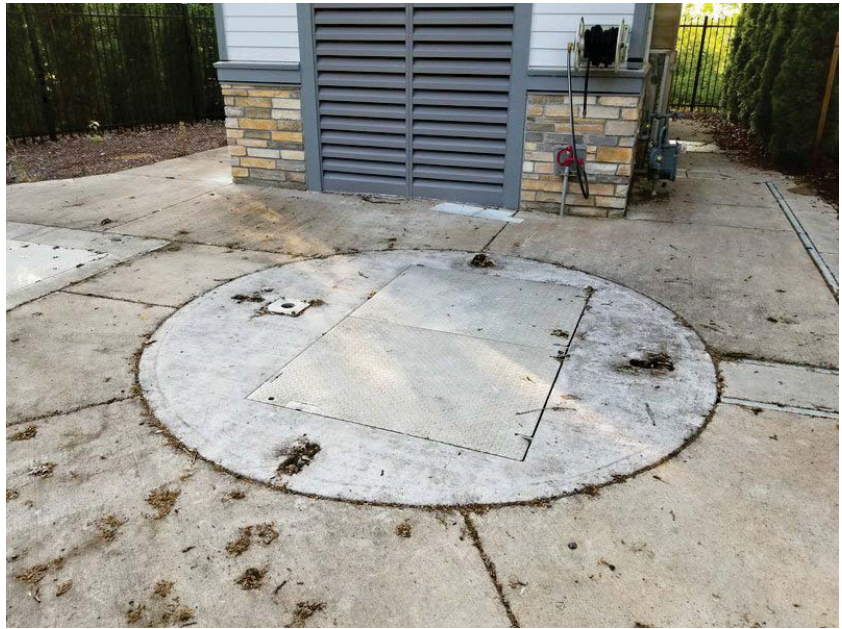
Lift Station	Grande Pointe LS
Station ID	GRANDEPOINTE-LS-09-P-1
What type of Asset?	Pumps and Motors
Condition Score	1 - Excellent
Performance Score	1 - Component Functioning as Intended
Recommendation	No immediate action required
Field Observations/Comments	Submersible pump could not be inspected

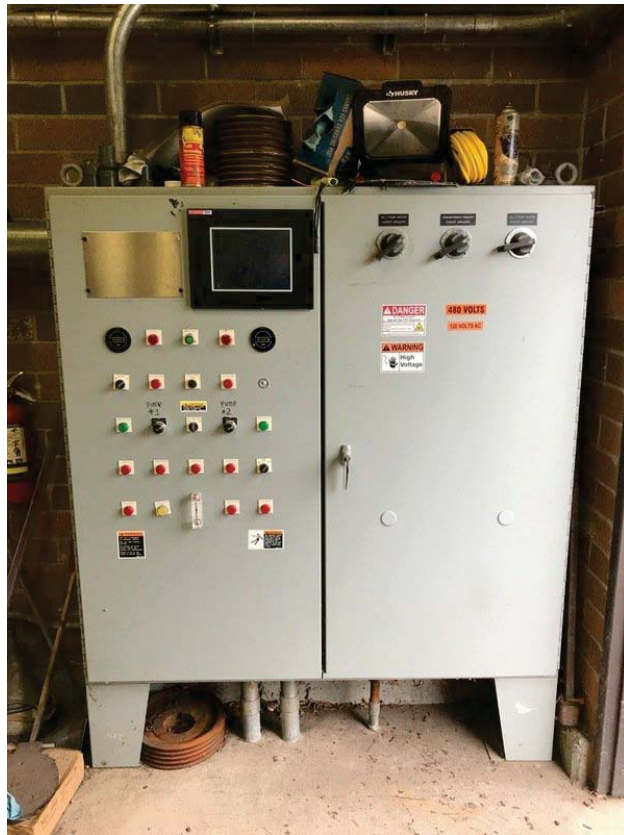
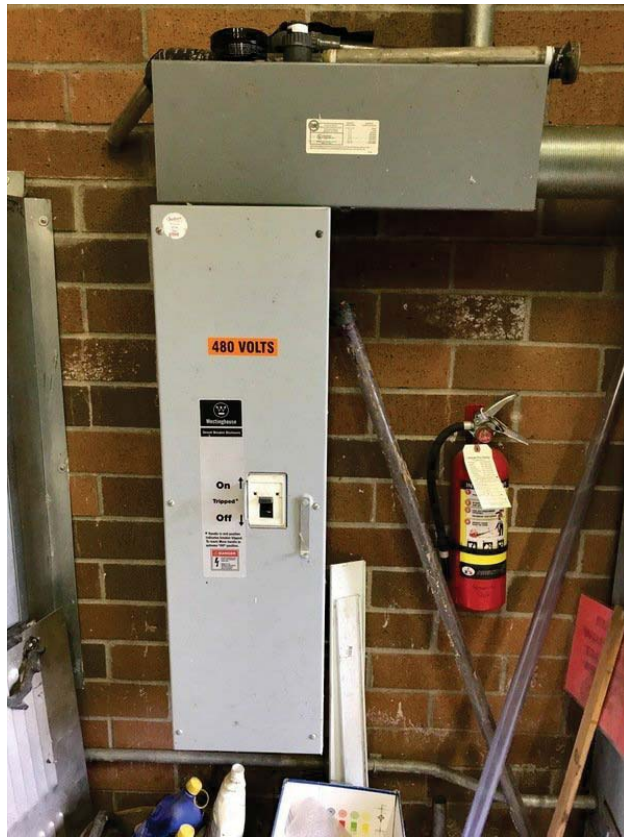
Description	Memoiral Park Control Panel
Condition Score	1 - Excellent
Performance Score	1 - Component Functioning as Intended
Recommendation	No immediate action required
Field Observations/Comments	Material stored in top of the control panel Should be removed.

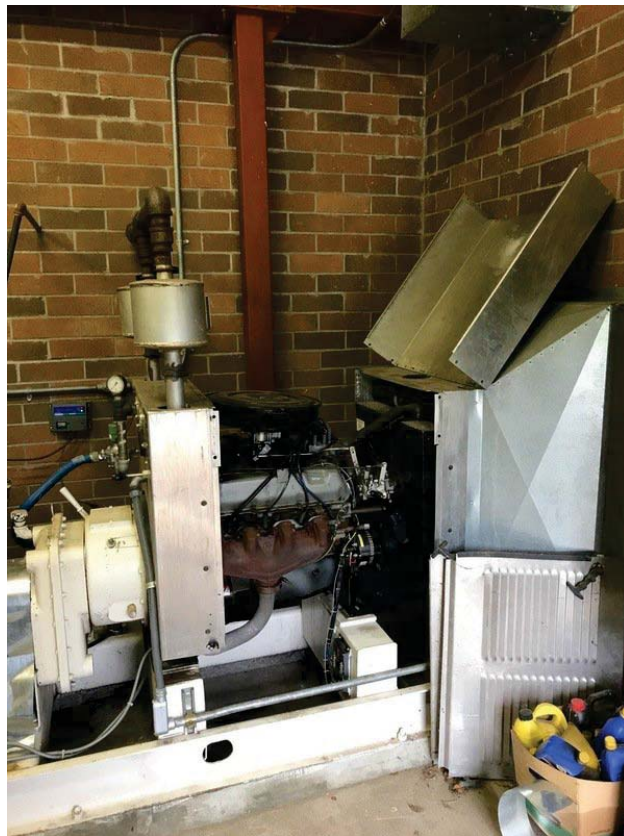
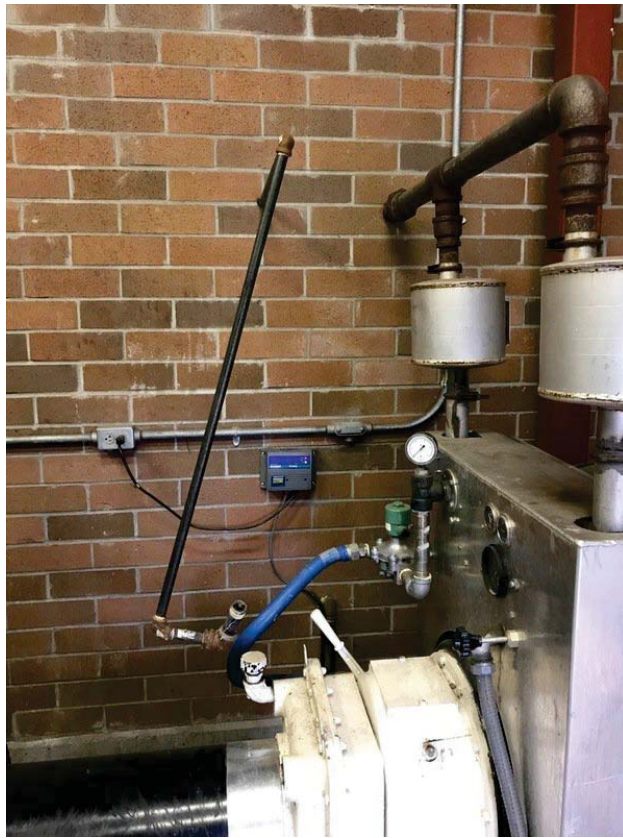
Lift Station	Memorial Park Auxillary Engine, MEMP-LS-03-AUX
Station ID	MEMP-LS-03-AUX
Asset Description	Memorial Park Auxillary Engine
What type of Asset?	Mechanical
Condition Score	2 - Slight Visible Degradation
Performance Score	1 - Component Functioning as Intended
Recommendation	Schedule corrective action work order near term
Field Observations/Comments	Engine did not run while onsite. Assume the engine functions as intended Covers need to be reinstalled as it is a safety hazard.
