# City of Wilsonville Triennial Inspection Report

Wilsonville WWTP and  
Wastewater Lift Stations:

Project Title: On-Call Civil Engineering and Related Services,  
Triennial Inspection of the Wilsonville WWTP and Nine Lift Stations

Subject: 2019 Triennial Inspection of the Wilsonville WWTP  
and Sewage Lift Stations

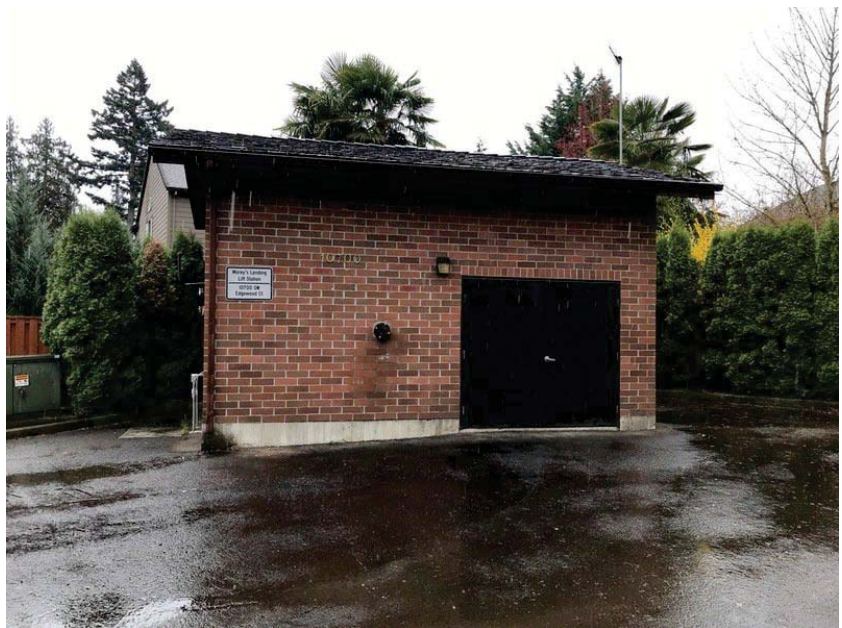
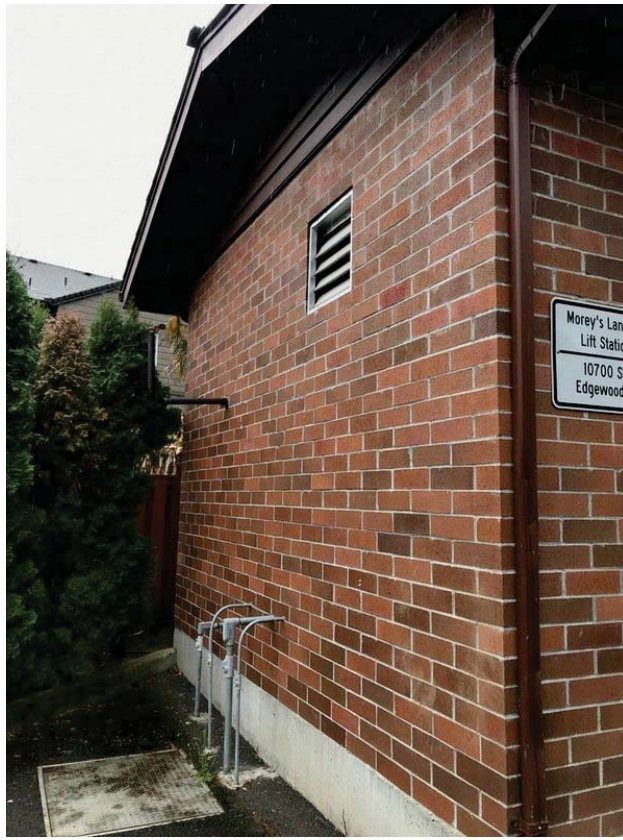
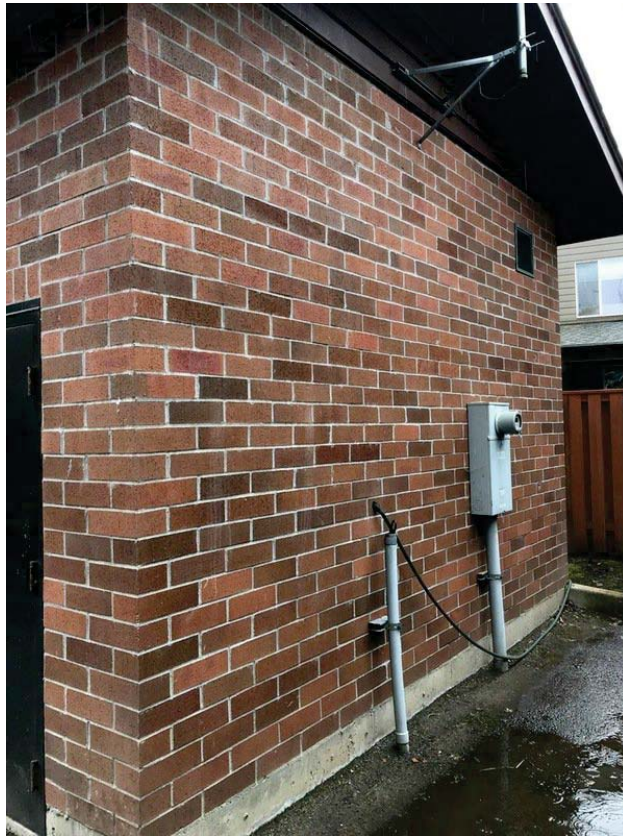
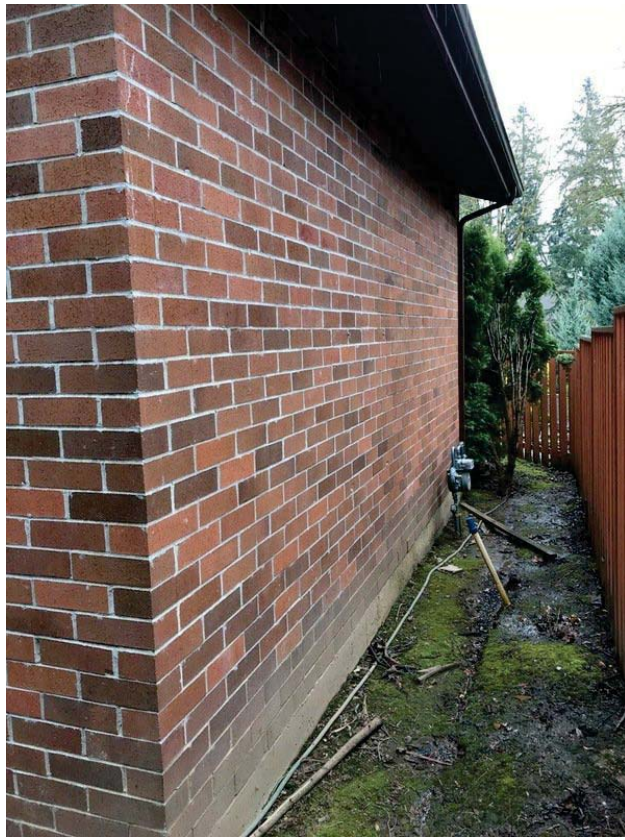
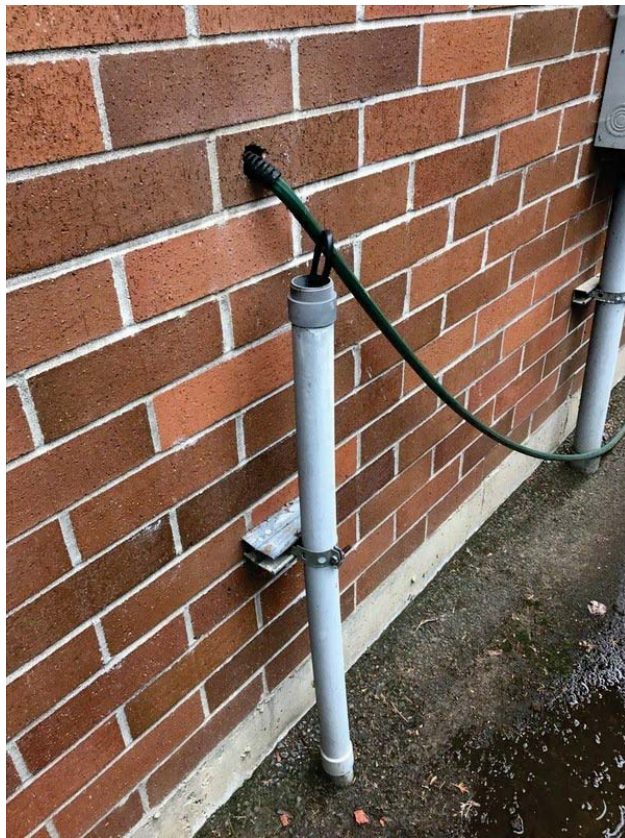
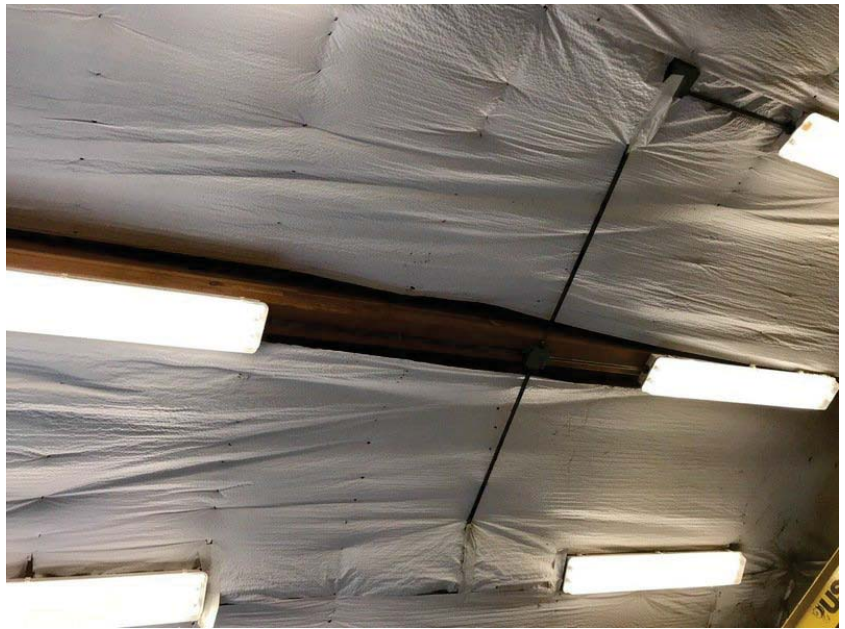
Lift Station	Morey's Landing Lift Station, MORL-LS-08
Station ID	MORL-LS-08
What type of Asset?	Structural
Condition Score	2 - Slight Visible Degradation
Performance Score	1 - Component Functioning as Intended
Recommendation	Schedule corrective action work order near term
Field Observations/Comments	Junction box for pump and check instrumentation not secured in place. Insulation starting to fall down Plastic cover on ceiling coming down in the center. No confined space entry sign on wet well. Hose running from inside pump station to soaker system for trees. General house keeping issues.

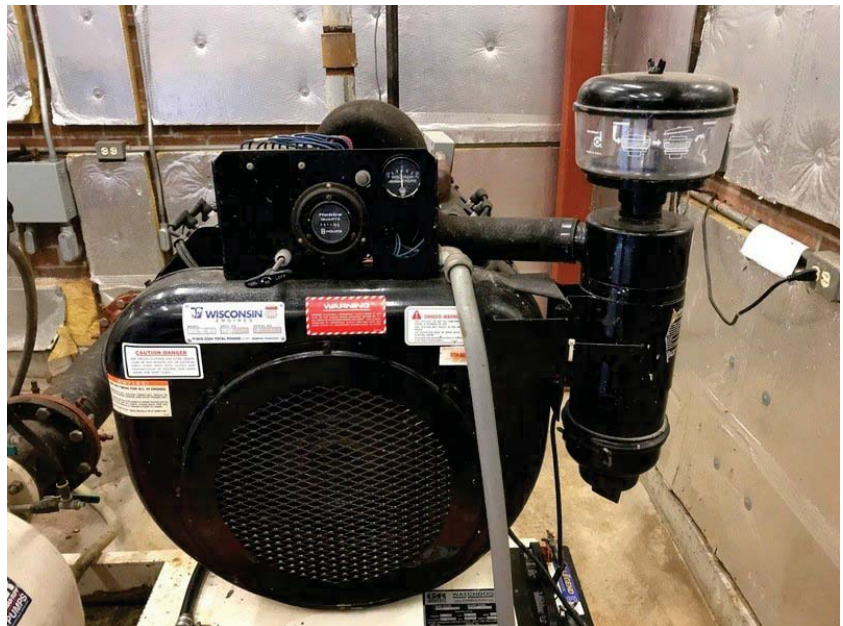
Field Observations	Corrosion
Condition Score	3 - Visible Degradation
Performance Score	1 - Component Functioning as Intended
Recommendation	Schedule corrective action work order near term
Field Observations/Comments	Unit did not operate while onsite Electrical connections corroded Battery not tied down No cover over battery posts Frame corroded Gas supply line is not supported very well and could easily be knocked out of place by an employee.

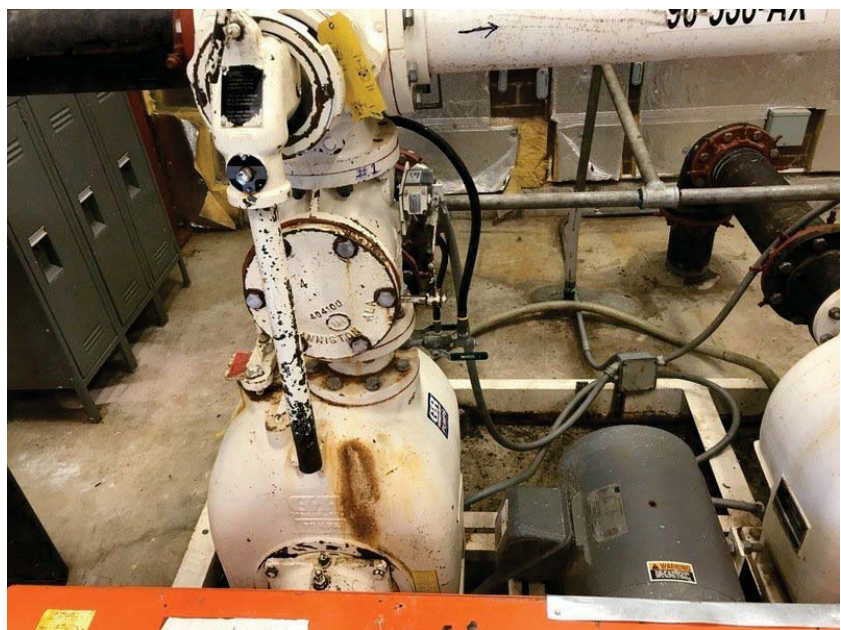
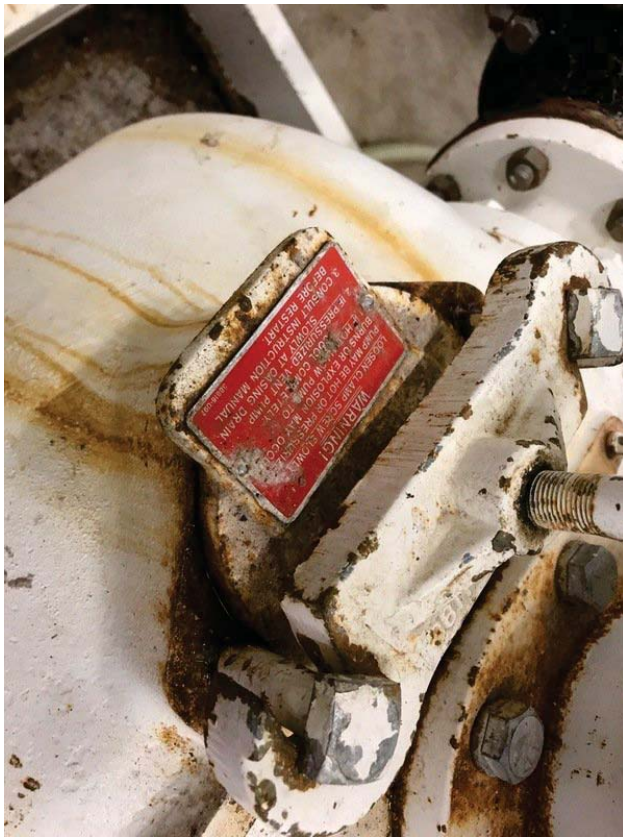
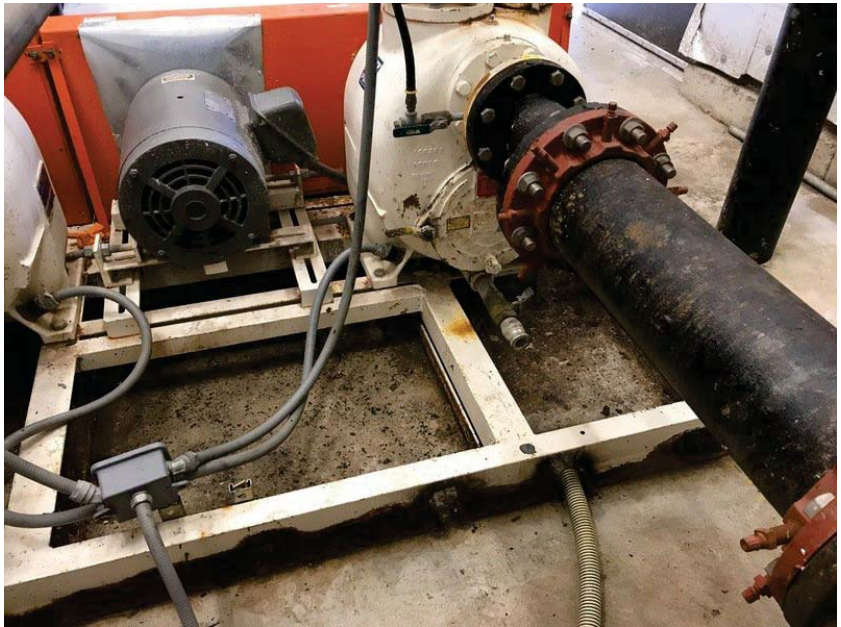
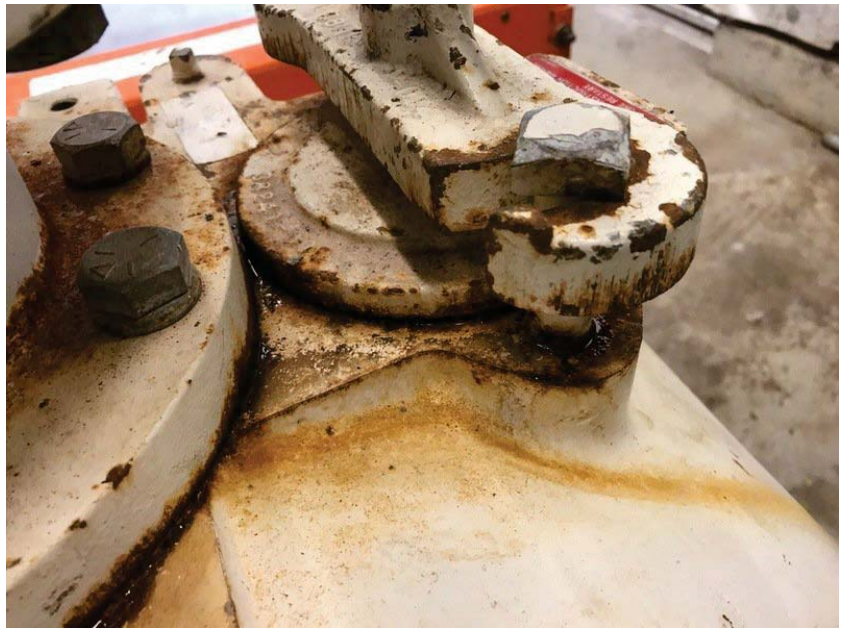
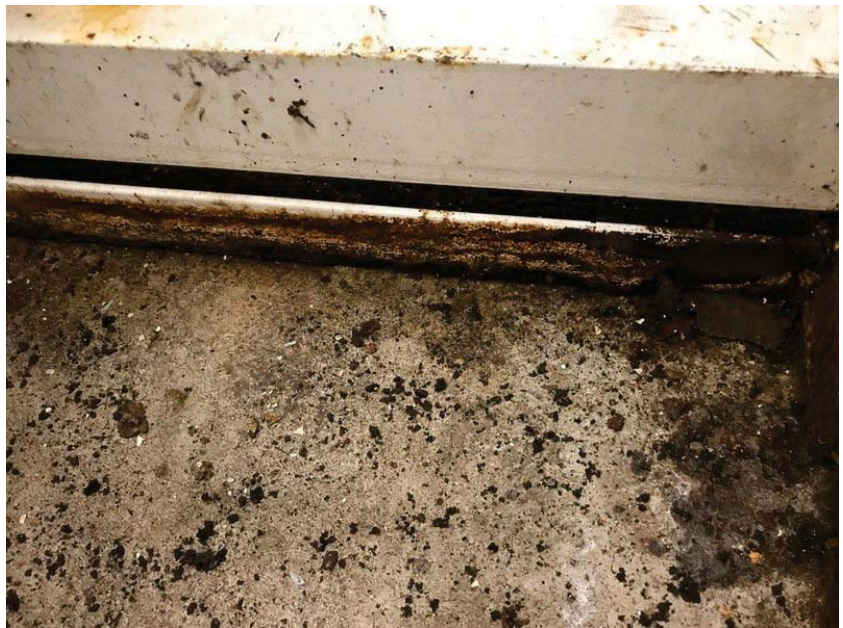
Field Observations	Corrosion
Condition Score	3 - Visible Degradation
Performance Score	1 - Component Functioning as Intended
Recommendation	Schedule corrective action work order near term
Field Observations/Comments	Pump mounting frame corroded Leak on inspection cover

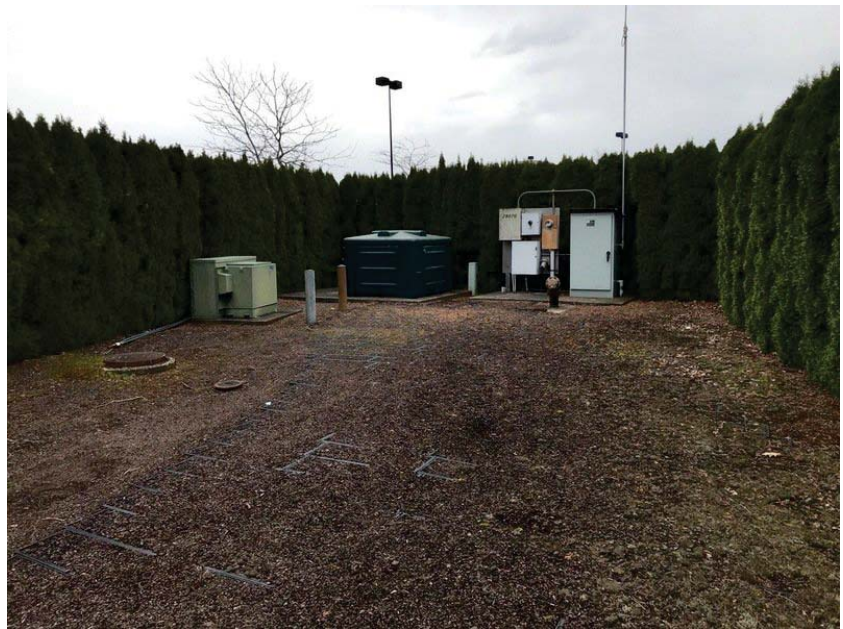
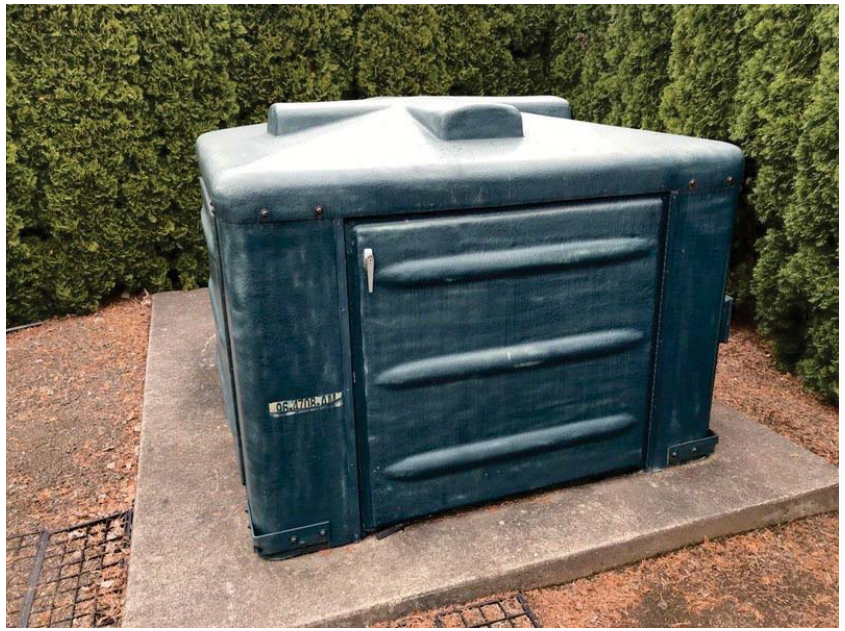
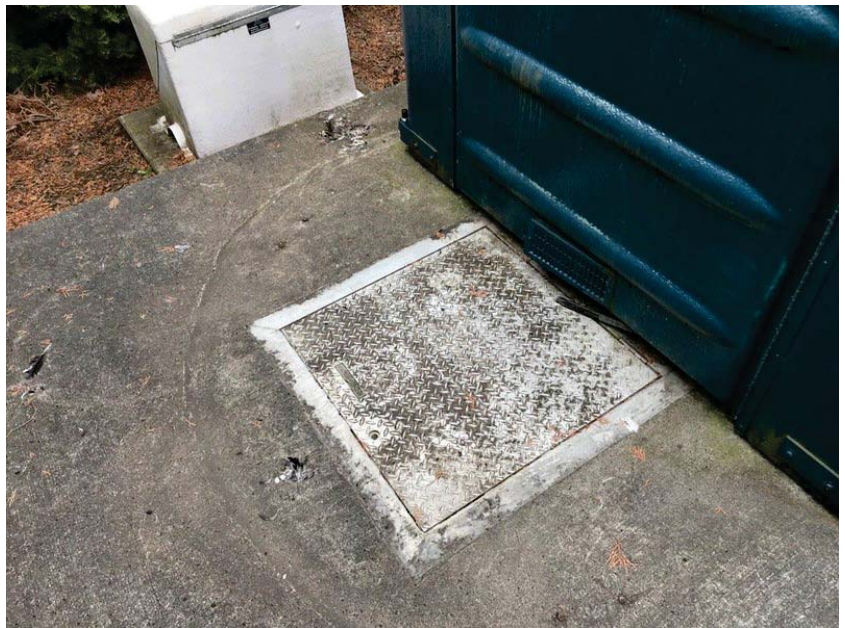
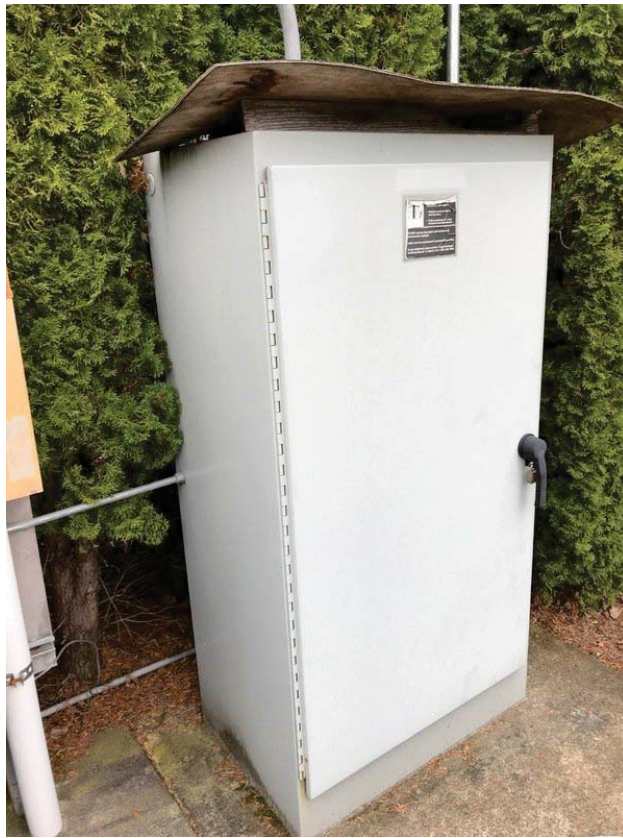
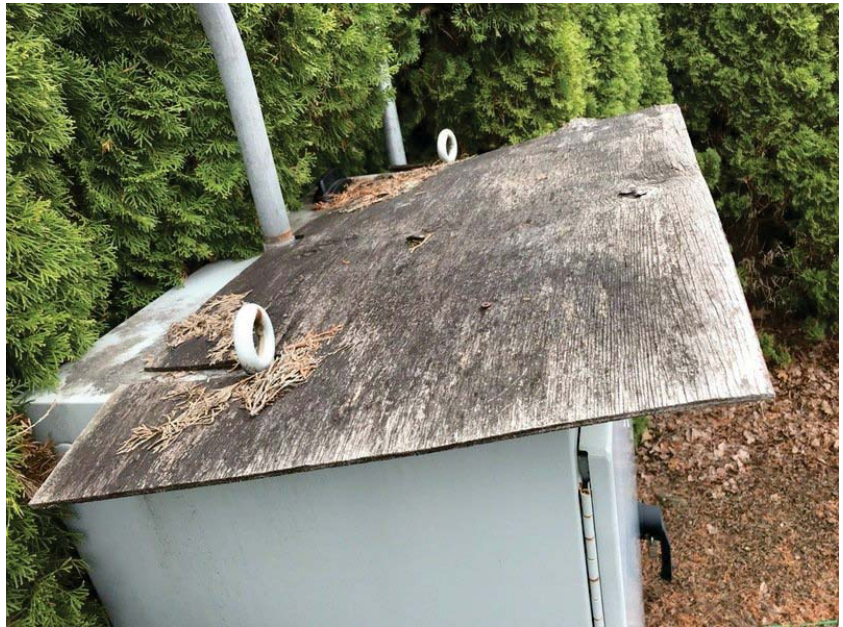
Lift Station	Town Center Lift Station, TOWNCENTER-LS-02
Station ID	TOWNCENTER-LS-02
What type of Asset?	Structural
Condition Score	2 - Slight Visible Degradation
Performance Score	1 - Component Functioning as Intended
Recommendation	No immediate action required
Field Observations/Comments	Overall condition looks good. Not sure why there is wood on top of the one panel.

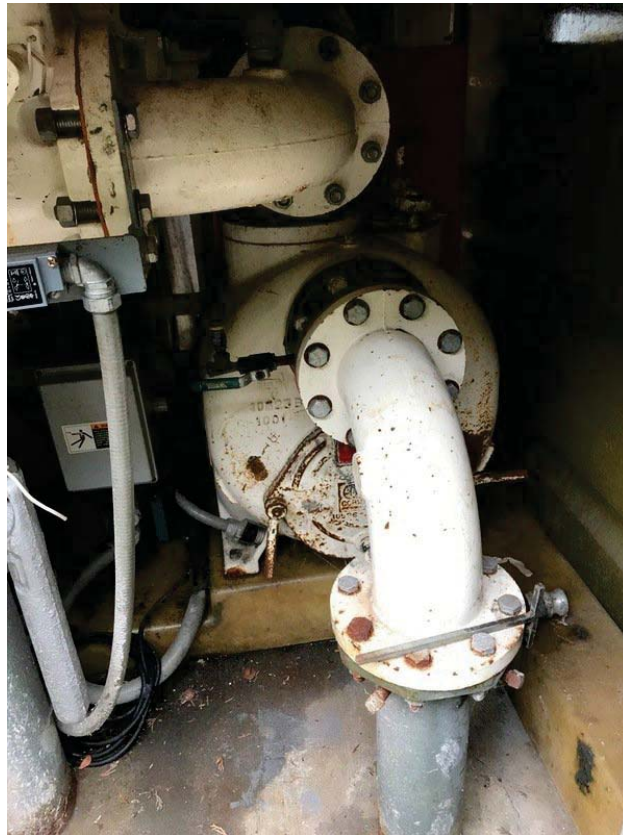
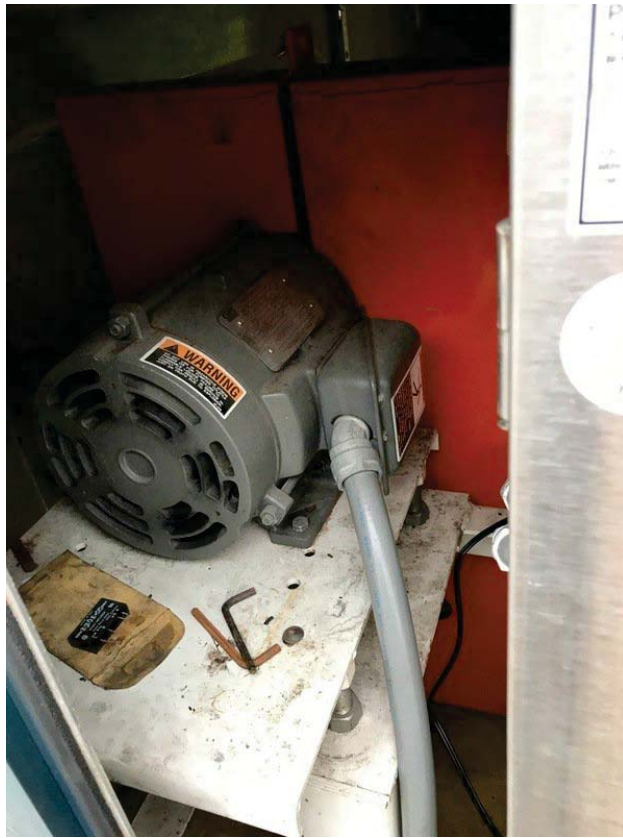
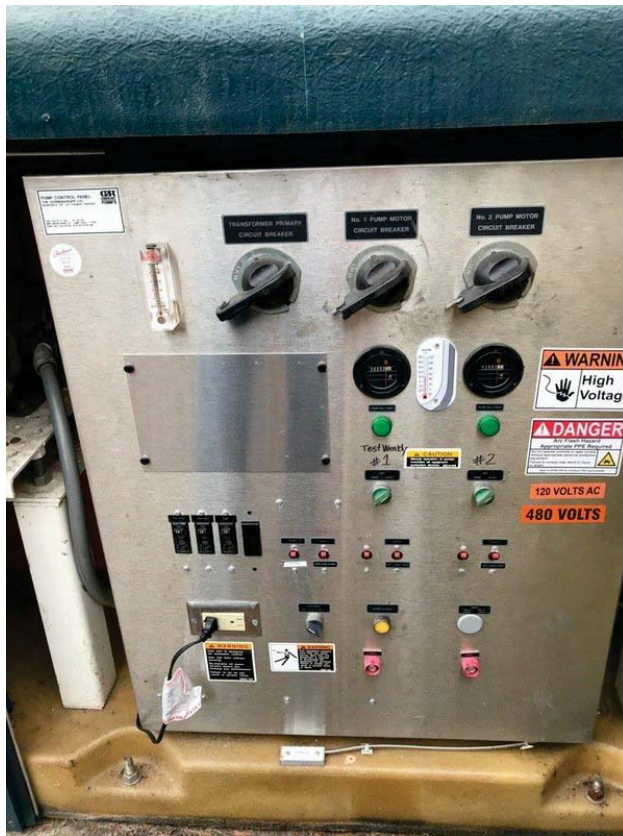
Lift Station	Town Center Lift Pump #1, TOWNCENTER-LS-02-P-1
Station ID	TOWNCENTER-LS-02-P-1
What type of Asset?	Pumps and Motors
Condition Score	2 - Slight Visible Degradation
Performance Score	1 - Component Functioning as Intended
Recommendation	No immediate action required
Field Observations/Comments	Pump seems to be in good condition Pump did not run while on site

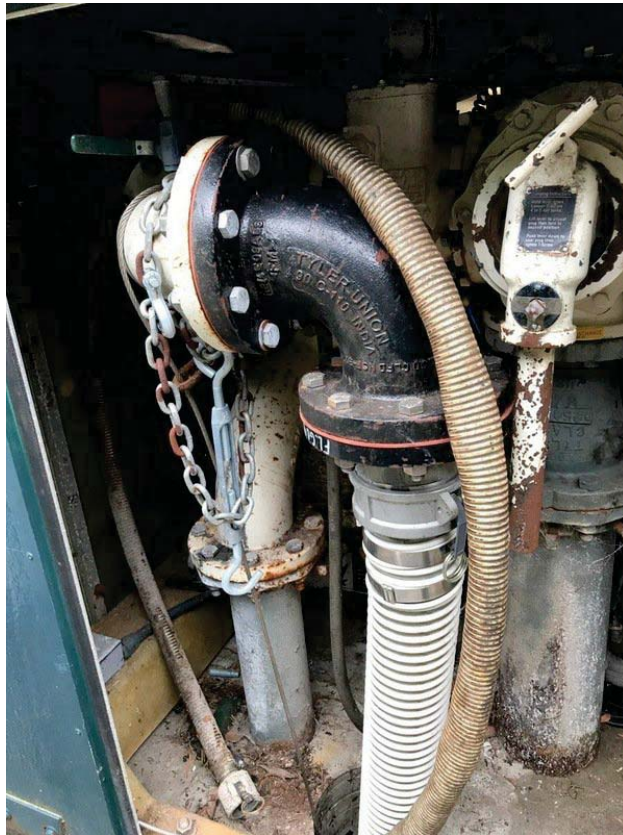
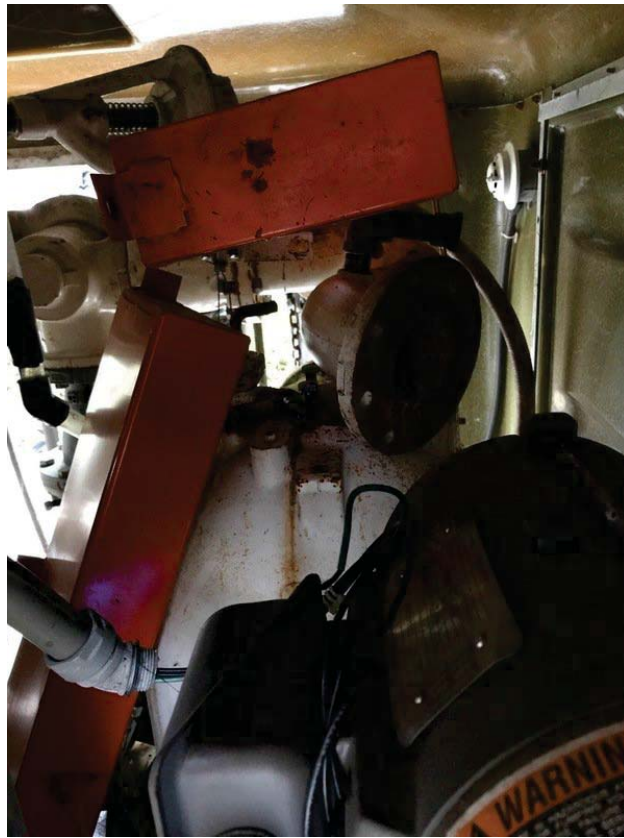
Lift Station	Town Center Lift Pump #2, TOWNCENTER-LS-02-P-2
Station ID	TOWNCENTER-LS-02-P-2
What type of Asset?	Pumps and Motors
Condition Score	2 - Slight Visible Degradation
Performance Score	1 - Component Functioning as Intended
Recommendation	Schedule corrective action work order near term
Field Observations/ Comments	Pump number 2 belt guard and elbow stored on top of the pump. Install belt guard and remove elbow.
